Report on the investigation of
the grounding of
mv Willy
Cawsand Bay, Plymouth Sound
1 January 2002

Marine Accident Investigation Branch
First Floor
Carlton House
Carlton Place
Southampton
United Kingdom
SO15 2DZ

Report No 31/2002
October 2002

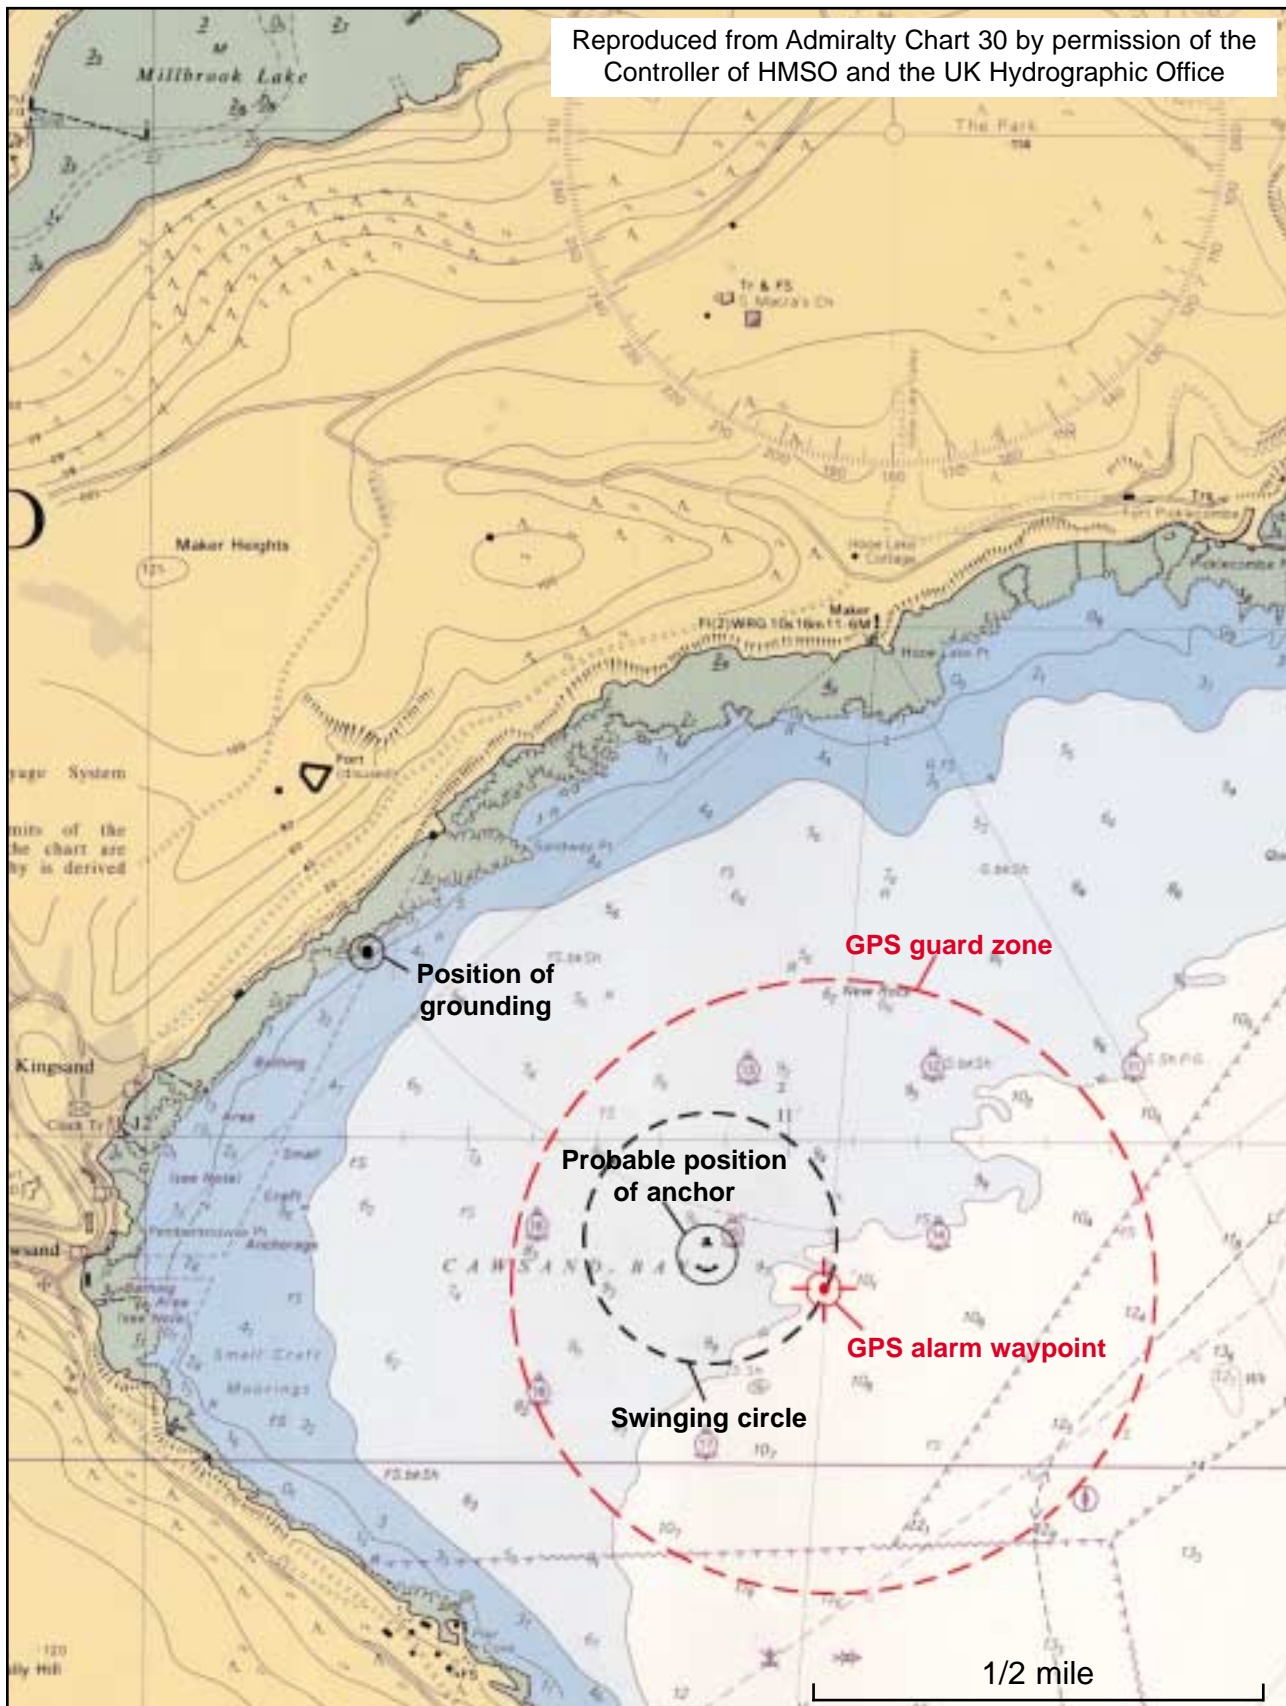
Figure 2

Willy was fitted with 2 bow anchors, each weighing 1445kg, with 8 shackles of chain cable, which had last been replaced in October 1999. A spare bow anchor was also carried. The GPS receiver was located above the radar display and could be monitored by the OOW while seated in the bridge chair. Following the accident, the GPS receiver was removed from the ship and examined ashore. Information retrieved from the receiver indicated that the position on which the 3-cable guard zone was centred was 50°19.85N, 004°10.94W (**Figure 2**), which was 5.6 cables away from the position when aground.

Chart extract showing *Willy's* estimated anchorage position, swinging circle and GPS guard zone

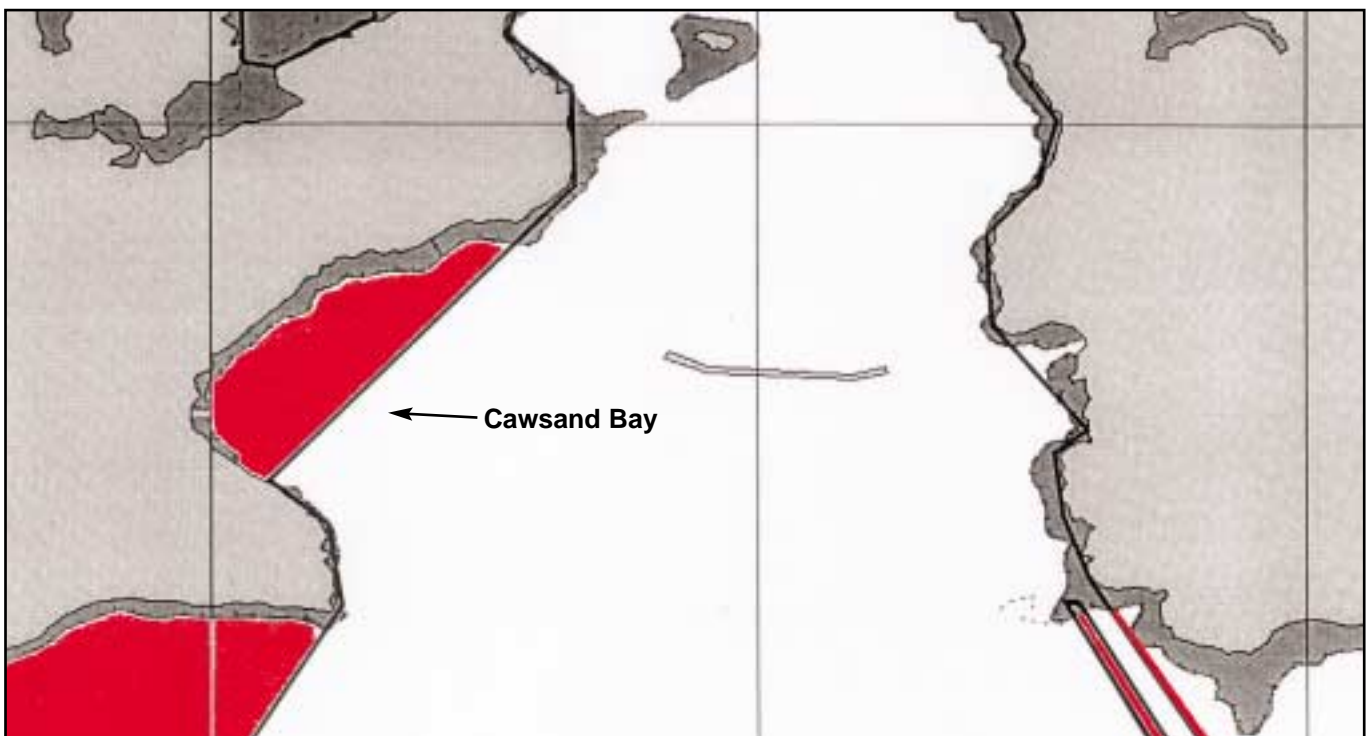
Figure 3

To assist Longroom Port Control meet its VTS function, radar coverage of Plymouth Sound is achieved by radar heads located at Longroom, and on Drake's Island. The diagram showing the combined radar coverage of these heads (**Figure 3**) shows that coverage of the deep water channels and main anchorages was satisfactory, but that much of Cawsand Bay was in a radar blind spot. When the pilot initially called, informing Longroom Port Control that *Willy* had anchored in No 15, she was painting on radar and the HCO estimated that she was about 0.5 cable to the south-east of the charted anchorage position. When *Willy* was lying to the west of anchorage No. 15, however, she could not be seen on the radar displays within the Port Control.

Diagram showing radar coverage in Plymouth Sound
- red areas indicate radar blind spots

Planned improvements to the radar and CCTV coverage, which are being progressed as part of a programme of continuous improvement to the VTS in Plymouth, will provide enhanced radar and CCTV coverage in Cawsand Bay when implemented. These are planned to be completed by mid 2003.
