Report on the investigation of an
accommodation fire on

mv Rosebank

14 December 2001

**Report No 28/2002
August 2002**

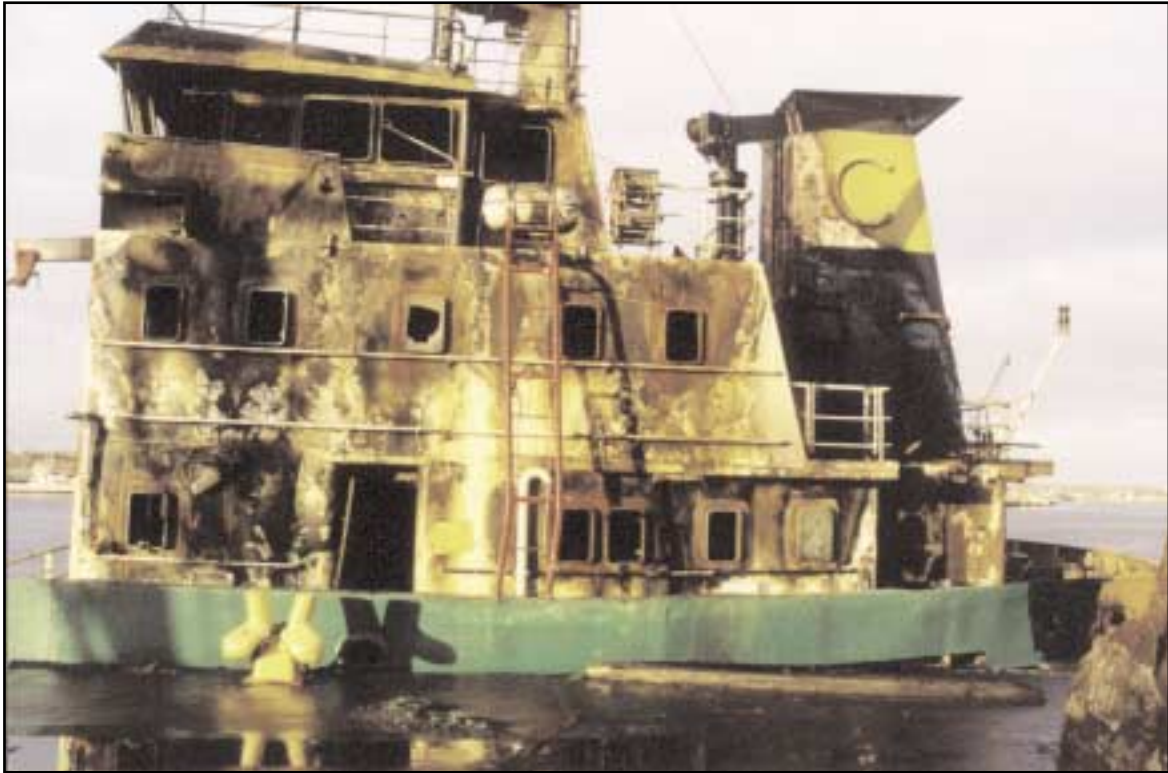
Figure 6

The accommodation block from the poop deck to the bridge was burnt out; only the main structure was left standing. The provision room was burnt out with severe deckhead damage in the laundry and lobby area. The washing and drying machines had suffered heat damage, but had not been burnt out. The engine workshop suffered fire and smoke damage at deckhead level, with evidence of heat transmission downwards, which damaged the upper part of the main switchboard.

Port side of superstructure

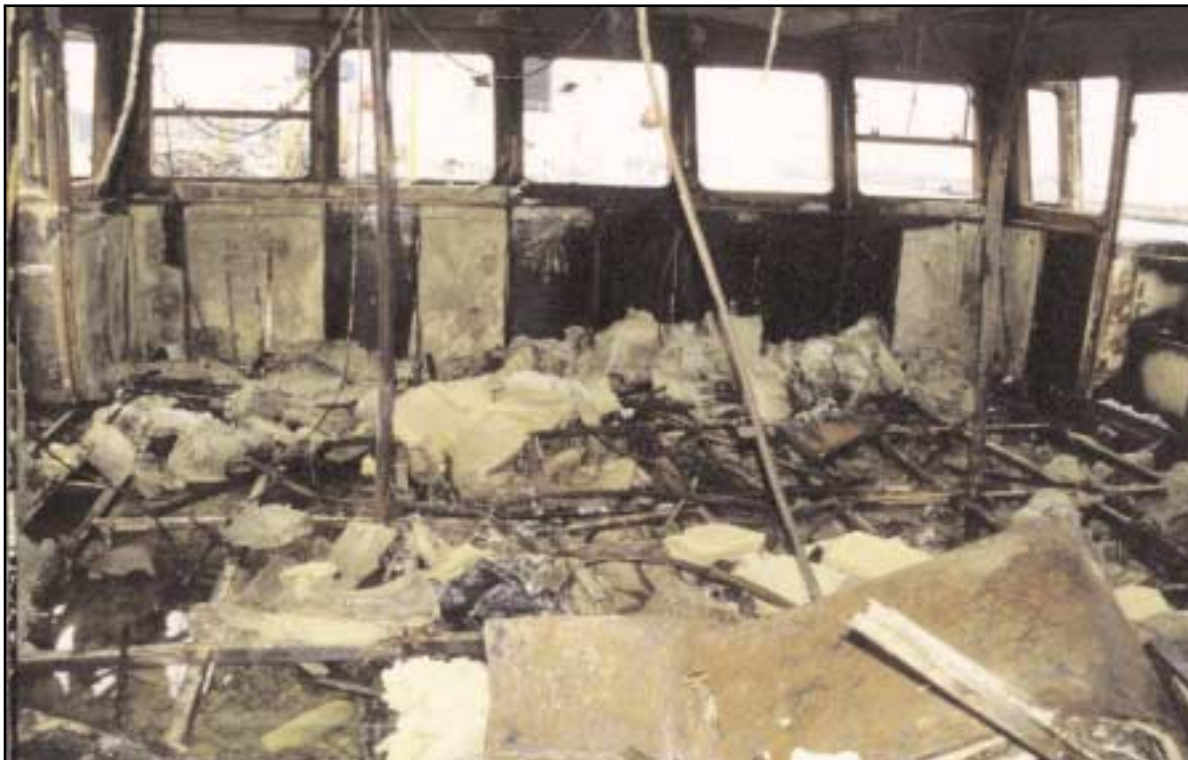
Figure 7

Fire damage

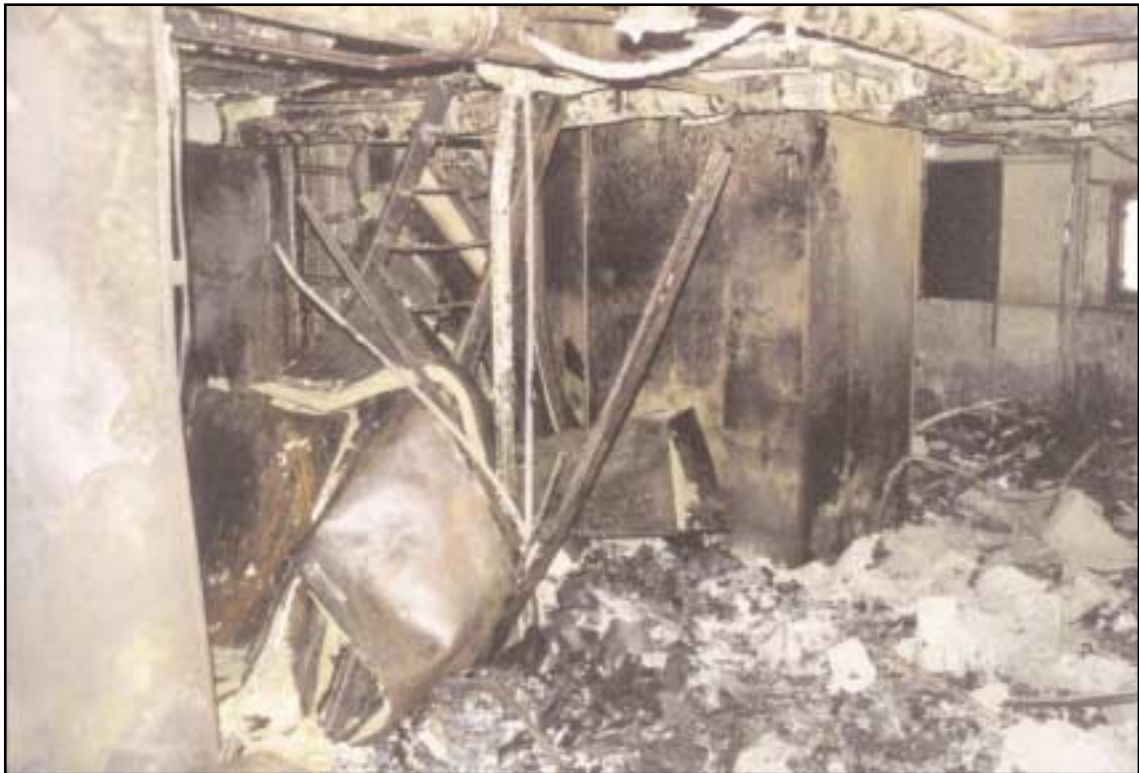
Figure 8

General view of fire damage of deck

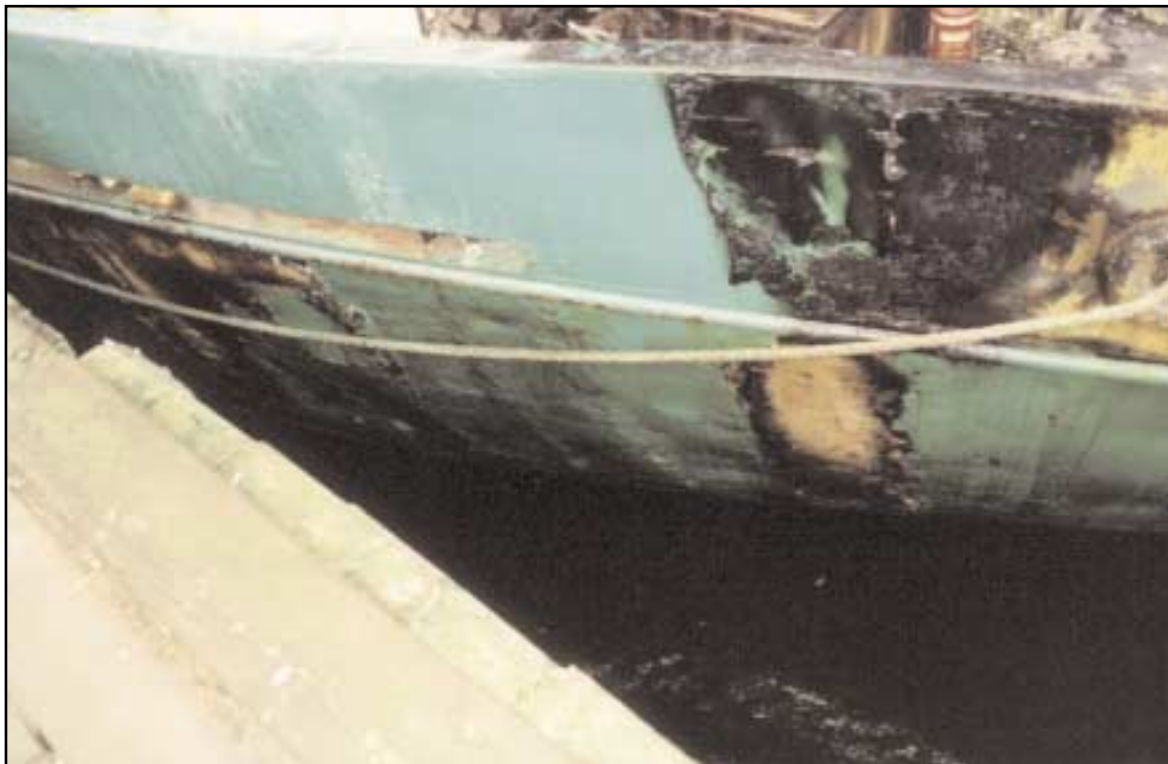
Figure 9

The port quarter of the vessel suffered severe fire damage on the bulwark, but only in the area of the provision store on the hull itself.

Port quarter showing "hot spot" on hull

A very distinctive and localised burn mark on the port quarter of the hull plating, in way of the provision room, suggests a particular point of intense heat. From the master's evidence, this roughly corresponds to an area in the provision room where toilet rolls were stacked on shelving, together with vegetables. Although all consumables, no readily available source of ignition such as electrical cables, light bulbs etc was in this area of the space. It is likely, therefore, that this was a secondary fire and not the initial cause.

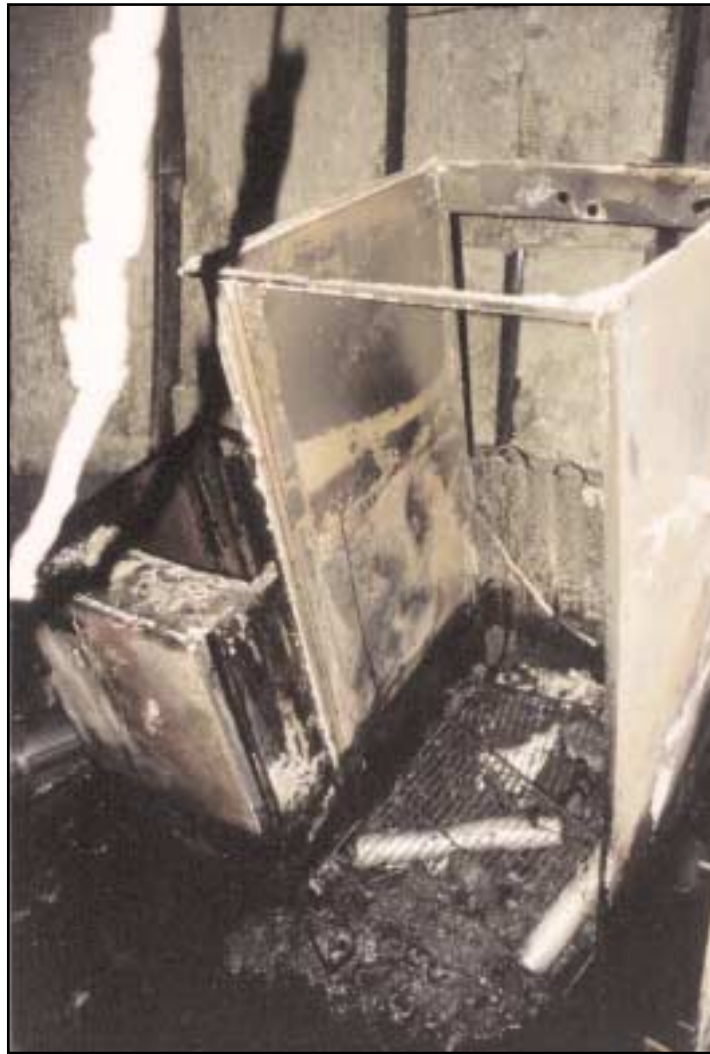
Figure 10

- 2.2.4 Given the contents of the provision store, spontaneous combustion is unlikely. It is probable, therefore, that the source of ignition was either an electrical fault in the electric motors of one of the fridges or freezers, or within the adjacent sockets and cabling. The strongest possibility is that a fault developed in a motor compartment of a fridge/freezer, causing a local fire within the unit. This in turn spread and developed using accumulated dirt, dust, and oil within the motor space as fuel. The subsequent ignition of the plastic covering of that unit, followed by adjacent units, would lead to a major fire developing in the space, and the generation of thick white acrid smoke.

Remains of fire damaged upright freezer

1. Although the site of the fire has been identified as the provisions room, the exact seat and cause of the fire has not been identified.
2. The most probable cause was an electrical failure within the motor compartments of one of the domestic fridges or freezers operating within the space. The subsequent ignition of residual dust, dirt or other debris within the motor cabinet led to a significant fire within that and other adjacent units.

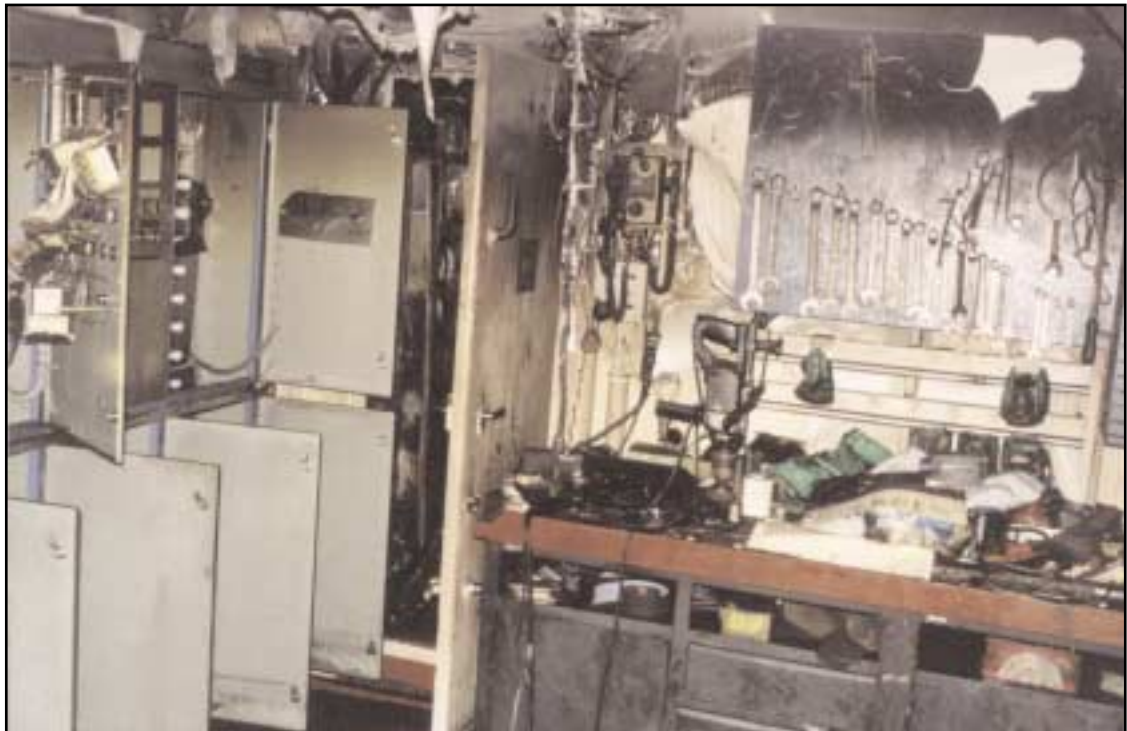
Figure 11

Engine workshop showing damaged deckhead
Note: lack of fire damage to items on workbench

Note open vent to
provision store below

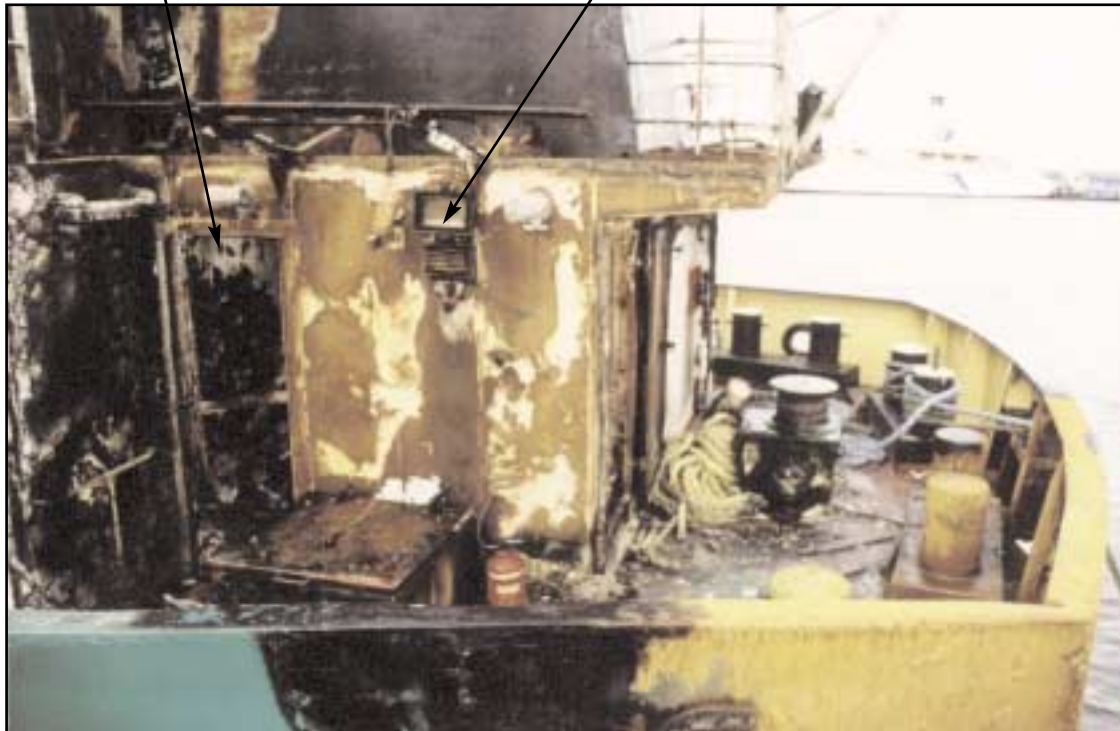
Figure 12

View of port quarter
