Report on the investigation of  
the failure of a warp block  
on board the UK registered fishing vessel

***Ocean Star***

north of the Shetland Islands

**Report No 13/2003  
May 2003**

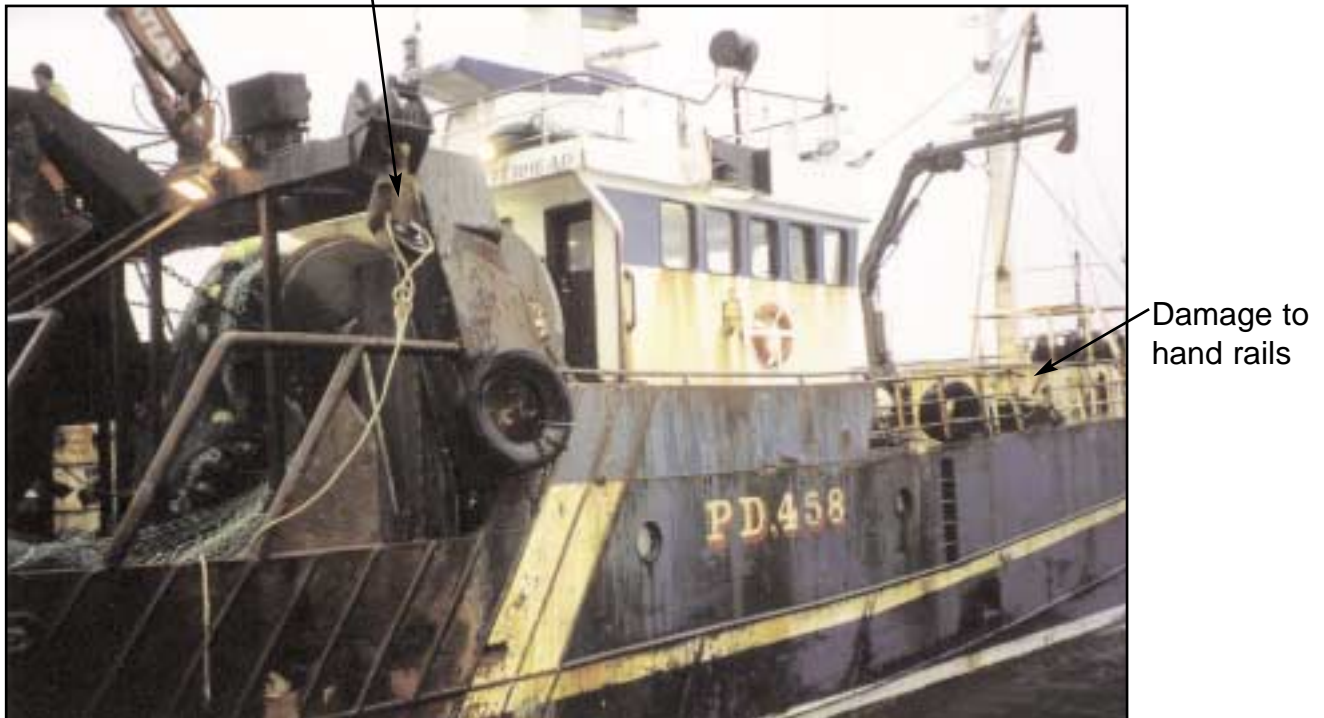
An analysis of the block showed that it had failed under load because of progressive wear of a cheek plate caused by the outward movement of a bearing sleeve. A full inspection of this block by a registered body for the purpose of certifying it safe, might well have detected the use of thin sleeving and have caused the block to be withdrawn from service as a result.

A view of *Ocean Star* and of the broken starboard main warp block

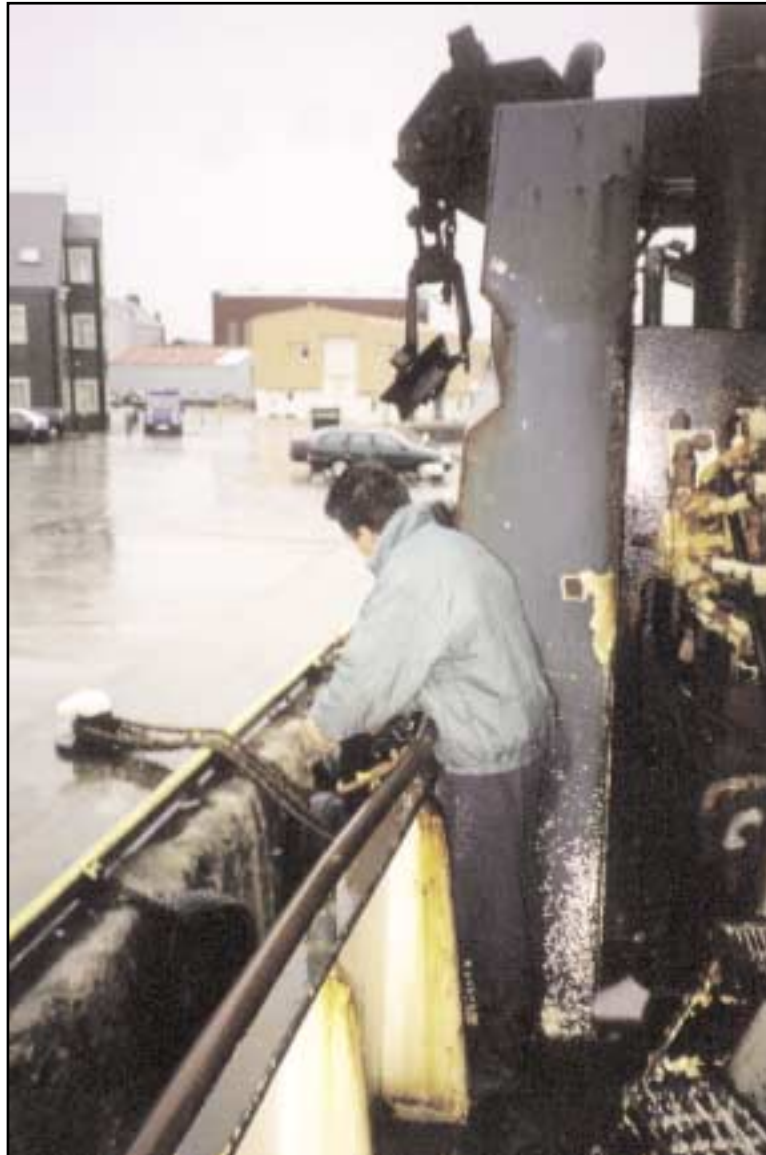
From the wheelhouse, the skipper saw the deckhand lying limp over the hand-rail (**see photograph 3**). He shouted for assistance from the rest of the crew, who arrived shortly afterwards.

The skipper standing where the deceased was found

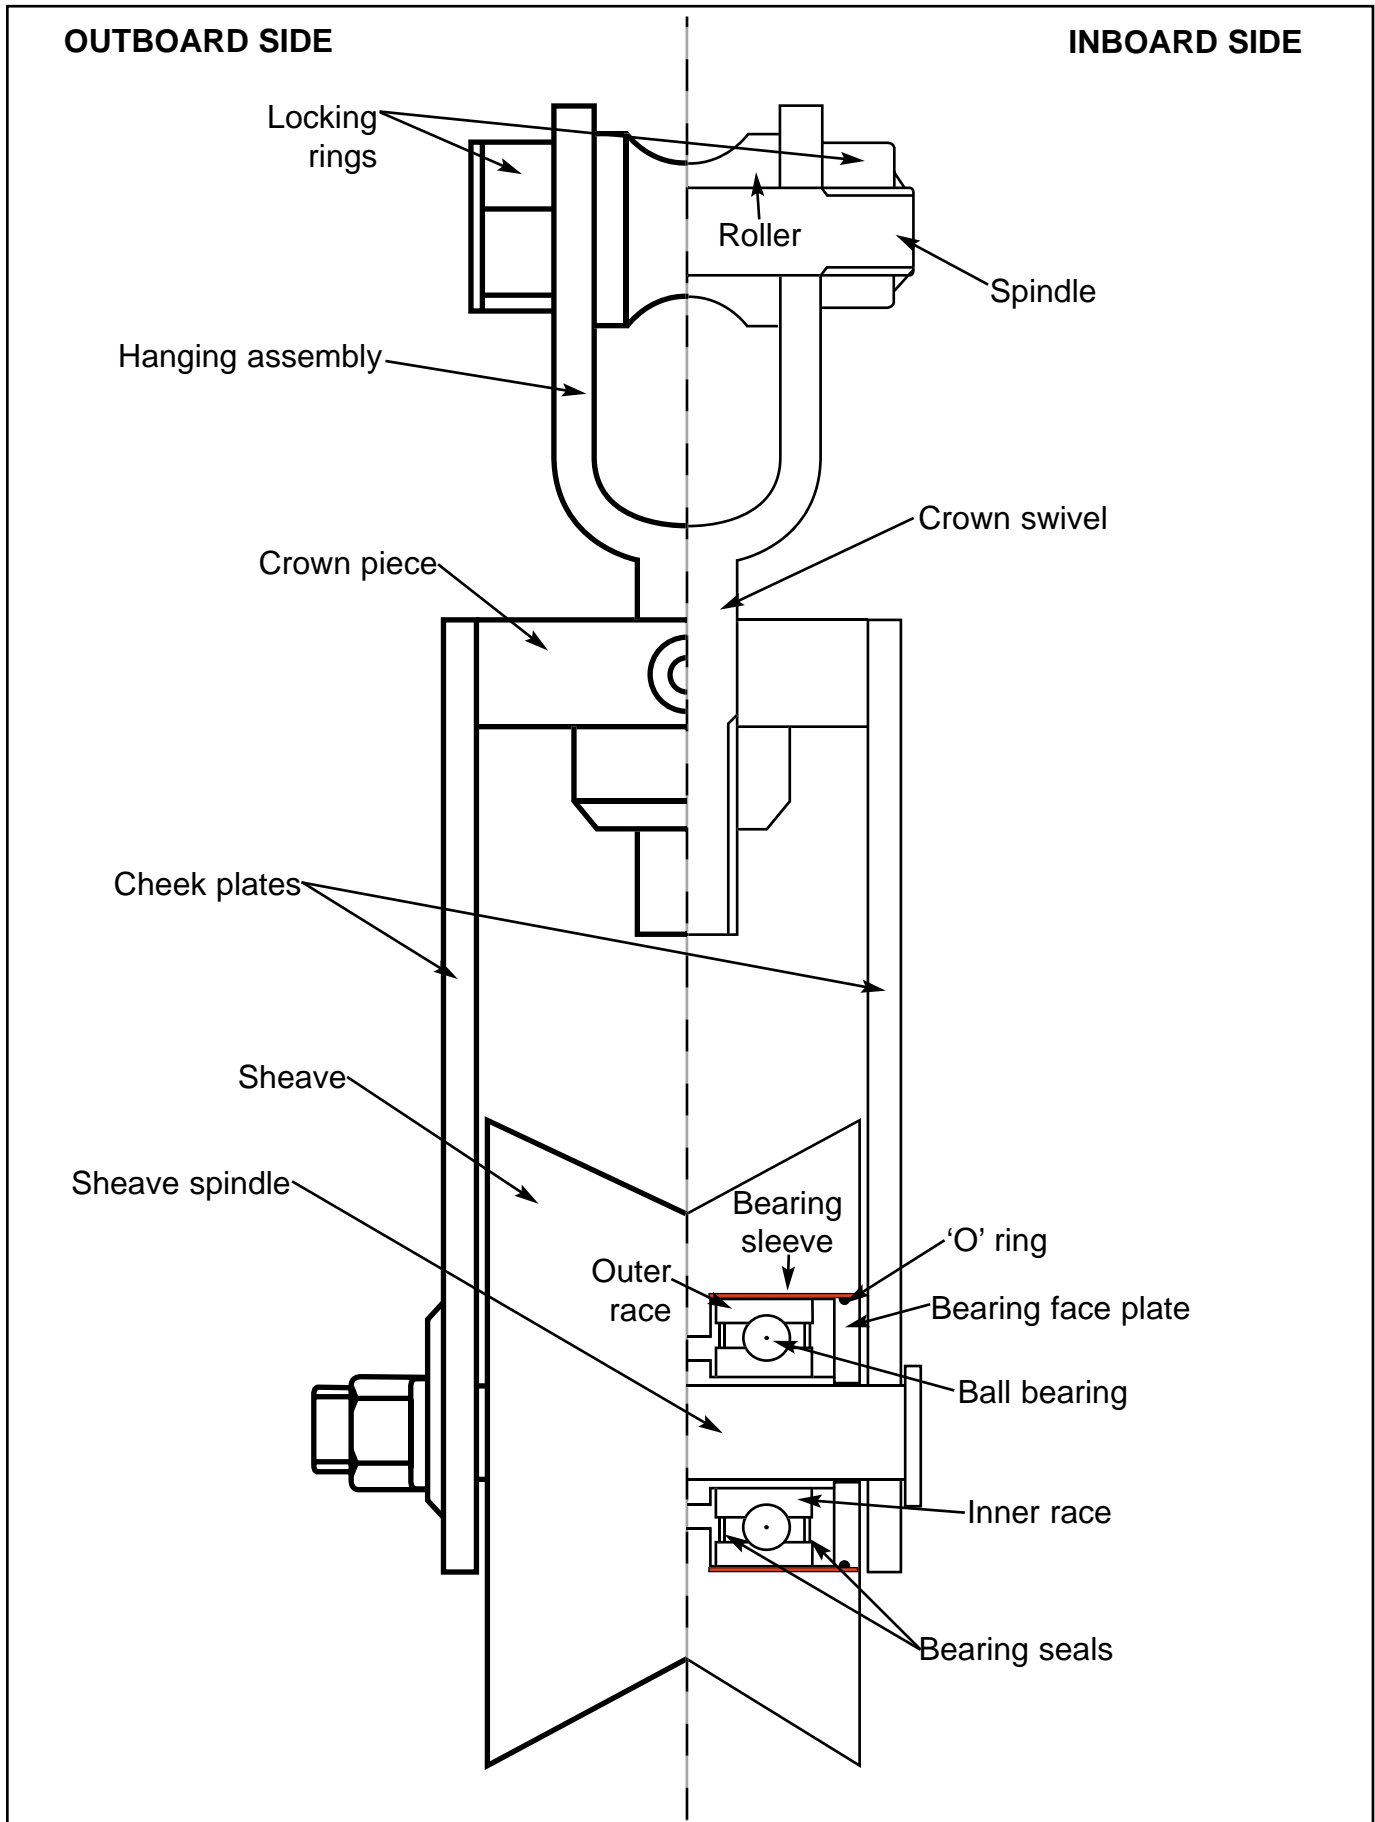
Diagram showing the construction of the starboard main warp hanging block  
 Note: Hanging bolt not shown

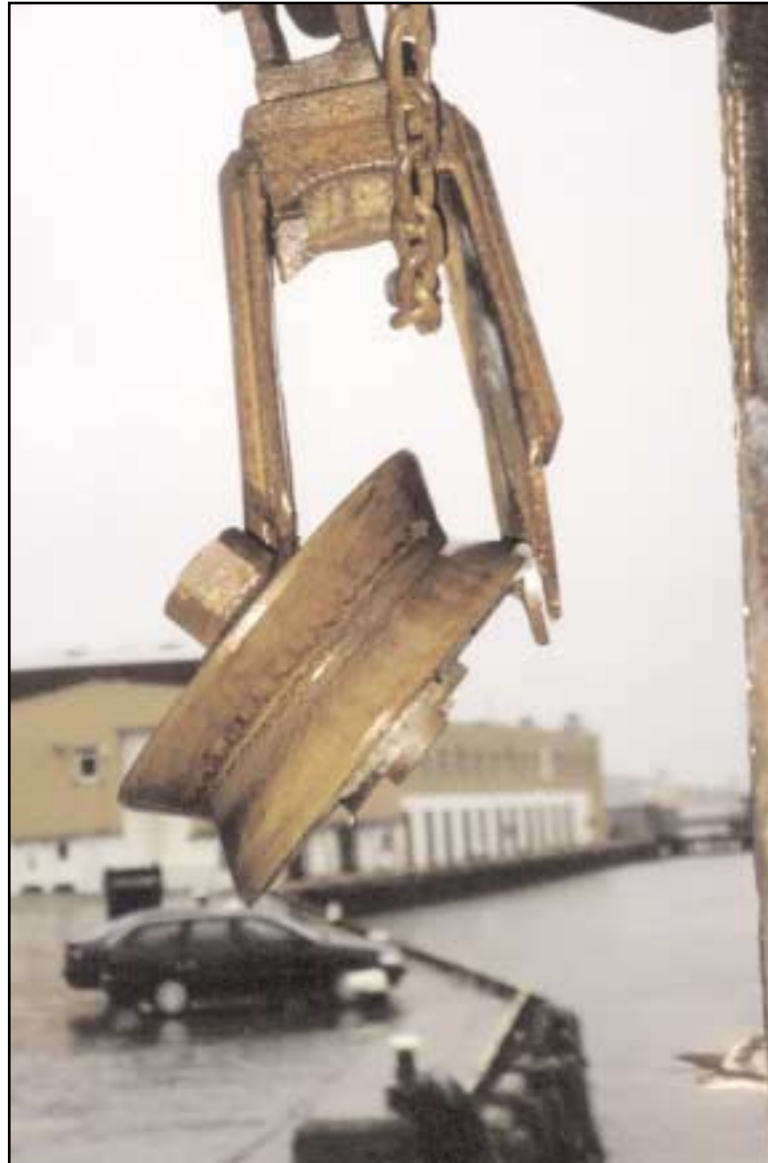
The block had been attached to the mounting point underneath the after gantry by a hanger and a shackle (**see photograph 4**).

The starboard main warp hanging block  
in-situ onboard *Ocean Star*

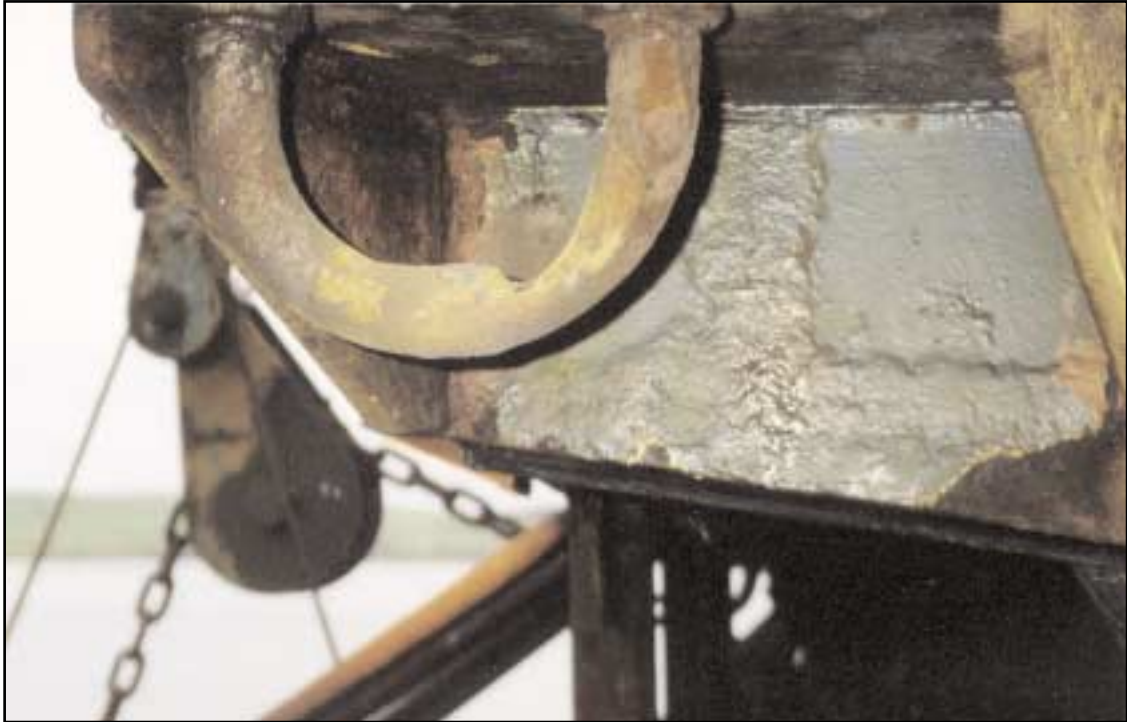
Photograph 5

The hanger bolt was made from steel bar, which had been formed into a 180° bend (**see photograph 5**). There was a wear zone on the inner bend which had been overlaid with a hard facing type of weld metal over a length of 65mm.

Immediately forward of this hard facing, the hanger bolt had suffered extensive rubbing wear which had reduced the bar diameter from 51.9mm to 31.4mm.

The hanger bolt for the starboard main warp block in-situ onboard *Ocean Star*

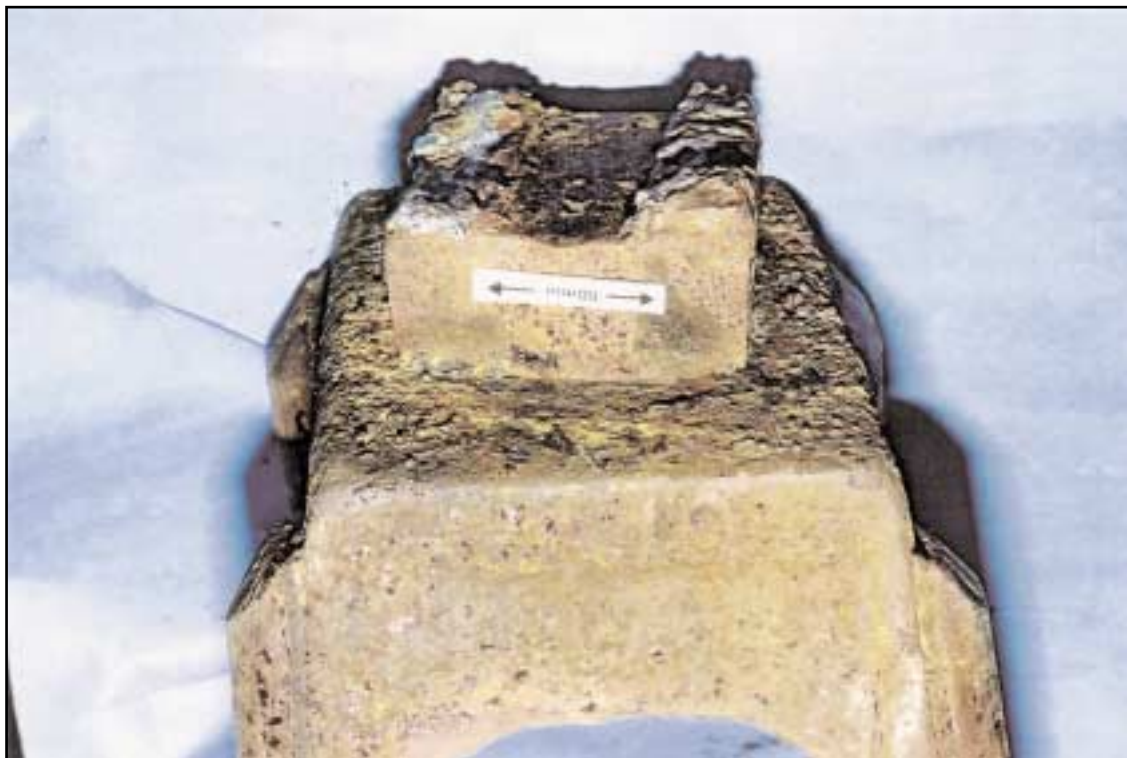
Photograph 6

Crown swivel

The wear to the cheek plates in way of the warp is not unusual in this type of block. It can indicate that the block swivel has seized, as was the case here, and such a seizure could lead to increased axial loading on the sheave bearings. However, in the absence of evidence to indicate high axial loading, the seizure of the swivel is not considered by The Test House or the MAIB to be a causal factor in either the failure of the inboard side bearing or the migration of the bearing sleeves.

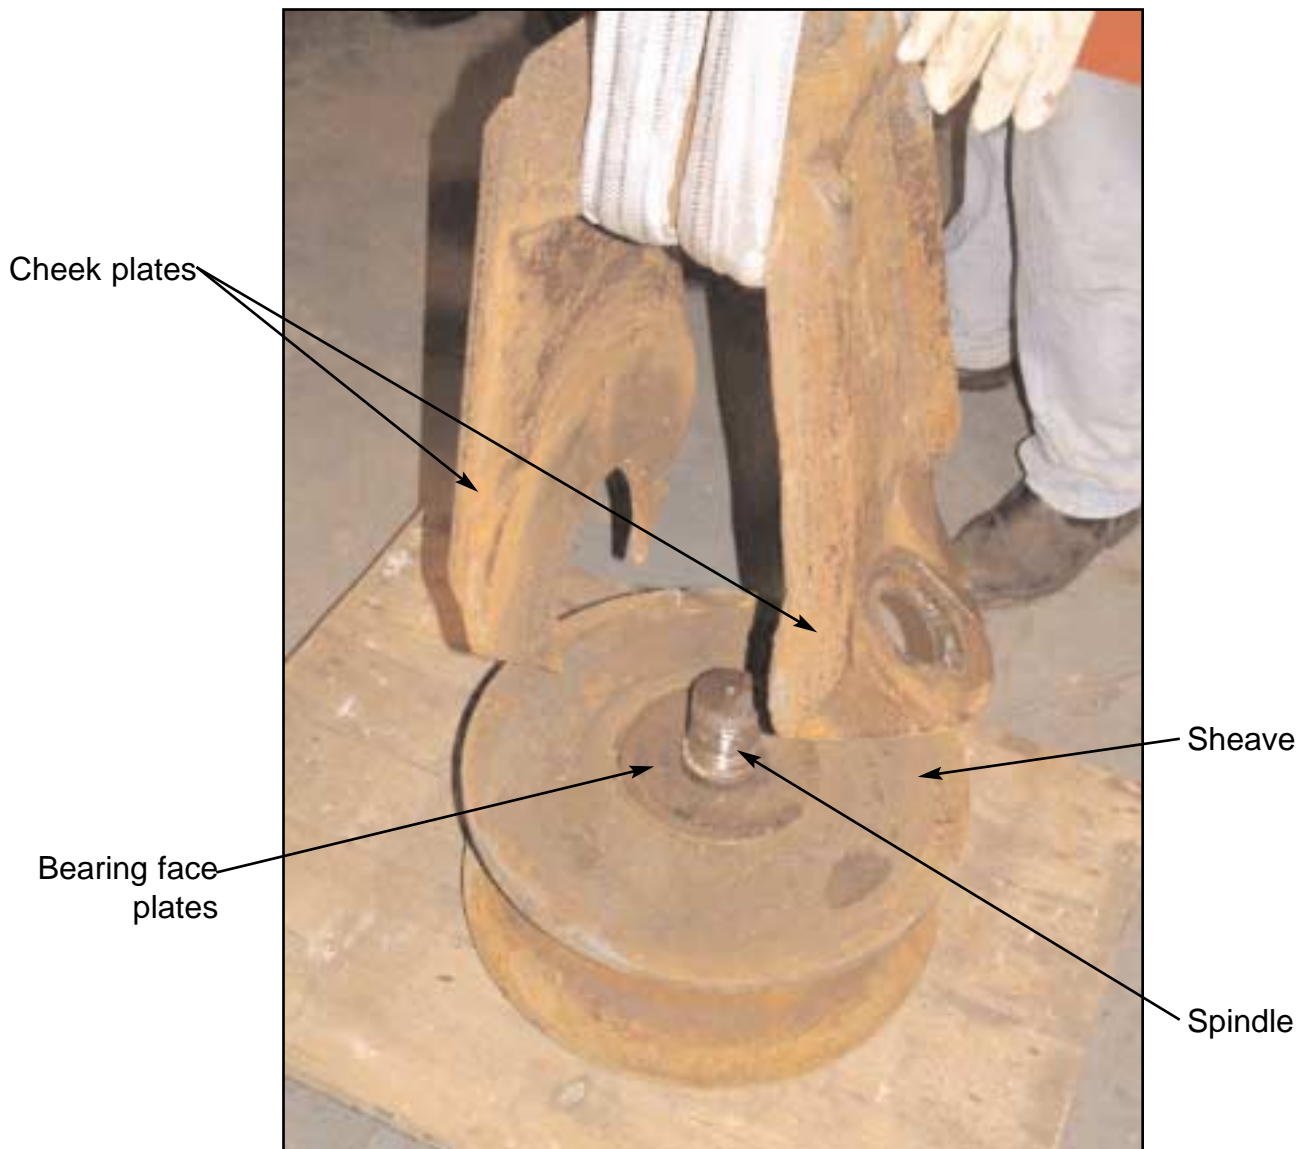
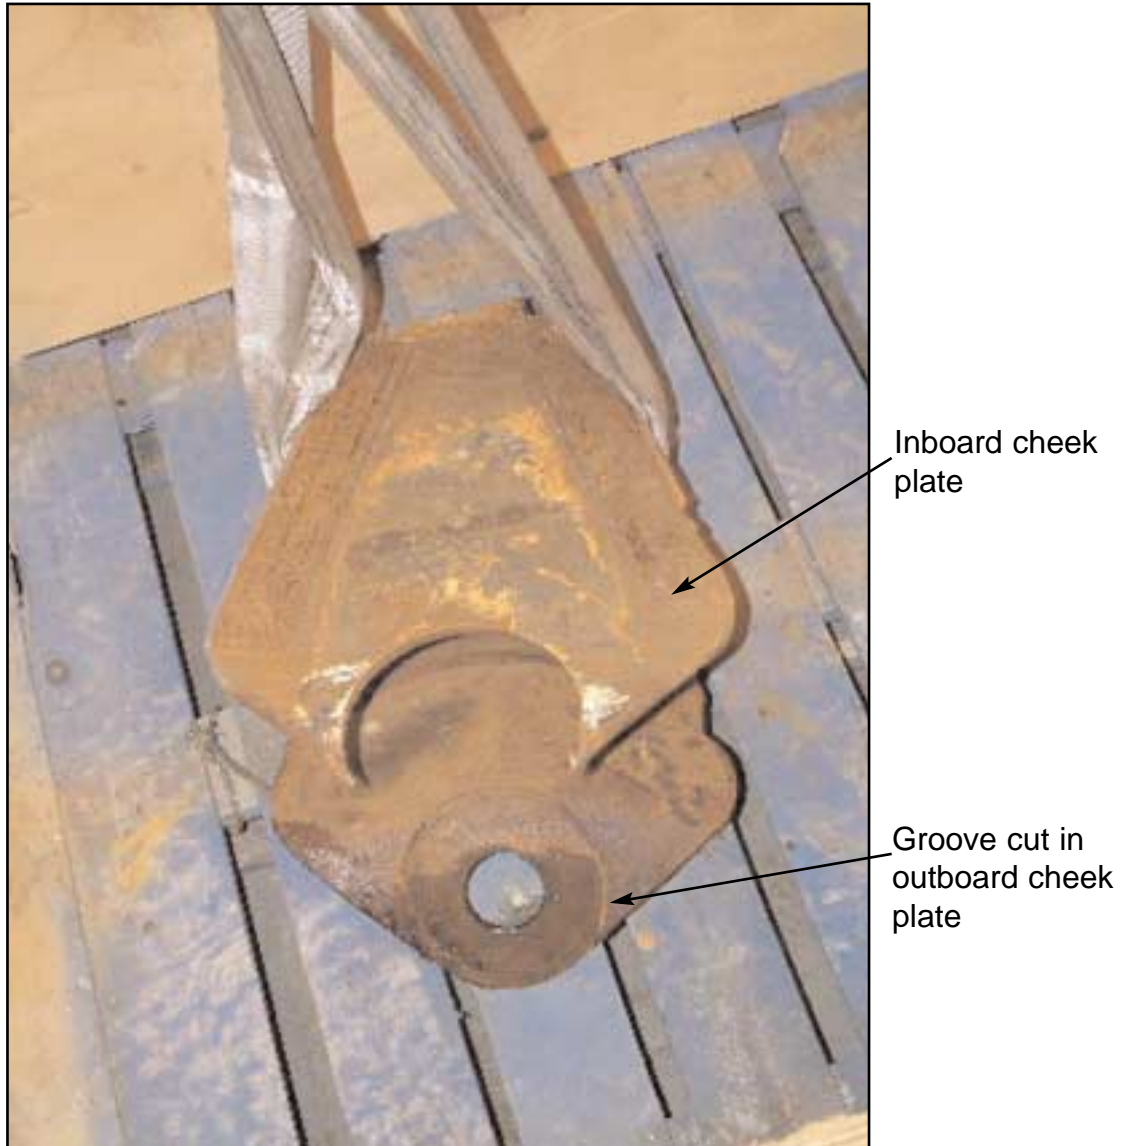
Photograph 7

The sheave block had failed as a result of the inboard side cheek plate being severed by way of the sheave's central spindle bearing. This had led to outward bending of the outboard cheek plate, which allowed the warp to drop clear of the block.

The cheek plates showed wear, consistent with the warp running against them.

**Photographs 7 and 8** show the severed cheek plate and the wear caused by the warp.

The cheek plates being removed from the roller

A view of both cheek plates

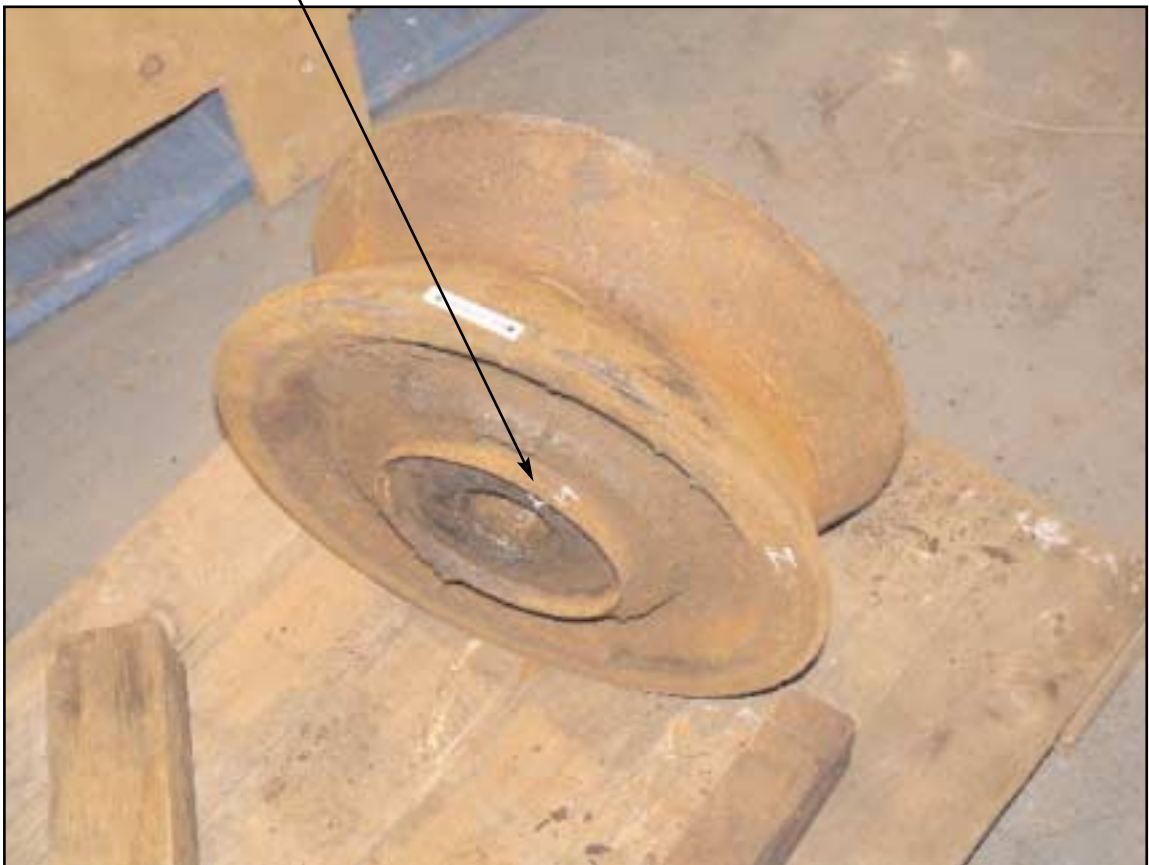
Photograph 10

Once the sheave was clear of the cheek plates, it was evident that the inboard side cheek plate had been severed by the inboard side sheave bearing sleeve migrating out of the sheave and wearing through the cheek plate like a coring tool.

The outboard side cheek plate showed similar damage, again caused by outward migration of the bearing sleeve. The depth of the damage to this side varied between 2.0mm and 3.4mm.

A view of the roller, showing the extent of the outward movement of the steel sleeve from the bearing housing

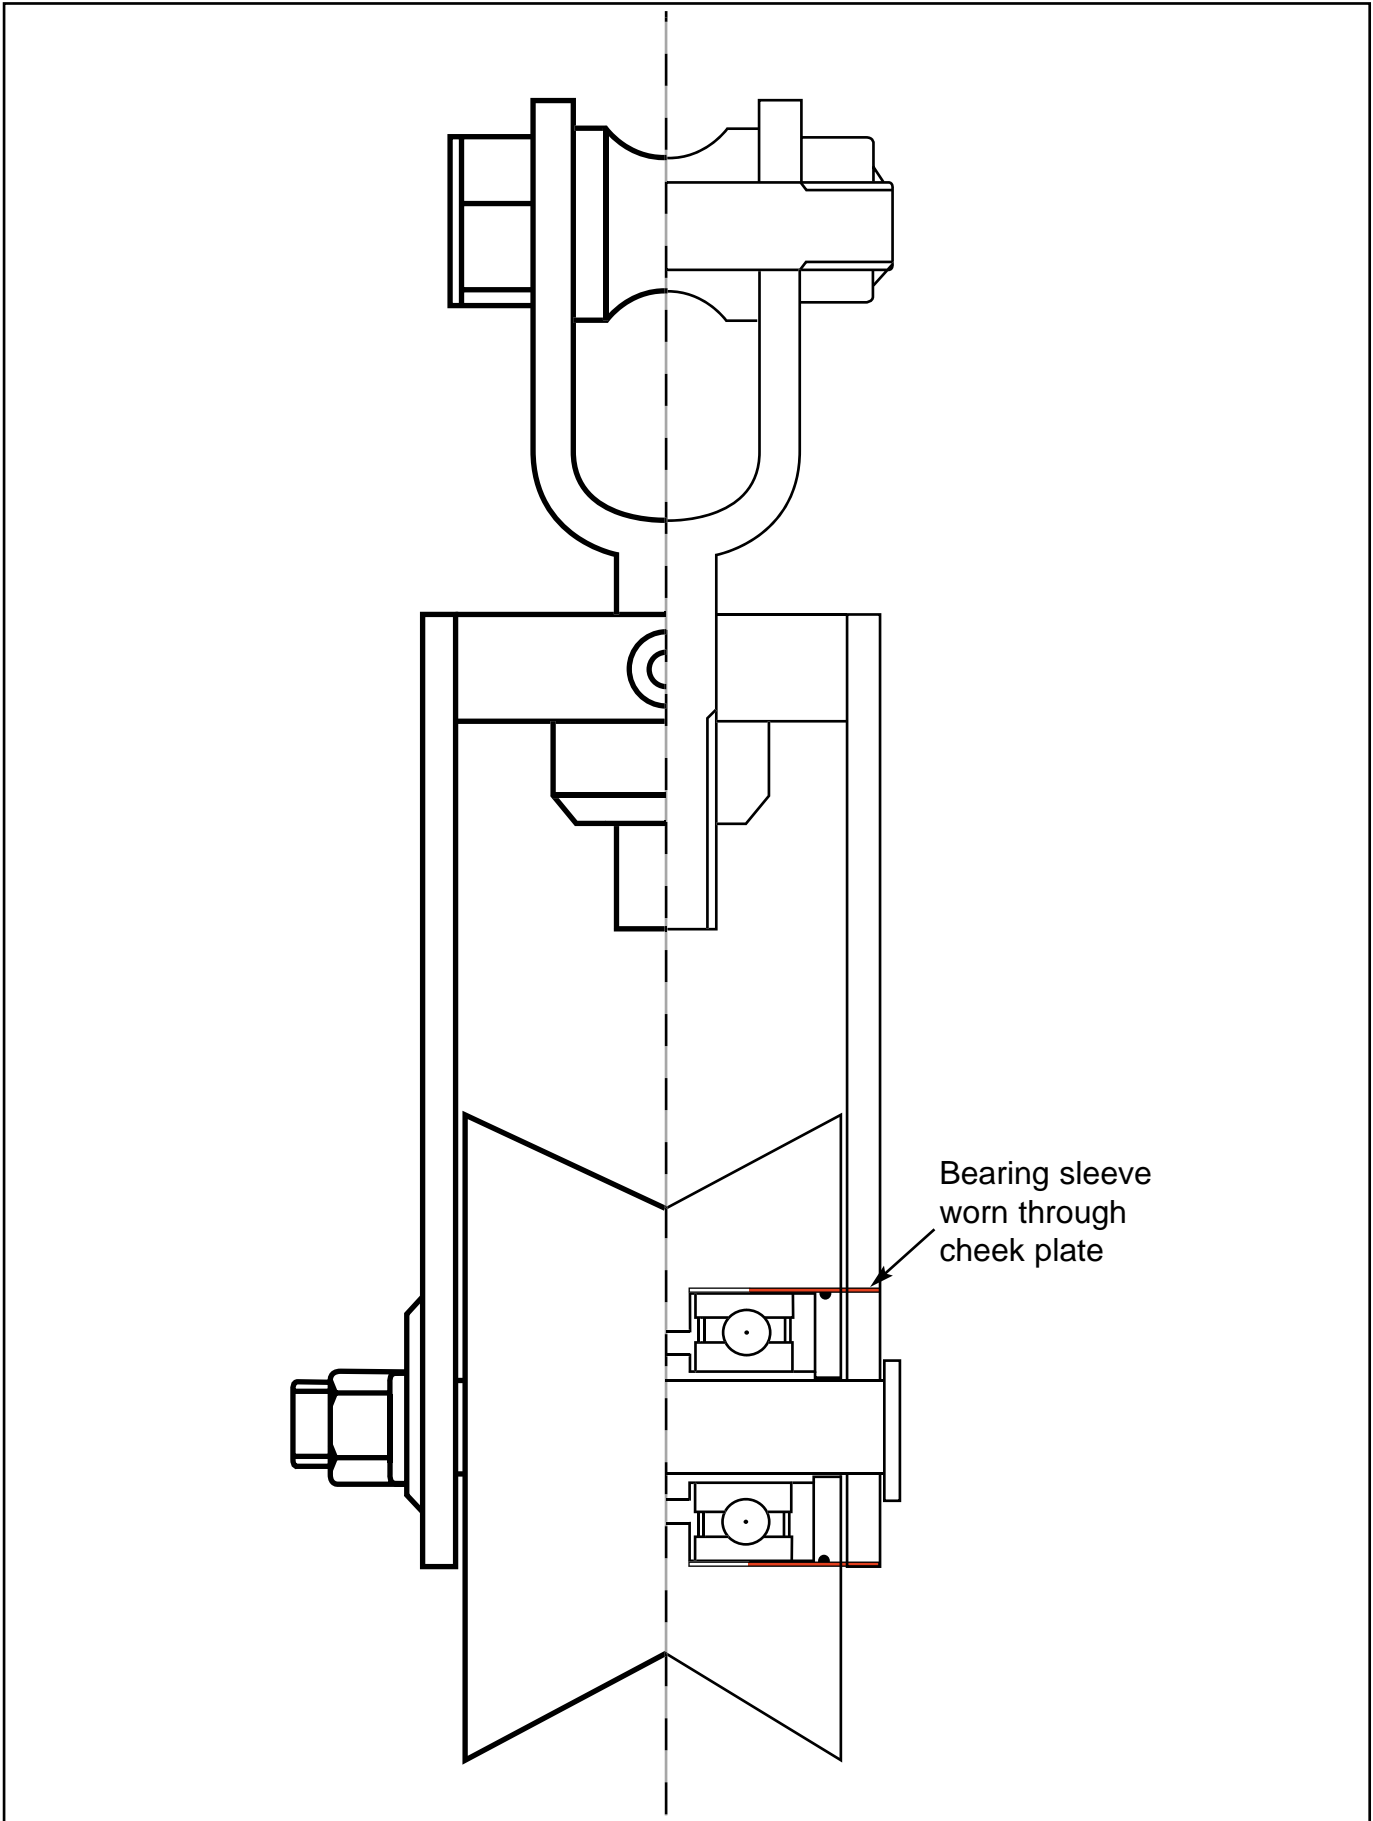
Diagram showing the migration of the inboard side bearing sleeve through the cheek plate

- The block failed as a result of the inboard bearing sleeve moving outward from the bearing housing and progressively wearing through the inboard cheek plate.
- The method of block sleeving represented the most contributory cause of the block failure.
- The use of thin unsecured sleeves, which had been press-fitted into the bearing housing, appeared to represent a refurbishment operation rather than an original design and construction feature.
- The relatively high hardness of the sleeves and their thinness allowed them to cut into the cheek plates like coring tools, when under load.

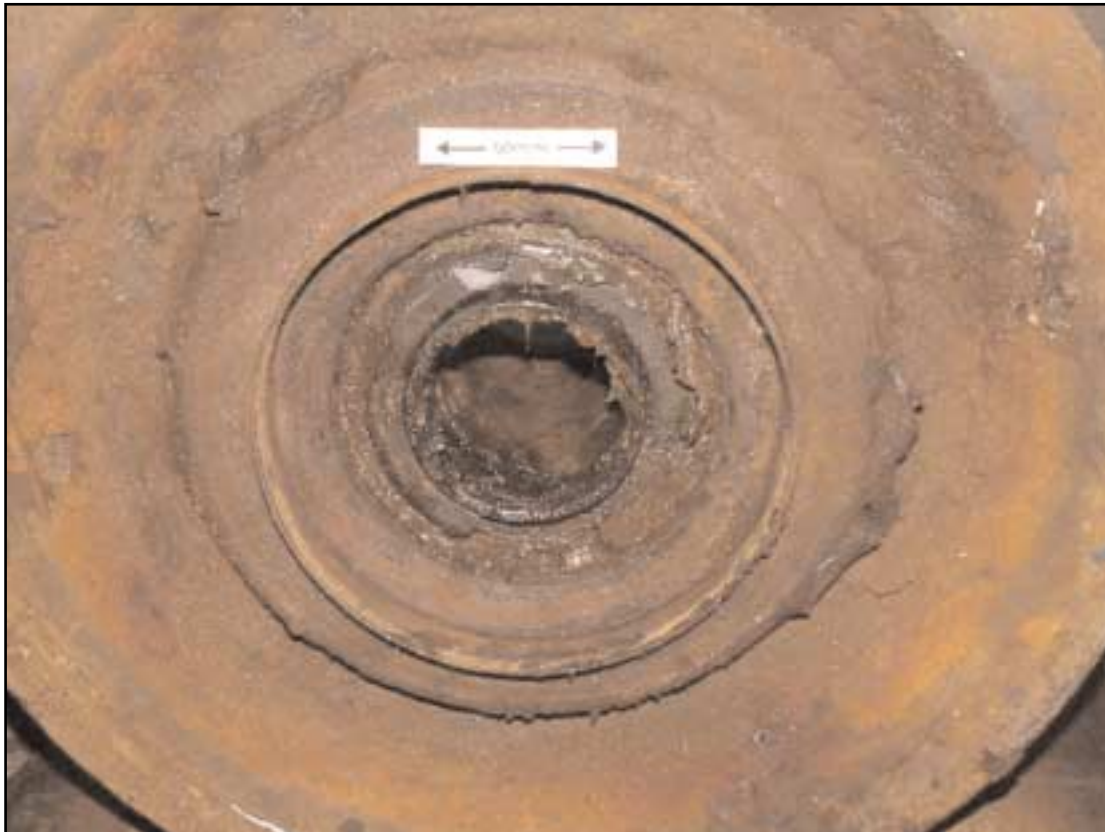
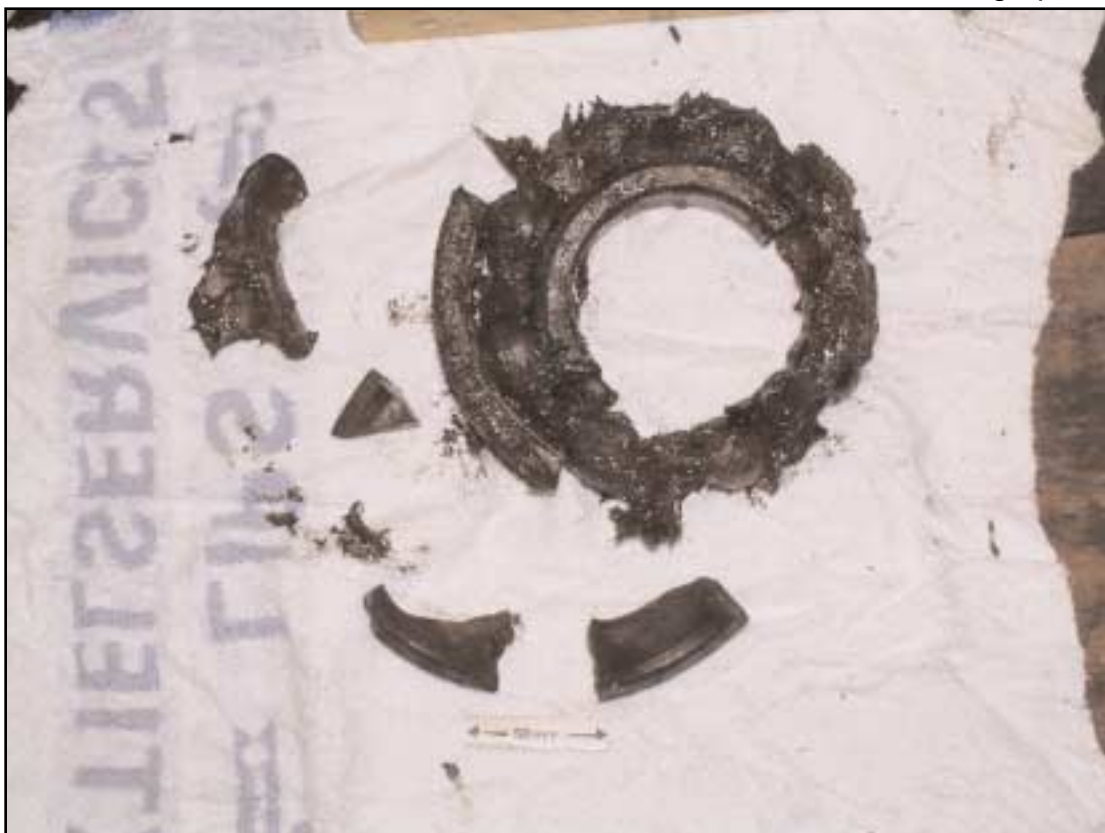
The ball bearings of the inboard side bearing were found to be in a similar condition to those of the outboard side. However, the inner and outer races of this bearing had suffered multiple fractures. Subsequent analysis showed that these fractures were of some considerable age and caused by rolling contact fatigue cracking (**see photographs 11 and 12**).

Closer view of inboard side of roller showing fractures to inner and outer ball races

The inboard inner and outer ball races removed from the roller

- The inner and outer ball races on the inboard side bearing had collapsed as a result of extensive radial and circumferential fatigue cracking. The apparent wear pattern at the rolling surfaces of the bearing suggested that high axial loading was not a significant contributory cause of the failure.
