Report on the investigation of  
a fatal accident on board

***CEC Crusader***

22 November 2001

**Report No 27/2002  
August 2002**

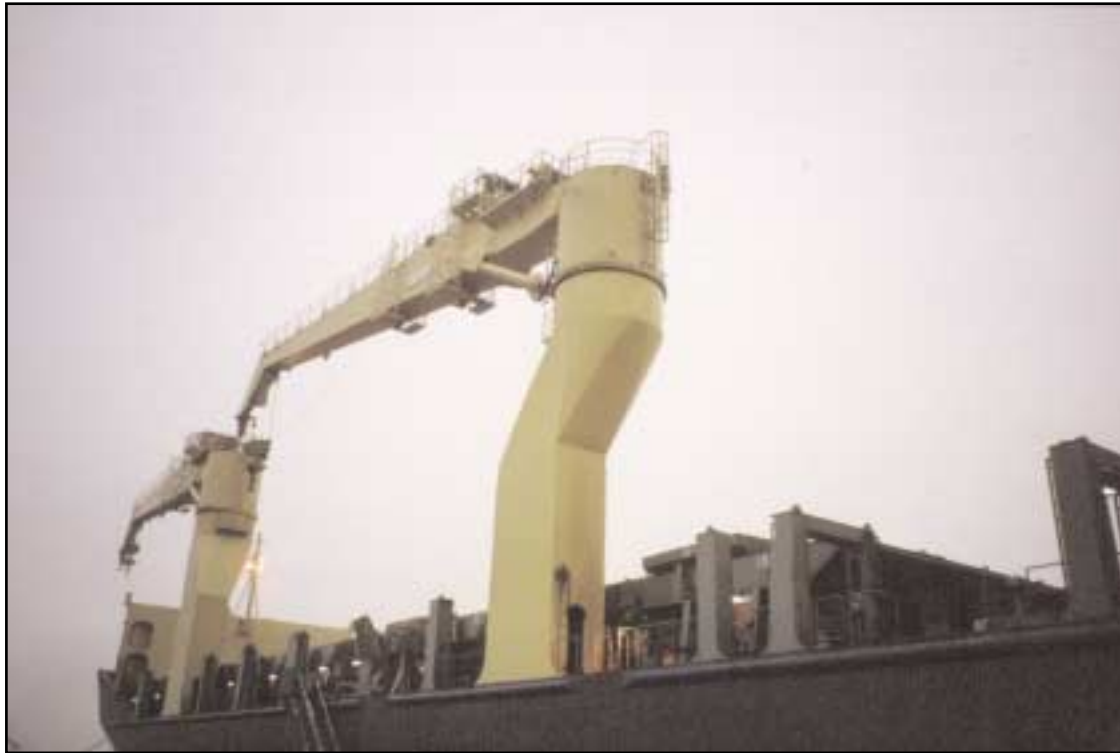
Photograph showing location of deck cranes

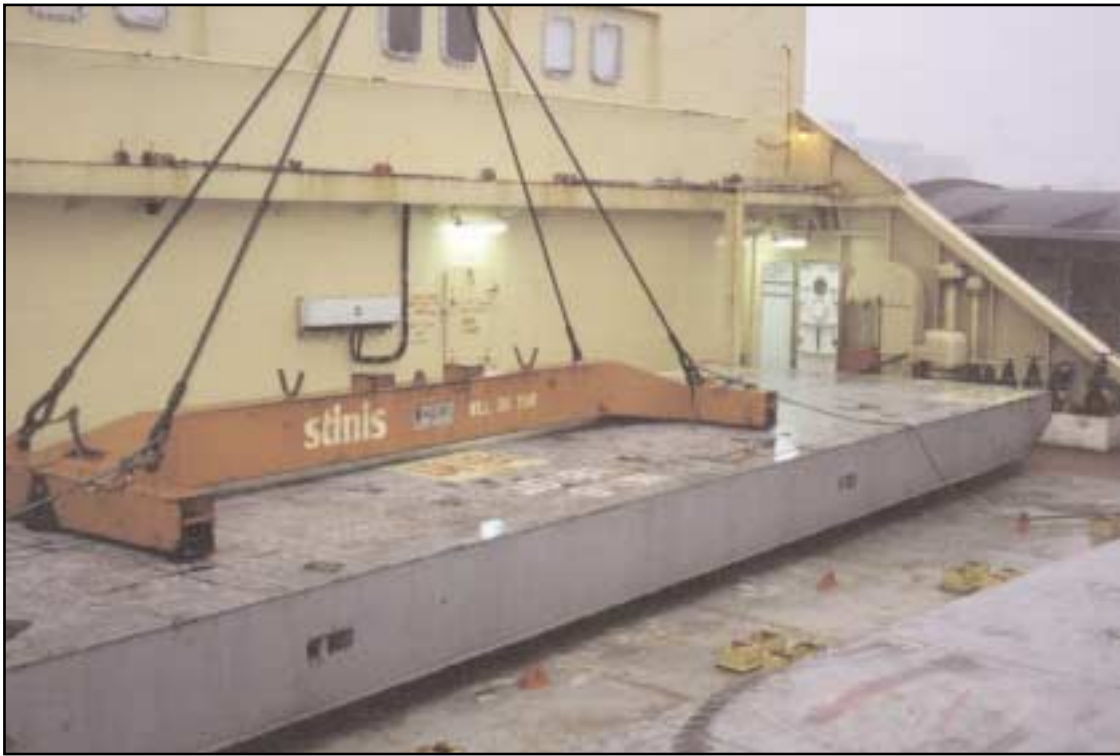
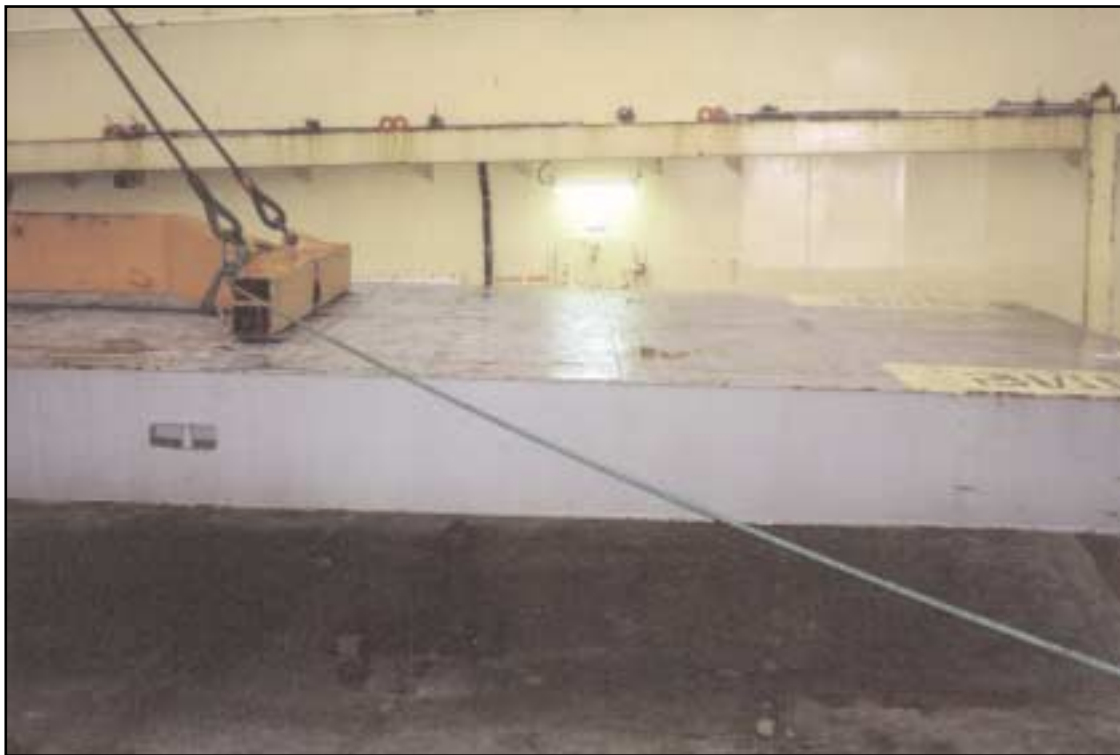
The seventh hatch cover was then transferred, by crane, from the main hold and lowered on to the deck into its approximate stowage position, 1 metre forward of the accommodation bulkhead. This was done to dampen any undue movement (**Figure 4**). The chief officer then contacted the crane driver by portable VHF radio. He instructed him to heave up the hatch cover to a position approximately 0.5 metre from the deck, so it could be manoeuvred manually into a position just above the retaining lugs, before instructions were given to the crane driver to lower it (**Figure 5**). This was the normal practice with regard to the first hatch cover in a stack. Guide ropes were attached for this purpose.

However, at approximately 1330, while the hatch cover was suspended, the chief officer placed himself between it and the bulkhead, against which he braced himself in an effort to push the inner port end into position. This was a practice which was not normally carried out. As he did this, the hatch cover developed a swing to port and, despite his efforts to restrain it, it struck him, crushing his pelvis against the bulkhead.

Figures 4 and 5 showing the seventh hatch cover's stowage position

The deck crew had been involved in the transfer of hatch covers on numerous previous occasions, without incident. However, for some reason, this time the chief officer decided he would manoeuvre the hatch cover into position by bracing himself against the accommodation bulkhead. This meant going into a space approximately 1 metre wide, with a solid bulkhead behind him, and a 17-tonne hatch cover suspended in front of him.
