Report on the investigation of  
a fatal accident on board  
***Gemma Fidelis (GY 419)***  
9 miles east of the River Tees  
on  
23 October 2001

Marine Accident Investigation Branch  
First Floor  
Carlton House  
Carlton Place  
Southampton  
United Kingdom  
SO15 2DZ

**Report No 24/2002**  
**July 2002**

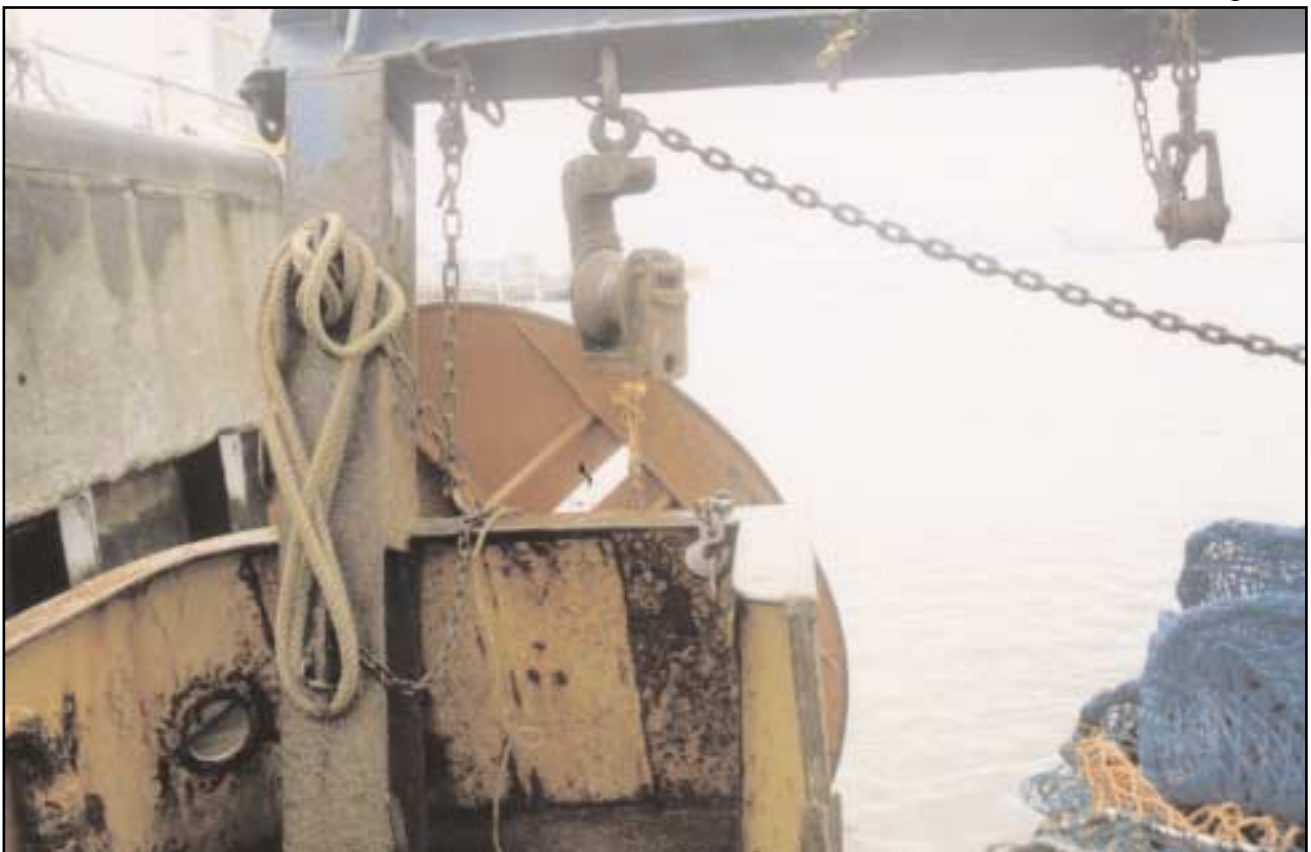
Figure 3

The warps, to which the trawl doors are connected, are led over the stern of the vessel through heavy snatch blocks which hang from both the port and starboard side of a stern gantry, at about head-height (**Figure 3**).

Aft deck starboard

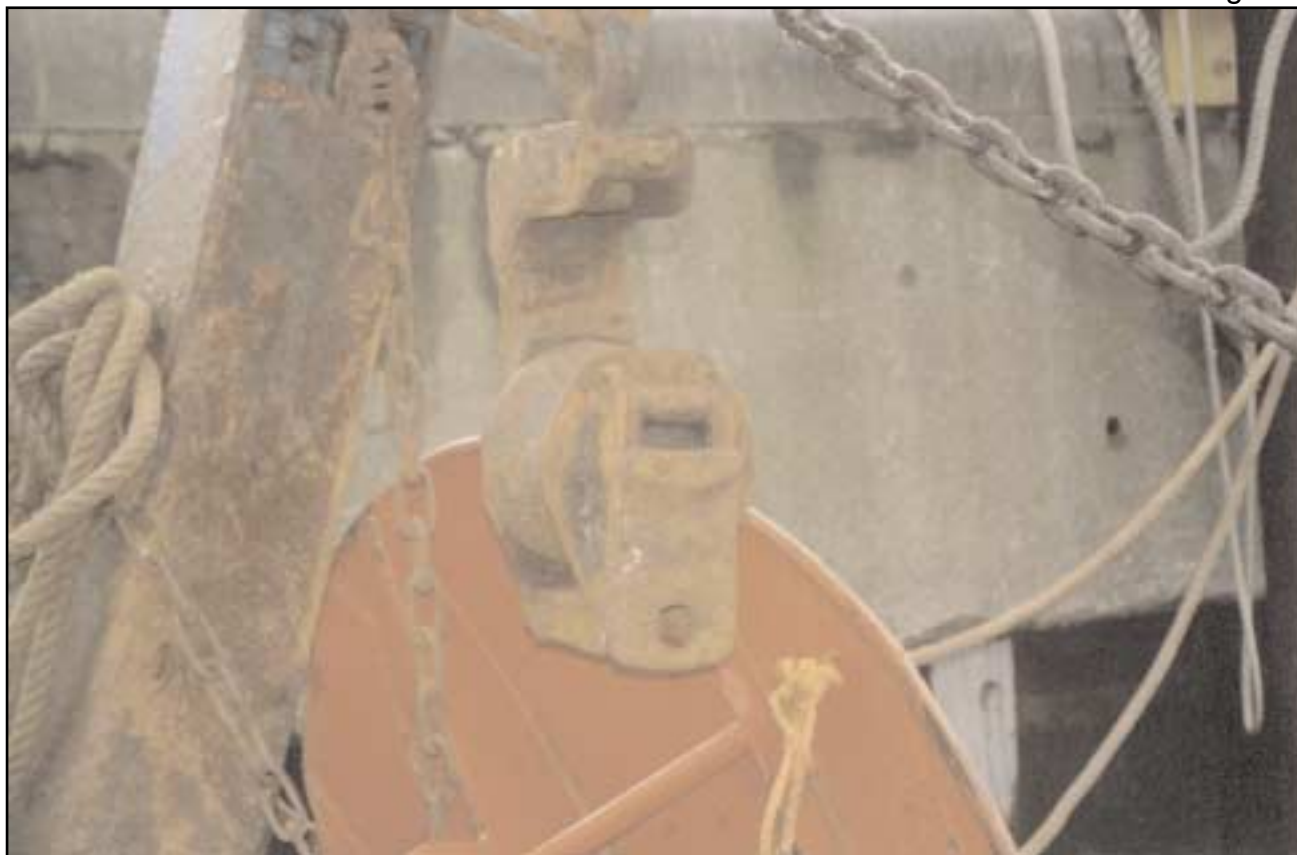
Figure 5

*In the opinion of the surveyors, the blocks sighted, stated to have been removed from Gemma Fidelis showed considerable wear consistent with the blocks being original equipment of the vessel, and also showed lack of recent maintenance, although still serviceable.*

*Further in our opinion, the distortion of the cheek plate of the starboard block although indicative of lack of maintenance or repair, was not of sufficient extent to make the block unusable or to have contributed to any accident involving the trawl wire jumping from the block.*

*Finally, in our opinion, the lack of locking pins for the hinged cheek plate of either block, and the apparent lack of recent wear or signs of recent steel to steel contact in the locking pin holes, indicate that it is most likely these blocks had been habitually used without pins, and may have been used open, that is without the hinged section of the cheek plate being closed. This is incorrect use of the snatch block and would make it possible for the wire to jump from the sheave, particularly if tension on the wire was momentarily released during movement of the vessel in open water with swell or seas causing pitching of the vessel if sufficient forward motion of the vessel was not maintained when hauling nets.*

Starboard snatch block

The condition of both trawl blocks was such that it was impossible to close them in the correct manner. Not only were the locking pins missing, but the securing lugs on the main body of the blocks were corroded to such an extent that they were also unusable.

The main reason for this was the lack of an on-board procedure for maintenance. This allowed the blocks to deteriorate to such a condition over a prolonged period of time, and would have adversely influenced any attempt to close the block by other means. An effective maintenance procedure would have enabled the snatch block to be closed correctly.
