Report on the investigation of
an accident involving the starboard lifeboat of
the Turkish registered bulk carrier
mv Gulser Ana
in Belfast harbour
on 17 October 2001

Marine Accident Investigation Branch
First Floor
Carlton House
Carlton Place
Southampton
United Kingdom
SO15 2DZ

**Report No 41/2002
December 2002**

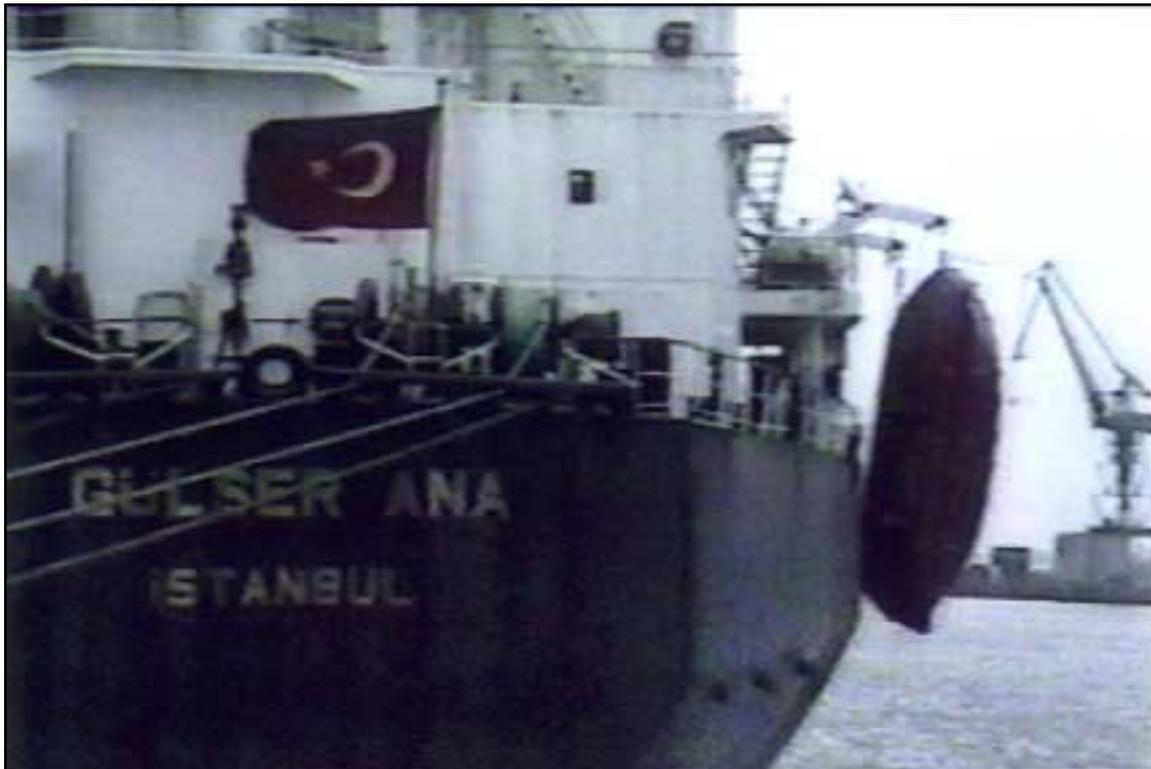
Figure 1

About 30 seconds to 1 minute after he boarded the boat, the forward hook released itself suddenly and without warning. The forward end of the boat dropped, leaving it suspended vertically from the aft fall (**Figure 1**). The two seamen and the chief officer were thrown into the water.

Gulser Ana's lifeboat suspended vertically from the aft fall

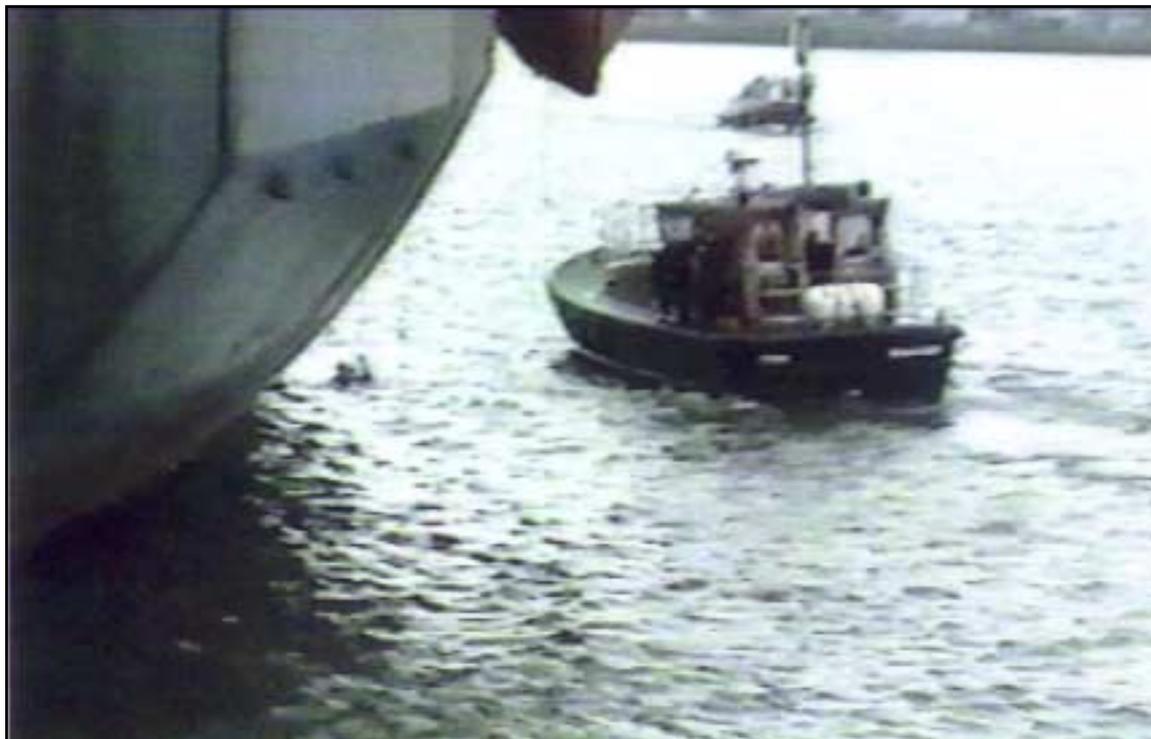
Figure 2

The two seamen were able to pull the chief officer to the surface and keep him afloat. About 5 minutes later, all three were picked up by the pilot launch (**Figure 2**), then met ashore by the dock police and an ambulance.

The pilot launch rescuing the three crew members

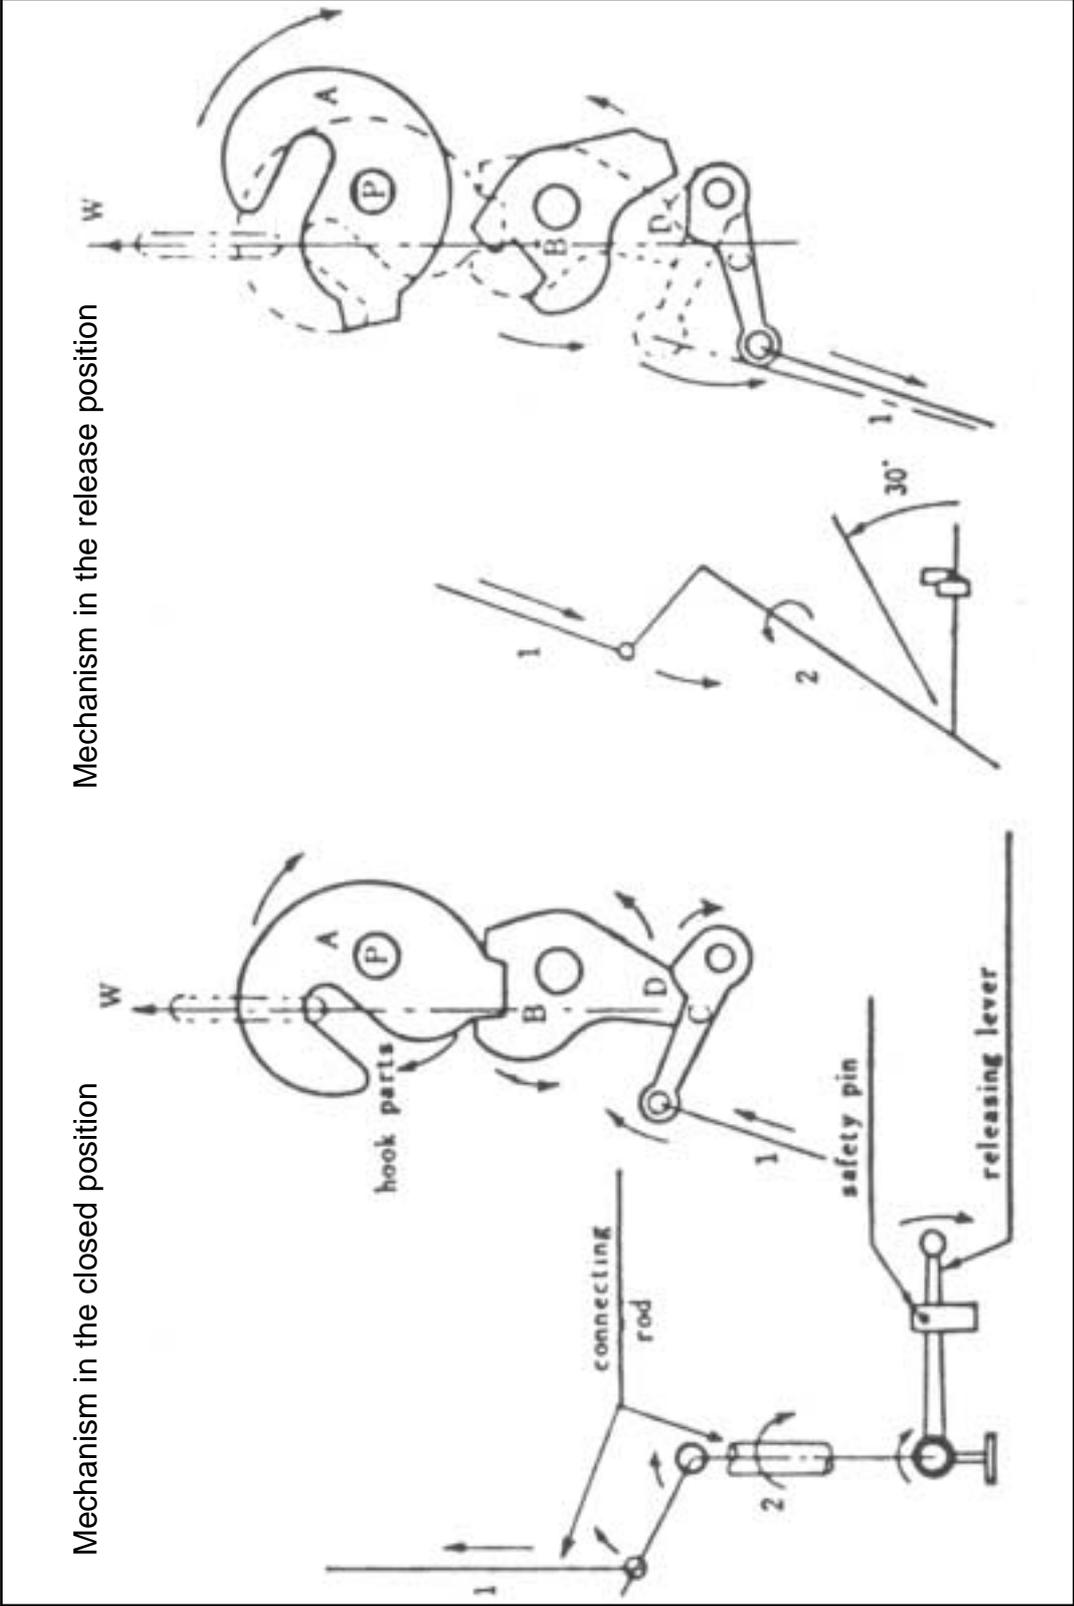
Figure 3

The hook release mechanism

1. The safety pin was missing from the releasing lever, as shown in **Figure 12** taken on the day of the accident by an MCA surveyor.
2. The operating rod to the aft hook cam C was sheared, and cam C had been lashed in the secure position. However, the loose end of this operating rod was not secured in any way.
3. There was free play in the mechanism and bearings because of wear of the rod bearings. The bearings are shown in **Figure 3**.

There was free-play in the rod bearings to such an extent that this could have allowed the forward hook to appear reset when in fact it was not. This, and possible wear at the interface D (**Figure 3**) between the operating cam and the hook element B, would contribute to the diminished locking capability of the release mechanism.

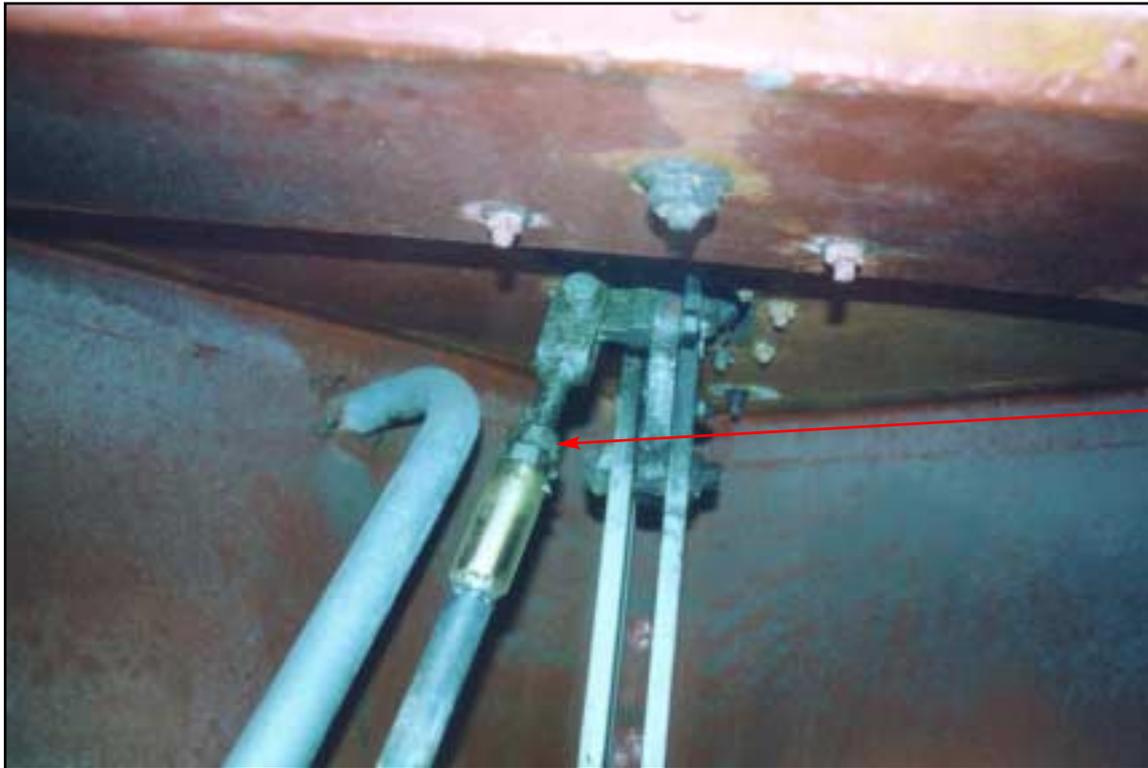
Figure 8

The above refers to both the forward and aft hooks. The length of the rods in the mechanism has a small degree of adjustment, allowing the mechanism to be adjusted so as to ensure that both forward and aft hooks operate simultaneously. **Figure 8** shows the adjusting arrangement of the aft hook.

The adjusting arrangement of the aft hook

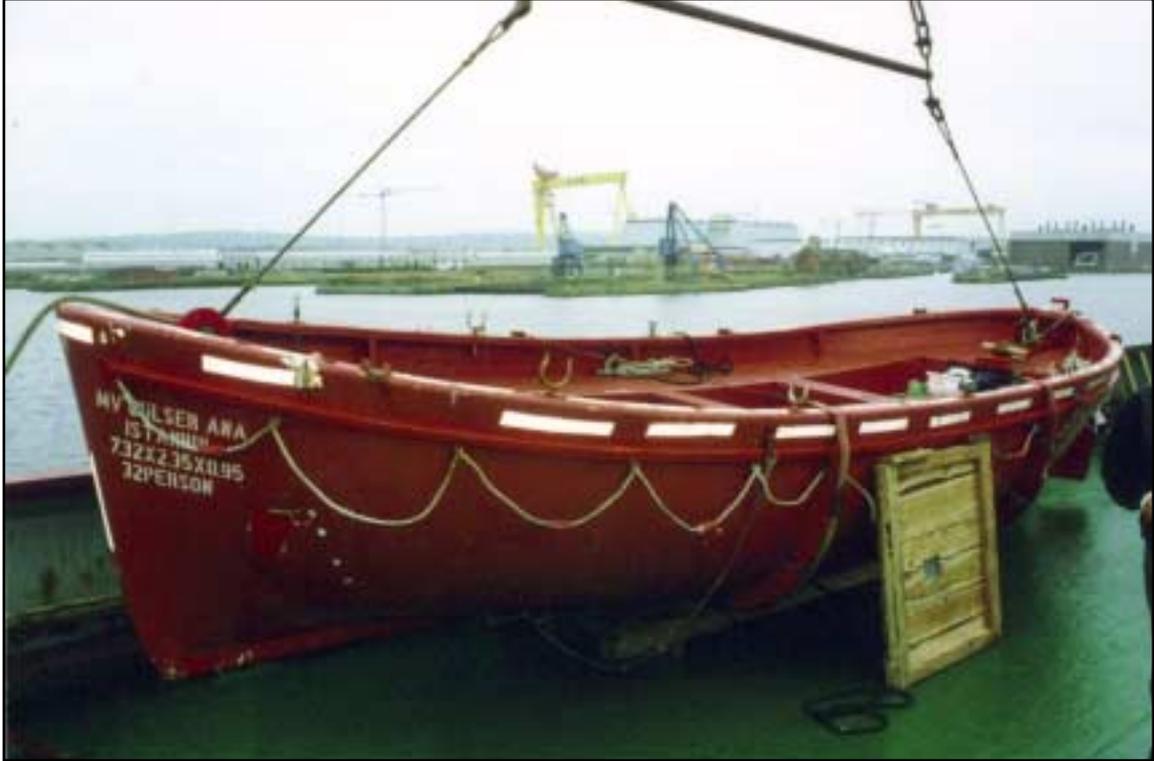
Figure 11

The lifeboat after recovery

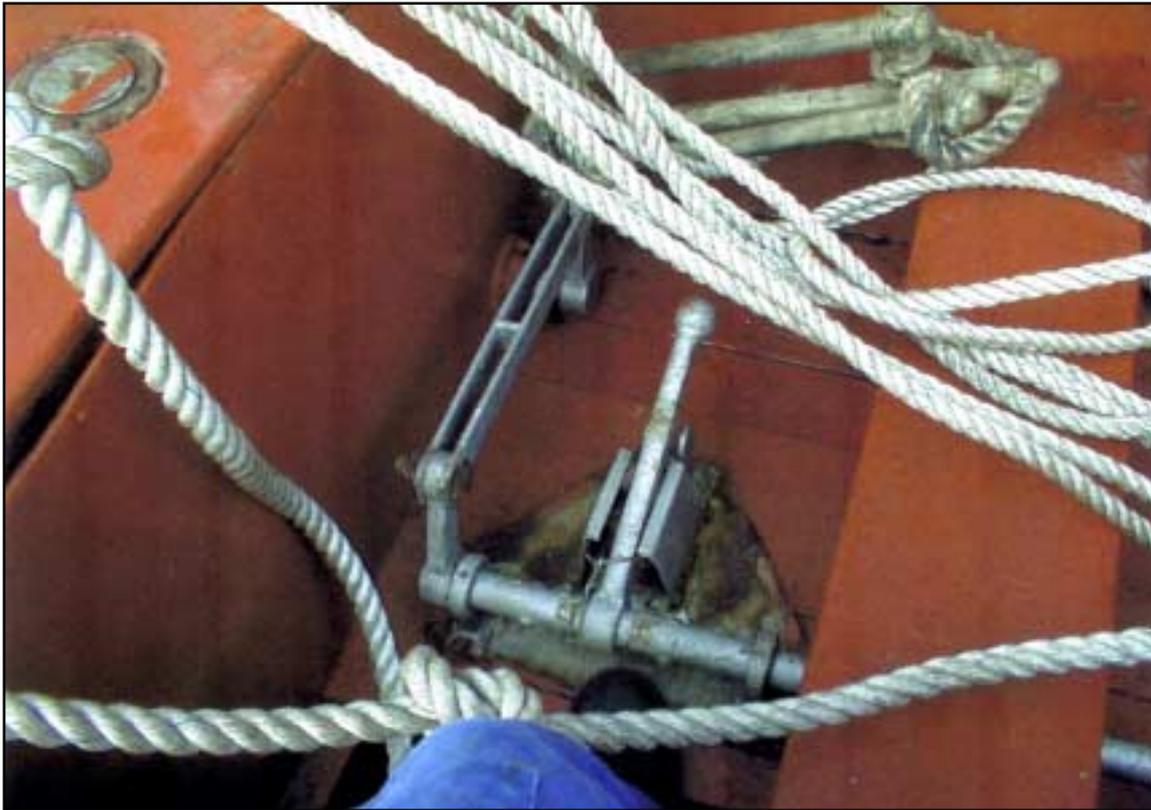
Figure 12

Releasing lever with safety pin missing

Post-accident inspection found that the release lever's locking pin had not been in place to lock it in the closed position. The locking pin is designed to prevent inadvertent movement of the lever or releasing mechanism, and, hence, premature release of the hooks.

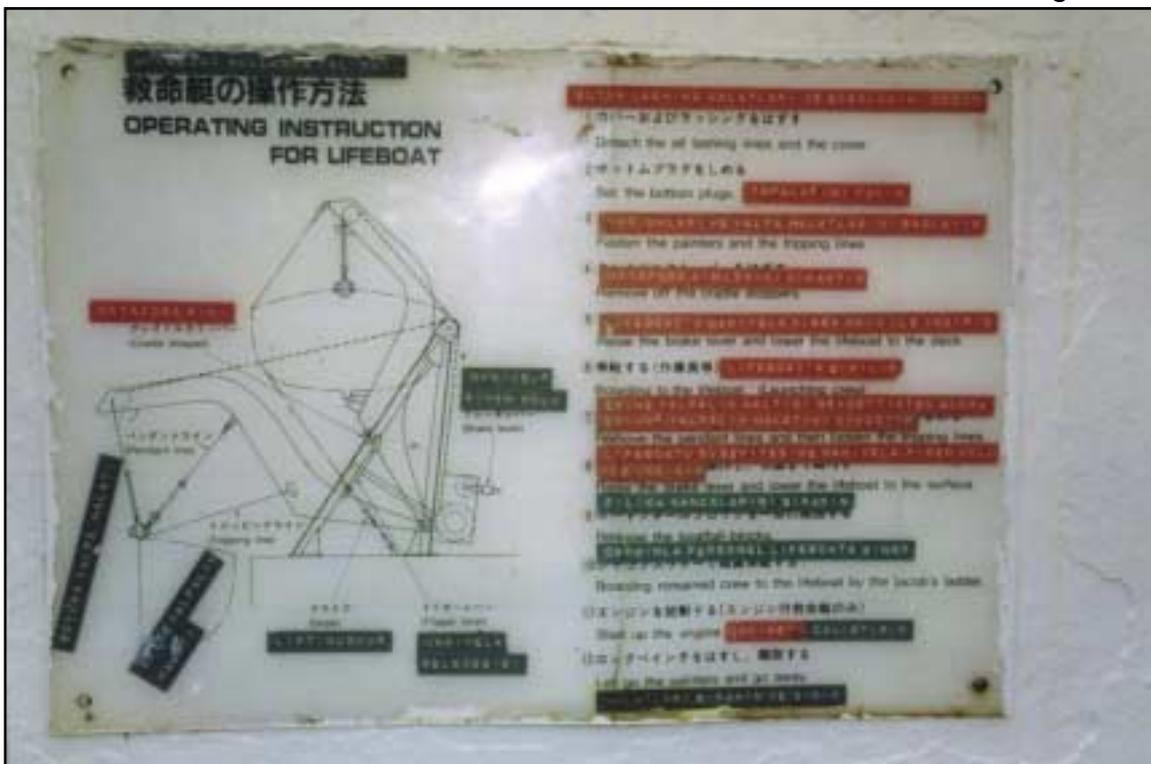
Figure 13

The posted "Operating Instruction for Lifeboat" (**Figure 13**) had been translated into Turkish, and this text placed on "Dymo" strips. The instructions describe the basic steps to be taken when launching the boat.

Operating instruction for lifeboat
