Report on the investigation of the fire on board

HSS Stena Explorer

entering Holyhead

**Report No 5/2003
February 2003**

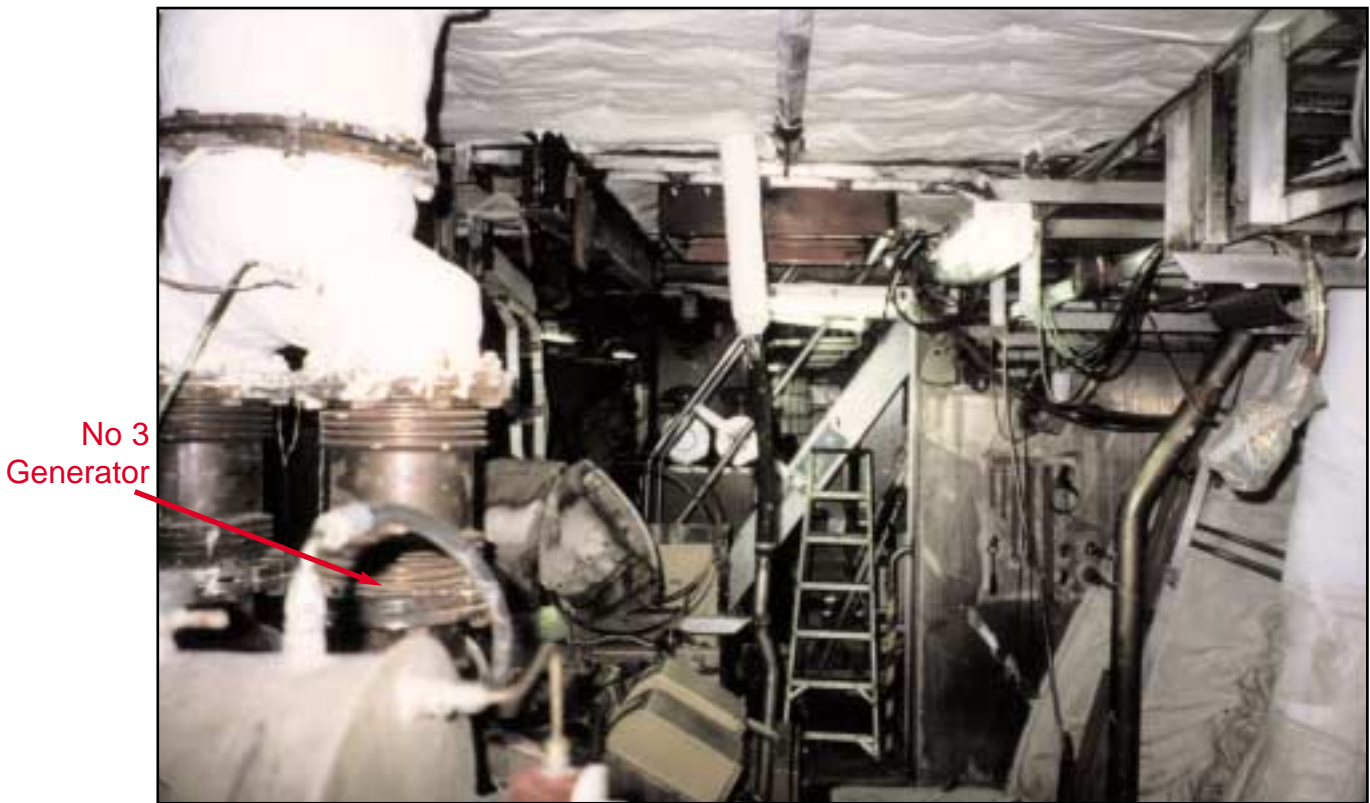
Figure 2

The chief engineer told the master immediately that he could see a fire on No 3 generator in the port pontoon, on the CCTV. **Figure 2** shows part of the port pontoon and No 3 generator. The navigator informed port control by radio, and requested the fire brigade to attend the vessel on arrival. Passengers were just starting to make their way towards their vehicles at the time of the fire alarm.

No 3
Generator

Port pontoon

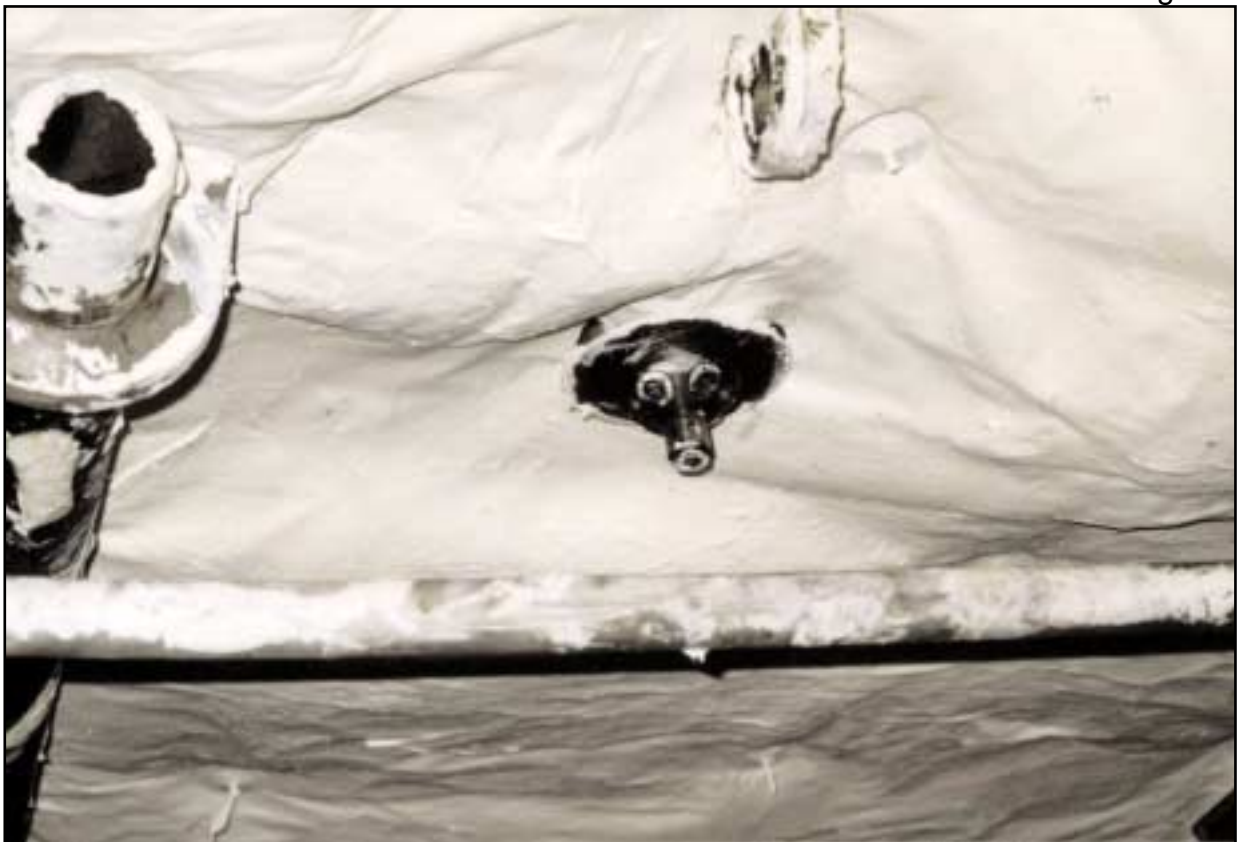
Figure 3

Hi fog head above generator No 3

The chief engineer activated the water Hi-fog fire-fighting system in the area of the fire at 1802. (**Figure 3** shows the Hi-fog head above generator No 3.) He requested the master's permission to shut down the port pontoon. The master, however, decided not to do this until the vessel was fully lined up with the approach to the linkspan. This decision was based on the following conditions:

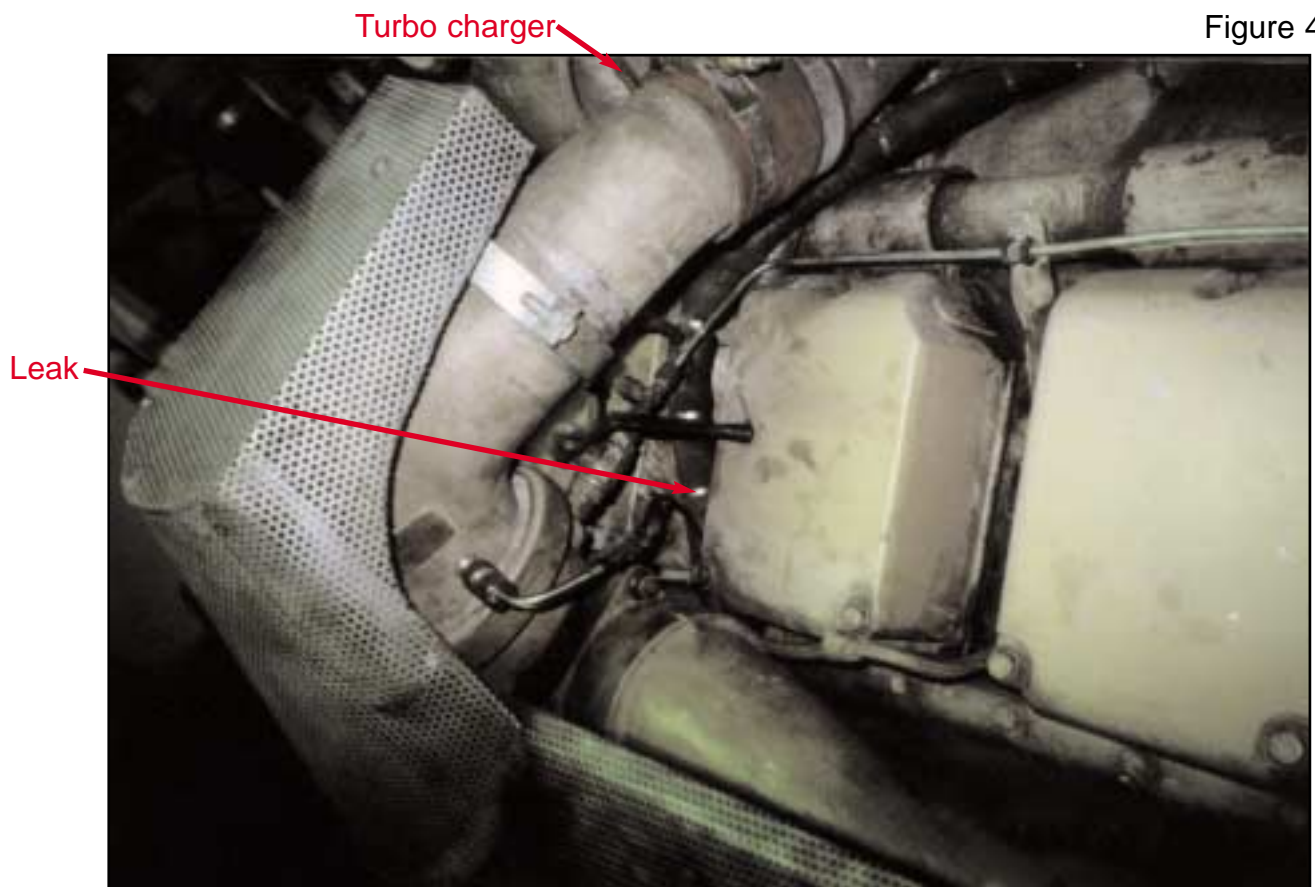
Figure 4

The fire was caused by an element of the fuel tubing on the aft generator in the port pontoon (No 3 generator) coming loose and being blown clear of the engine. This then allowed gas oil, at a pressure of 10.2 bar, to be pumped out of the fuel manifold and over the running engine and surrounding area. This fuel came into contact with the exposed hot surface of the engine's turbo-charger unit, located above the leak, and was ignited. **Figure 4** shows the position of the turbo-charger relative to the position of the leak.

Position of turbo charger relative to leak

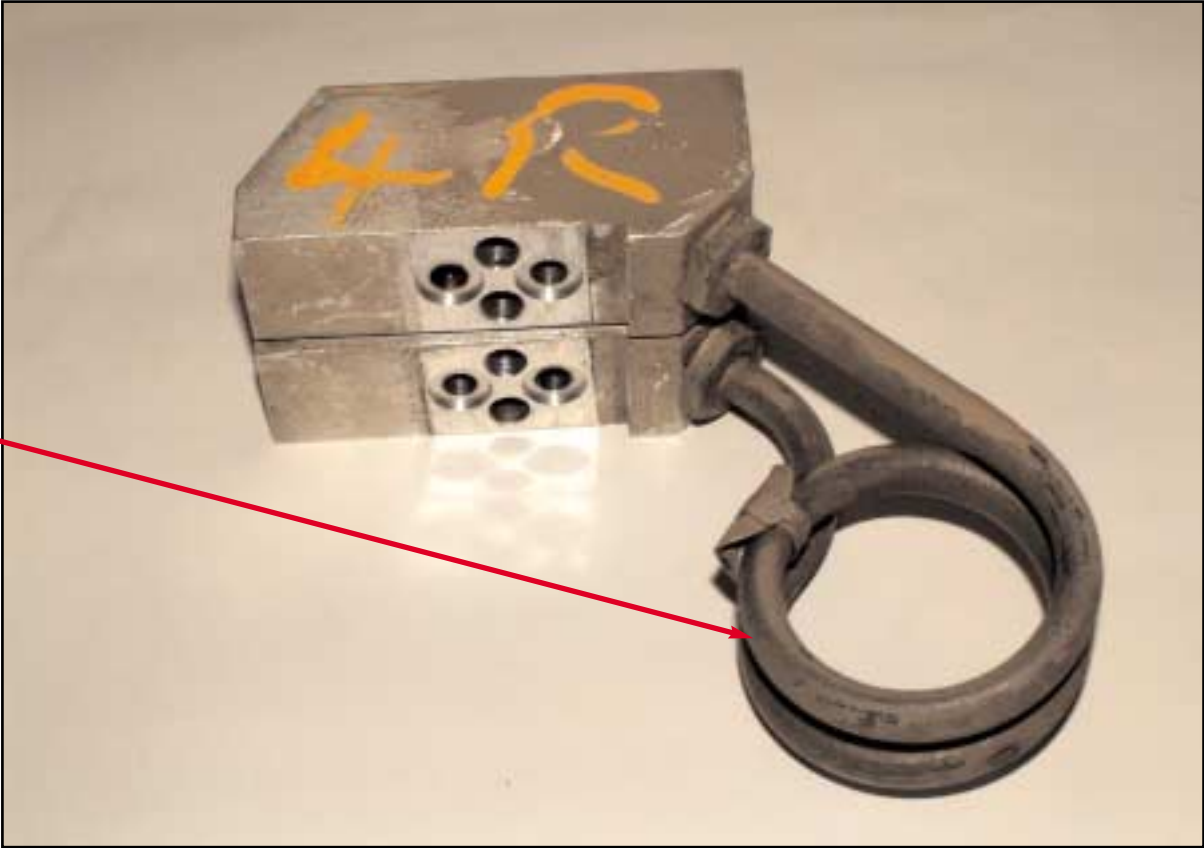
The diesel generator fuel oil system arrangement is illustrated in **Figure 5**. The high and low pressure pipes of the system, between the booster pump and fuel injectors, are joined together by flange or compression type fittings. The fitting which failed, resulting in leakage of oil, was a compression fitting on what is known as a pig-tail pipe, see **Figure 6**. The pipe was on the low pressure side, between the booster pump and high pressure pump, and was one of four connecting the forward and aft, upper and lower, fuel rails for each bank of cylinders in the 'V' configuration engine. This is shown in **Figure 7**.

Pig-tail pipe

Fuel block and pig-tail pipe

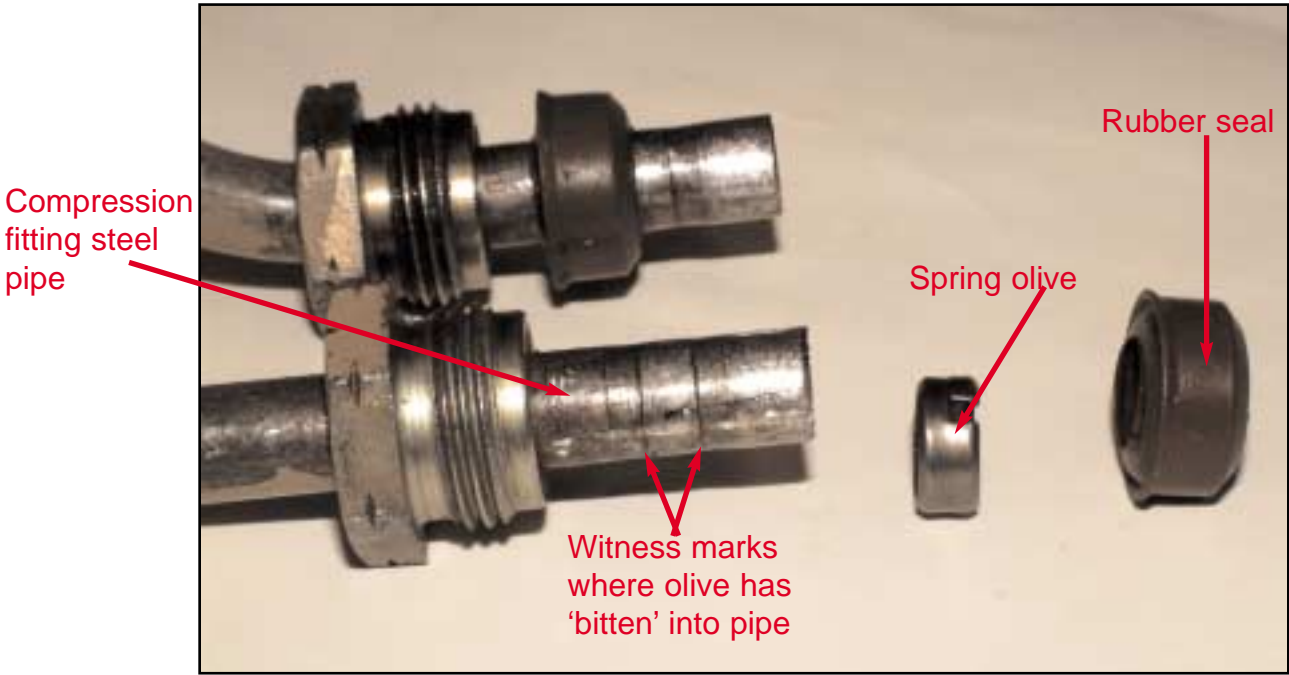
Figure 8

A dismantled pig-tail, showing the components of the compression fittings, can be seen in **Figure 8**. The steel olive provides support to the rubber seal, and bites into the steel pipe securing the fitting to it. However, these olives cannot provide the seal because they are not solid, but are of sprung construction. In the more common design of compression fitting, a solid metal olive is used. This is deformed by the tightening of the nut, causing it to bite into the wall of the pipe, securing it to the pipe and forming the seal.

Compression fitting components of dismantled pig-tail

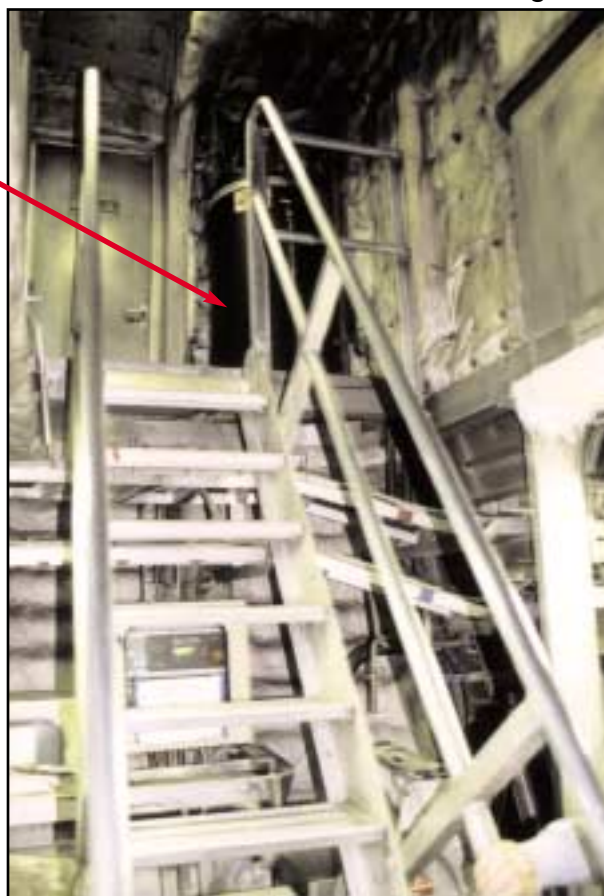
Figure 9

While inspecting the scene of the fire in the auxiliary engine room in the port pontoon, the MAIB inspector noticed a free-standing lubricating oil storage tank of plastic (Polystone G) construction. The tank can be seen in **Figure 9**.

The auxiliary engine room is an area of major fire hazard, and there was no documentary evidence to show that the material used was considered an equivalent to steel.

Freestanding
lubricating oil
storage tank

It is uncertain whether or not the plastic lubricating oil storage tank fitted on board complies with the requirements of paragraph 7.5.2 of *The International Code of Safety for High-Speed Craft*. The safety certificate on board does not record that the plastic tank has been exempted from the code's requirements. The owners do not have any documented evidence to support an exemption.

The MCA needs to examine whether or not the plastic, free-standing lubricating oil storage tanks installed on board *Stena Explorer*, and any of her sister vessels operating in UK waters, comply with the requirements of *The International Code of Safety for High-Speed Craft*.

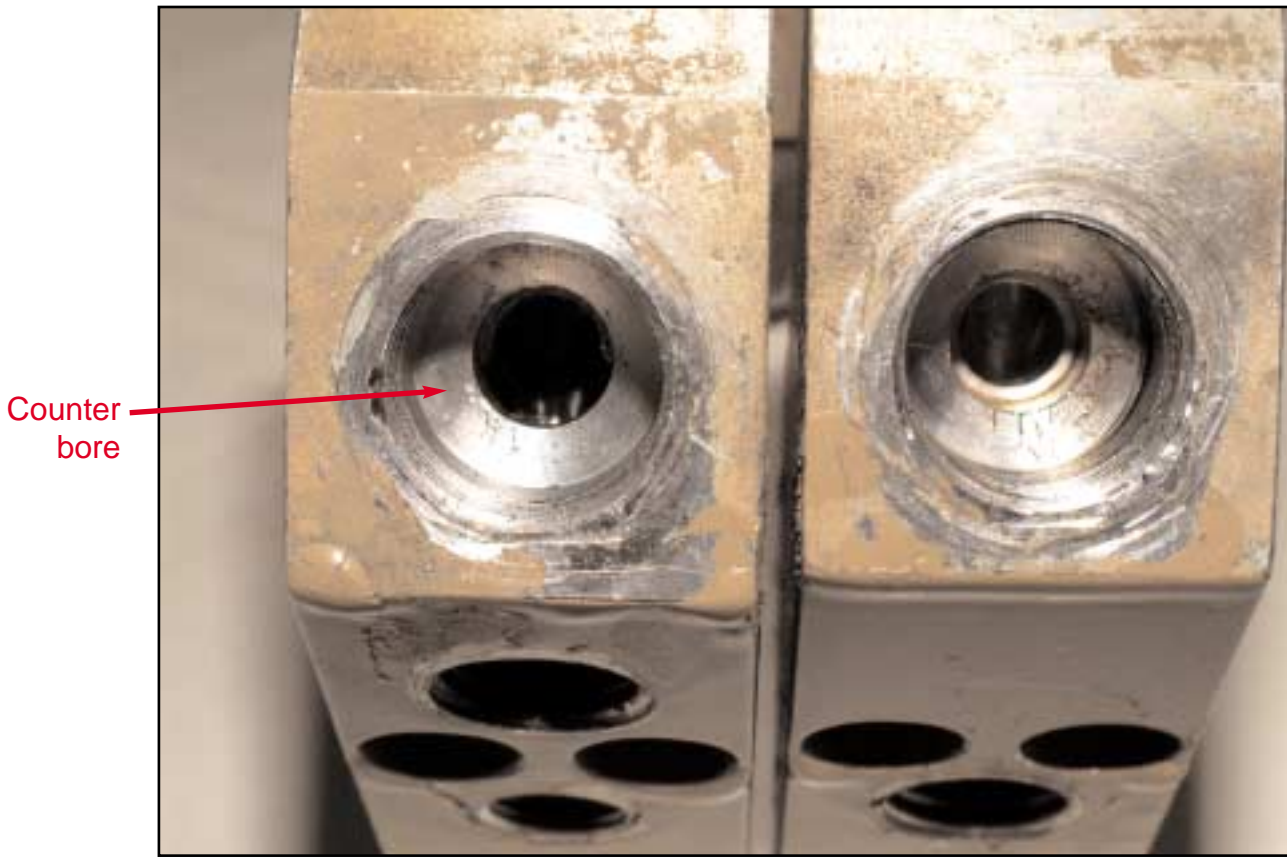
Figure 10

Subsequent examination of the failed pig-tail, showed that it had not been pushed as far as possible into the fuel block before it was tightened. Only one half of the steel olive had bitten into the pipe, so the compression of this olive was incomplete, and was not enough to provide adequate purchase on the pipe.

Fuel blocks

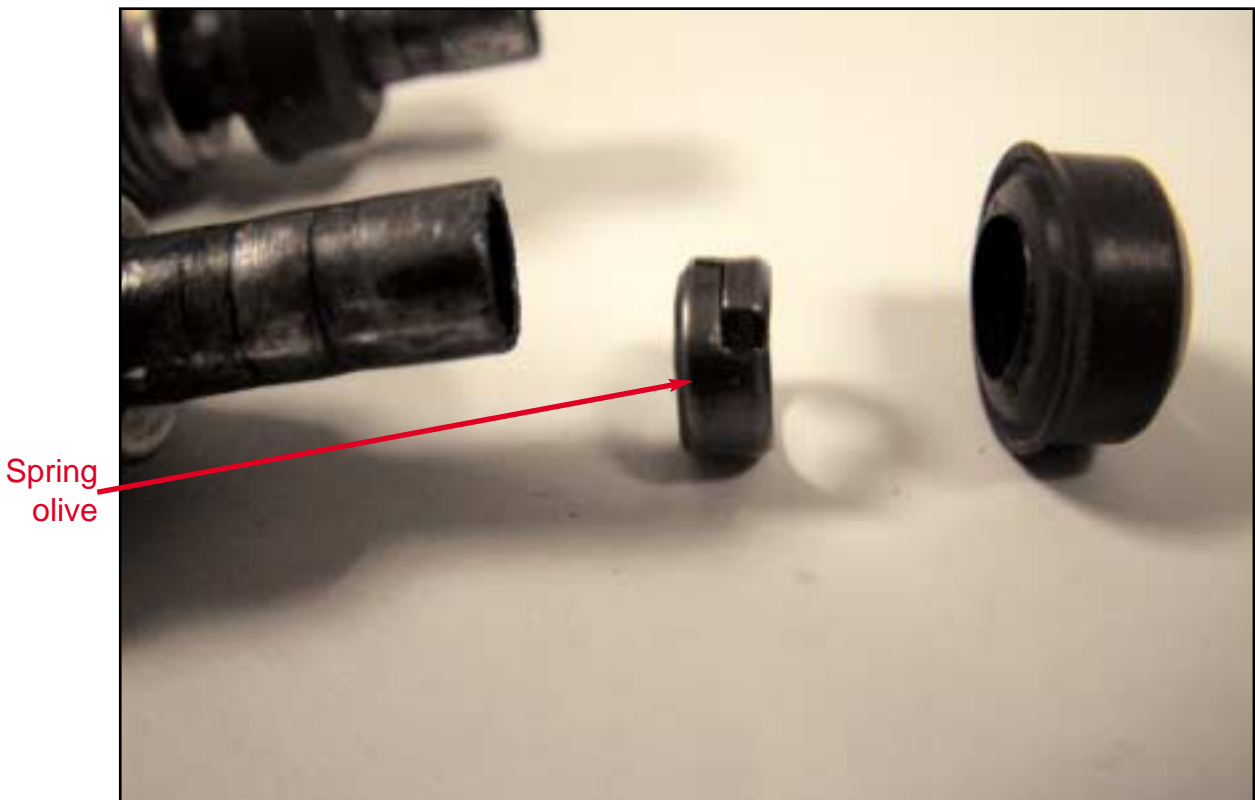
Figure 11

Since the olives in these fittings were sprung in construction (see Figure 11), the fitting was sealed by compressing the rubber element between the pipe and the fuel block counterbore. As a result, it is probable that it would still have provided a full seal against fuel leakage, even though the pipe was not correctly fitted when it was last overhauled. This condition could have given the impression that the pipe had been correctly fitted. In fact, it was in danger of blowing out at any time.

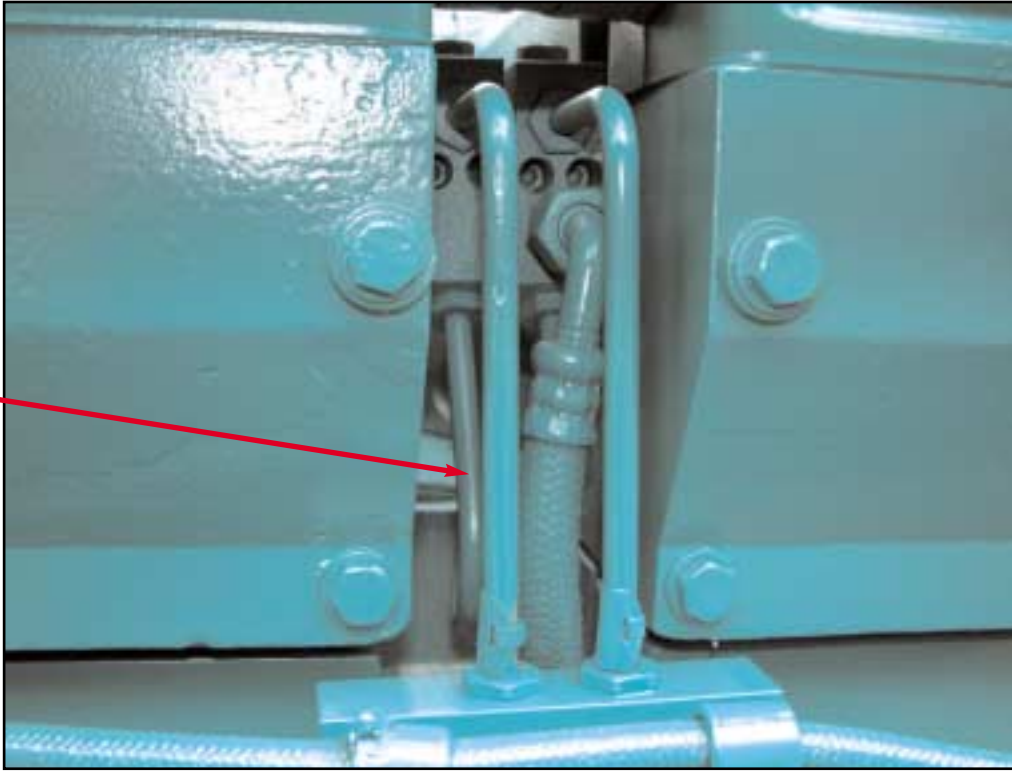
Figure 12

There was no way of ensuring that the pig-tail pipes were correctly fitted, without removing them for inspection. Because of their position on an engine in service, access is extremely restricted, and they cannot be easily seen.

Figures 12 and 13 show lower pig-tail pipes in position on a similar engine at Cummins Diesel in Wellingborough (note that this type of engine is not fitted with upper pig-tails) and on an engine on board *Stena Explorer*.

Lower pig-tail
on engine at
Cummins
Diesel,
Wellingborough

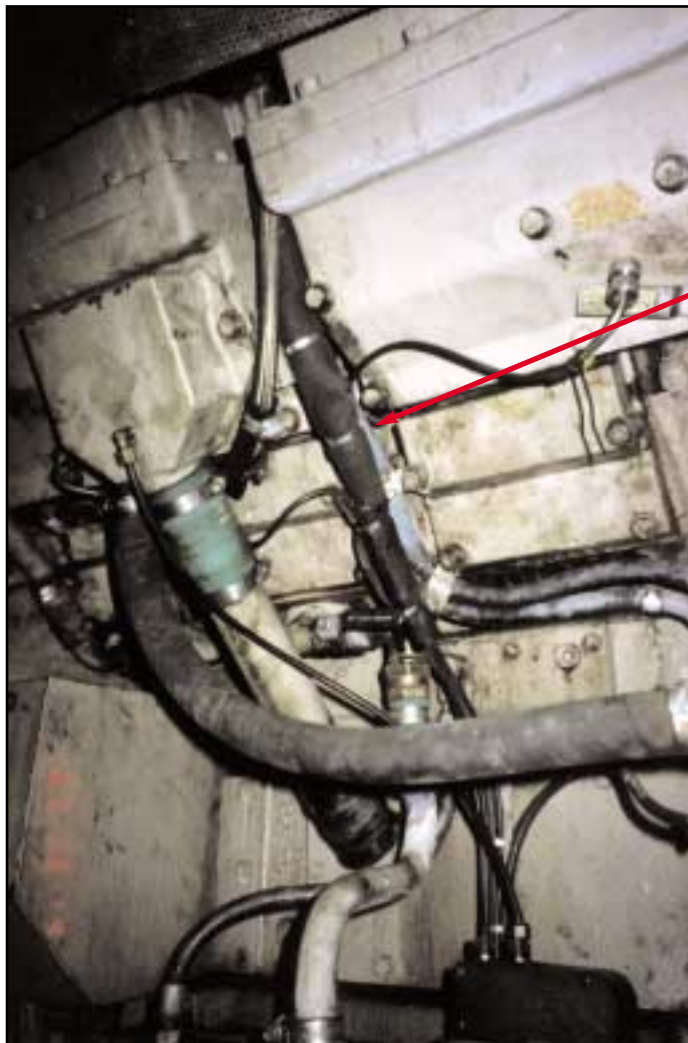
Figure 13

Lower pig-tail

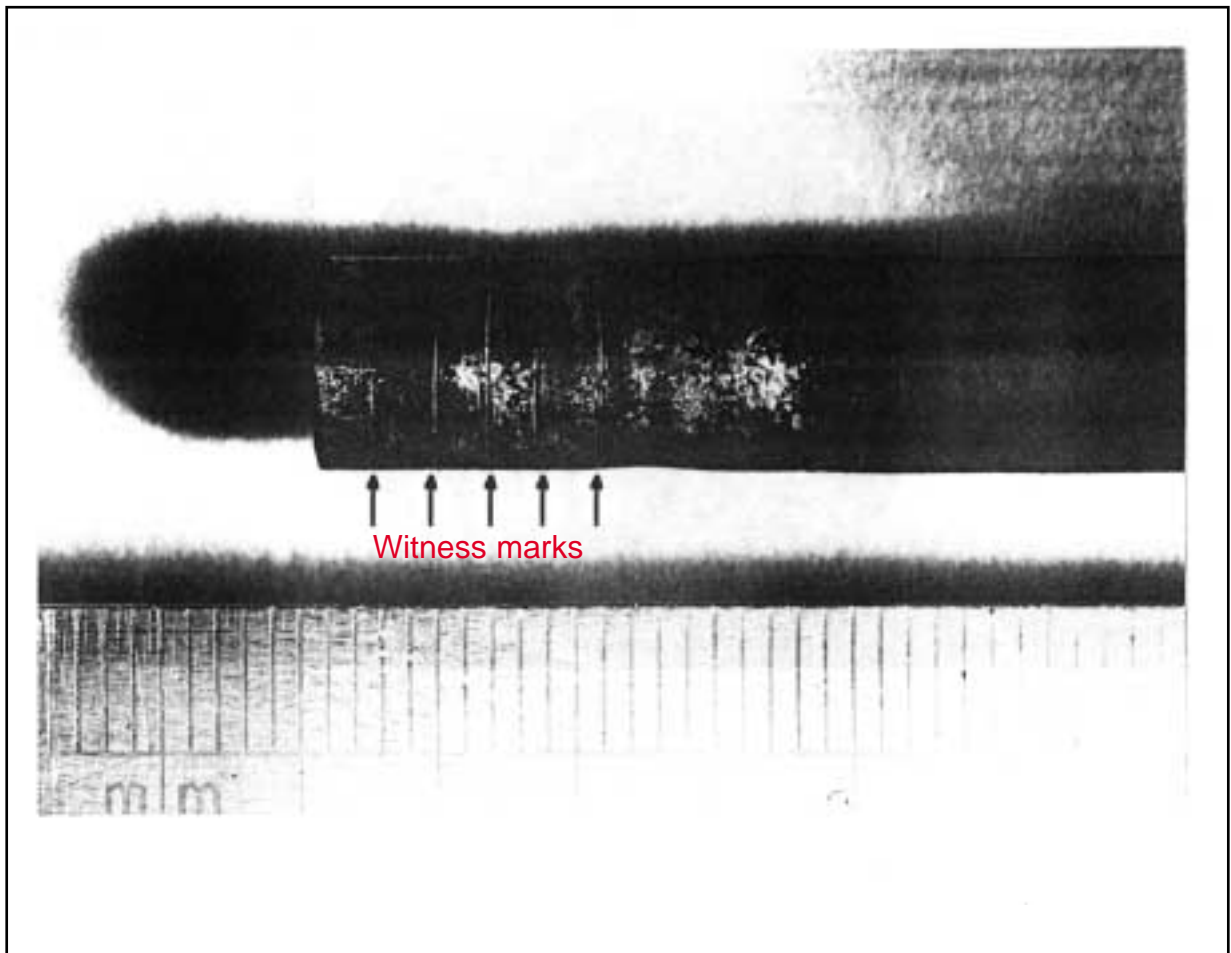
Figure 14 is taken from “Examination of failed fuel system component, ex *Stena Explorer*”, a report carried out by Atlantic Engineering after the accident. It shows five distinct witness marks in the end of the pig-tail pipe, which blew off the engine. The report concludes that the lowest of these is the single bite where the olive had gripped the pipe at the time of the accident.

The other four can only be explained by the olive being compressed on to the pipe in two different positions previously. Had the pipe been in the same position every time the fitting was tightened, there would only be two witness marks on it, from the top and bottom of the olive. This shows that the pipe could not have been pushed fully home before tightening on at least one previous occasion.

Pig-tail pipe end showing five witness marks
