Report on the investigation of
the capsizing and foundering of

fv Sundance

Off Gilkicker Point, East Solent

Report No 22/2002
July 2002

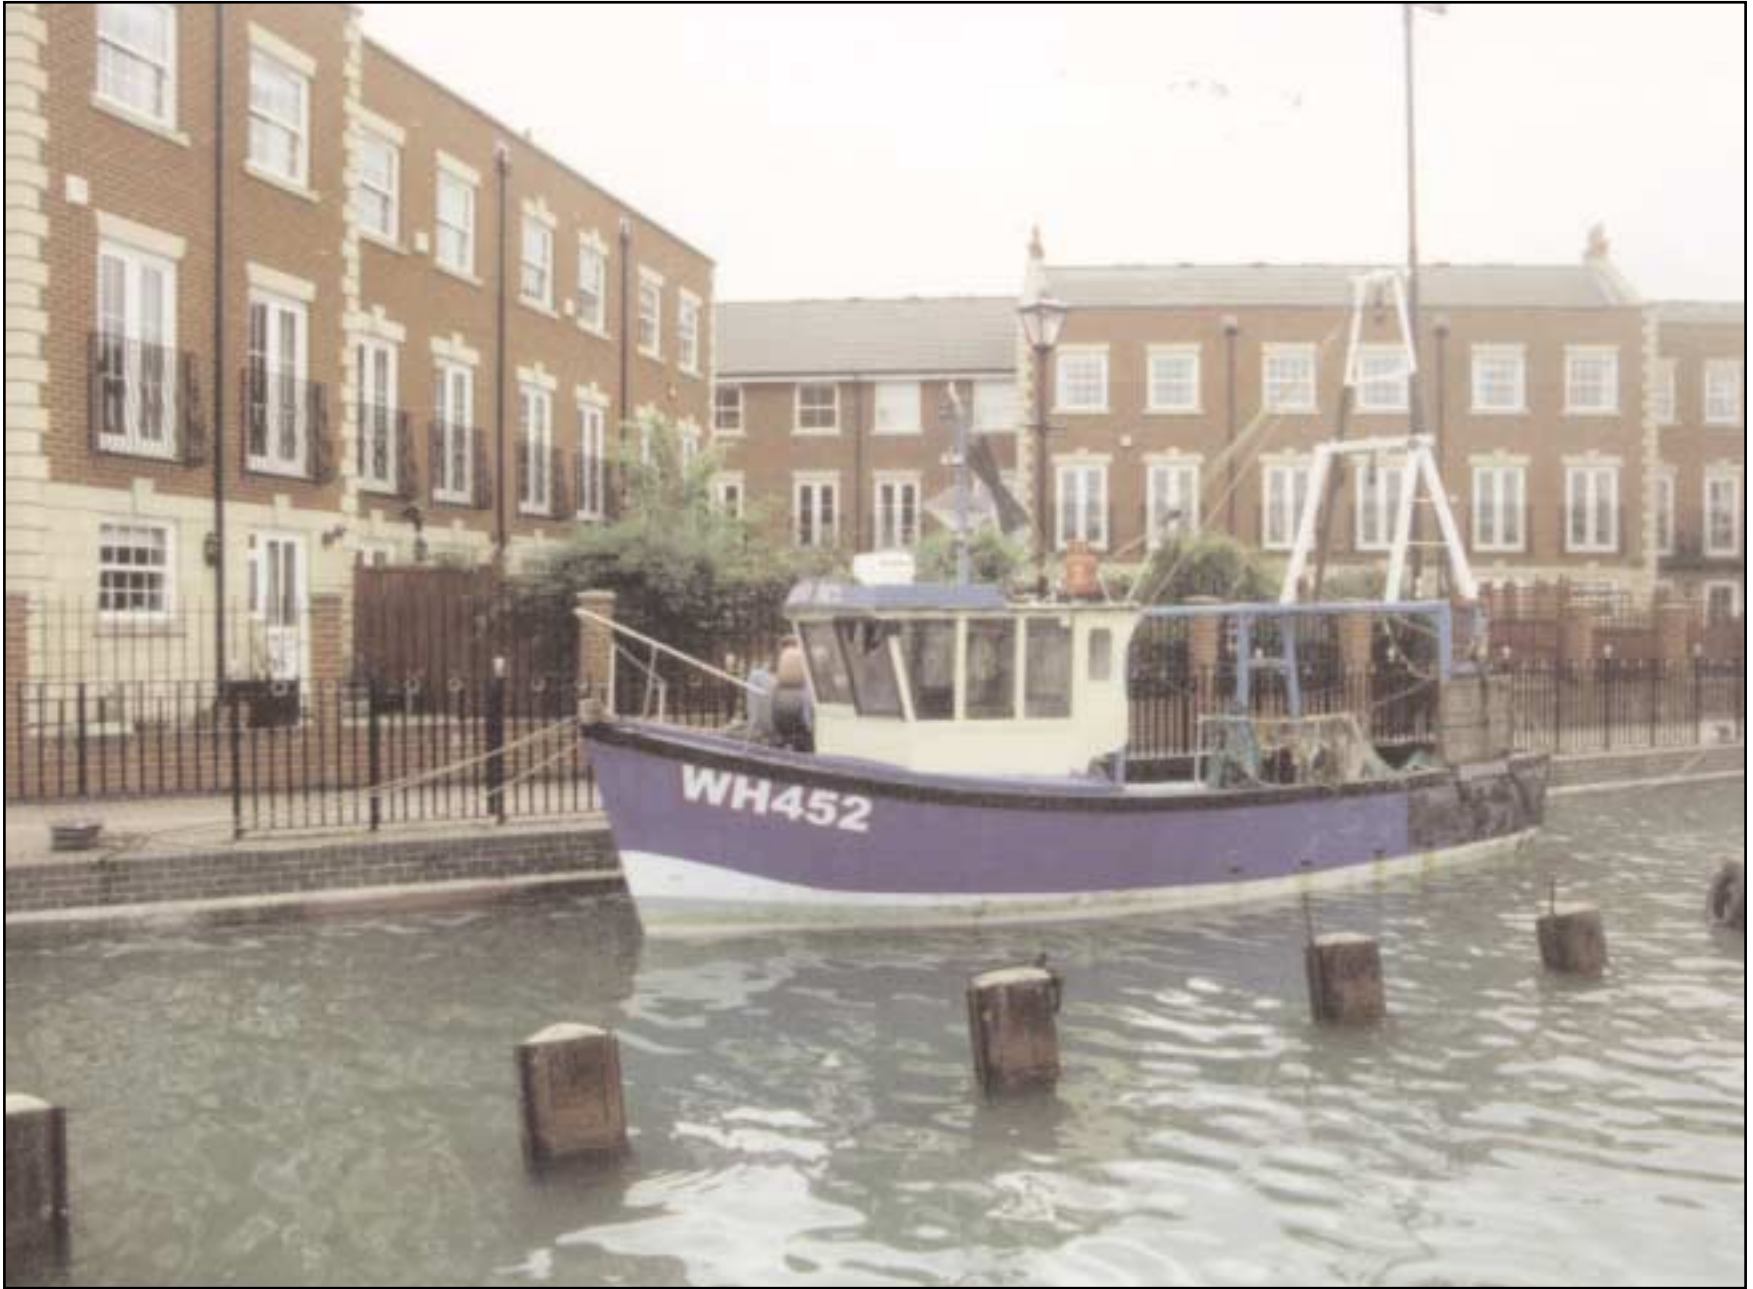
(Photograph 1)

Sundance

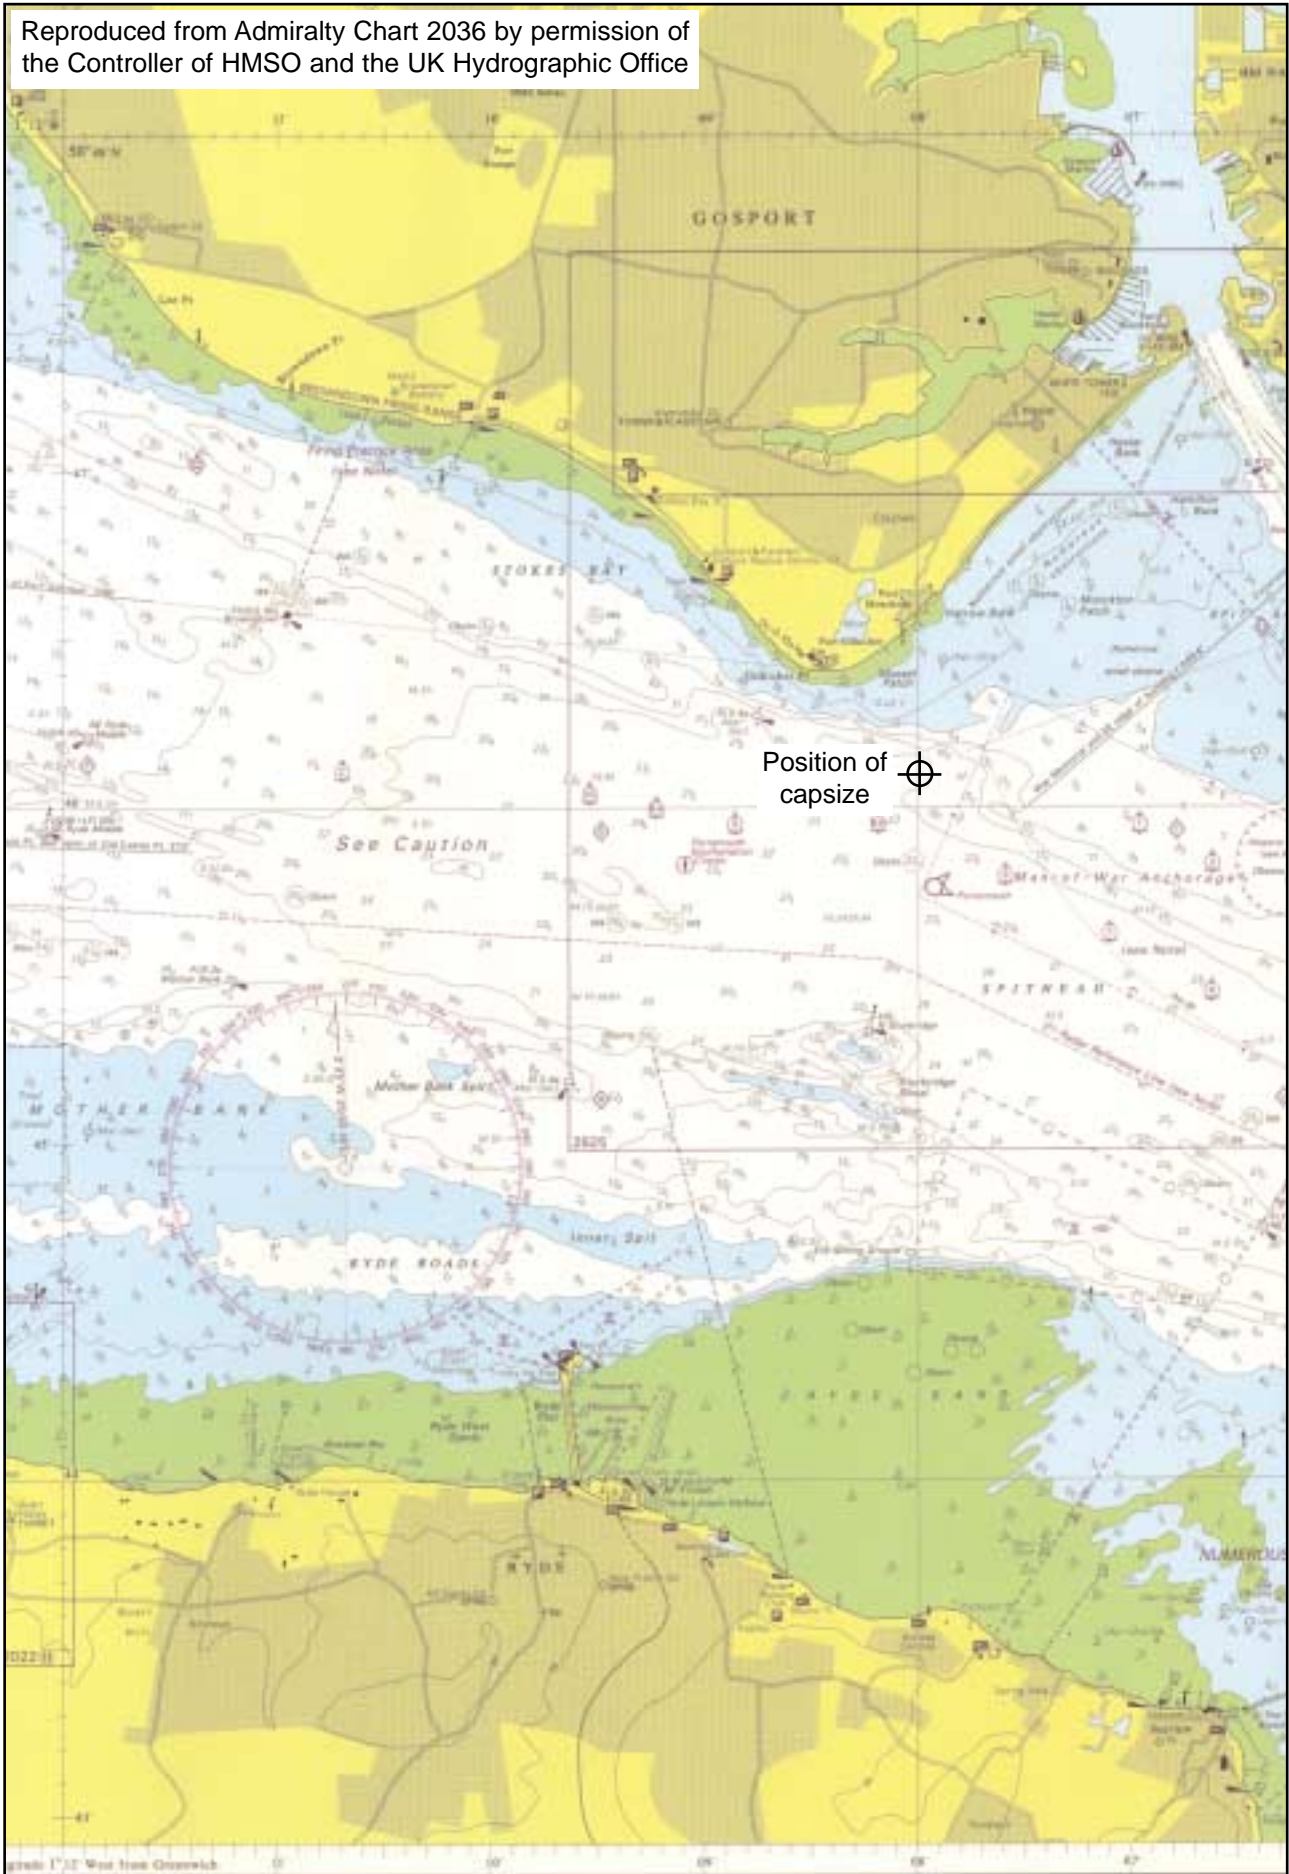
Sundance began the first trawl of the day near to the outfall pipe in Stokes Bay and trawled east at about 2 knots ([see chart extract](#)).

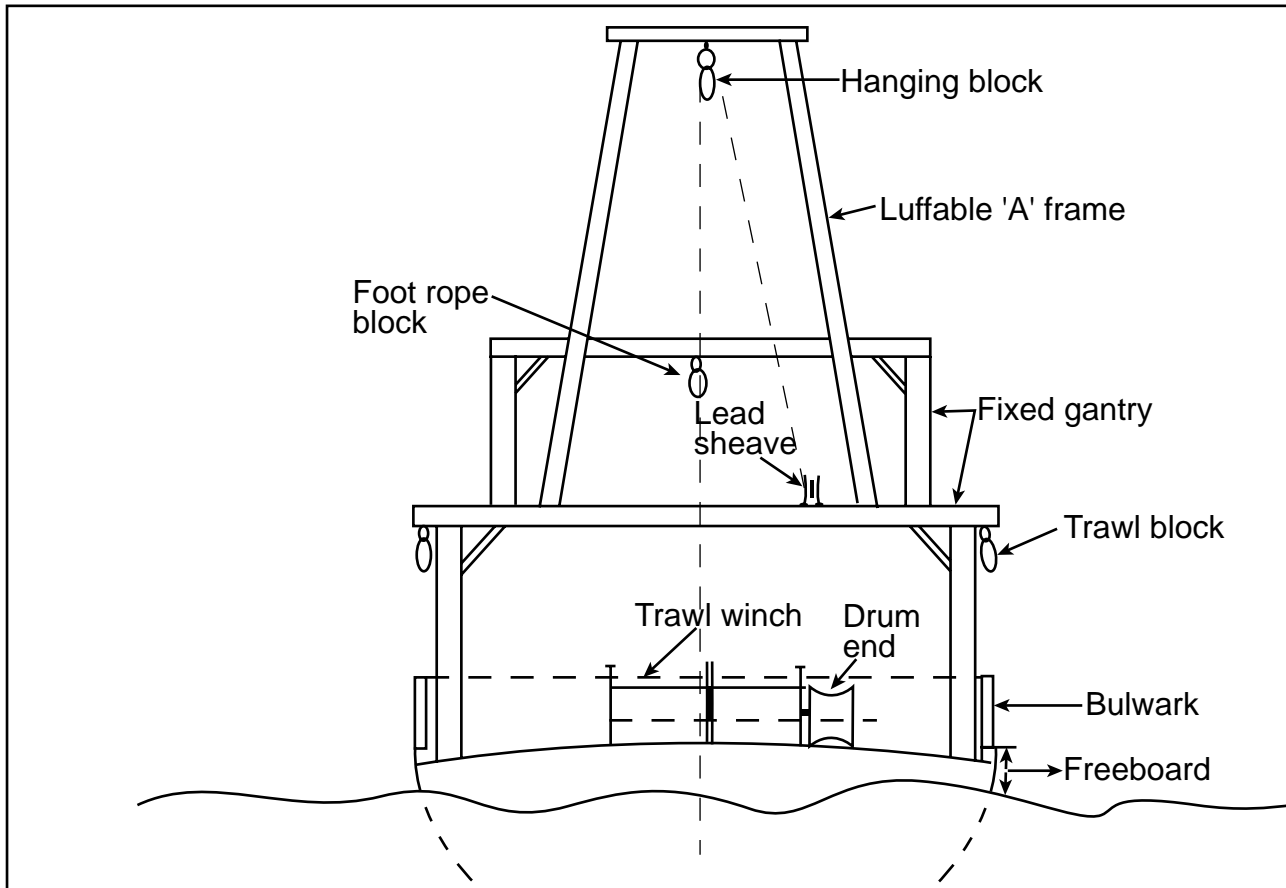
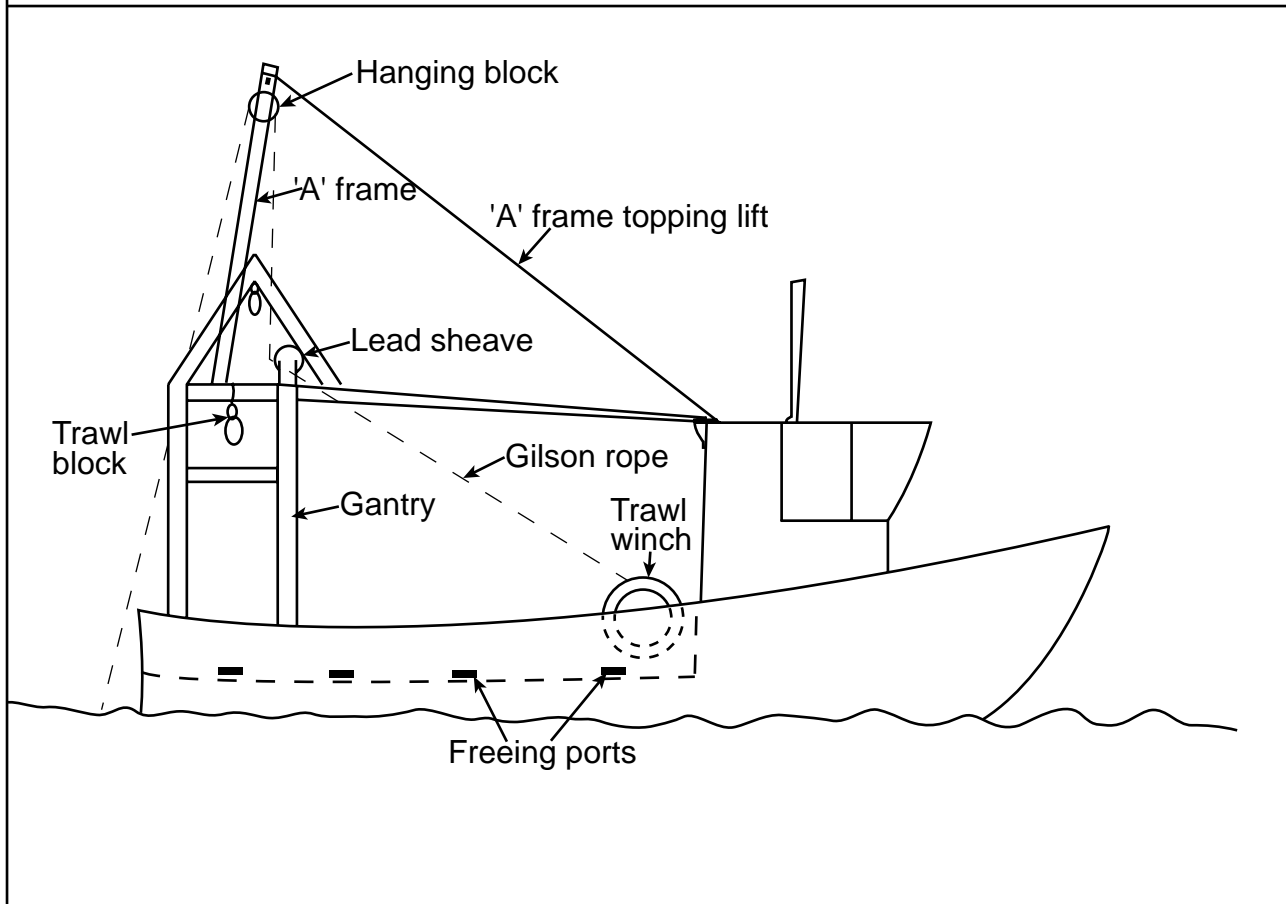
The crew brought home the doors successfully, and then hauled home the wings. As they did so, they felt a juddering as though something heavy had rolled down in the net. They continued hauling, and the mouth of the net was brought to the surface and close up under the vessel's stern. They connected a rope to the foot rope and hauled it to a block at the top of the gantry. The foot rope was tied off ([see Figure 1](#)).

Sundance (not to scale)

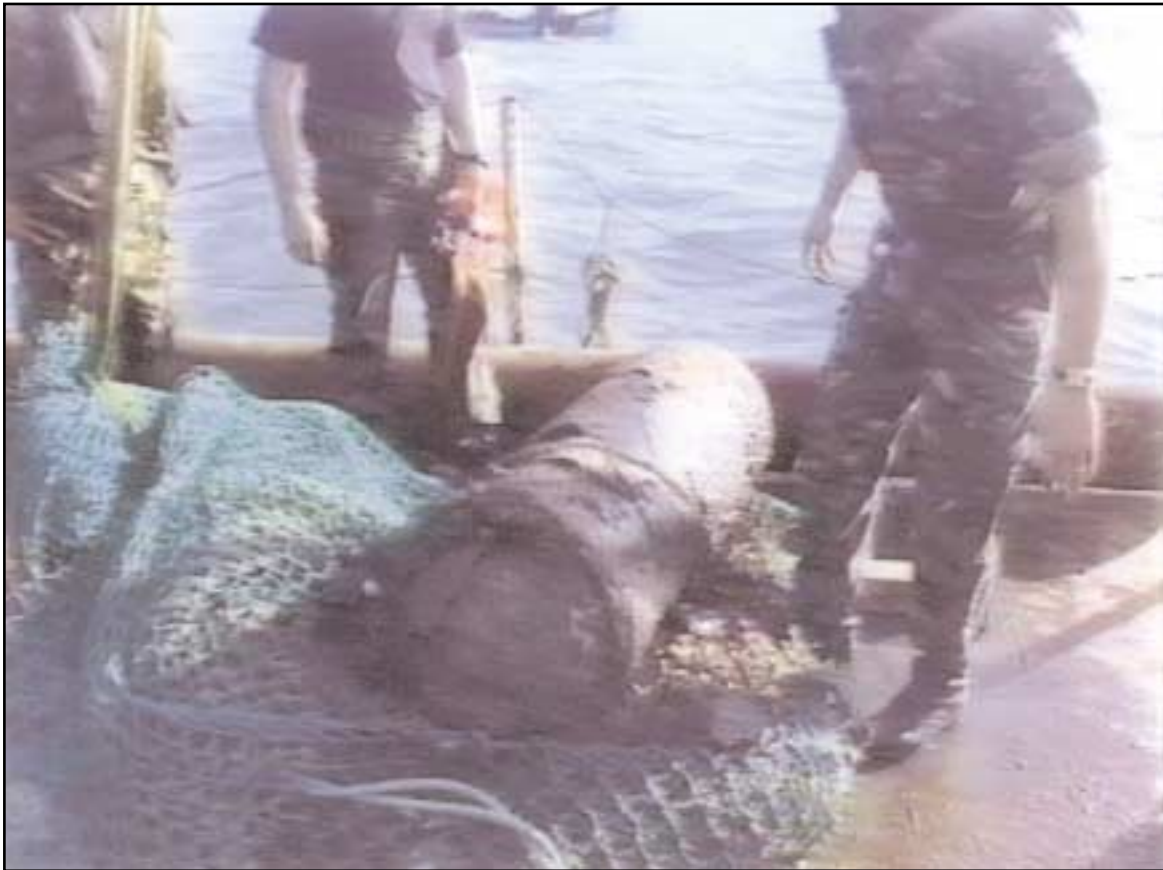
Sundance was located and raised a few days after the accident. The cod end of the net was found to contain shells, mud and part of a WW2 torpedo which was later positively identified as the air vessel section of an Air Steam Torpedo (UK Mk8) ([see video still 1](#)).

Part of a WW2 torpedo

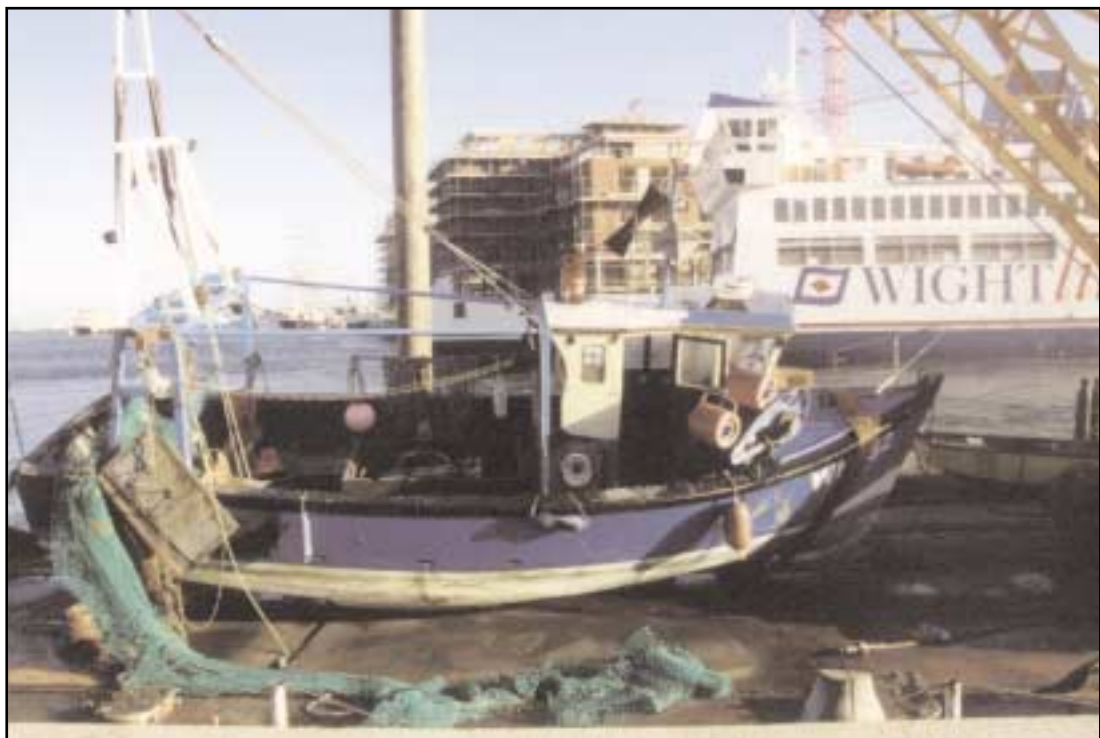
[Photograph 2](#)

Sundance was built in Weymouth in 1989. She was of wooden carvel built construction with a small wheelhouse forward and a large open working deck aft ([see photograph 2](#)). A small cabin was reached by steps leading forward from the wheelhouse. The diesel engine was sited aft and protected by a casing.

Sundance

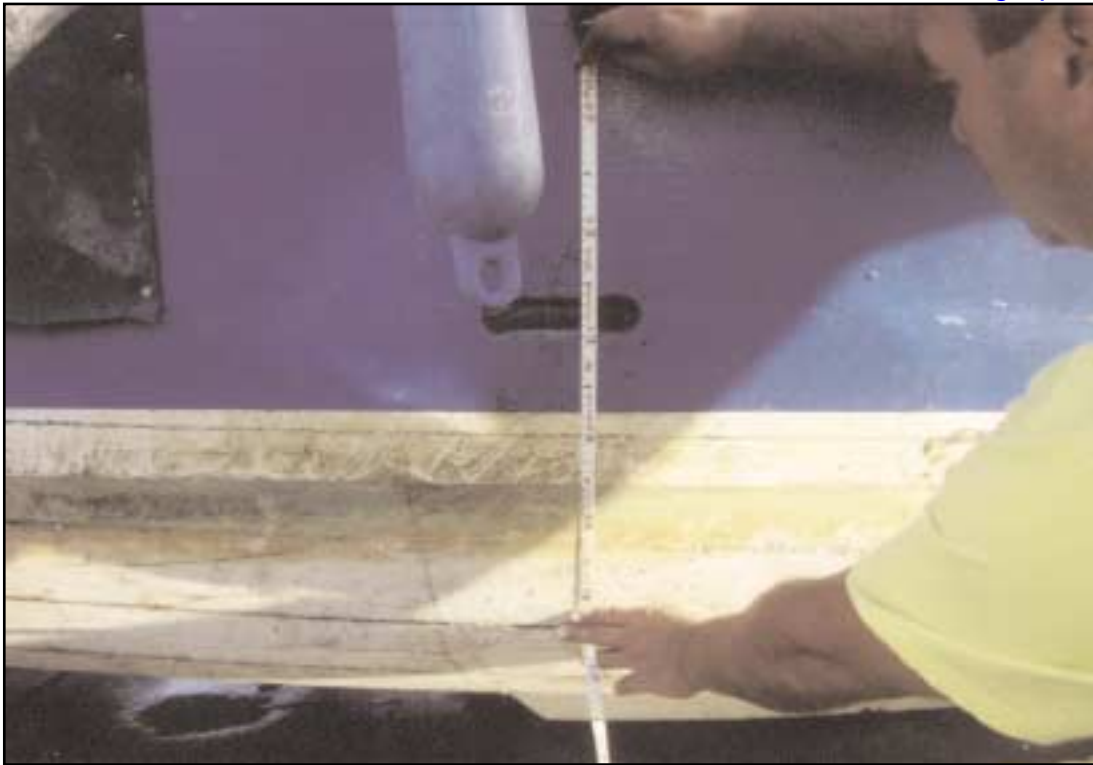
Photograph 3

The afterdeck drained through eight freeing ports each of about 10 x 4 cm. The freeing ports were each capable of being blocked off by wooden “doors” that could be kicked quickly into position ([see photograph 3](#)). Generally, the four aftermost freeing ports were kept open. The freeboard in the seagoing condition was about 18 to 20 cms. The height of the bulwarks aft was about 60cm above the deck.

One of the freeing ports

The freeboard and freeing arrangements are described in section 1.4. The freeing ports were very small and some might have been blocked off. The freeboard was small and the bulwark height was low, about 60cm. However, these aspects are typical of this size and type of boat.

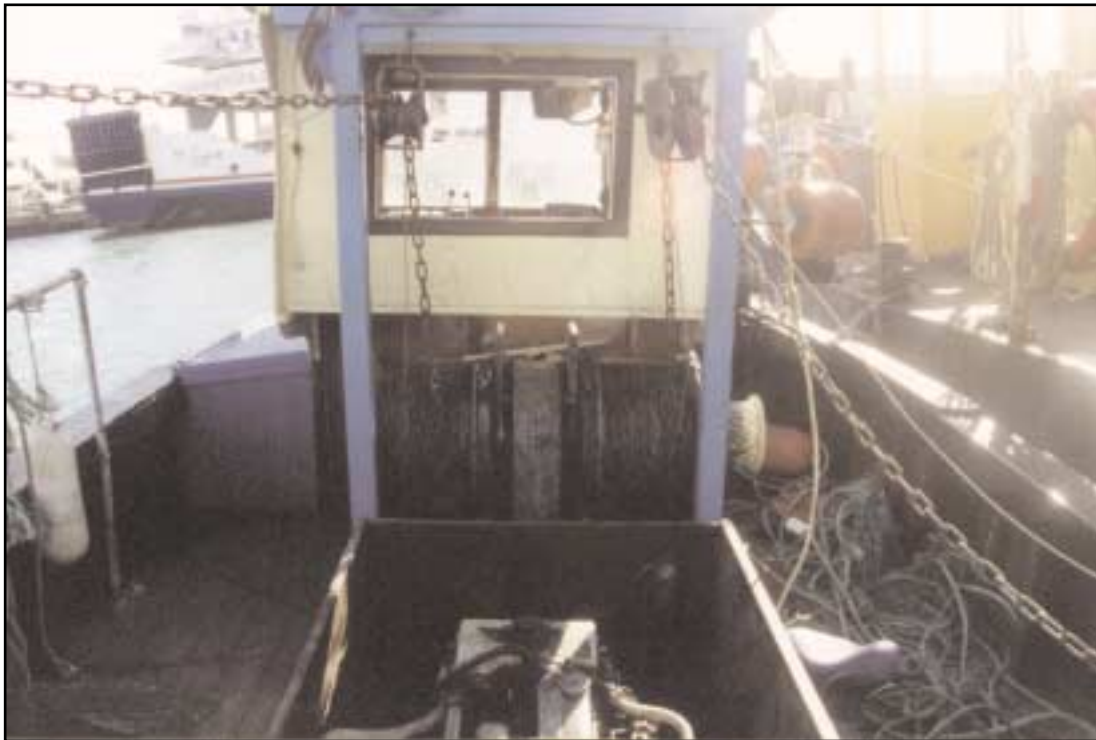
Photograph 4

The “Spencer Carter” trawl winch, which was sited just aft of the wheelhouse at the forward end of the working deck, was powered by a hydraulic motor which had been adjusted to allow a maximum lift of 984kg (1 ton) ([see photograph 4](#)).

The trawl winch

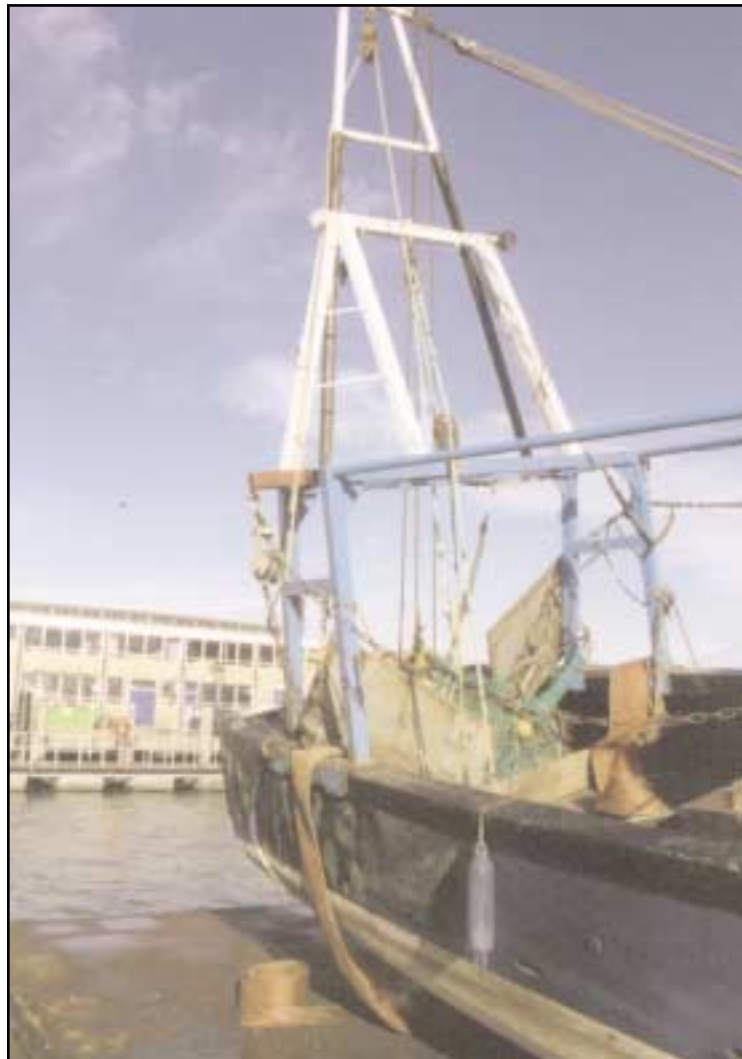
Photograph 5

Sundance was arranged as a twin-warp stern trawler. She had a fixed stern gantry, on top of which was mounted a luffable “A” frame (**see photograph 5**). The gantry had been renewed earlier in 2001. The new gantry was of similar design to the old one but possibly built with slightly bigger scantlings. The original “A” frame was retained, and the overall height of the arrangement was not changed. Although the “A” frame was luffable (capable of being raised and lowered) generally it remained topped up in one position during trawling operations.

The gantry and “A” frame

The cod end lifting block was a swinging block about 4.8m above the deck, and the lead sheave was sited to starboard of the centre line on the gantry. Any load lifted by this gear acted slightly to starboard of the centre line and caused a starboard list (see Figure 1). Anecdotal evidence suggests that the boat generally assumed a small starboard list in the latter stages of recovering the nets. The size of the list increased with a larger load.

- The height of the "A" frame meant that when the cod end and its contents were lifted by the gilson rope, the weight was transferred to a block which was 4.8m above the deck. This substantially reduced the vessel's stability. [2.3.2]
- The arrangement for handling gear on board caused the vessel to list to starboard while recovering the catch: the heavier the catch the larger the angle of list produced. [2.3.2]
- *Sundance's* low freeboard and low bulwark height affected her ability to recover from large angles of heel safely. This meant that she became more vulnerable to the roll produced by wash waves, especially when already in a listed condition. [2.3.3]

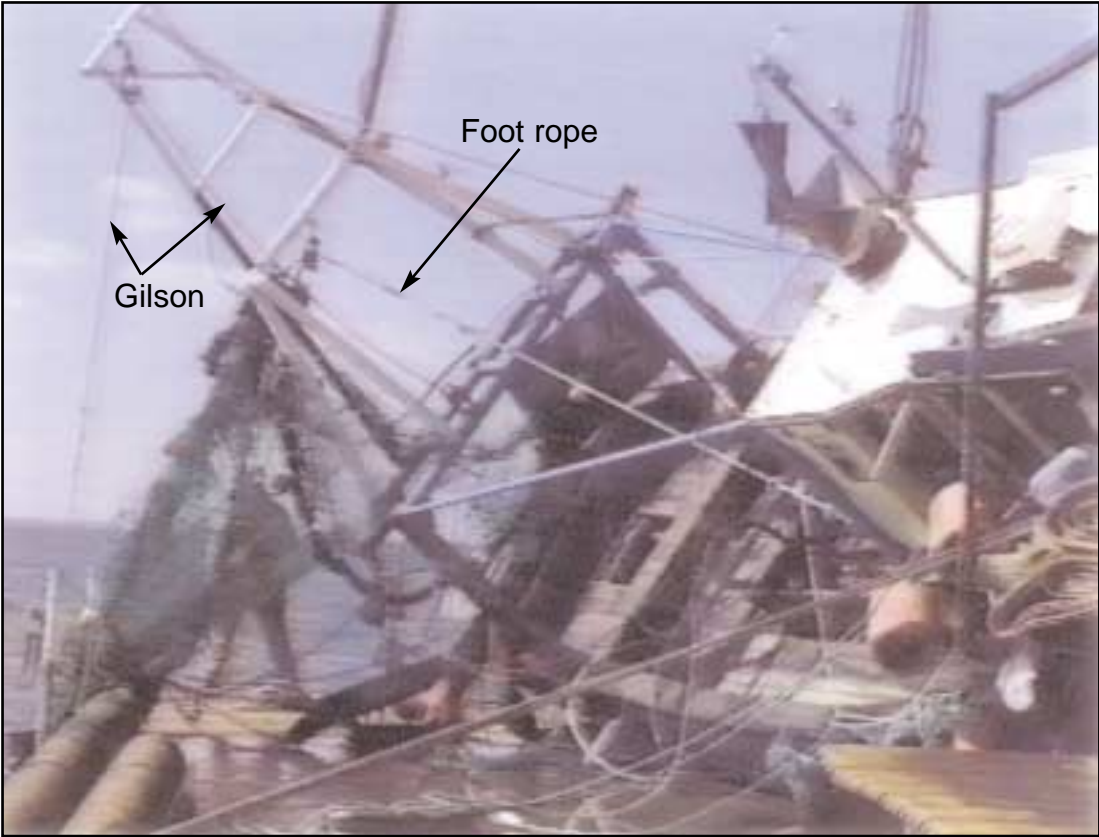
At the time of the accident the cod end was being lifted via the highest swinging block on the "A" frame (see video still 2). This was a single purchase and, although it is impossible to be precise about the weight in the net, it is likely that in air it neared the 980kg (1 ton) at which the winch's pressure relief valve was set. The winch appeared to be just able cope with the weight of the load while it was in the water, but failed to cope with it as it was being hauled clear.

Sundance showing the foot rope hauled in and the gilson rope connected to the cod end

Sundance just prior to capsize

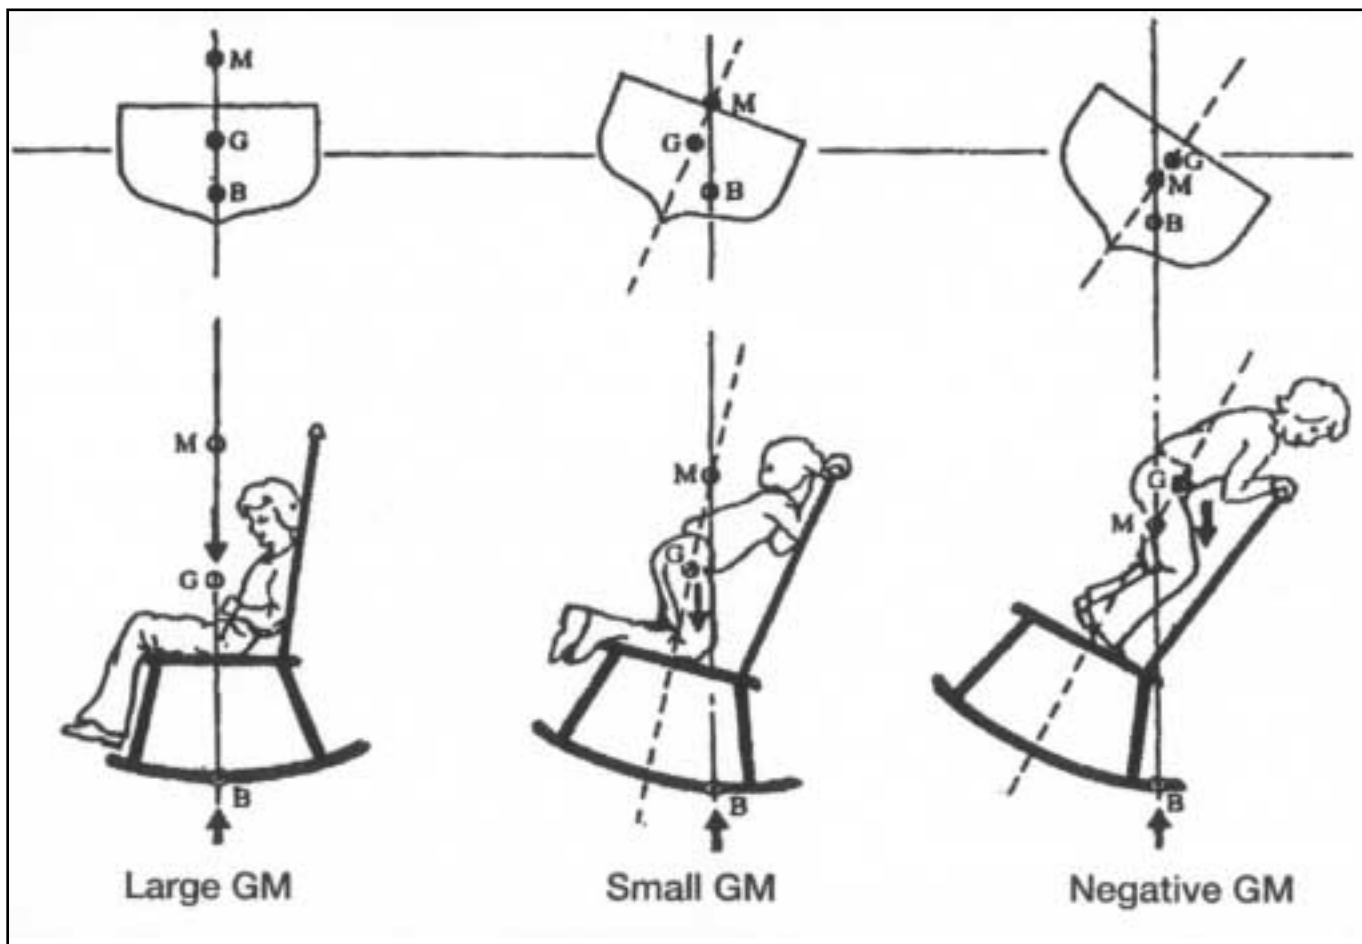
During trawling and for the first part of the net recovery process the loads were hauled and lifted through the trawl blocks. Although the load was unusually large, the vessel's stability was able to cope because the trawl blocks were sited low on each side of the gantry. When the cod end rope was connected to the gilson and hauled through a block hanging at 4.8m above the deck, the heavy load was effectively transferred to act at that height in the vessel. This made the vessel top-heavy and led to a dramatic reduction in the vessel's stability (see [Figure 2](#)).
