Report of an investigation  
of an injury sustained during  
the firing of cannon on  
***sv Grand Turk***  
while alongside at Portsmouth  
on 24 August 2001

Marine Accident Investigation Branch  
First Floor, Carlton House  
Carlton Place  
Southampton  
SO15 2DZ

**Report No 15/2002**  
**April 2002**

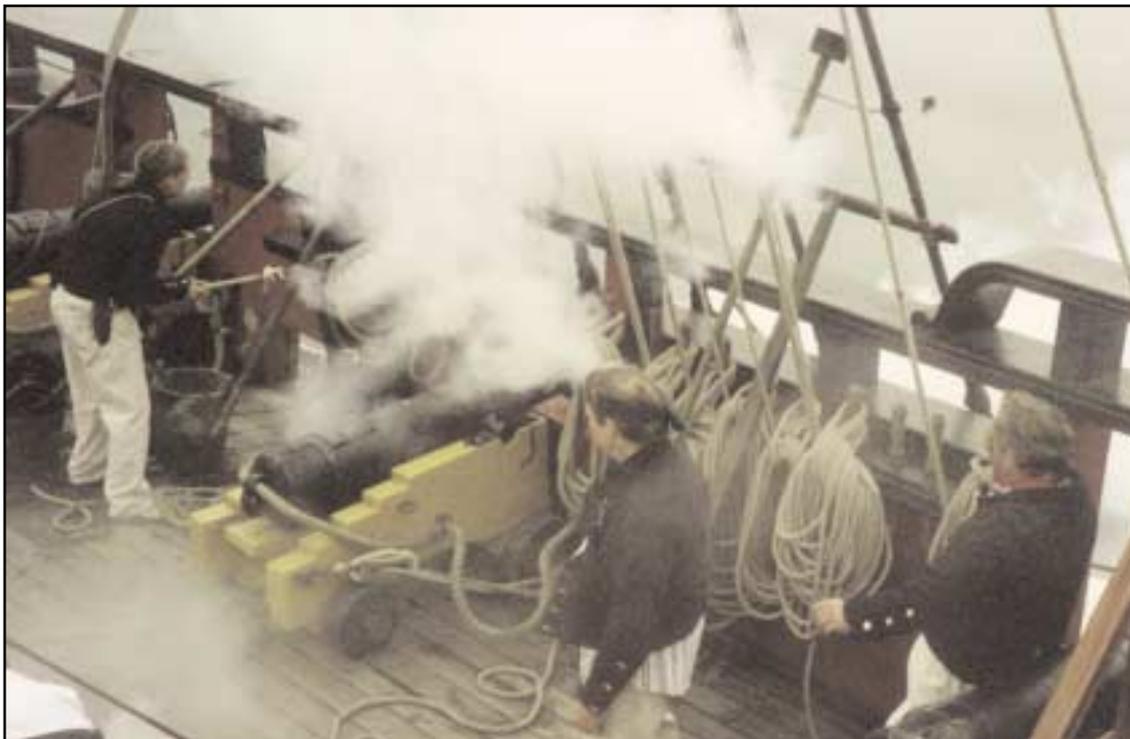
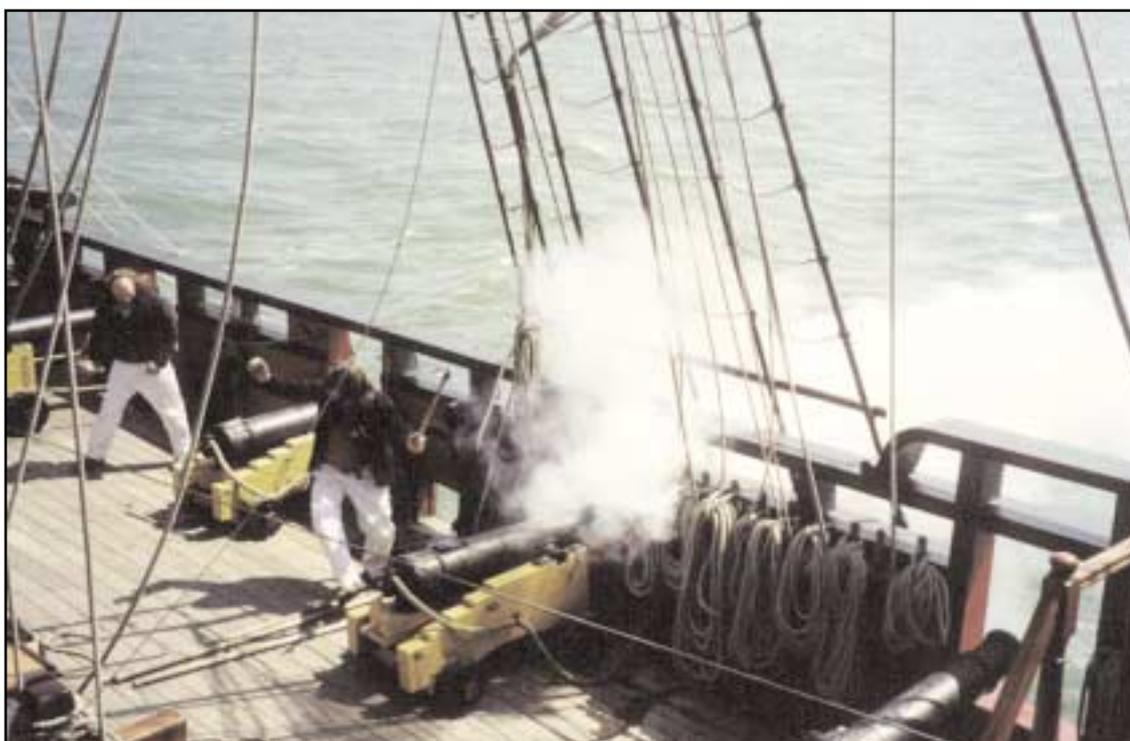
Figure 1

Cannon firing aboard *Grand Turk*

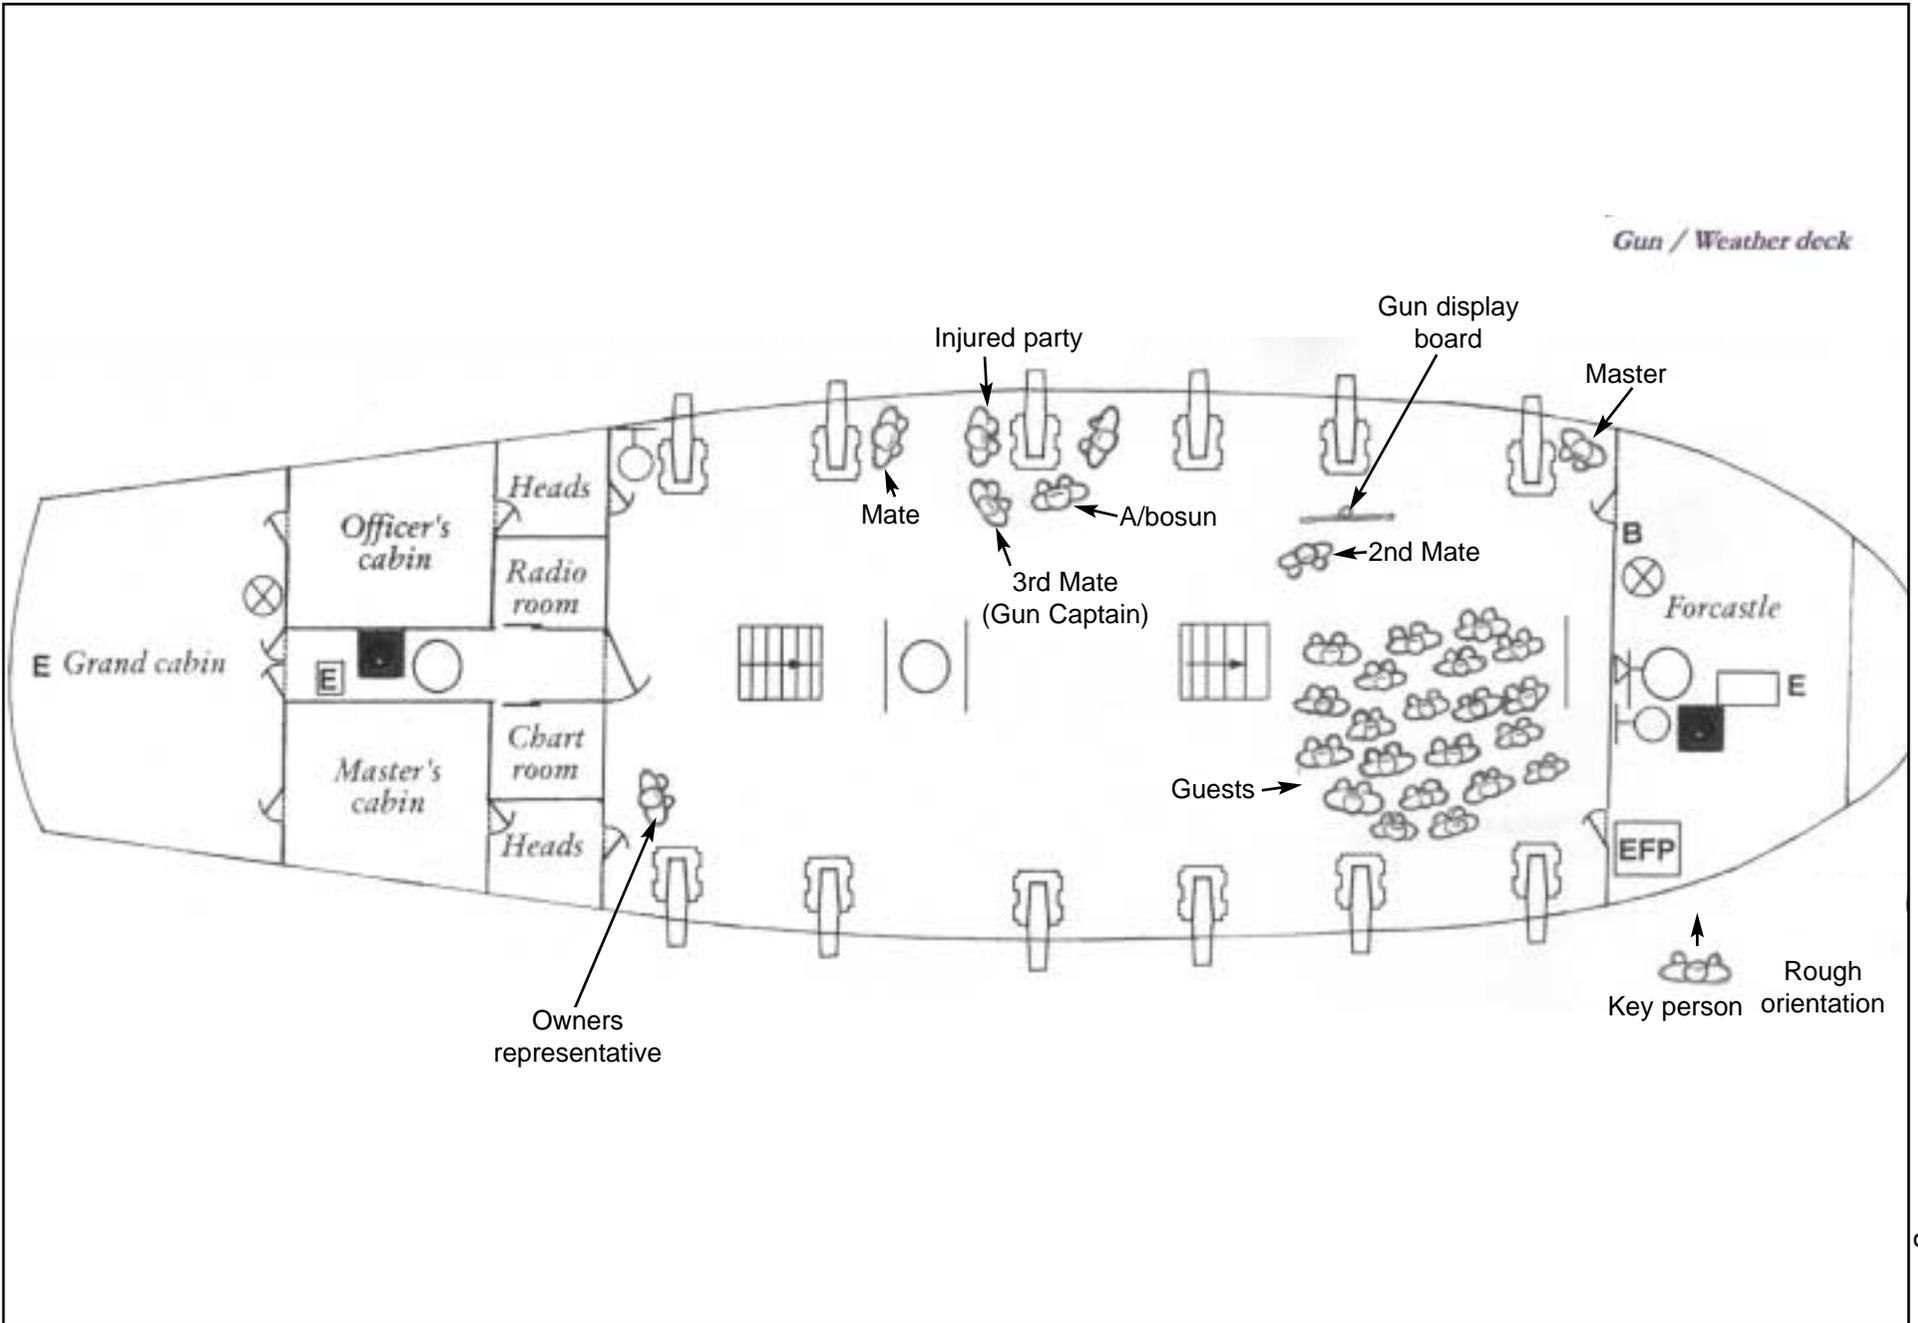
Figure 2

- 1.3.5 On Friday 24 August, with *Grand Turk* tied up alongside the north wall of HM Dockyard, Portsmouth, the vessel’s charterers, *BAE Systems* and their guests, boarded the vessel to join in the International Festival of the Sea festivities. By about 1145, all six 9lb cannons on the port, or seaward side, of *Grand Turk* had been loaded and wadded but not primed. The demonstration gun team was in position and dressed in period costume (**Figure 2**).

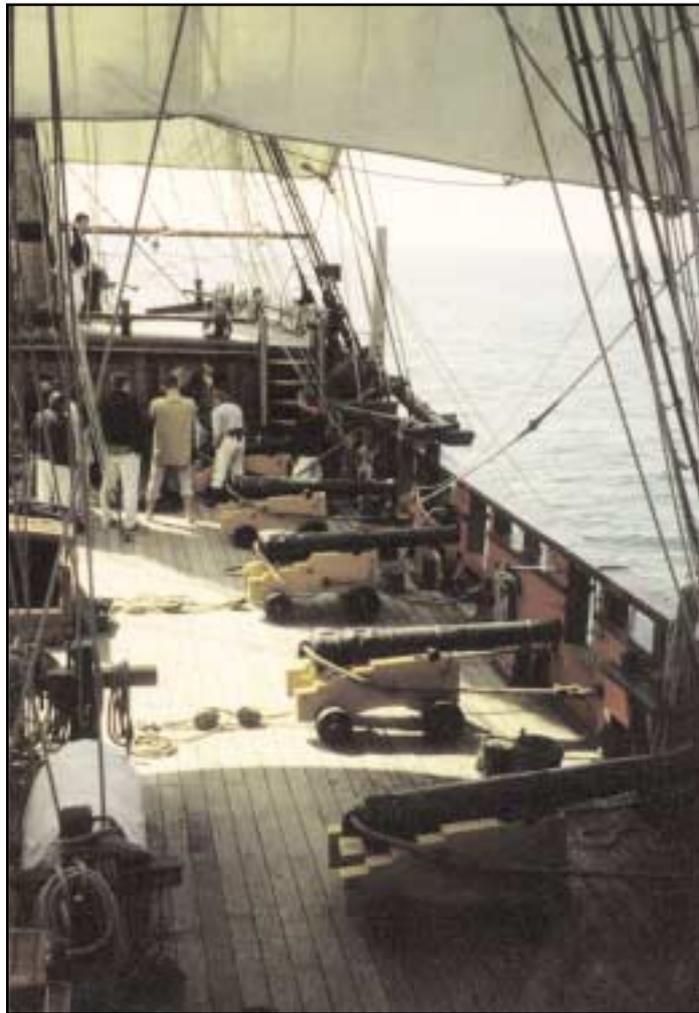
Figure 3

The guests were standing in a group on the forward starboard side of the main deck, with the second mate standing in front of them with the gun display board (**Figures 3 & 4**). The board showed a cut away section of a cannon on which the various actions of loading, priming and reloading could be seen. It was the second mate’s duty to explain to the guests what happens during cannon firing, and to answer questions regarding the demonstration.

Forward starboard side of *Grand Turk's* main deck

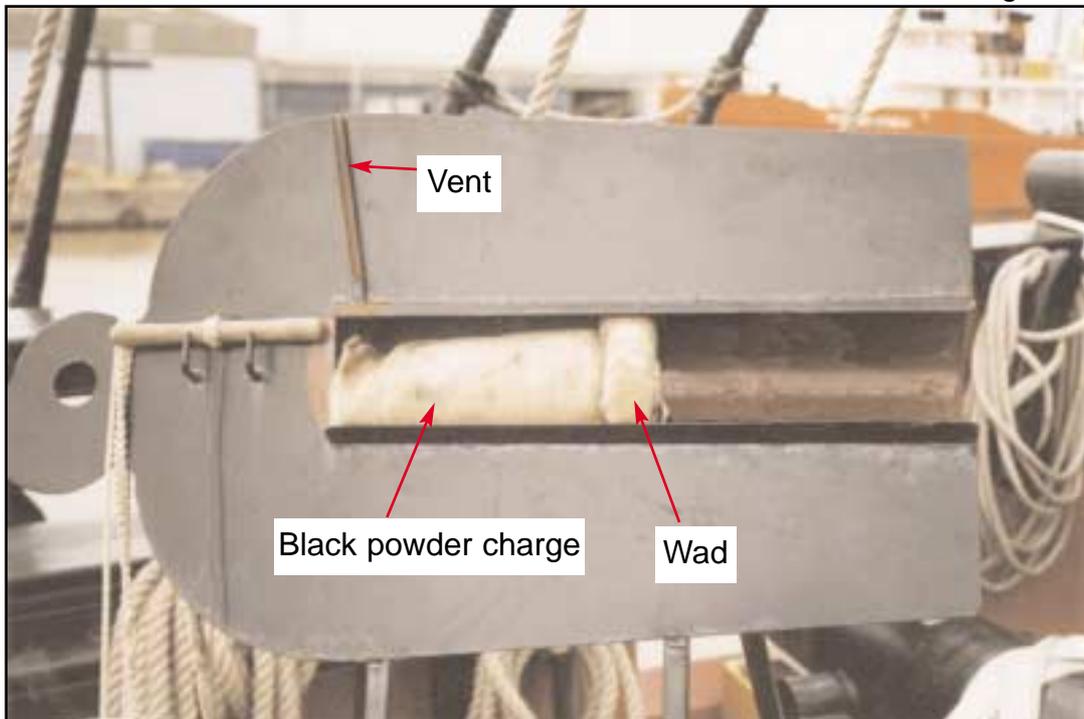
Figure 4

Cut away model of cannon

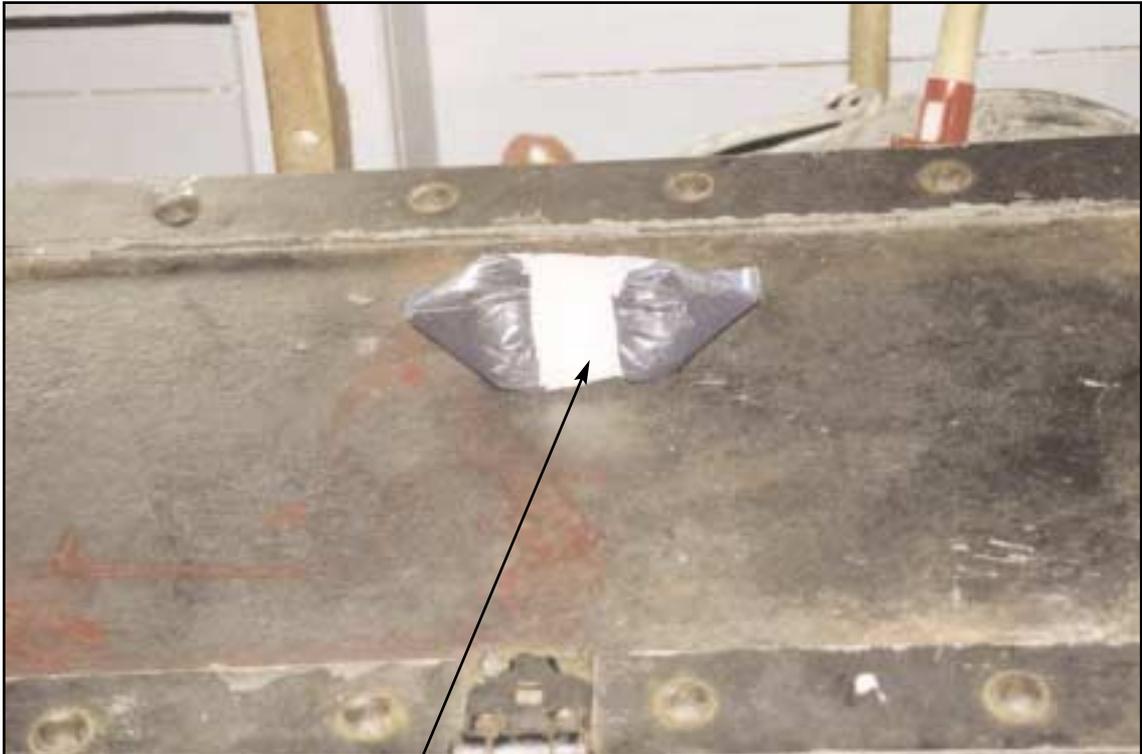
Figure 6

- 1.6.4 The current construction of the gunpowder cartridges had been developed by the mate after he had studied the actions of film and TV special effects technicians and others. This resulted in a 400-gram charge being contained in a thin plastic bag, such as a food freezer bag. This in turn was wrapped with tape until it formed a sort of sausage about 35mm in diameter (**Figure 6**). This was pushed down the barrel until it rested on the breech immediately below the vent. Loose gunpowder was then poured down the vent to provide a fire trail once a flame had been applied externally. In theory what followed was an explosion and the discharge of the wad.

Gunpowder charge for cannon

The cause of the premature ignition of the gunpowder charge was the exposure of thin plastic casing of the cartridge to smouldering debris from the noon day firing.

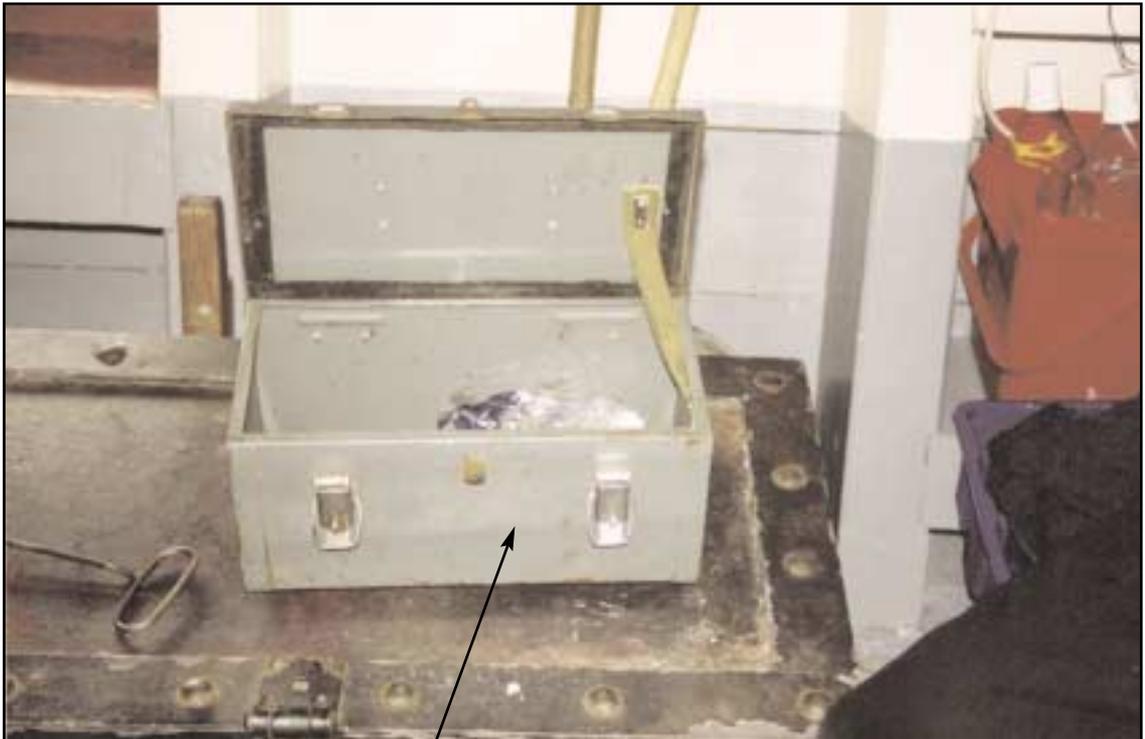
The charges were made by the mate, in the “boot” where the magazine was stowed. When required for firing, they were carried out on deck in a fireproof box and only brought forward to the guns when cannon firing was to be carried out (**Figure 7**).

Fireproof box for transporting charges on to deck

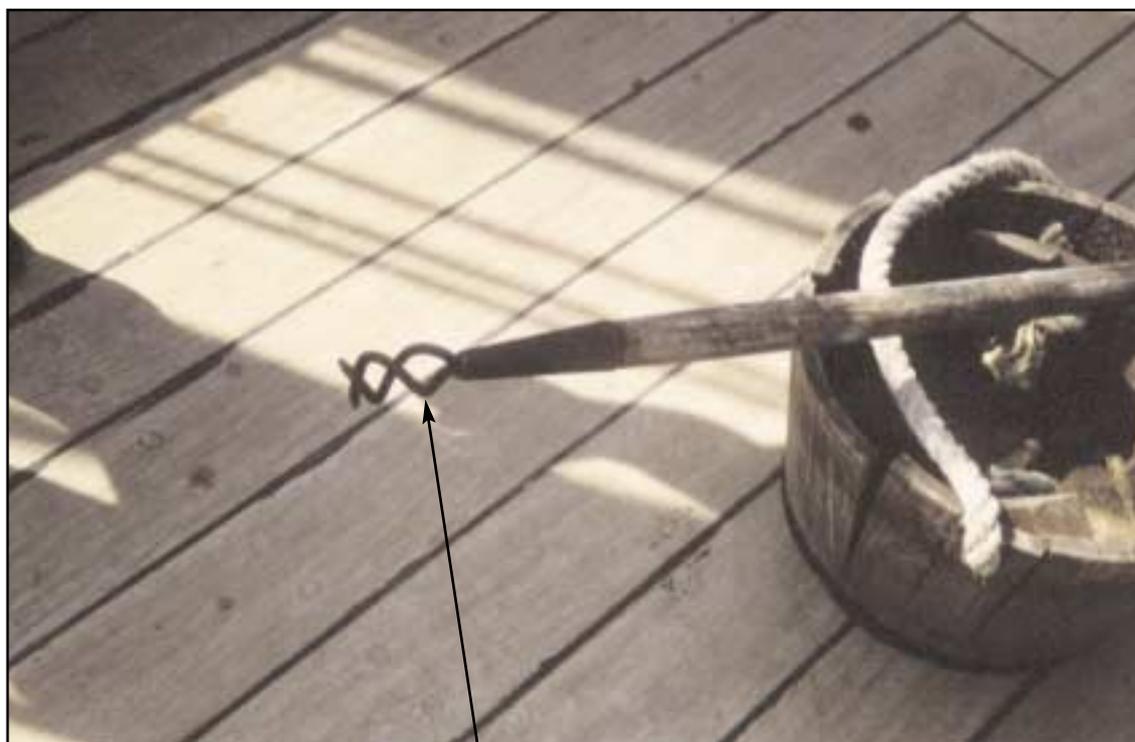
Figure 8

The standard routine for reloading after firing is, first, the barrel is wormed using a two start, open end metal spiral fitted to a wooden pole. This is rotated against the end of the barrel to remove any debris left after the firing. After removing the wormer, the barrel is swabbed. The tool used is a wet sheepskin secured to a wooden pole. This should extinguish any residue sparks or embers remaining in the barrel after firing. Once this is withdrawn, the black powder charge is inserted in the muzzle and pushed down the barrel with the rammer; a wooden bung fixed to the end of a wooden pole. When the charge is down at the breech end, a tightly bound wad of old cloth is pushed down from the muzzle to rest against the charge. The cannon is now “loaded and wadded” but not primed. Once in this condition, the breech is covered with a lead cover until the cannon needs to be primed ready for firing.

Wormer

Before the rammer could be removed, the black powder charge ignited prematurely, causing the rammer to be ejected with some force from the cannon, striking a crewman's left hand. The use of the wormer after the swabber is thought to have uncovered burning material, which subsequently ignited the charge.

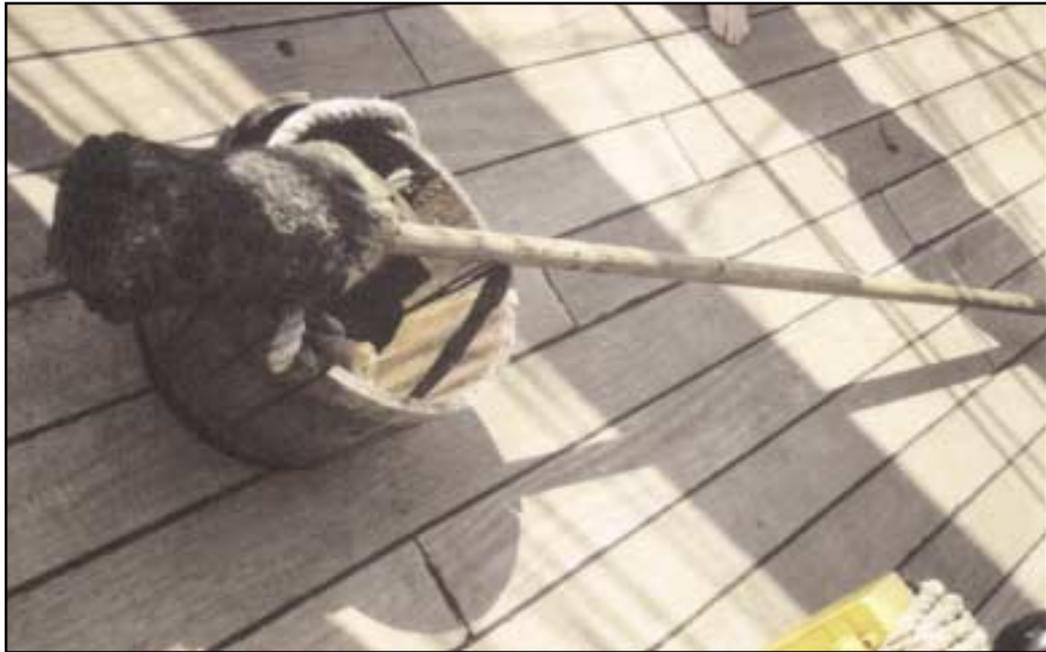
Figure 9

Wet swabber

- Sponging. During gun firing, the sponging is of great importance. The sponge should not be too wet as this can cause a misfire or hangfire. The sponge needs to be fully home to the breech face and rotated firmly in both directions, ideally a full turn each way. The sponge must be visually inspected for signs of debris and/or unburned powder and repeated until satisfactory. If two sponges are available, one can be used wet and then sponging finished with the dry. Sponges should be washed thoroughly after cease firing and kept free of grit. Canvas covers for the sponge heads were often supplied.
