Report of an investigation  
of an injury sustained during  
the firing of cannon on  
***sv Grand Turk***  
while alongside at Portsmouth  
on 24 August 2001

Marine Accident Investigation Branch  
First Floor, Carlton House  
Carlton Place  
Southampton  
SO15 2DZ

**Report No 15/2002**  
**April 2002**

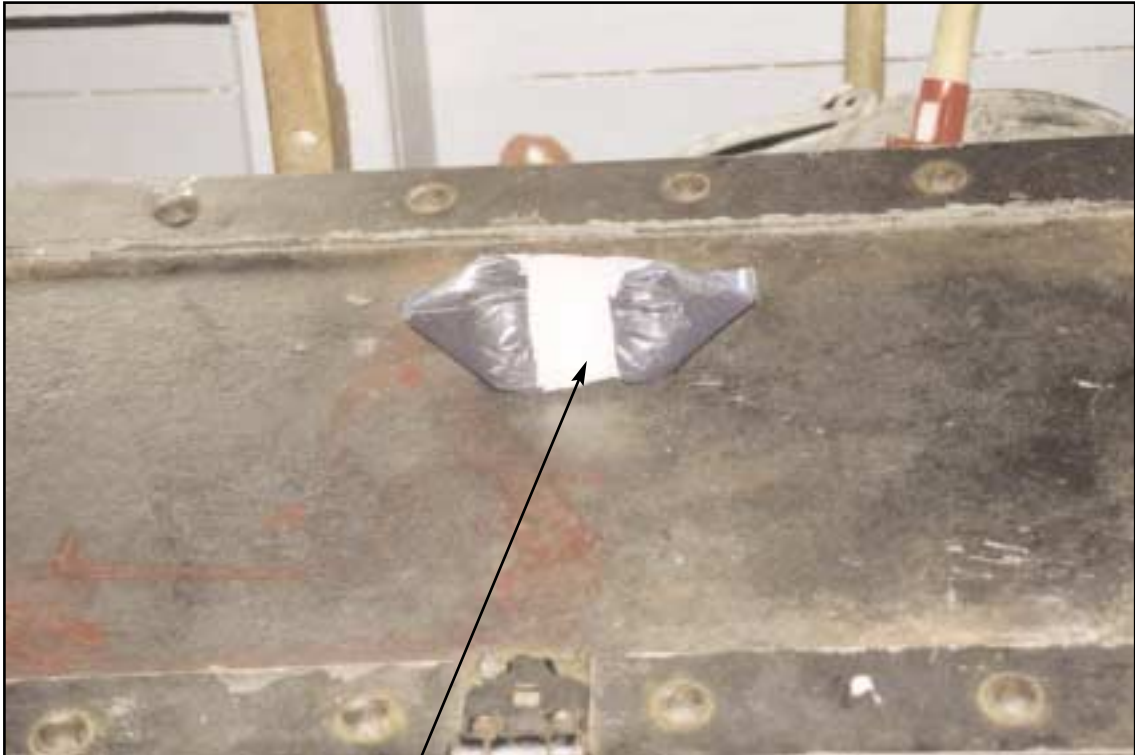
Figure 6

Gunpowder charge for cannon

The cause of the premature ignition of the gunpowder charge was the exposure of thin plastic casing of the cartridge to smouldering debris from the noon day firing.

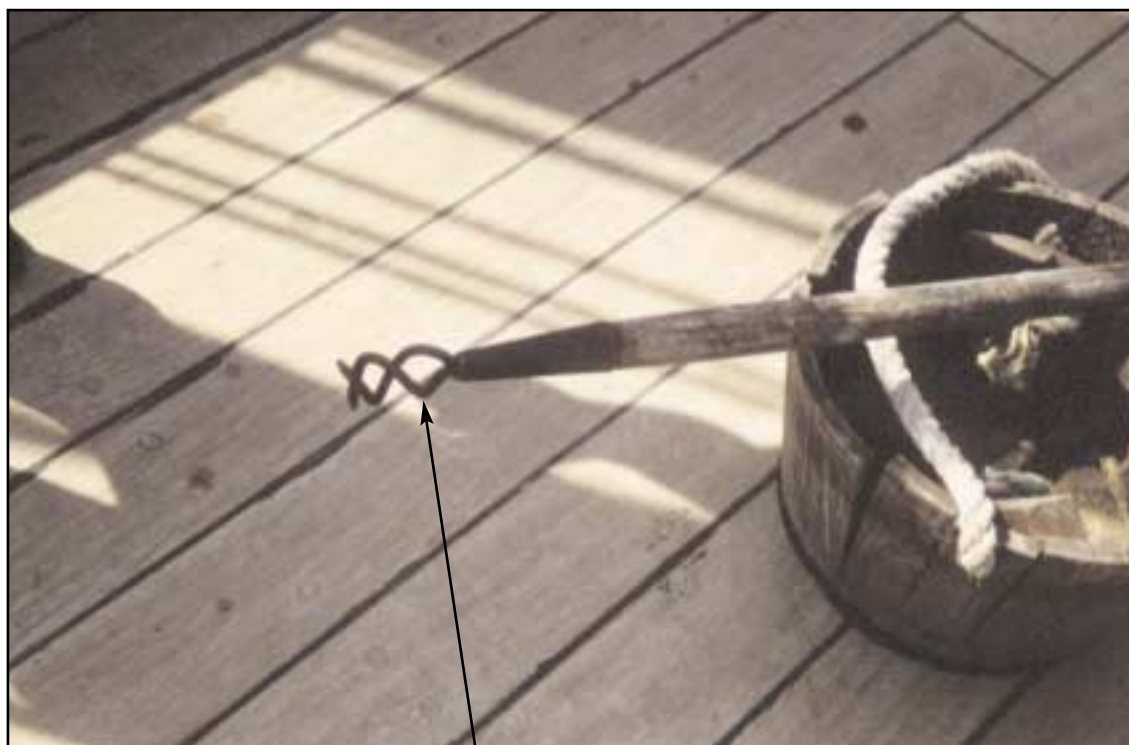
Figure 8

Wormer

Before the rammer could be removed, the black powder charge ignited prematurely, causing the rammer to be ejected with some force from the cannon, striking a crewman's left hand. The use of the wormer after the swabber is thought to have uncovered burning material, which subsequently ignited the charge.

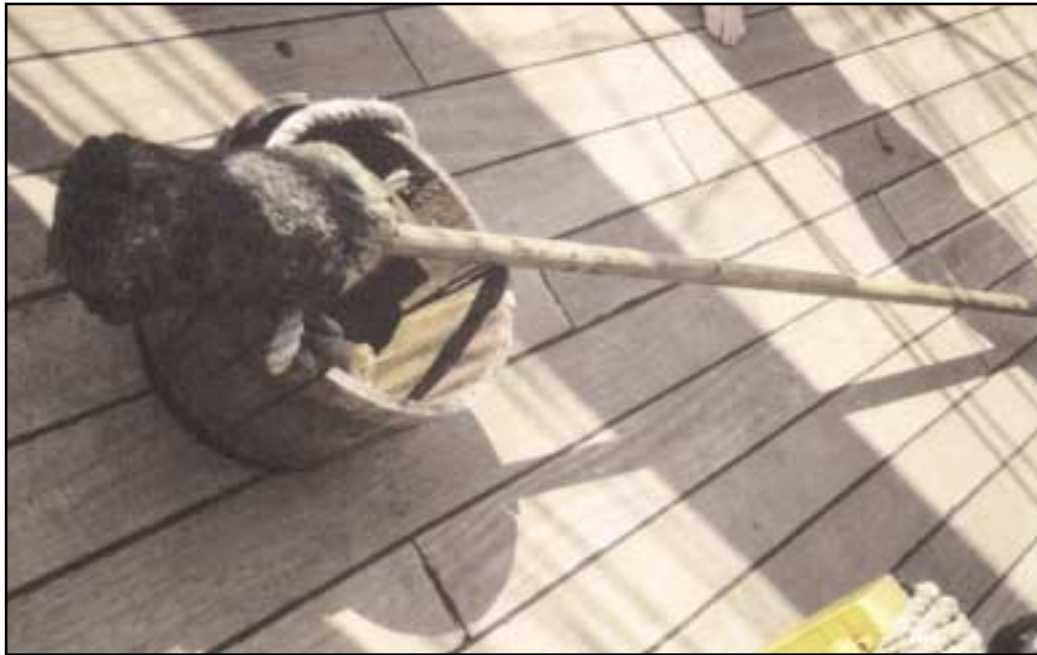
Figure 9

Wet swabber
