Report on the investigation of
the flooding and loss of the fishing vessel

Aurelia (BF15)

13 August 2001

**Report No 40/2002
December 2002**

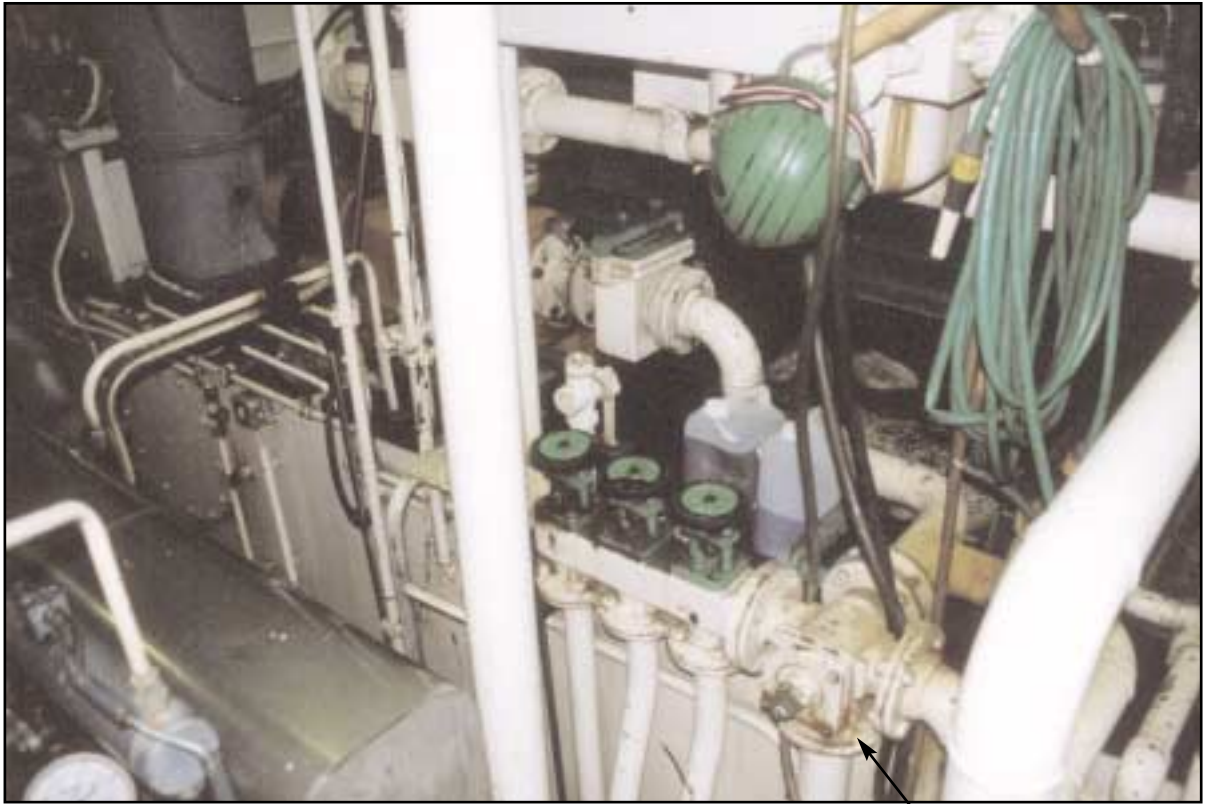
The watchkeeper set both pumps to pump the engine room bilges. He started the pumps and then primed them using the four-way open bottom cock on the suction side of each. This allowed the suction to be taken from the sea, the ballast tanks, or the bilges via a valve chest.

Figure 1 shows the four-way open bottom cock in the same position on a similar vessel.

Four way bottom cock

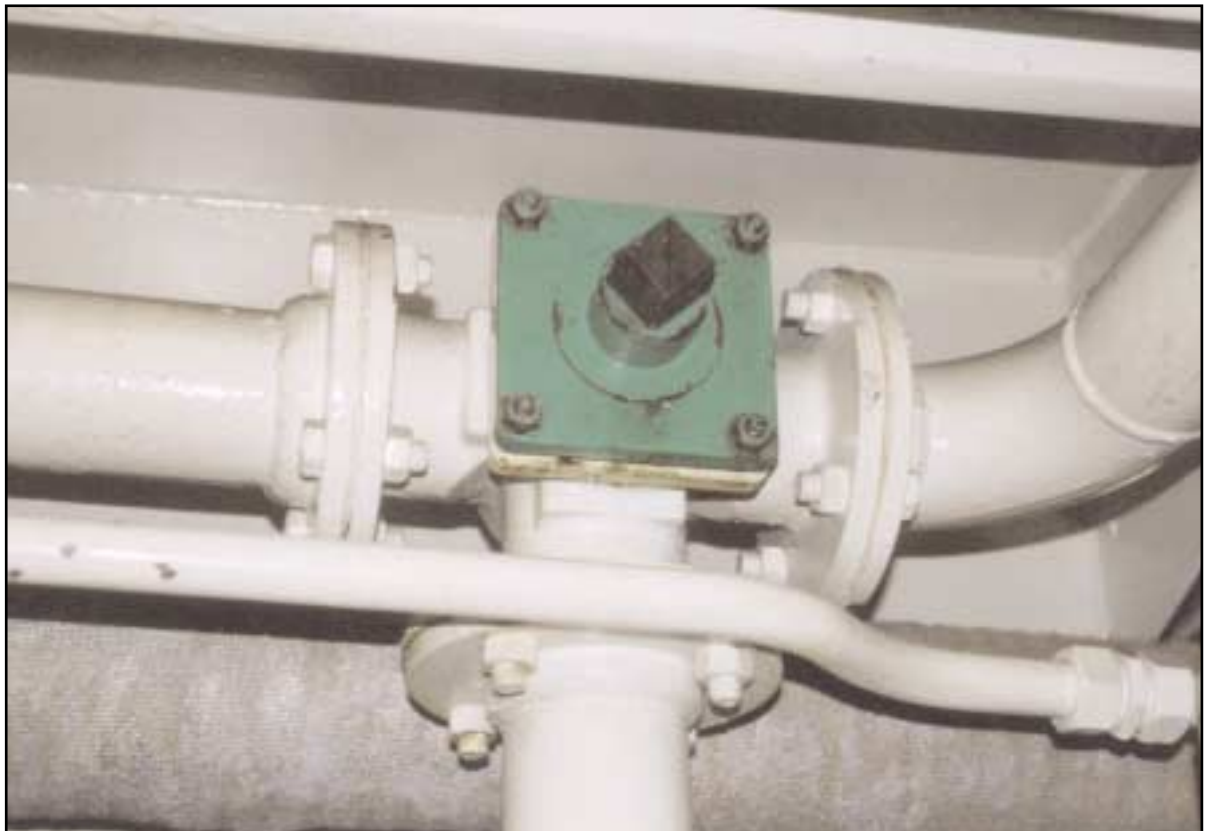
In his haste to change the discharge of the port pump from deck wash, the watchkeeper dropped the changeover spanner for the three-way pump discharge cock into the bilge. This pump, therefore, remained on deck wash.

Figure 2 shows a cock similar to this three-way cock on another vessel.

Three way pump discharge cock

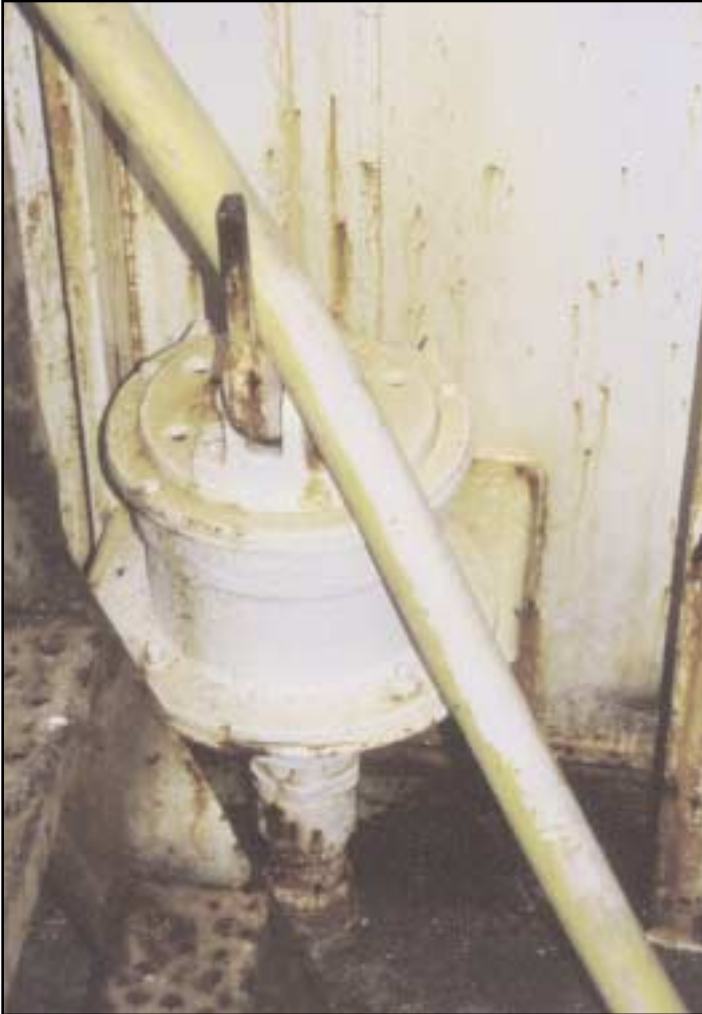
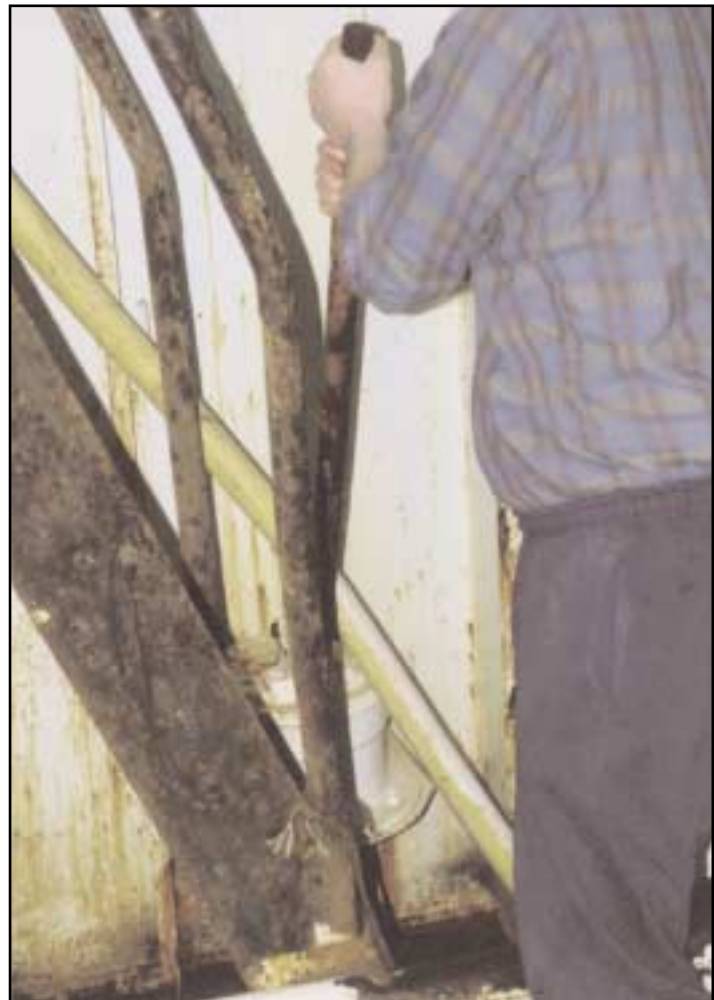
Figures 3 and 4 show a hand pump of the same type, on a similar vessel, both on its own and being operated.

Engine room bilge hand pump on aft working deck

Engine room bilge hand pump on aft deck being operated

A hand pump was also available. This was capable of pumping up to 5m³/hour. A similar pump is shown alone, and being operated, in **Figures 3 and 4**.

Crew members who manned this pump found it extremely tiring to use. Had they found it necessary to swim or to paddle the raft for a longer period, to escape the sinking vessel, their tiredness would have had an adverse effect on their chances of survival.

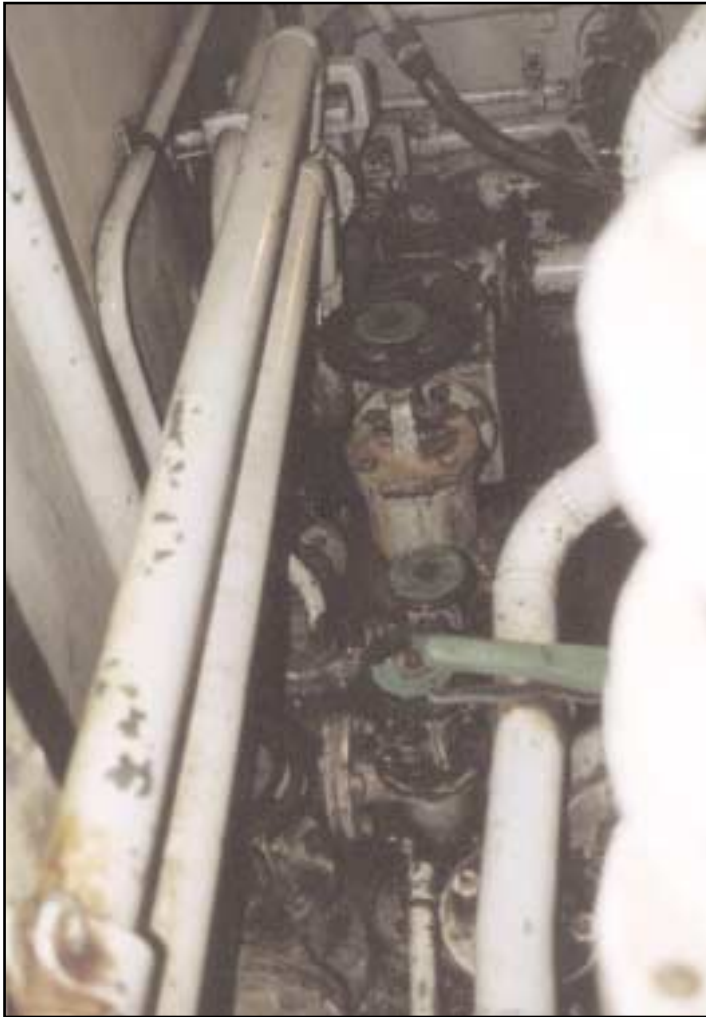
Figure 5

No extended spindles were fitted to the main sea water inlet valves. This meant that since the flooding was at an advanced stage when it was discovered, the crew were unable to shut them.

Figures 5 and 6 show the sea water valves on a vessel similar to *Aurelia*. The restricted access to these valves is clear.

Sea water inlet valves - port side main engine well

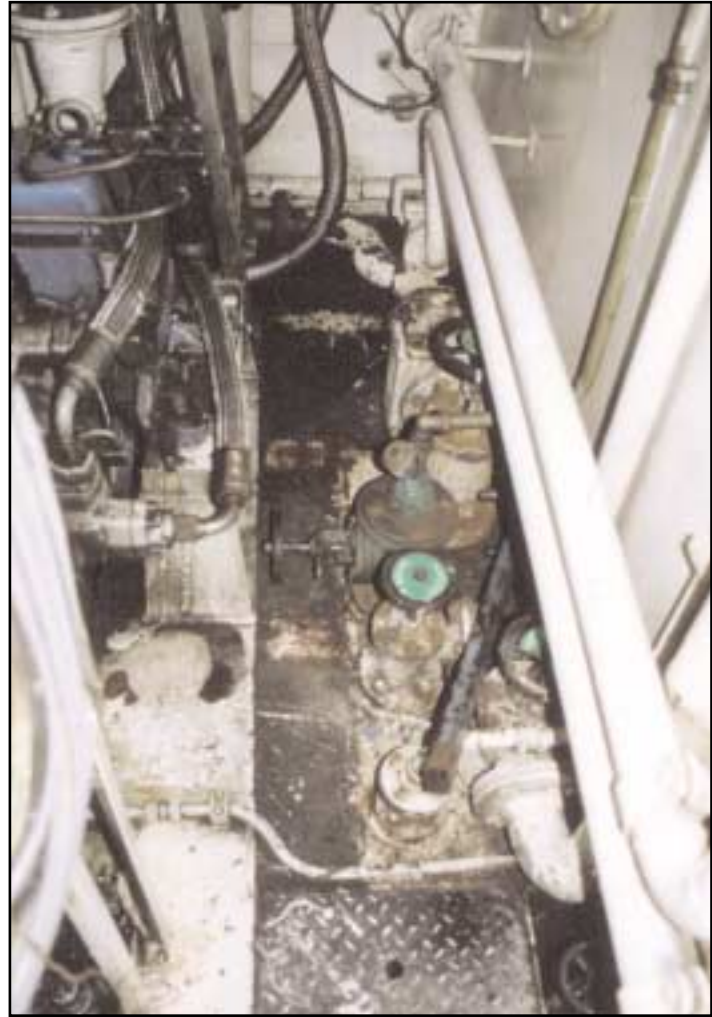
Figure 6

Sea water inlet valves - starboard side main engine well

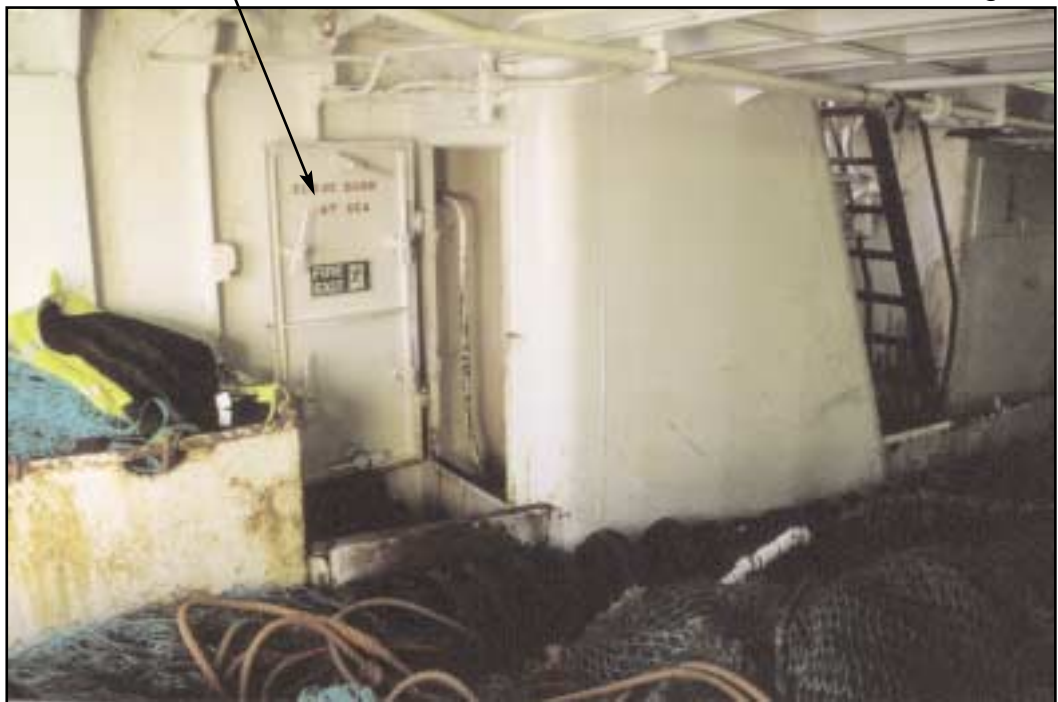
Figure 7

The engine room had by that time flooded to within 650mm of the deckhead, and the vessel was listing to port. Water, which had shipped aft, had pushed the port net into the open aft engine room escape door, preventing its closure. **Figure 7** shows the aft engine room escape door on a similar vessel.

Aft engine room escape door

Aft working deck

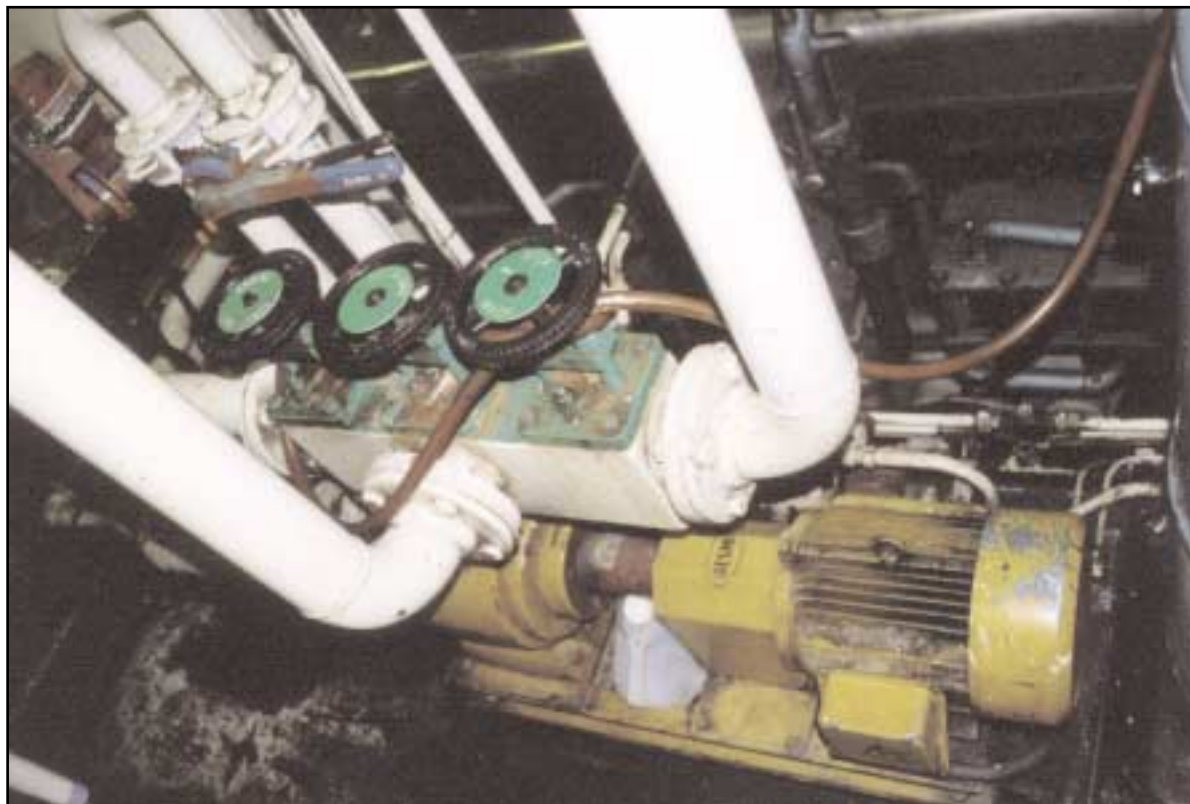
Figure 8

Aurelia was fitted with two electrically-driven Desmi Type S70 50 175 centrifugal bilge and ballast pumps. **Figure 8** shows the same make and model of pump on board a vessel similar to *Aurelia*. Each pump was theoretically capable of pumping up to 50 m³/hour. In practice, this would be reduced to around 30 m³/hour in the case of the port pump, because of the restricting effect of the deck wash system. A typical deck washing connection can be seen in **Figure 9**, and shows the restriction.

Centrifugal bilge and ballast pump

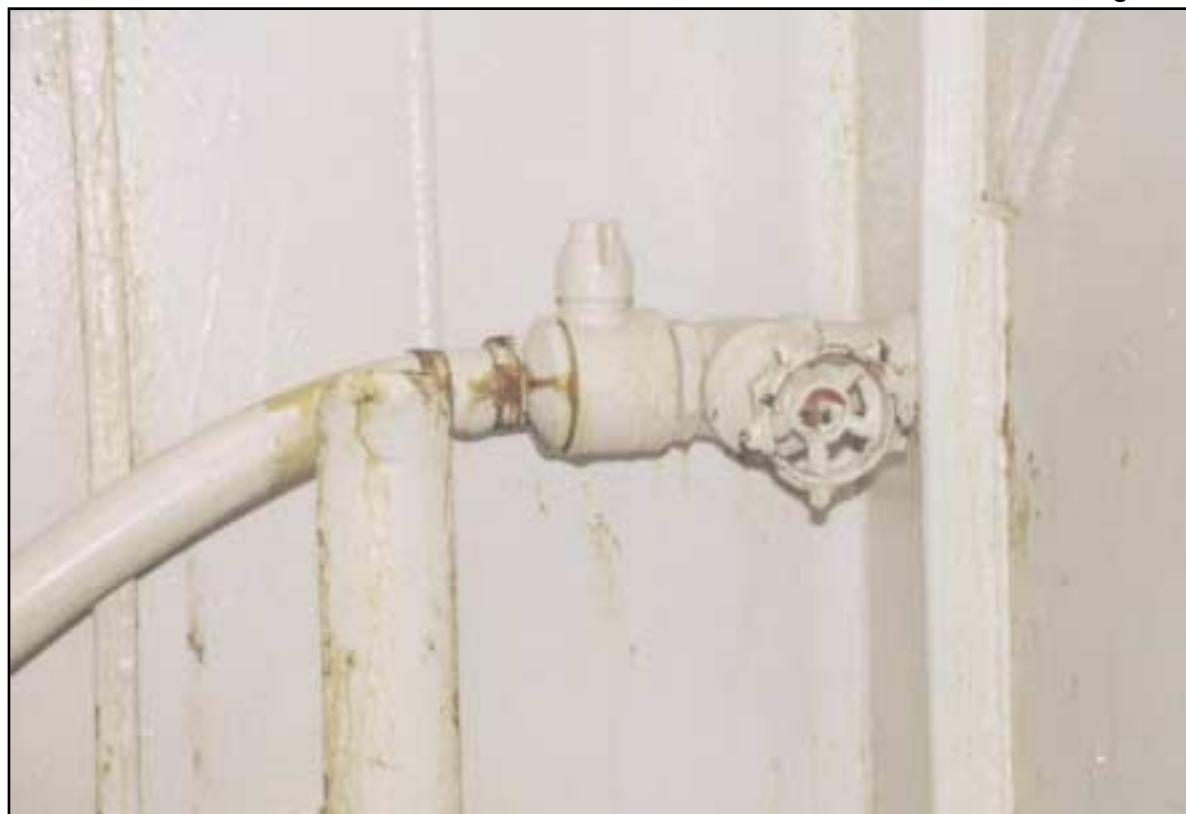
Figure 9

Typical deck wash connection

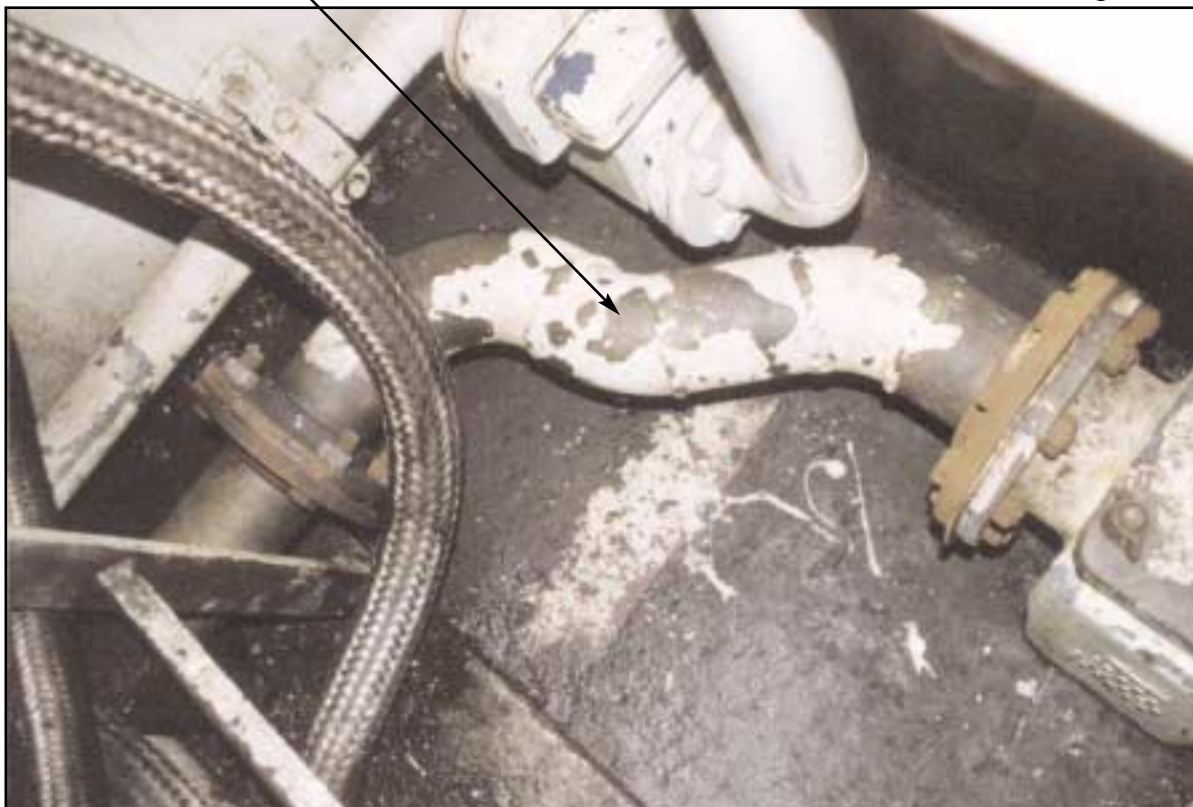
Figure 12

- Although the water velocity through the sea water pipework was within the limits for the aluminium brass used, the pipes were constructed by joining straight sections to elbows. These elbows and joins set up localised areas of turbulence which could lead to erosion corrosion. (**Figure 12** shows a section of pipe immediately downstream of the starboard sea water inlet strainer on board a similar vessel to *Aurelia*.)

Section of pipe downstream
of starboard main engine SW
cooling inlet valve

Main engine seawater cooling system
