Report on the investigation of  
the grounding of  
**mv Choice**  
Blyth Sands,  
River Thames-Sea Reach  
9 August 2001

**Report No 33/2002**  
**October 2002**

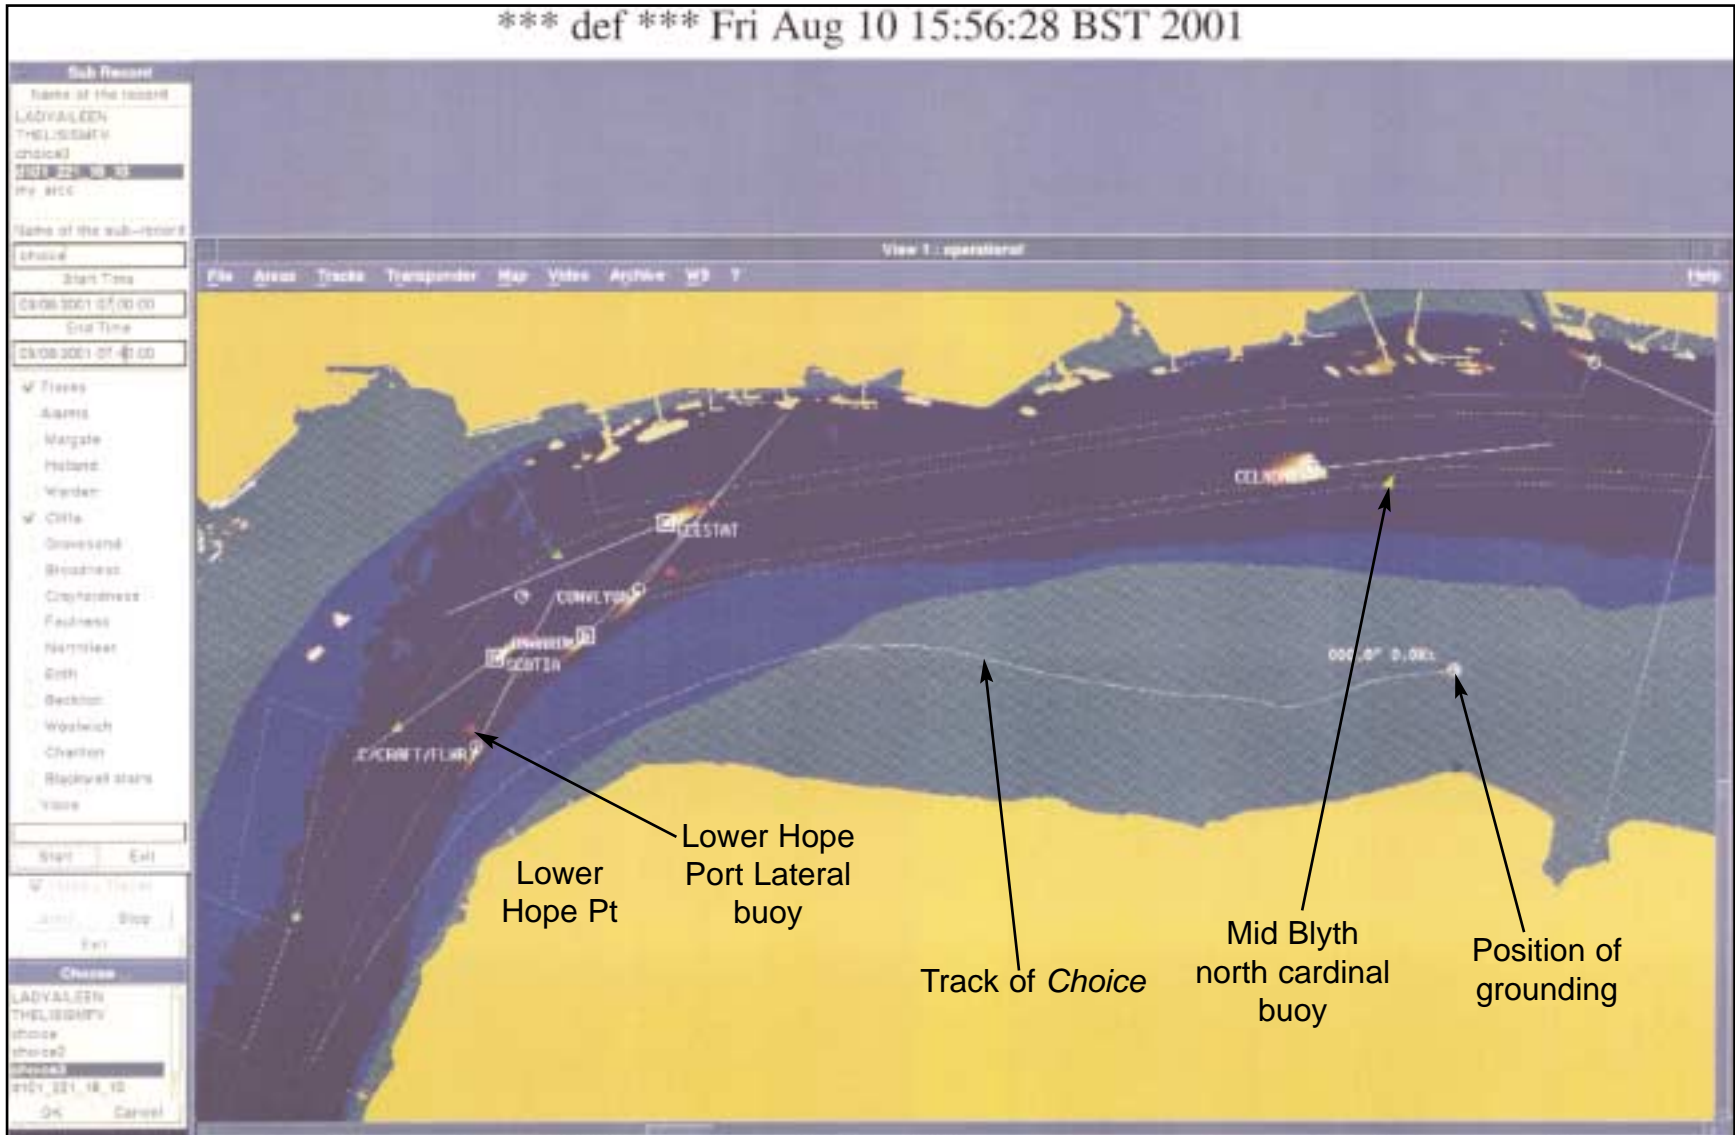
Figure 1

*Choice* had left the channel, and was now heading across the shallower waters of Blyth Sands, which dries at chart datum and is accordingly shaded green on the relevant nautical charts. The master was not aware that *Choice* had left the channel. At about 0640, however, he did notice that she was starting to feel the ground, and instructed the helmsman to steer towards the middle of the river. The helmsman responded accordingly, but moments later, *Choice* touched the bottom. The master took the helm immediately, applied more rudder to port, and put the engine gear astern. Although the ship initially responded by swinging to port, she was soon hard aground in a position with a charted drying height of about 1.5m. The PLA radar plot (**Figure 1**) shows the ground track of *Choice* between 0600 and 0640, and the main navigation channel. **Figure 2** shows the corresponding ground track drawn on the appropriate BA chart.

PLA radar plot showing *Choice's* track history

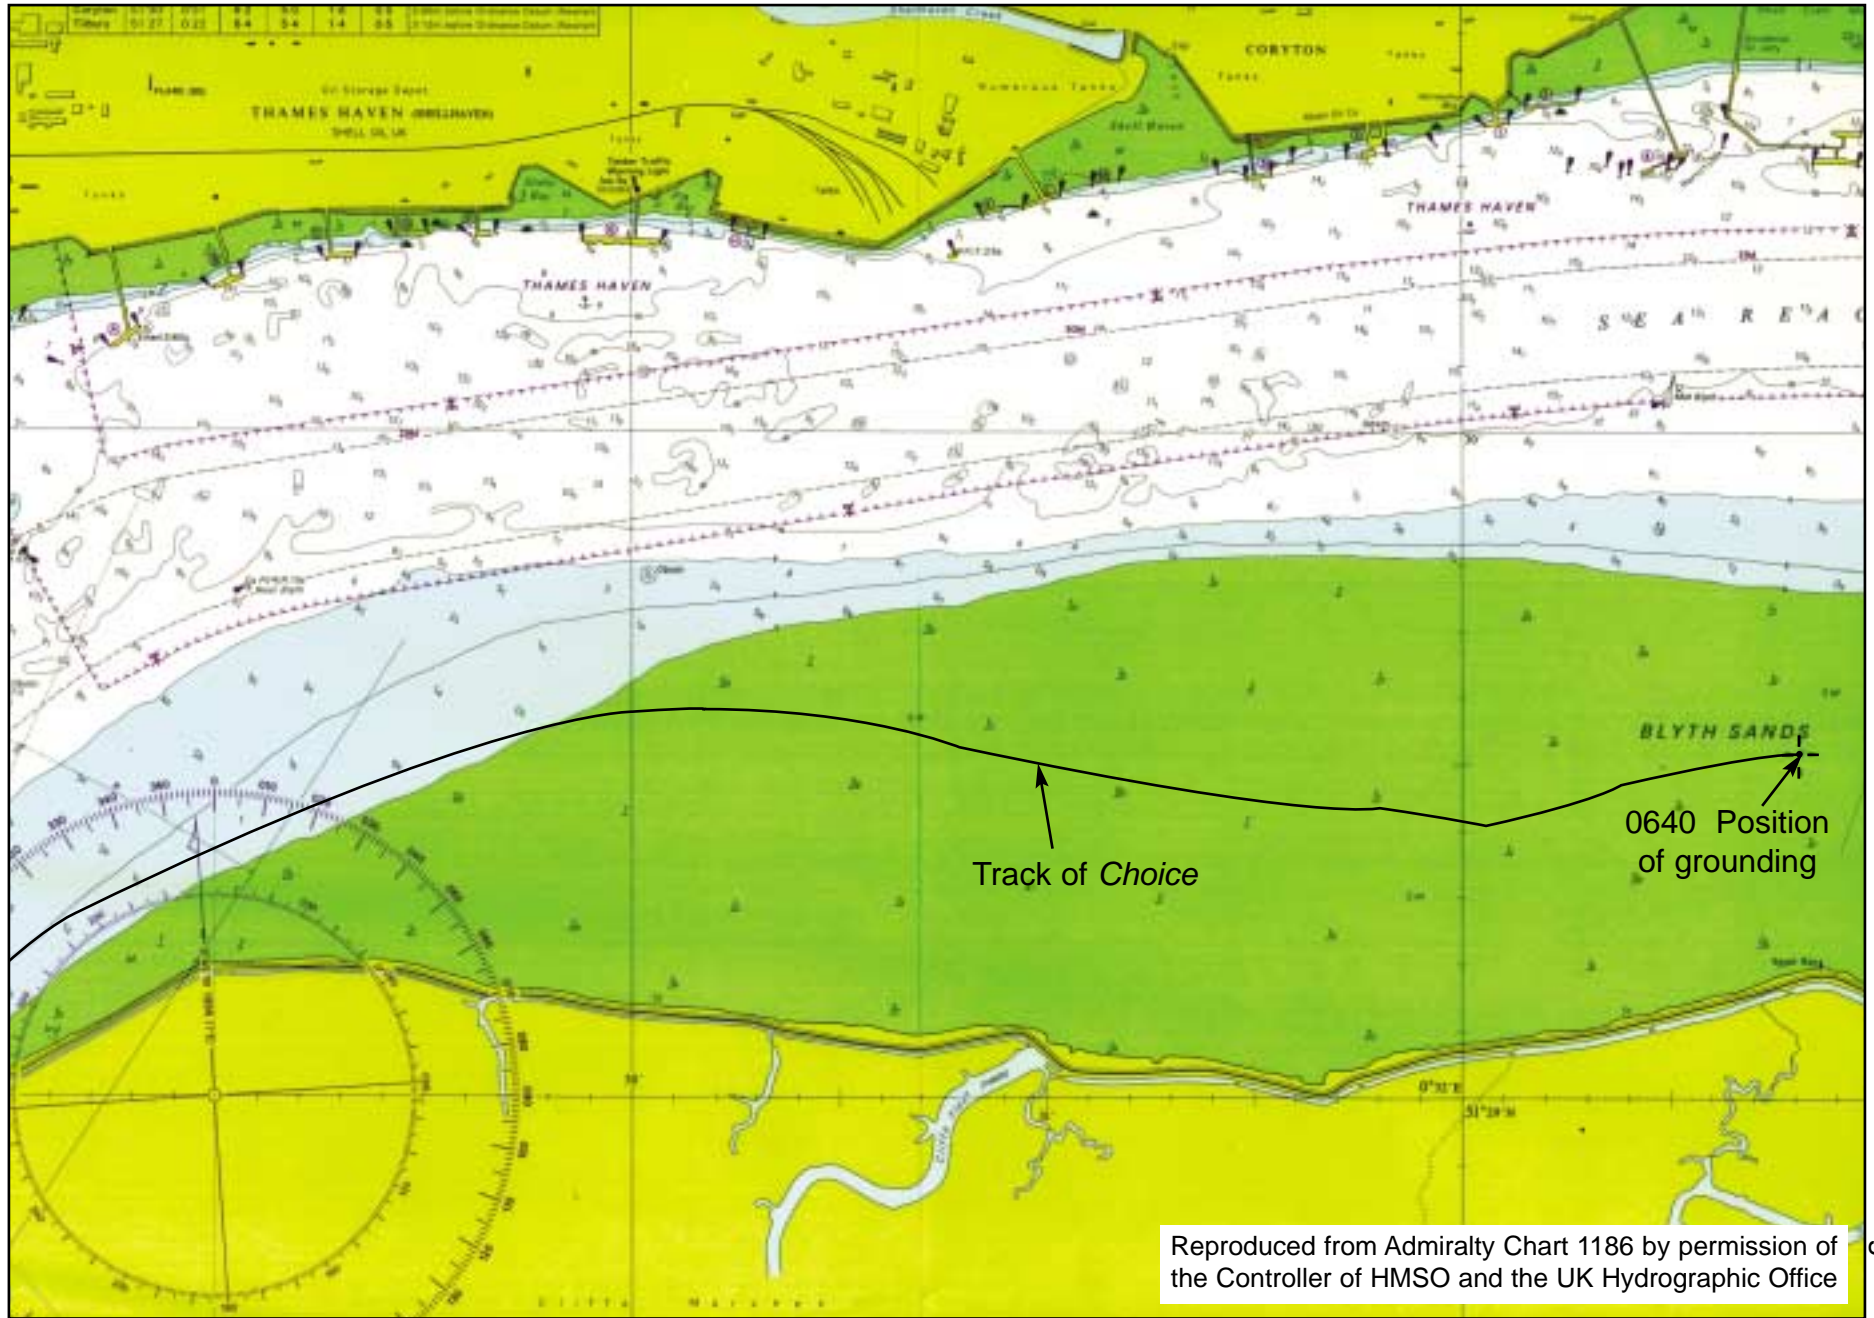
Figure 2

Extract of chart showing the approximate route taken by *Choice*

The adjustment of the vessel's course to take *Choice* across Blyth Sands, where the depth of water was insufficient to keep her afloat. [1.3]

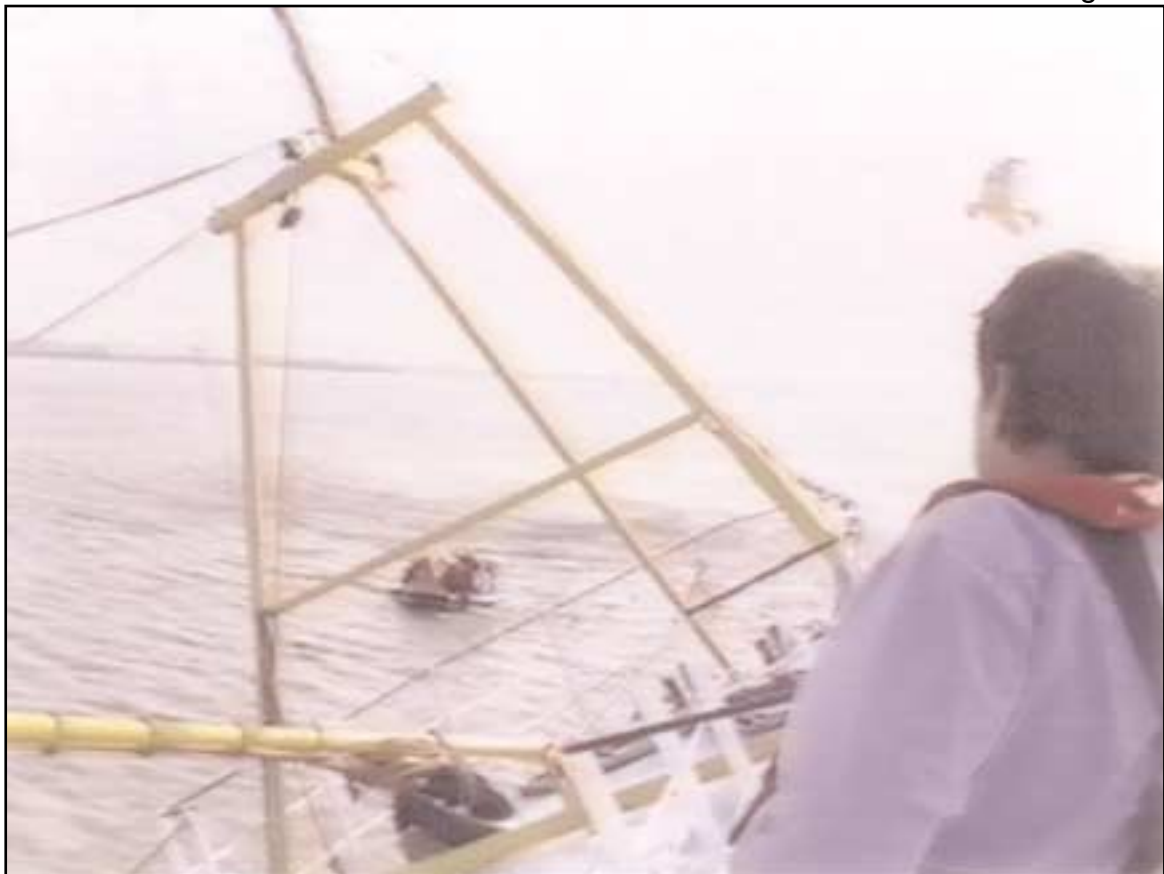
Figure 3

Photograph showing the rescue of the passengers and non-essential crew

The actions taken following the grounding are considered to have been appropriate. Although *Choice* was successfully refloated with four of the crew on board, the disembarkation of the students and non-essential crew into the liferafts was prudent, particularly in view of the fact that the vessel had a 30° heel, and was in danger of falling over. The use of the boom to prevent the vessel heeling further demonstrated quick-thinking, and might have prevented her from sustaining more serious damage.

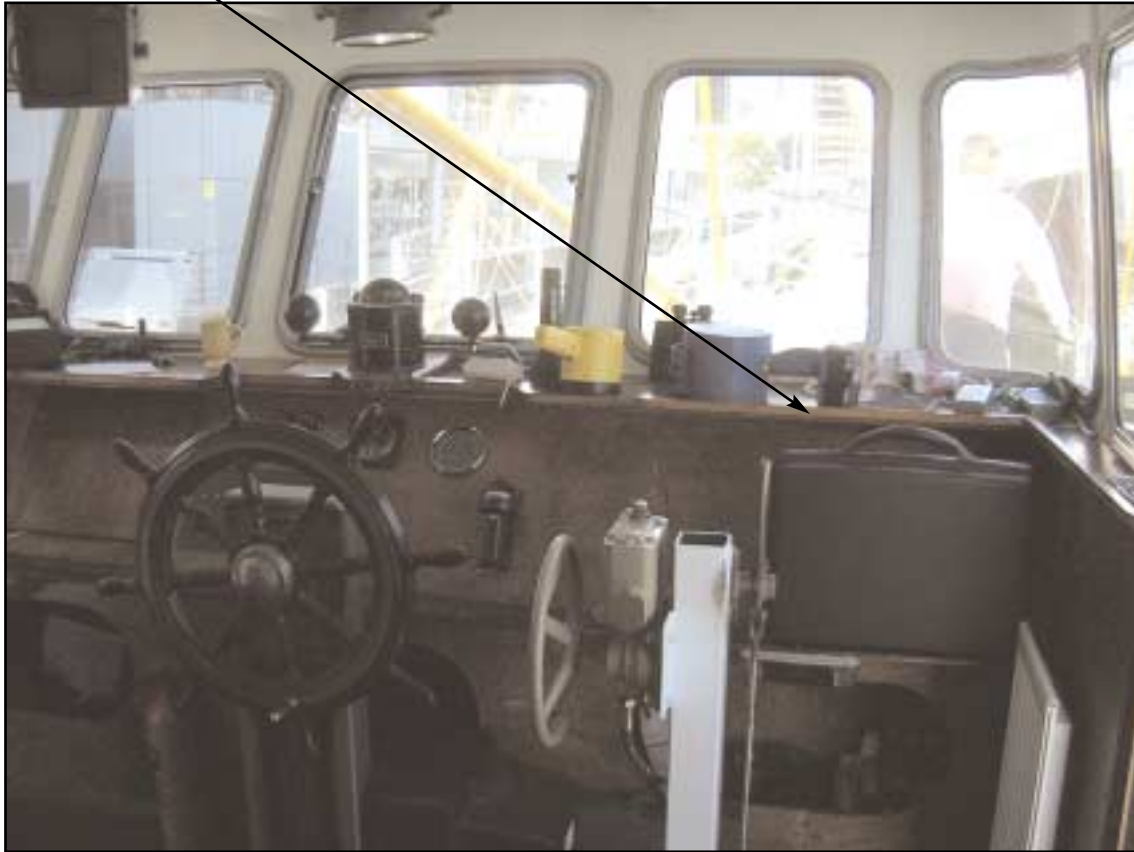
Figure 4

Position where paper charts were spread open

View of the starboard side of the wheelhouse

Using paper charts to navigate, without a suitable table on which to place them, can be extremely awkward. This was almost certainly so when the master and students were trying to use the charts in the starboard, forward corner of the wheelhouse. Ideally, the paper chart in use should be fully opened to allow a watchkeeper ready access to its information, and to allow appropriate positional information to be annotated. This is achieved normally by the provision of a suitably sized flat surface. When training at sea, it is important that the training requirements do not interfere with the safe operation of a vessel. Consequently, in such circumstances, it is frequent practice to duplicate navigational resources, such as chart tables, to allow ships' crew and students to work independently. While this was not possible, and not necessary on *Choice*, it is considered the provision of one chart table, or use of the desk behind the wheelhouse, would be of benefit to the wheelhouse watchkeeper and the students alike.

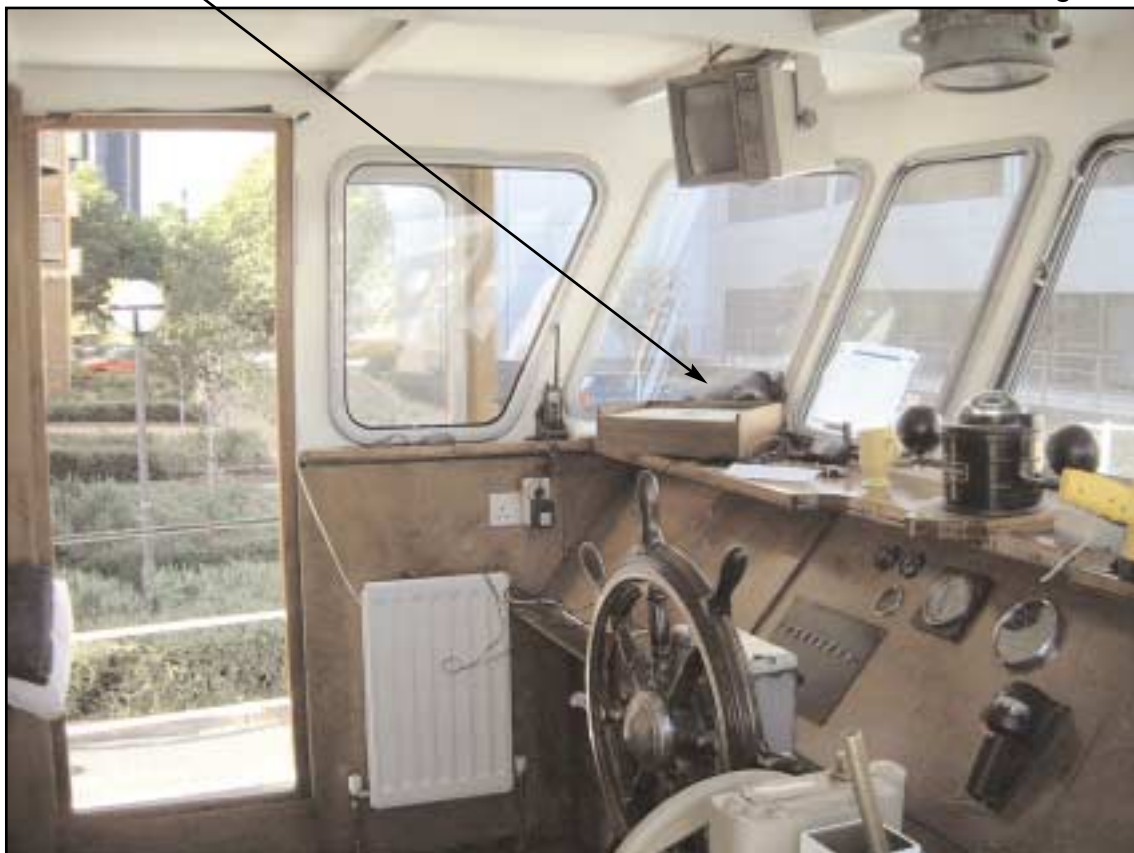
Figure 5

Position of the laptop computer displaying the electronic charts

Photograph of the port side of the wheelhouse

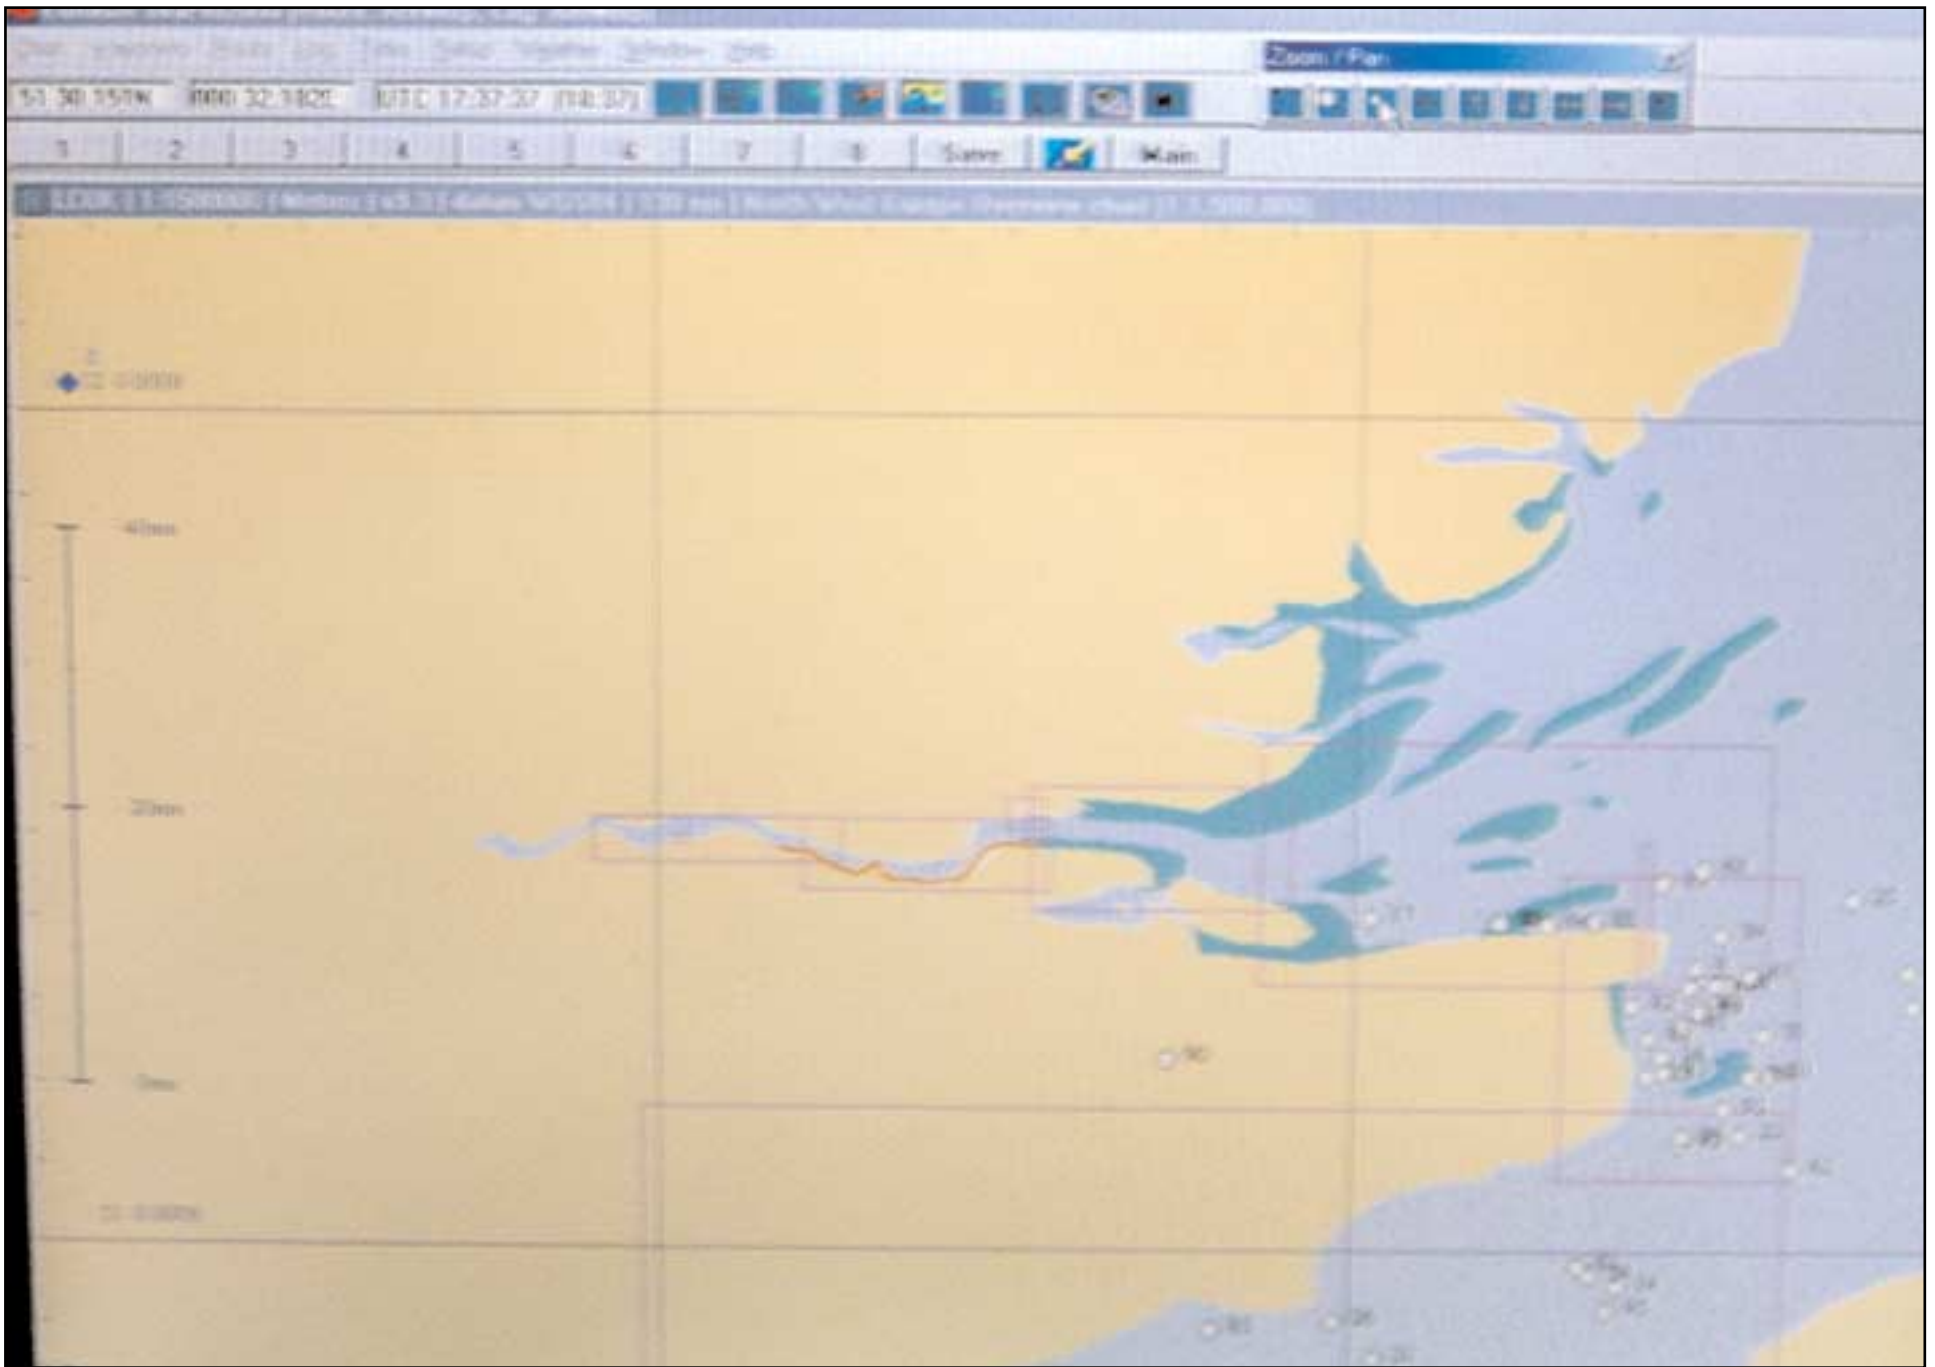
Figure 6

Example of a small scale chart inadvertently selected

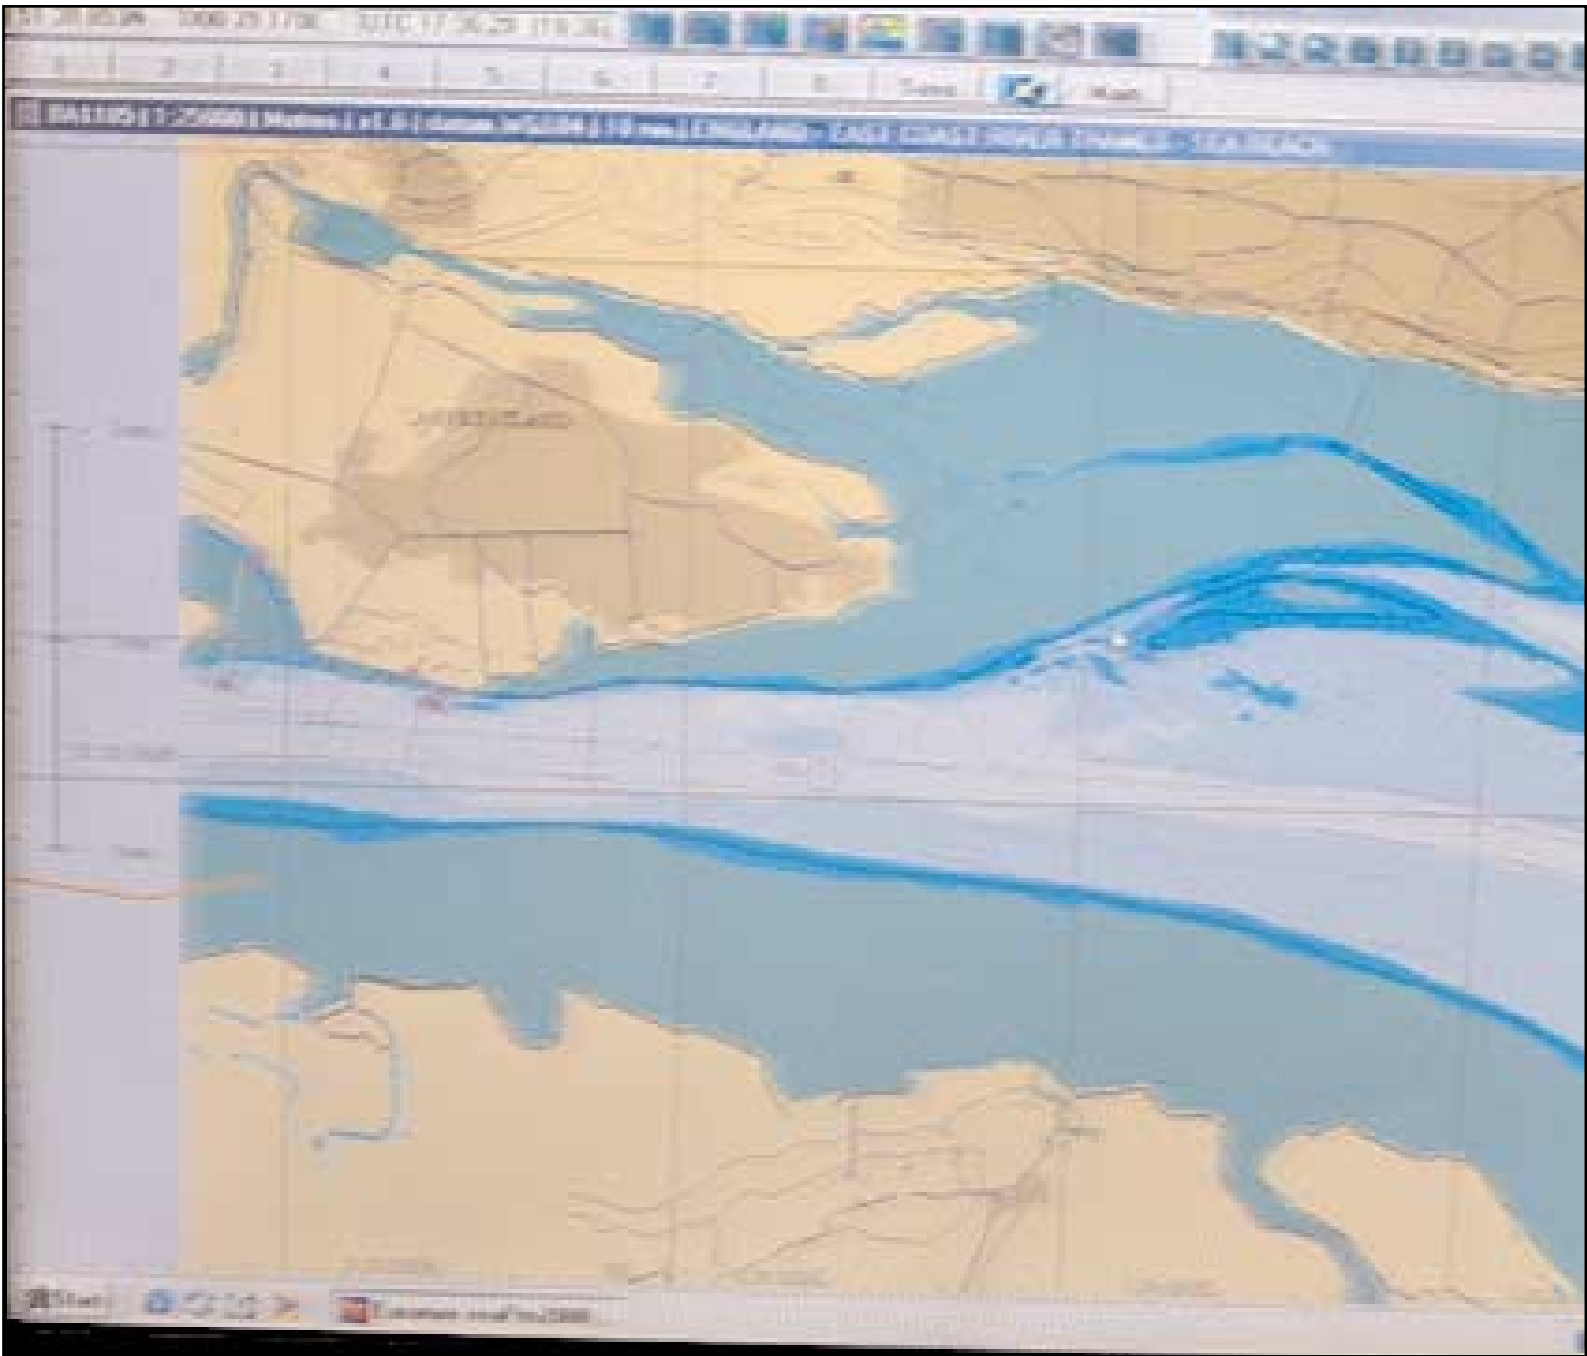
Figure 7

Photograph of an electronic chart showing only track history on its left hand edge  
Note : This does not represent the scale of chart in use at the time of grounding
