Report on the investigation of
an accident which caused major injury
to an engineer officer on board

Royal Princess

4 August 2001

**Report No 34/2002
November 2002**

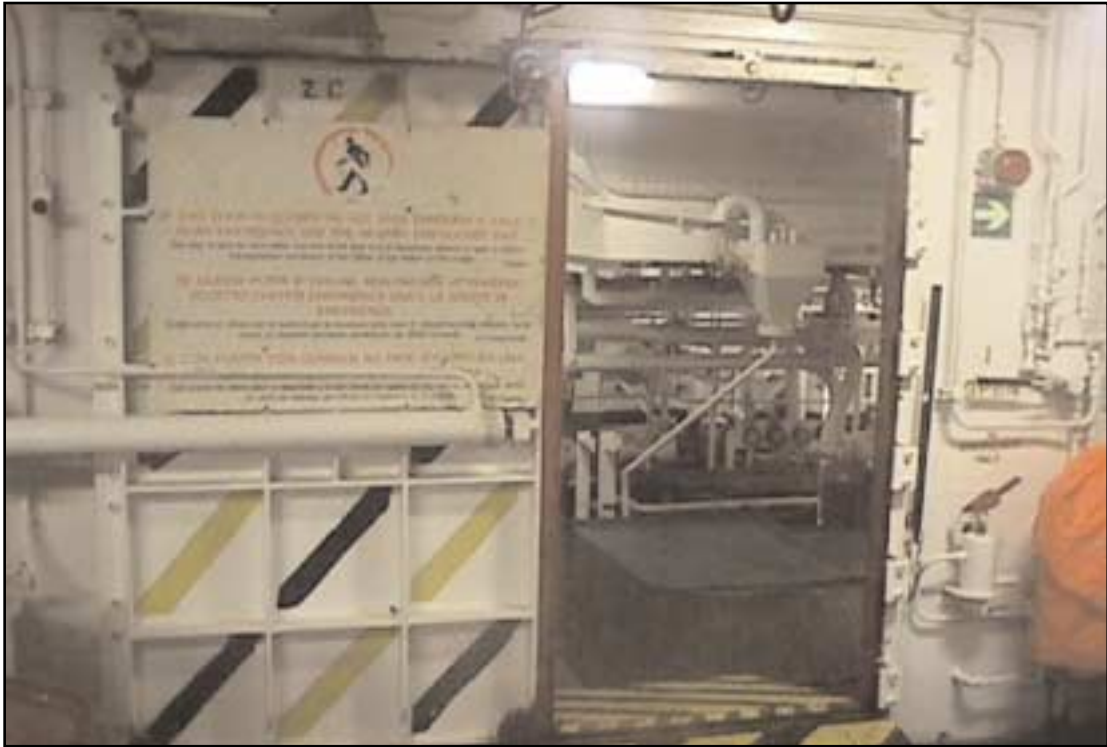
At about 0105, the 3EO attempted to pass through watertight door No 2 (**see photograph 1**). He operated the controls to start the door opening and, when it had opened sufficiently to allow him to pass through, he locked the operating lever in the 'close' position. As the door was closing, he began to step through, but his boilersuit became snagged, or something else caused him to hesitate and momentarily delay or abort his progress through the doorway.

No 2 watertight door, looking forward

The accident occurred at No 2 watertight door, situated between No 2 and No 3 pump rooms in the forward auxiliary machinery spaces. It was a steel, horizontally sliding door, of Type C which closed from port to starboard (**see photograph 1**).

The door was examined to establish what might have caused the boilersuit to become snagged. Nothing obvious was found. There were no protrusions on the leading edge of the sliding door itself. On the upright of the door frame, the heads of the machine screws, which secured the tapered wedges, and one of the wedges itself, were identified as possible causes of snagging (**see photographs - video stills 2 + 3**). It was also considered possible that the boilersuit sleeve might have become caught on one of the operating levers.

The staff engineer examined the door soon after the accident, and found it in local control and operating correctly. The speed of the door was in accordance with regulations. When examined by the MAIB it was found to take approximately 15 seconds to open and 25 seconds to close.

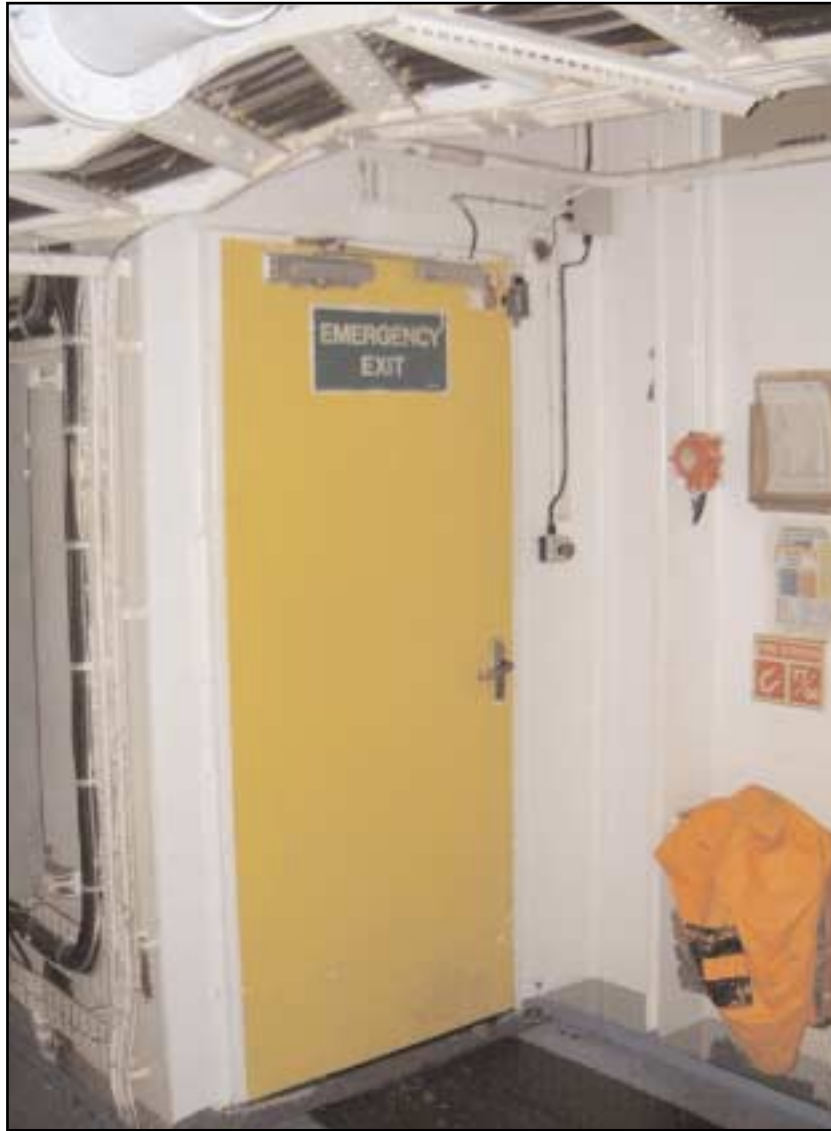
The 3EO, supporting his very badly injured arm, then attempted to use the emergency escape from No 2 pump room (**see photograph 2**). Two hands were needed to open the door, one to press the interlock button and one to turn the handle. Despite trying to use his knee and his one good hand, he was unable to open the door.

The escape door from No 2 pump room

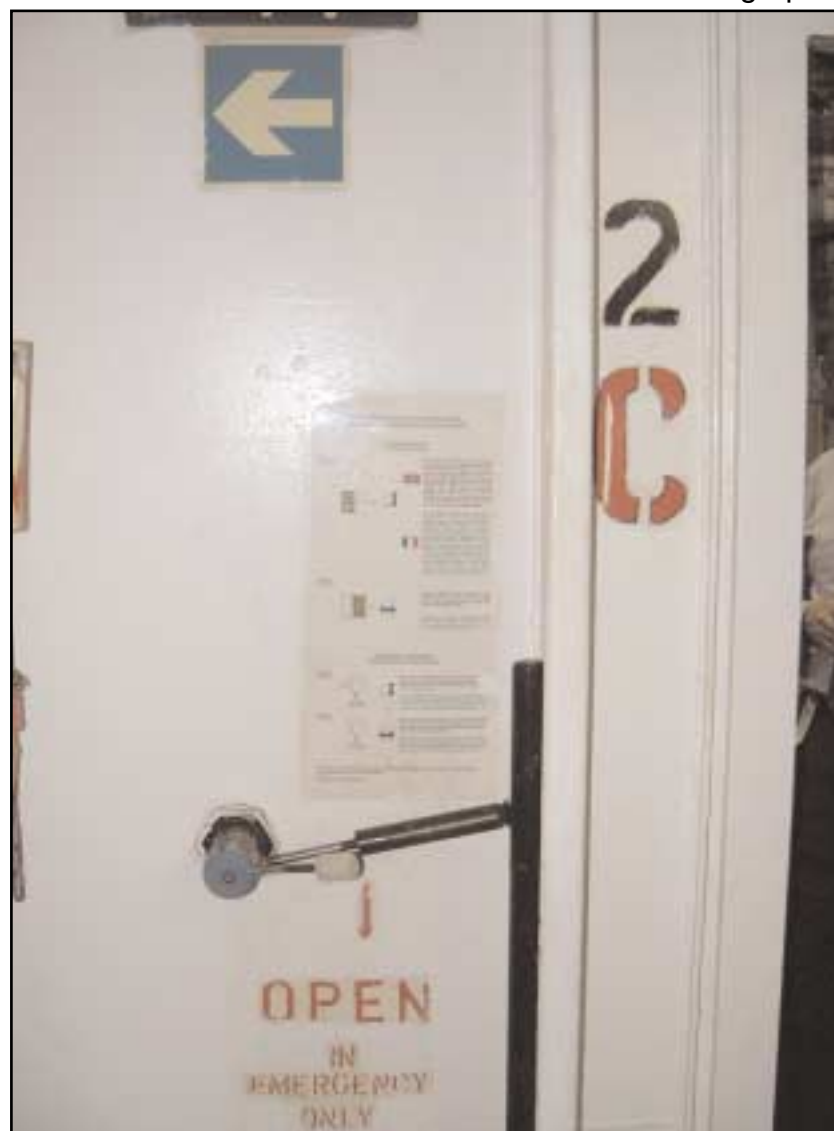
Photograph 3

The control levers

- (ii) The longer operating lever caught inside the left sleeve of the 3EO's boilersuit as he moved to pass through the door.

One way in which exactly the same accident could be avoided in the future, would be to change the design of the operating mechanism so that the operating lever could not be locked in the close position and, therefore, would have to be held until the door was closed. This would bring the operating mechanism in line with that commonly found on other vessels, and for which the guidance written by MCA was produced. However, an operating mechanism of this type was in place on the cross-channel ferries that had the accidents, including one fatality, mentioned in section 1.12. The MAIB believes that, while such a design change would prevent recurrence of this accident, the fundamental flaw that some officers and crew will continue to disobey the operating instructions for expediency, would still be in place. It could be further argued that such a change would increase still further the time needed for passage through a door and, therefore, encourage even more widespread disobeying of the instructions.

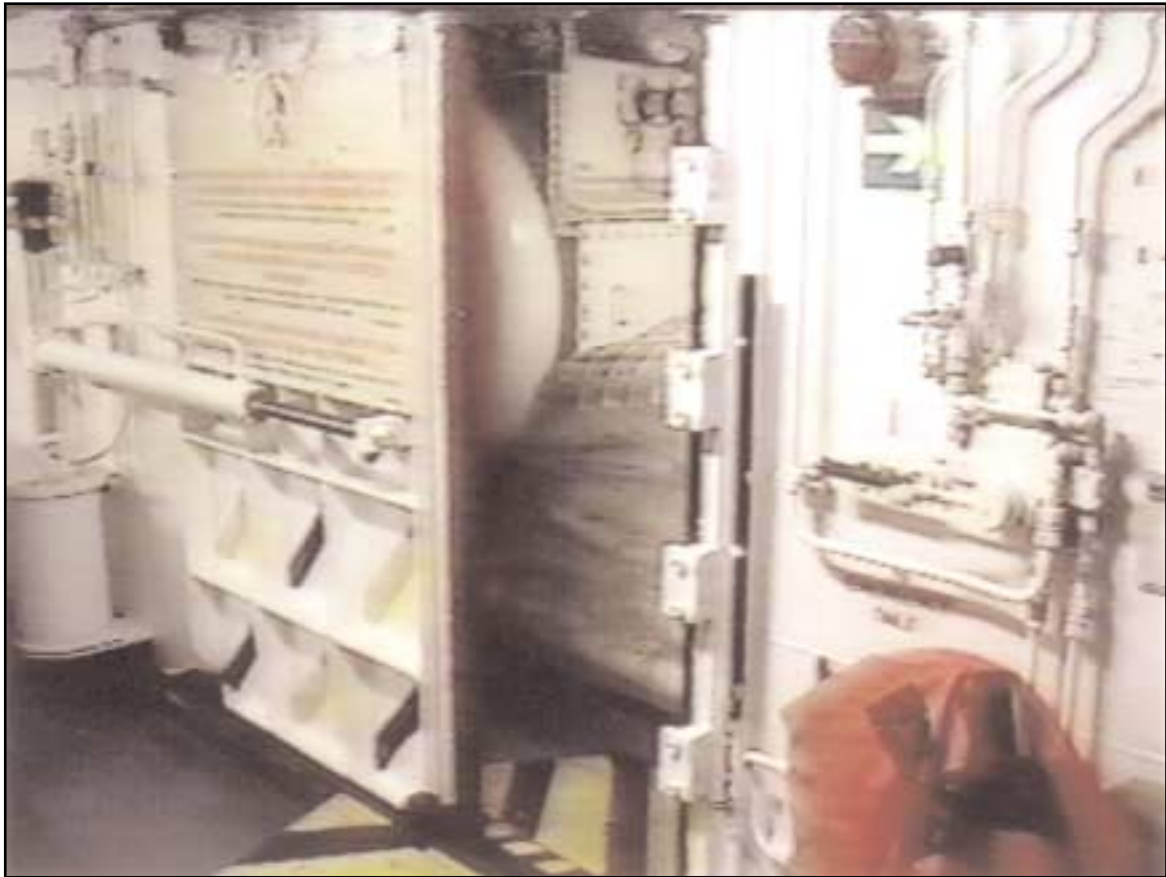
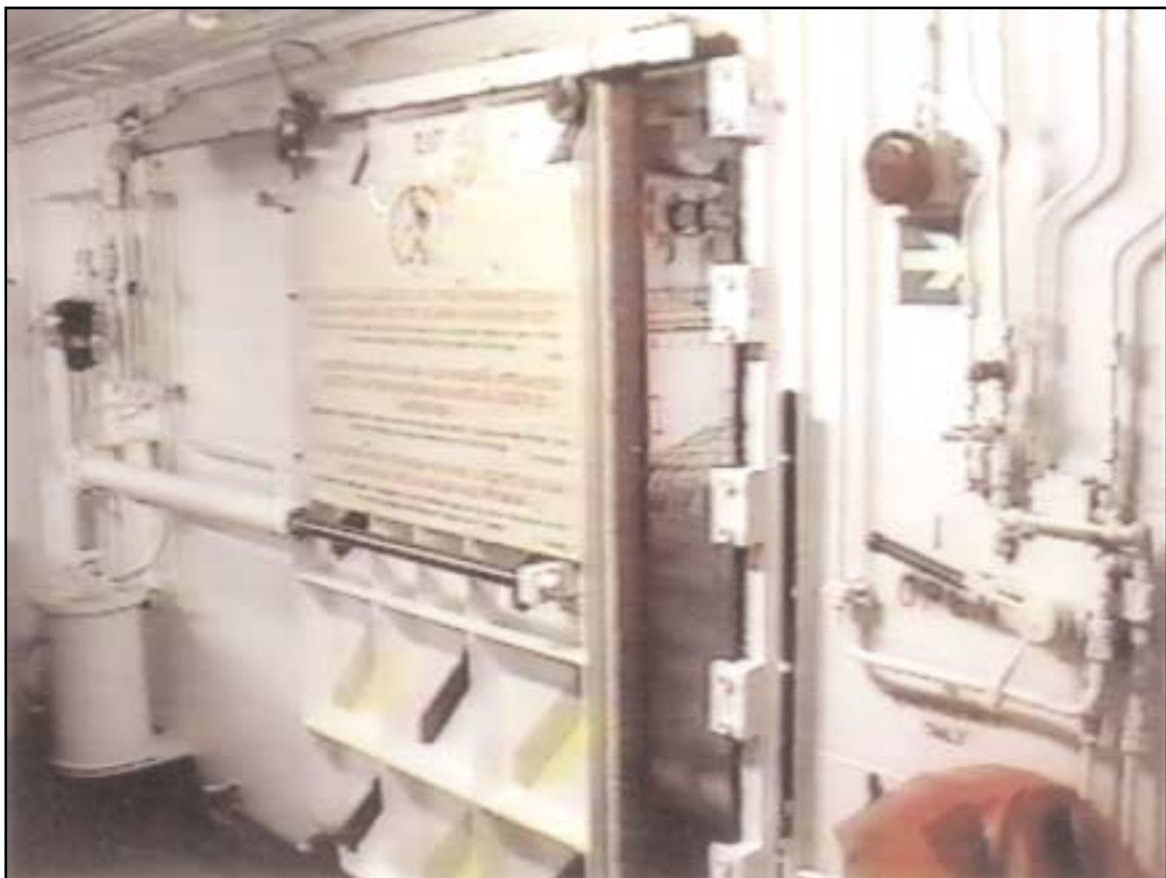
Video Stills 1 and 2 - The partially closed door

The ruler pocket opening was about 90cm from the deck when the wearer was standing upright (**see photograph 9**). This height coincided, approximately, with the third tapered wedge up from the deck (**see photograph video still 1**). If the 3EO was passing through the doorway from aft, to forward, his right leg would have been adjacent to the wedge as he did so.

It is conceivable that the adjustable spanner, which had been protruding forward from the top of the pocket, might have caught behind the wedge, causing the damage to the pocket and a momentary delay to his progress.

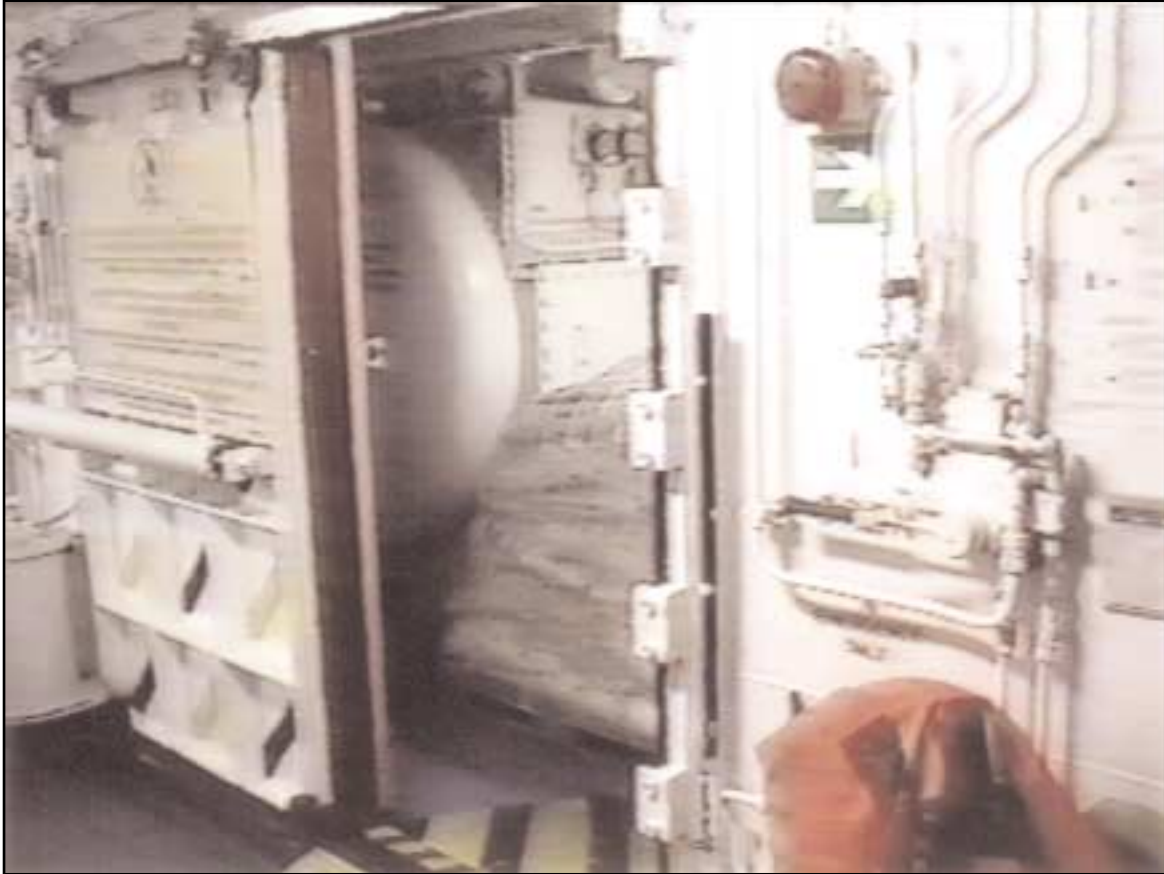
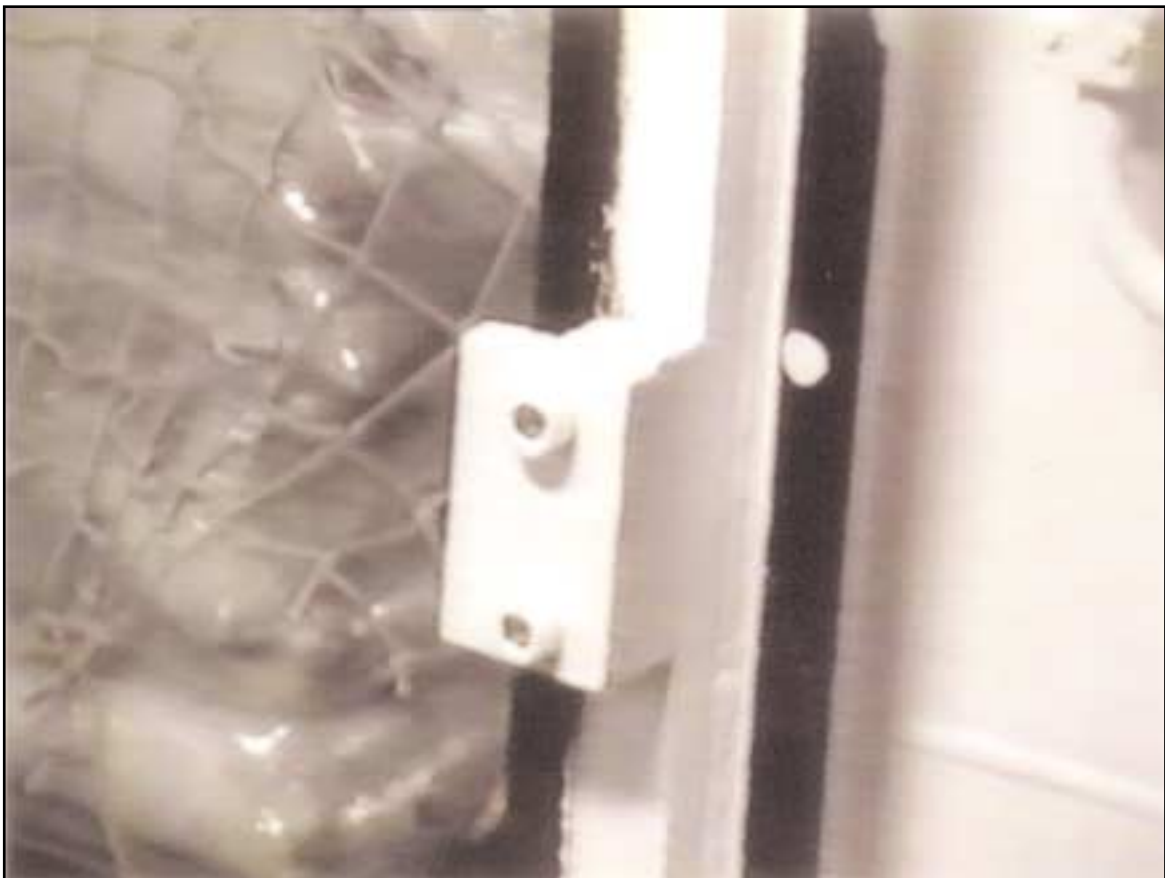
Video Stills 3 and 4 - The watertight door and its tapered wedges

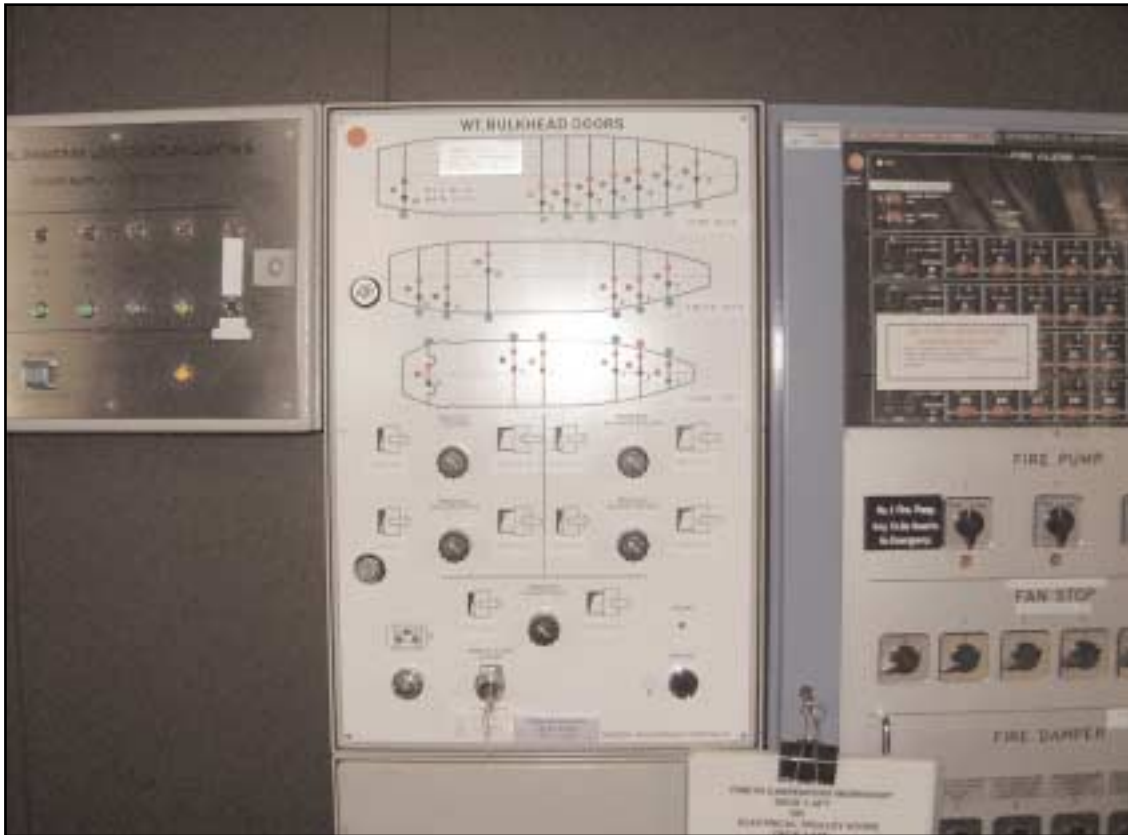
The watertight door mimic board

A mimic diagram on the navigating bridge indicated when a watertight door was open. The regime of keeping them closed at sea, especially in a potentially hazardous situation, was strictly adhered to and monitored by the bridge watchkeeping team in accordance with the Captain's Standing Orders. Anecdotal evidence indicates the bridge watchkeeping officers were generally very quick to inform the engine room if they noticed a door to be open. However, on the night in question, Nos 10, 5, 4, 3, 2 and 1 doors were open between at least 0105 and 0130 without the navigating officers reporting it to the engine room.

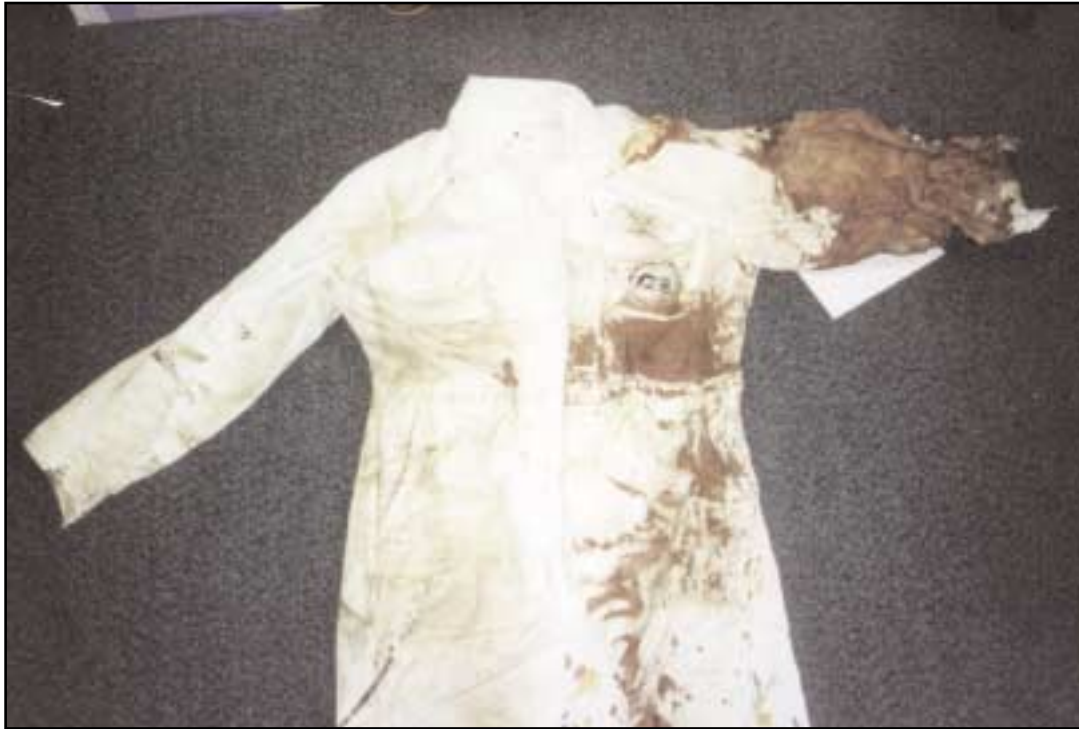
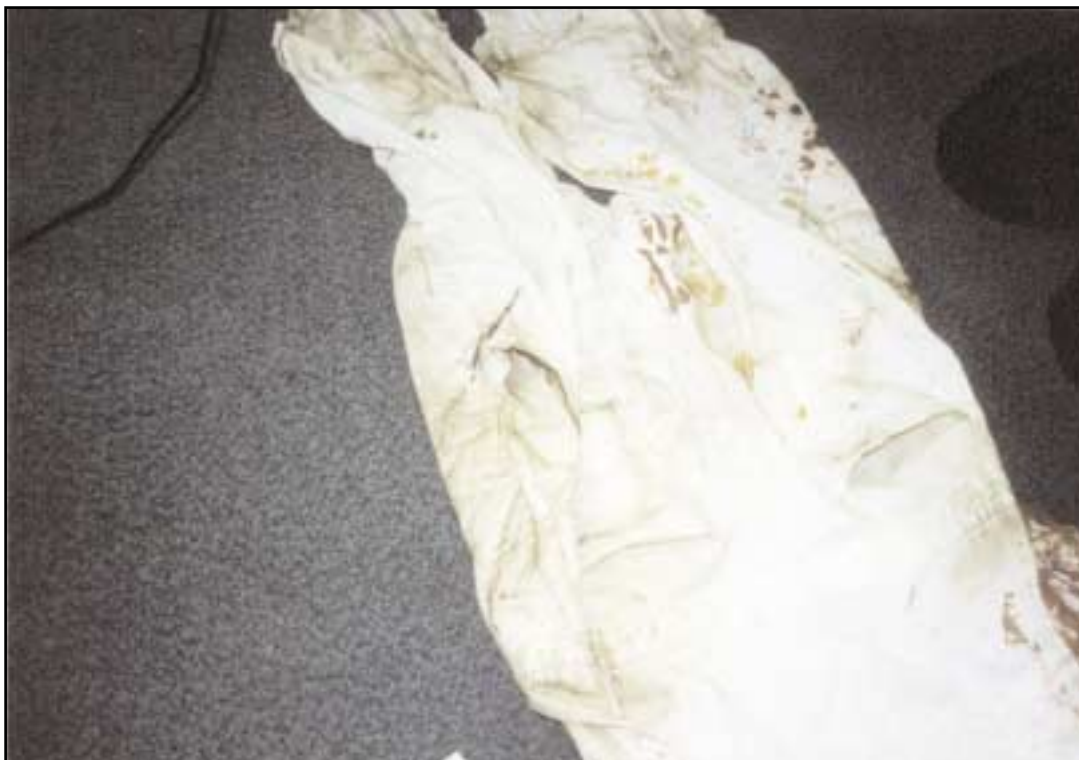
At the time of the accident, the 3EO was wearing a white cotton boilersuit and was carrying a 10" adjustable spanner in the ruler pocket. The boilersuit was examined by the MAIB after the accident and found to be in a relatively good condition, apart from the left sleeve. Buttons, buttonholes, seams and pockets were examined for signs of pulling and excessive strain. Nothing untoward was discovered, other than a small tear in a seam immediately below the ruler pocket on the right leg. The open seam revealed clean white material, suggesting that the tear had occurred recently. The left back pocket was slightly distorted, indicating that the 3EO habitually carried either his notebook or a rag in it. The left sleeve was extensively bloodstained and damaged in the accident, which obliterated any pre-existing faults or signs of excessive strain (**see photographs 5, 6, 7 and 8**).

Photographs 5 and 6 - The examination of the boilersuit

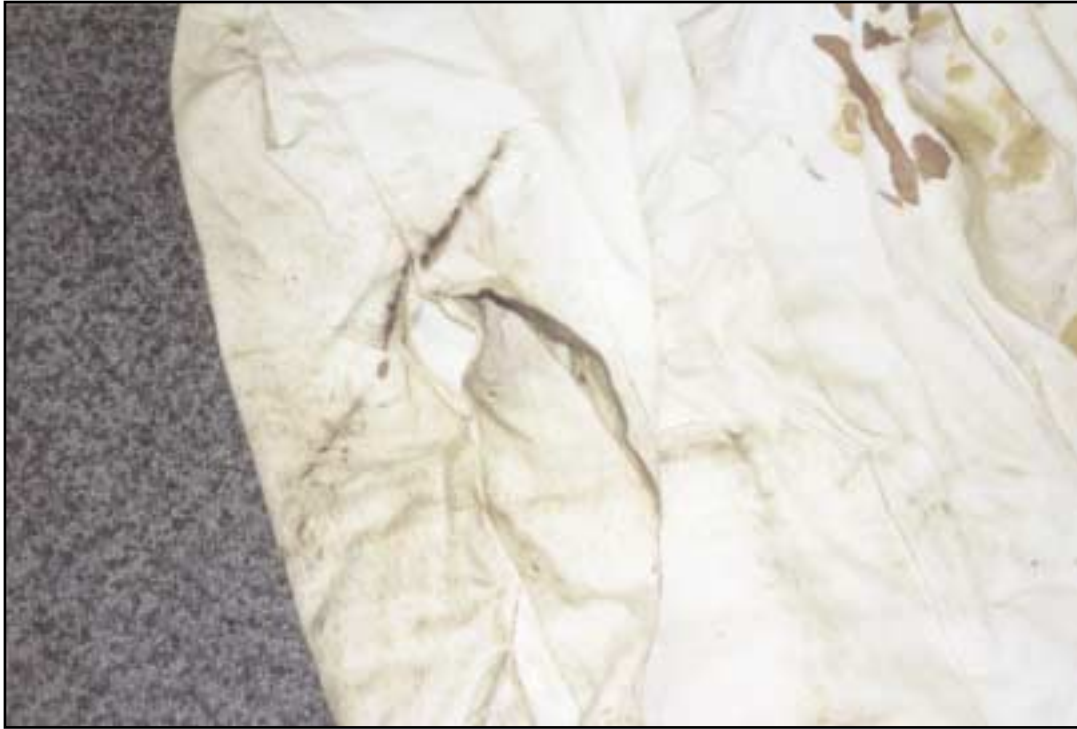
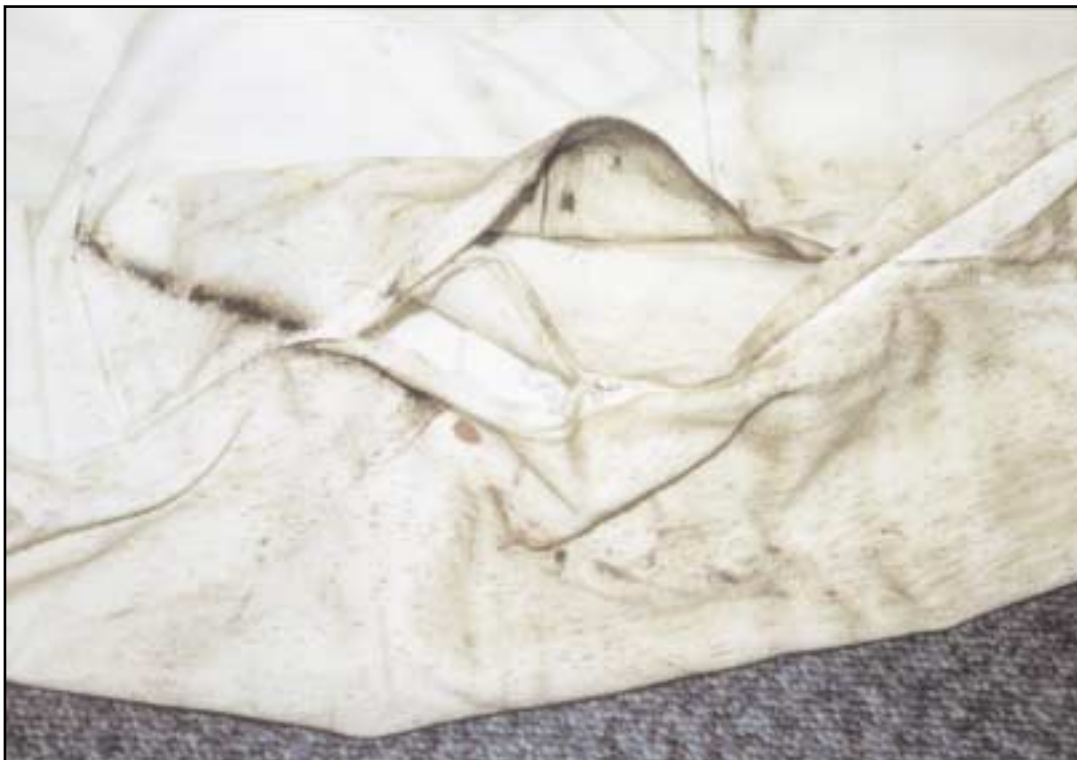
Photographs 7 and 8 - The examination of the boilersuit (continued)

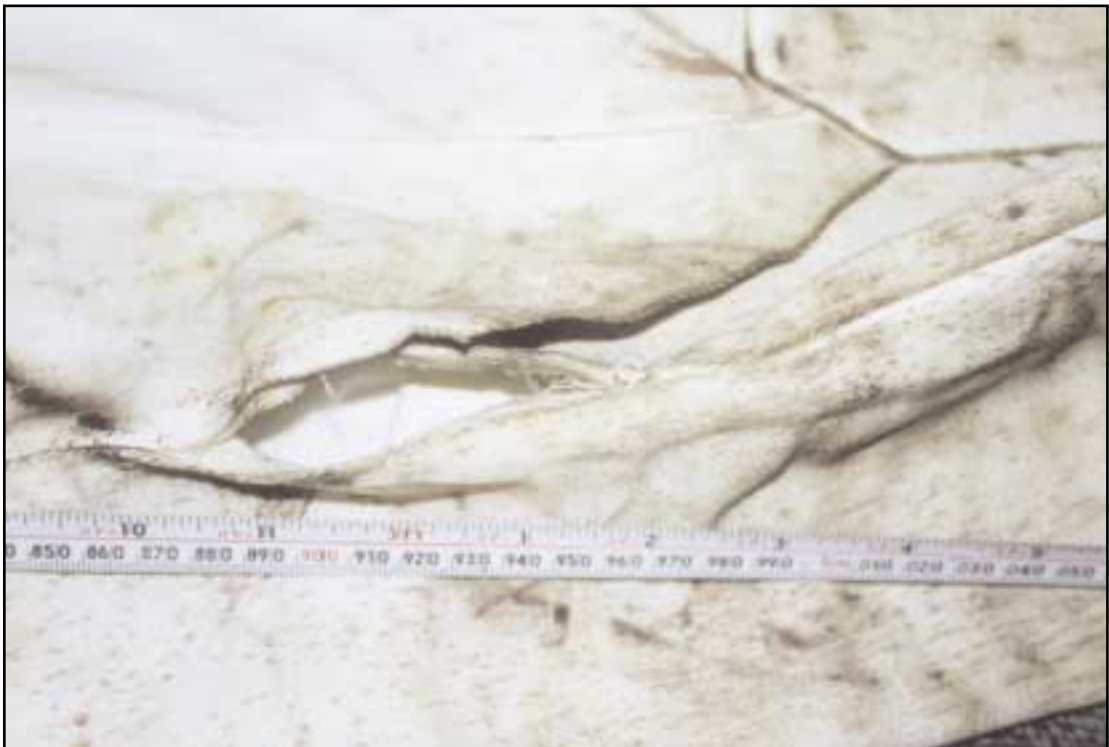
Photograph 9

The opening to the pocket was angled so that the handle of the spanner projected forward. This made it more vulnerable to becoming snagged when the wearer was moving in that direction.

Examination of the seam below the pocket opening indicates that it had been pulled undone over a distance of about 7cm (**see photograph 9**). It is likely that this was caused by the pocket, or something in the pocket, becoming snagged and the consequent strain being transmitted to the seam. The exposed hem was cleaner than the surrounding material, indicating that the split in the seam had occurred recently.

The open seam below the pocket opening
