Report on the investigation of  
the collision between  
***mv Sand Heron and fv Celtit***  
NE Traffic Lane, Dover TSS  
30 July 2001

**Report No 14/2002**  
**April 2002**

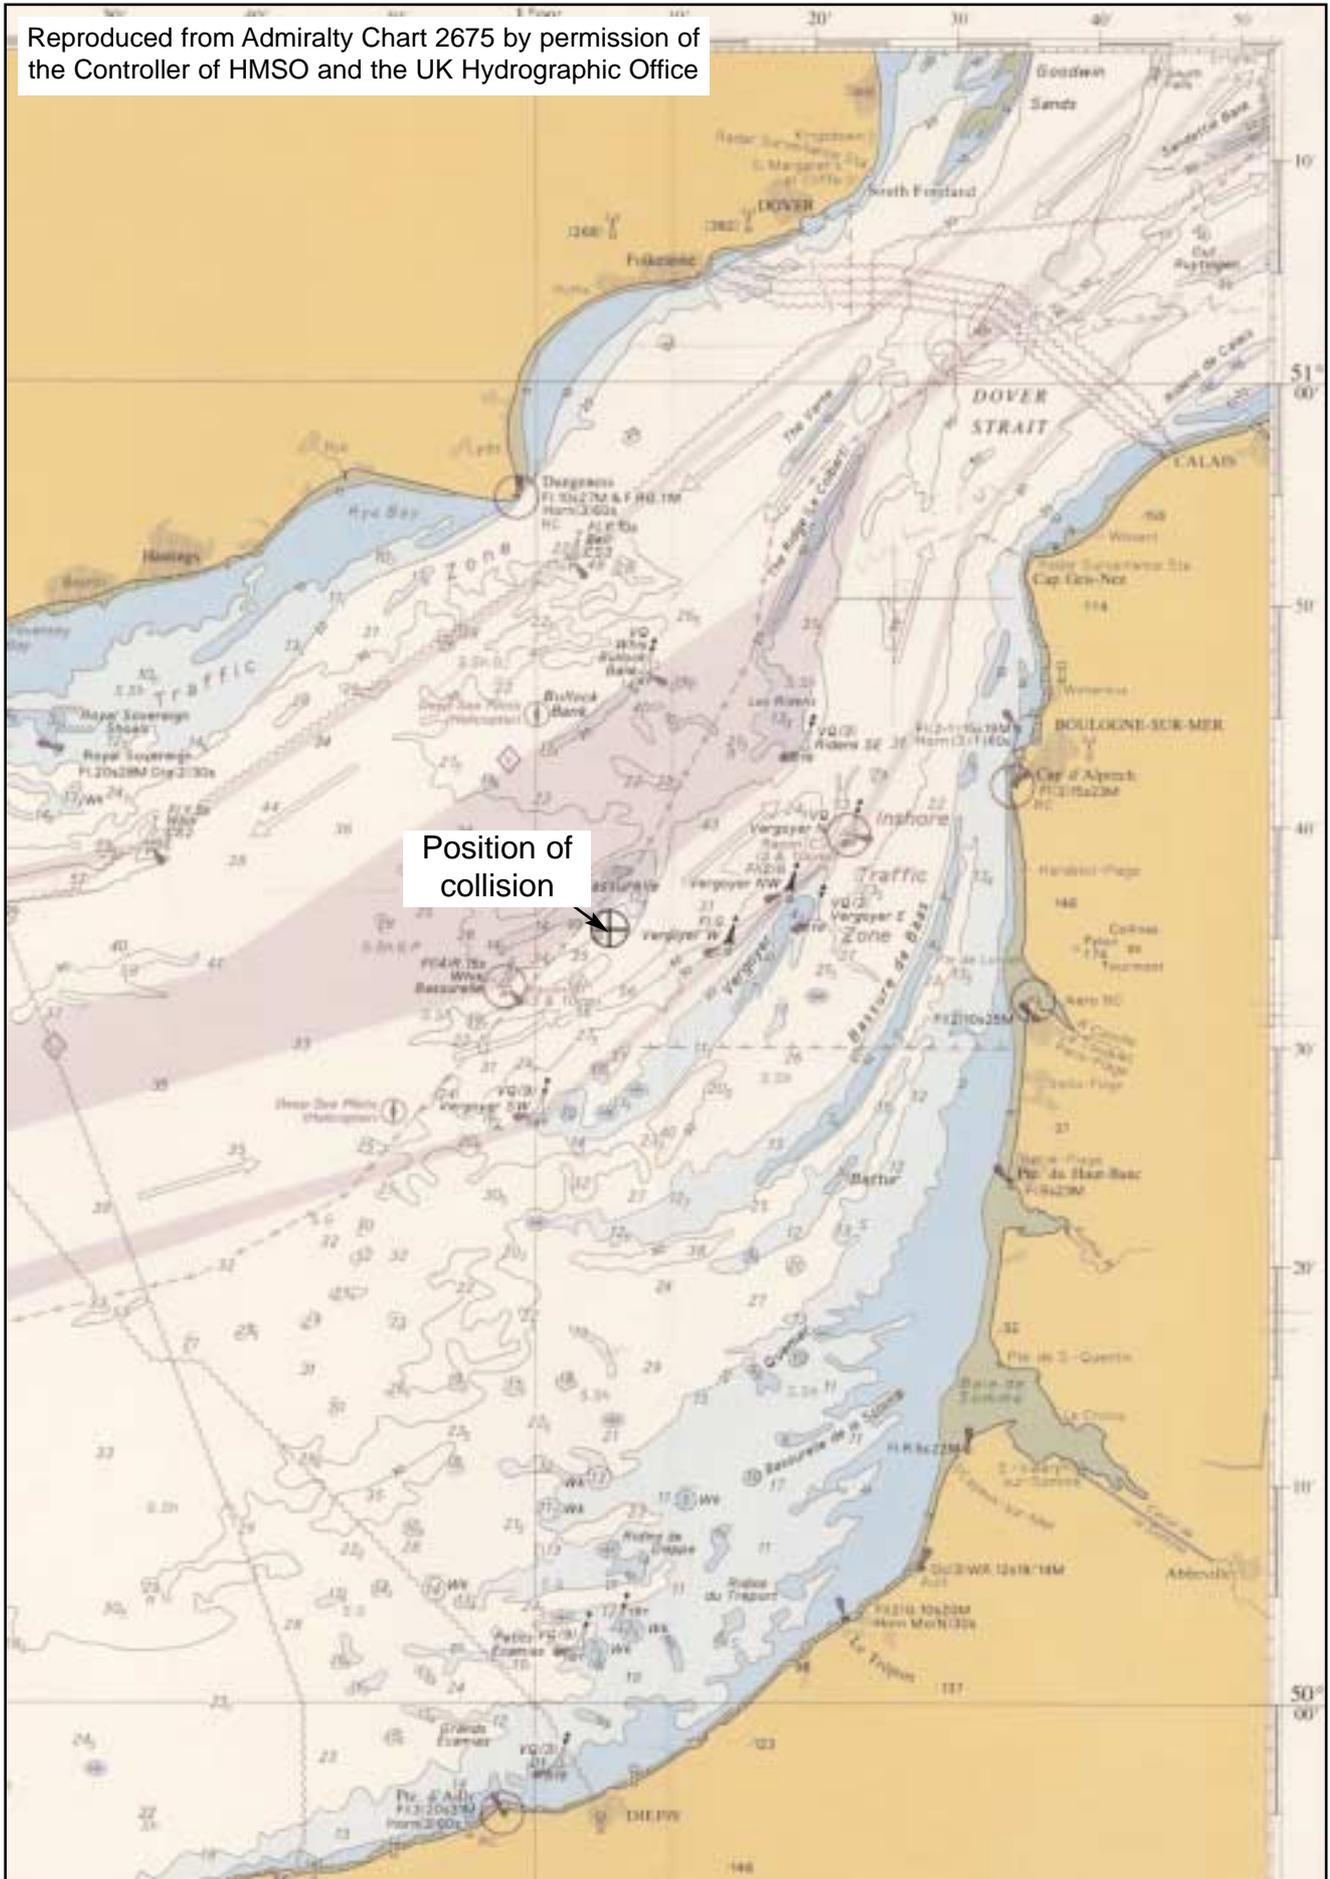
The skipper was on watch on *Celtit*. He had seen *Sand Heron* but did not think there was a risk of collision. **(Chart extract 1)**

Chart extract showing position of collision

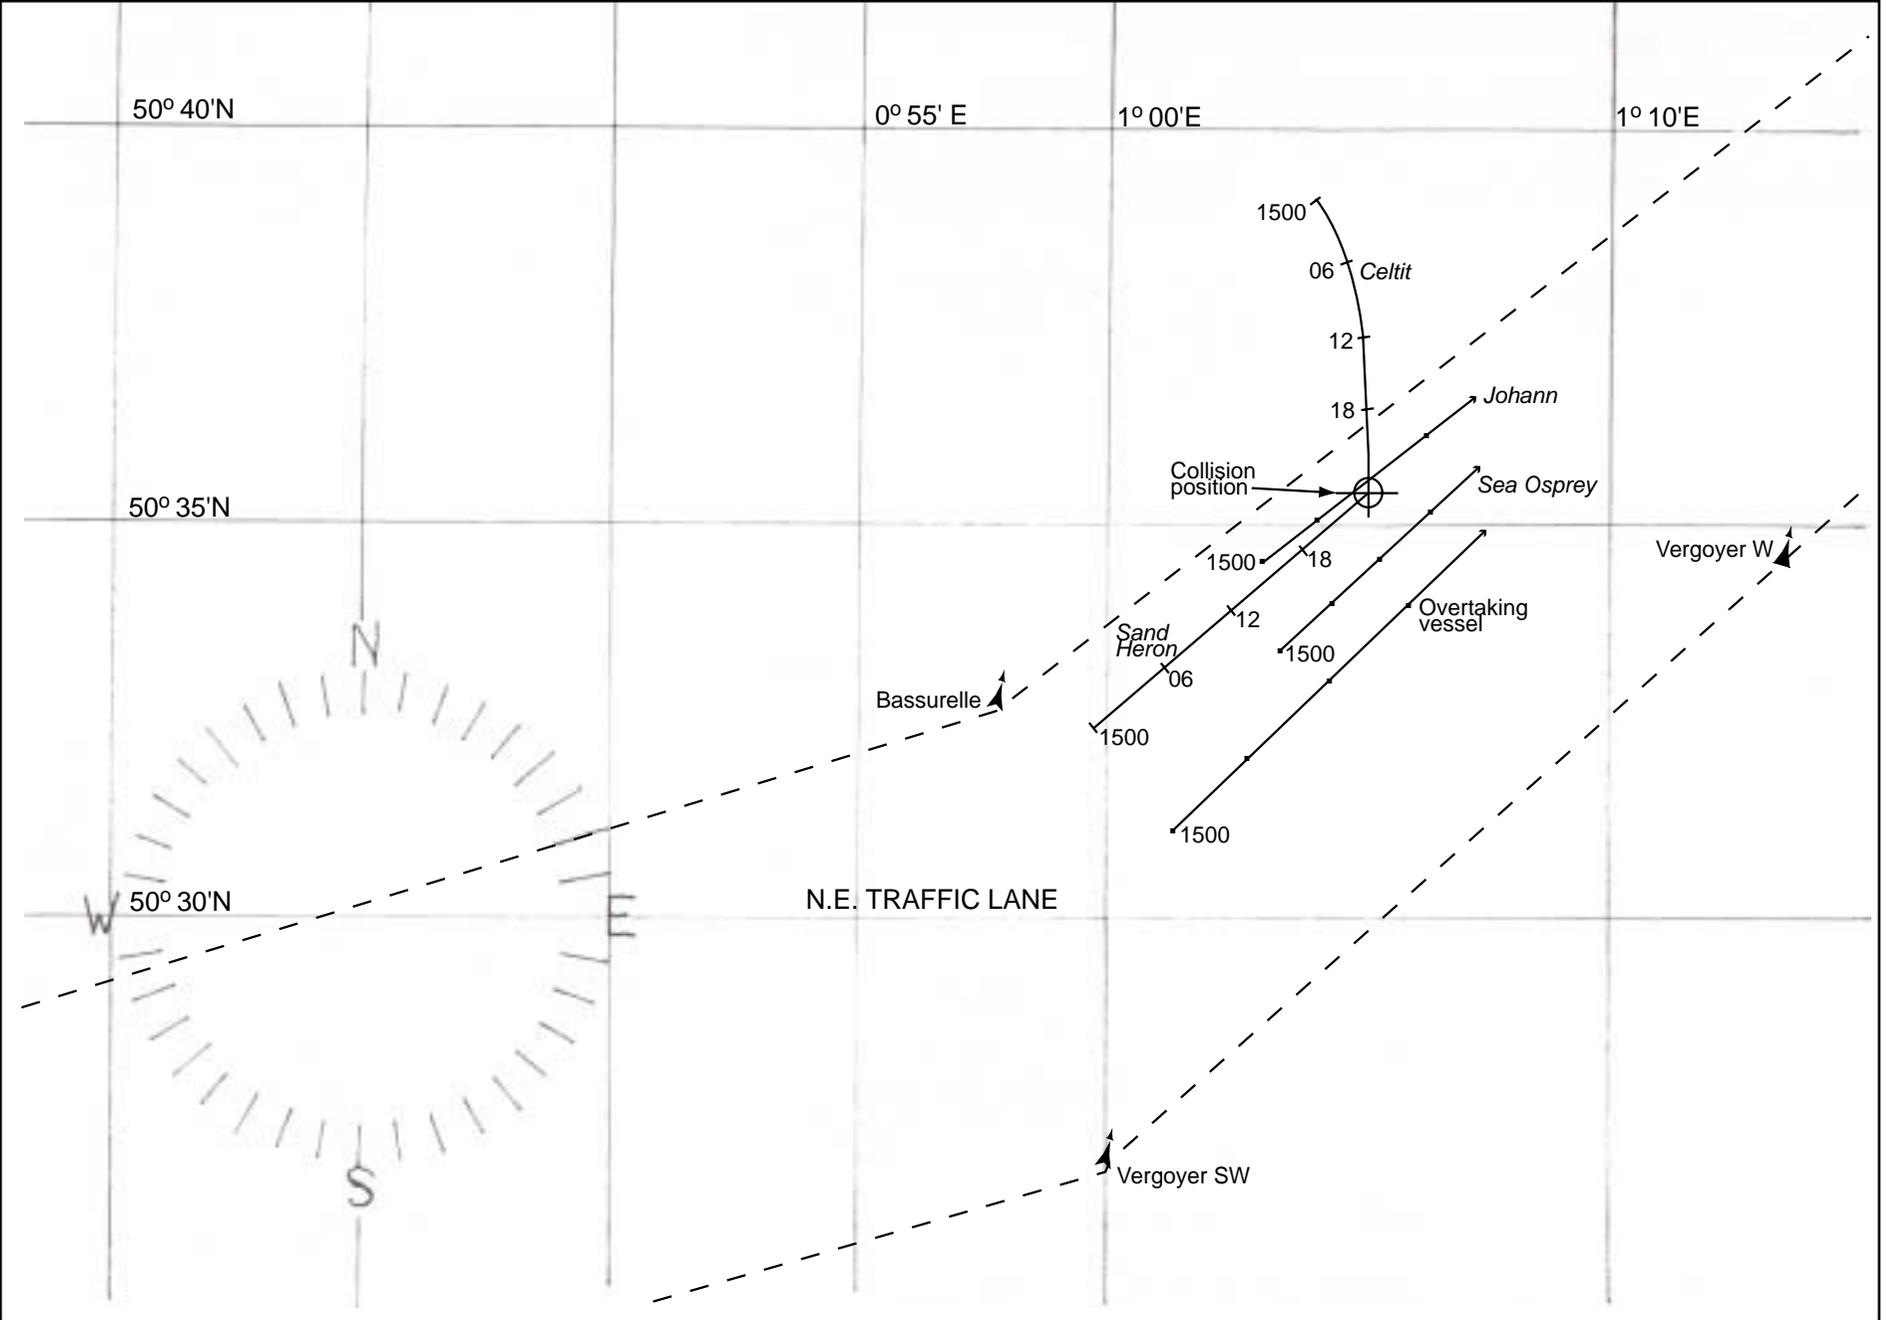
Figure 1

Track plot of Celtit and Sand Heron collision

The tracks of all those vessels in the vicinity of the collision were recorded by the CNIS at Dover (**see Figure 1**). It can be seen from the plot that at 1500 *Celtit* was shaping to cross the north-east traffic lane on a south-easterly course, at about right angles to the flow of traffic, which was in accordance with the Collision Regulations. At this time, she had a relative bearing of about 3 points on *Sand Heron*'s port bow at a range of 7.3 miles. Had the two vessels maintained their course and speed, *Celtit* would have passed clear ahead of *Sand Heron*. However, for an unexplained reason, possibly as avoiding action for the collision situation that existed with *Johann* and *Sea Osprey*, or simply to head for her home port of Dieppe, *Celtit* gradually altered her heading to starboard until, at about 1512, she was making good a course of about 175°. At that time, *Sand Heron* was bearing about 205°(T) from *Celtit* at a range of about 4 miles, and they were on a collision course.

The watchkeeper on *Celtit*, on the other hand, did not fully appreciate that risk of collision existed. The track plot recorded by CNIS clearly shows the two vessels on a collision course for the 10 to 12 minutes before the accident. *Celtit's* watchkeeper was not, therefore, maintaining a proper lookout.

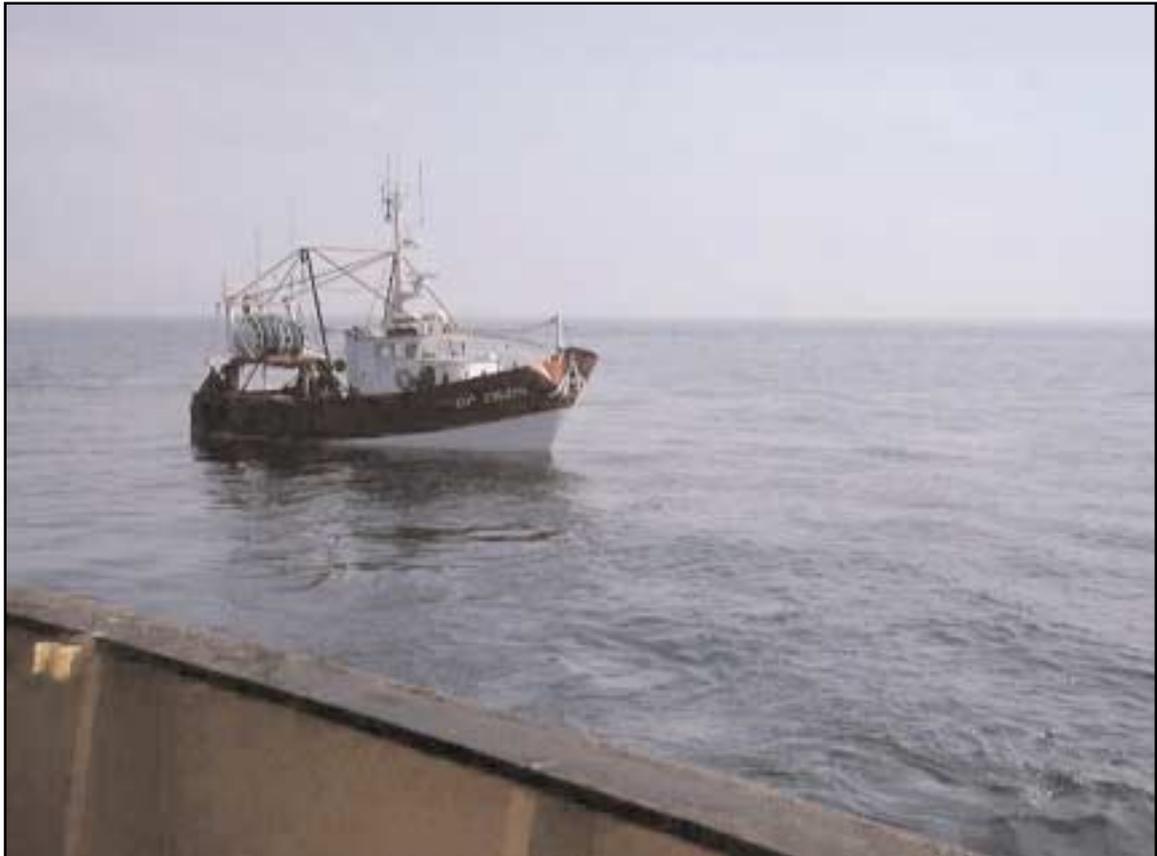
Photograph 1

Damage : *Sand Heron* - superficial bulwark damage  
*Celtit* – damaged bow

The master had been alerted by the blowing of the ship's whistle, and had arrived on the bridge at about the time of the impact. *Sand Heron's* engine was stopped, and the vessel was manoeuvred towards *Celtit* to offer assistance if necessary. Radio contact between the two vessels was established, and it was learned that *Celtit* had a badly damaged bow, but was not in need of assistance **(see photograph 1)**.

*Celtit* soon after the collision

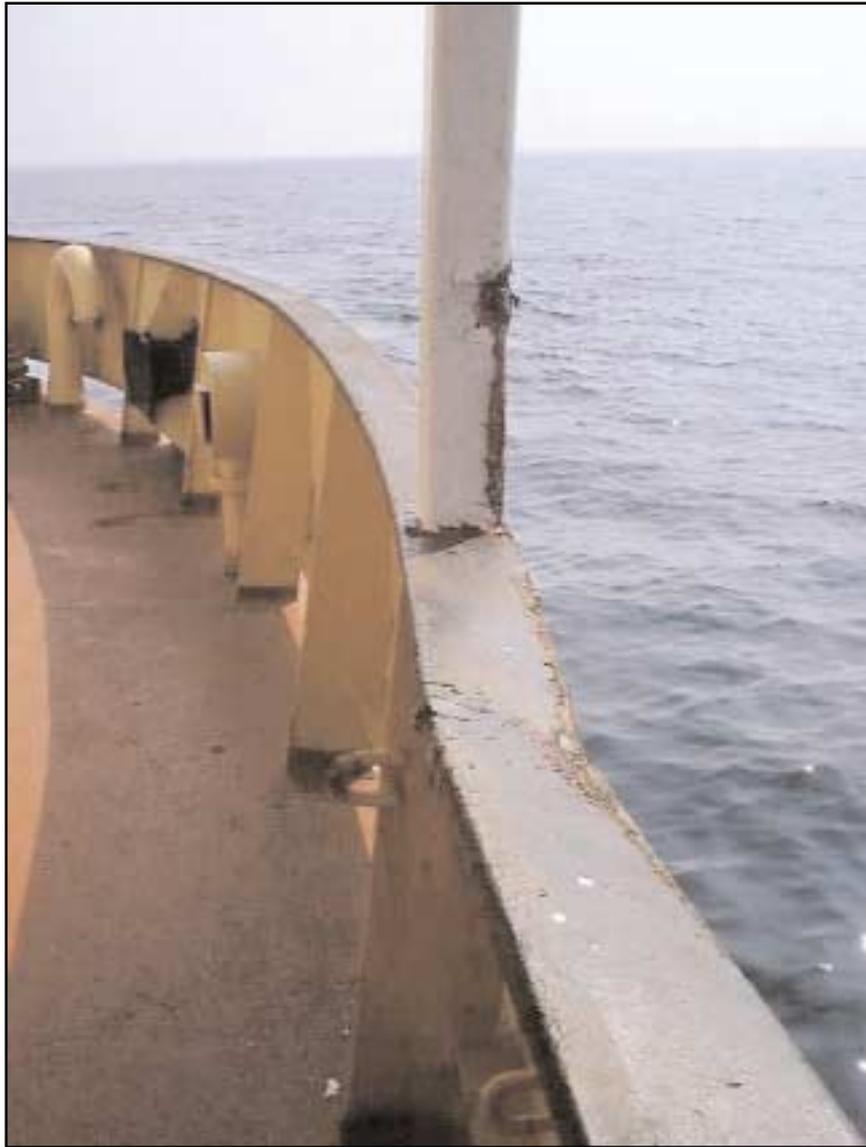
*Sand Heron* then continued her passage to Rochester, with the permission of Dover Coastguard. She arrived to anchor off the River Medway at 2340. Subsequent inspection revealed that *Sand Heron* had suffered only superficial damage to her port bulwark (**see photograph 2**).

Damage to *Sand Heron*

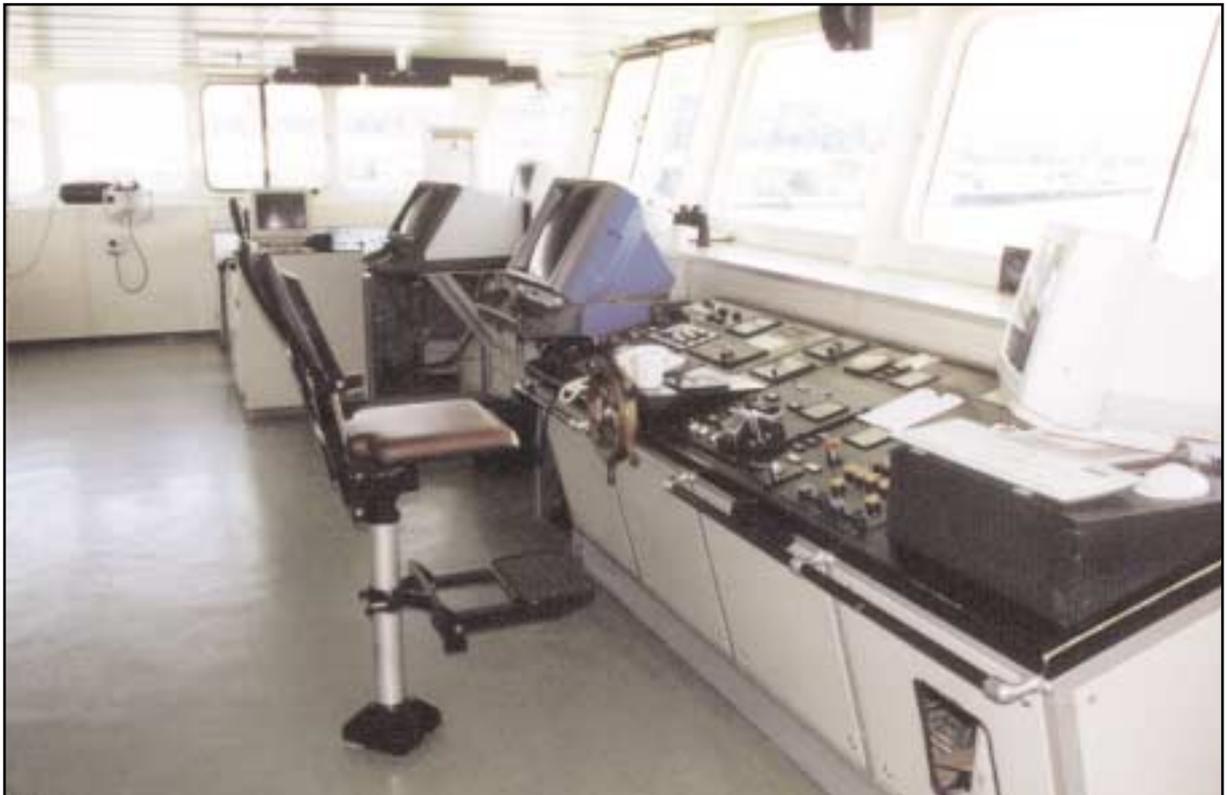
Photograph 3

*Sand Heron* was equipped with two radars, a Kelvin Hughes Nucleus 2 5000 ATA which was situated forward on the port side of the bridge adjacent to the bridge front window. The second radar, a Kelvin Hughes HR 3061, was sited more centrally on the port side, immediately outboard of the main central control console (**see photograph 3**). She had a Sperry gyro compass, a Robertson autopilot and a Sailor Compact VHF radio. Her Microplot 7 electronic chart system had inputs from one of the two DGPS navigators. Paper charts were carried and Admiralty chart 2451 (Newhaven to Dover) was in use at the time of the collision. There are three locations where whistle controls are sited, one on the central console and one on each bridge wing. An Aldis light was rigged ready for use on the port side of the bridge.

The vessel was fitted with a Doppler log which was not operational at the time of the accident. The Nucleus radar relied on a speed input to calculate the courses and speeds of acquired targets. The Doppler log was interfaced with the radar, but manual speed input was also possible. It is uncertain whether a manual speed had been set on the radar on 30 July. The second officer assessed risk of collision by reference to the relative vectors produced by the radar which were not reliant on speed input.

Bridge layout of *Sand Heron*
