Report on the investigation of  
the collision between  
***mv Sand Heron and fv Celtit***  
NE Traffic Lane, Dover TSS  
30 July 2001

**Report No 14/2002**  
**April 2002**

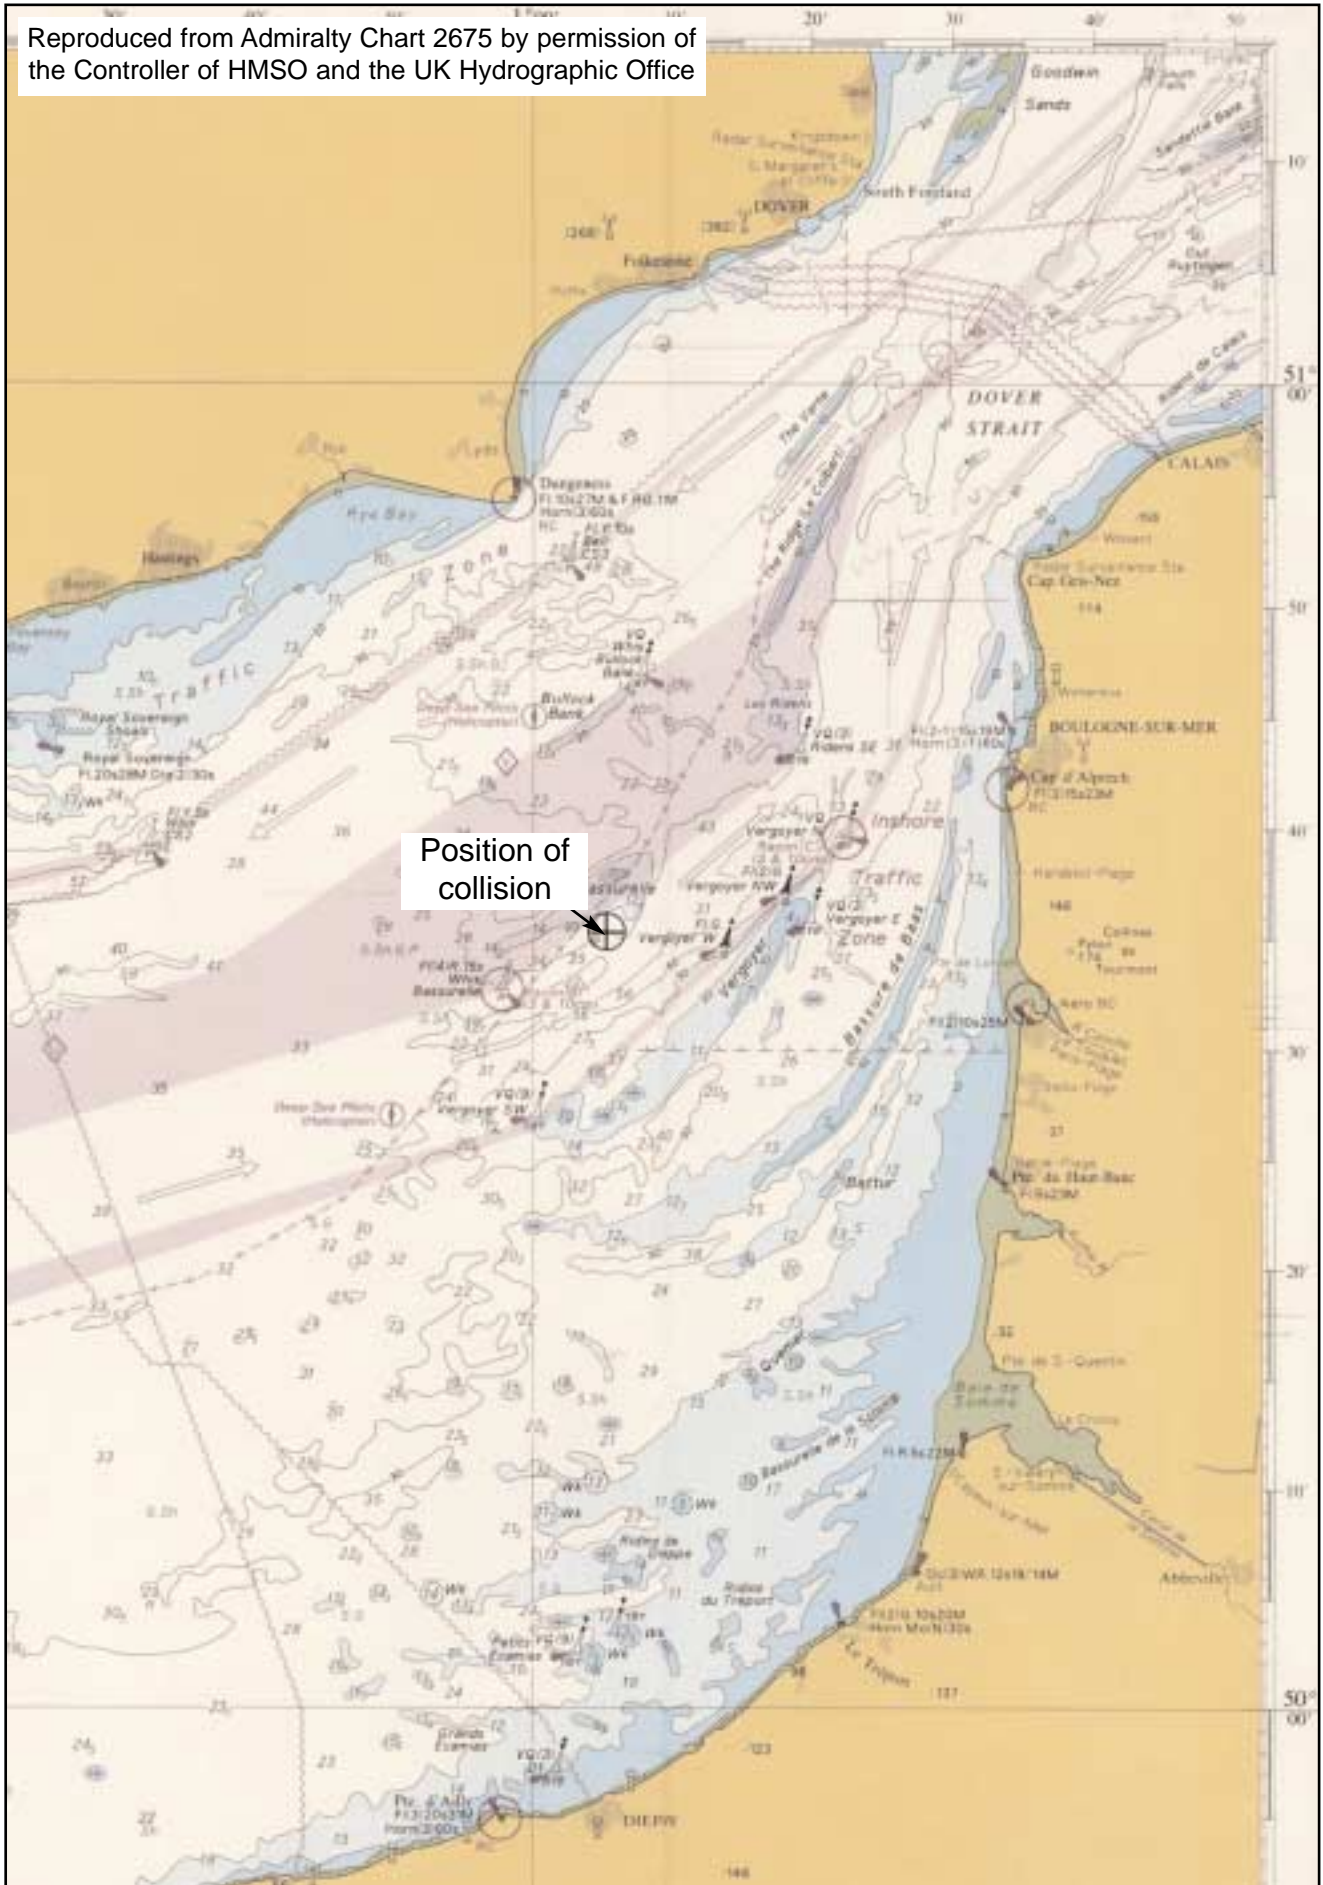
The skipper was on watch on *Celtit*. He had seen *Sand Heron* but did not think there was a risk of collision. **(Chart extract 1)**

Chart extract showing position of collision

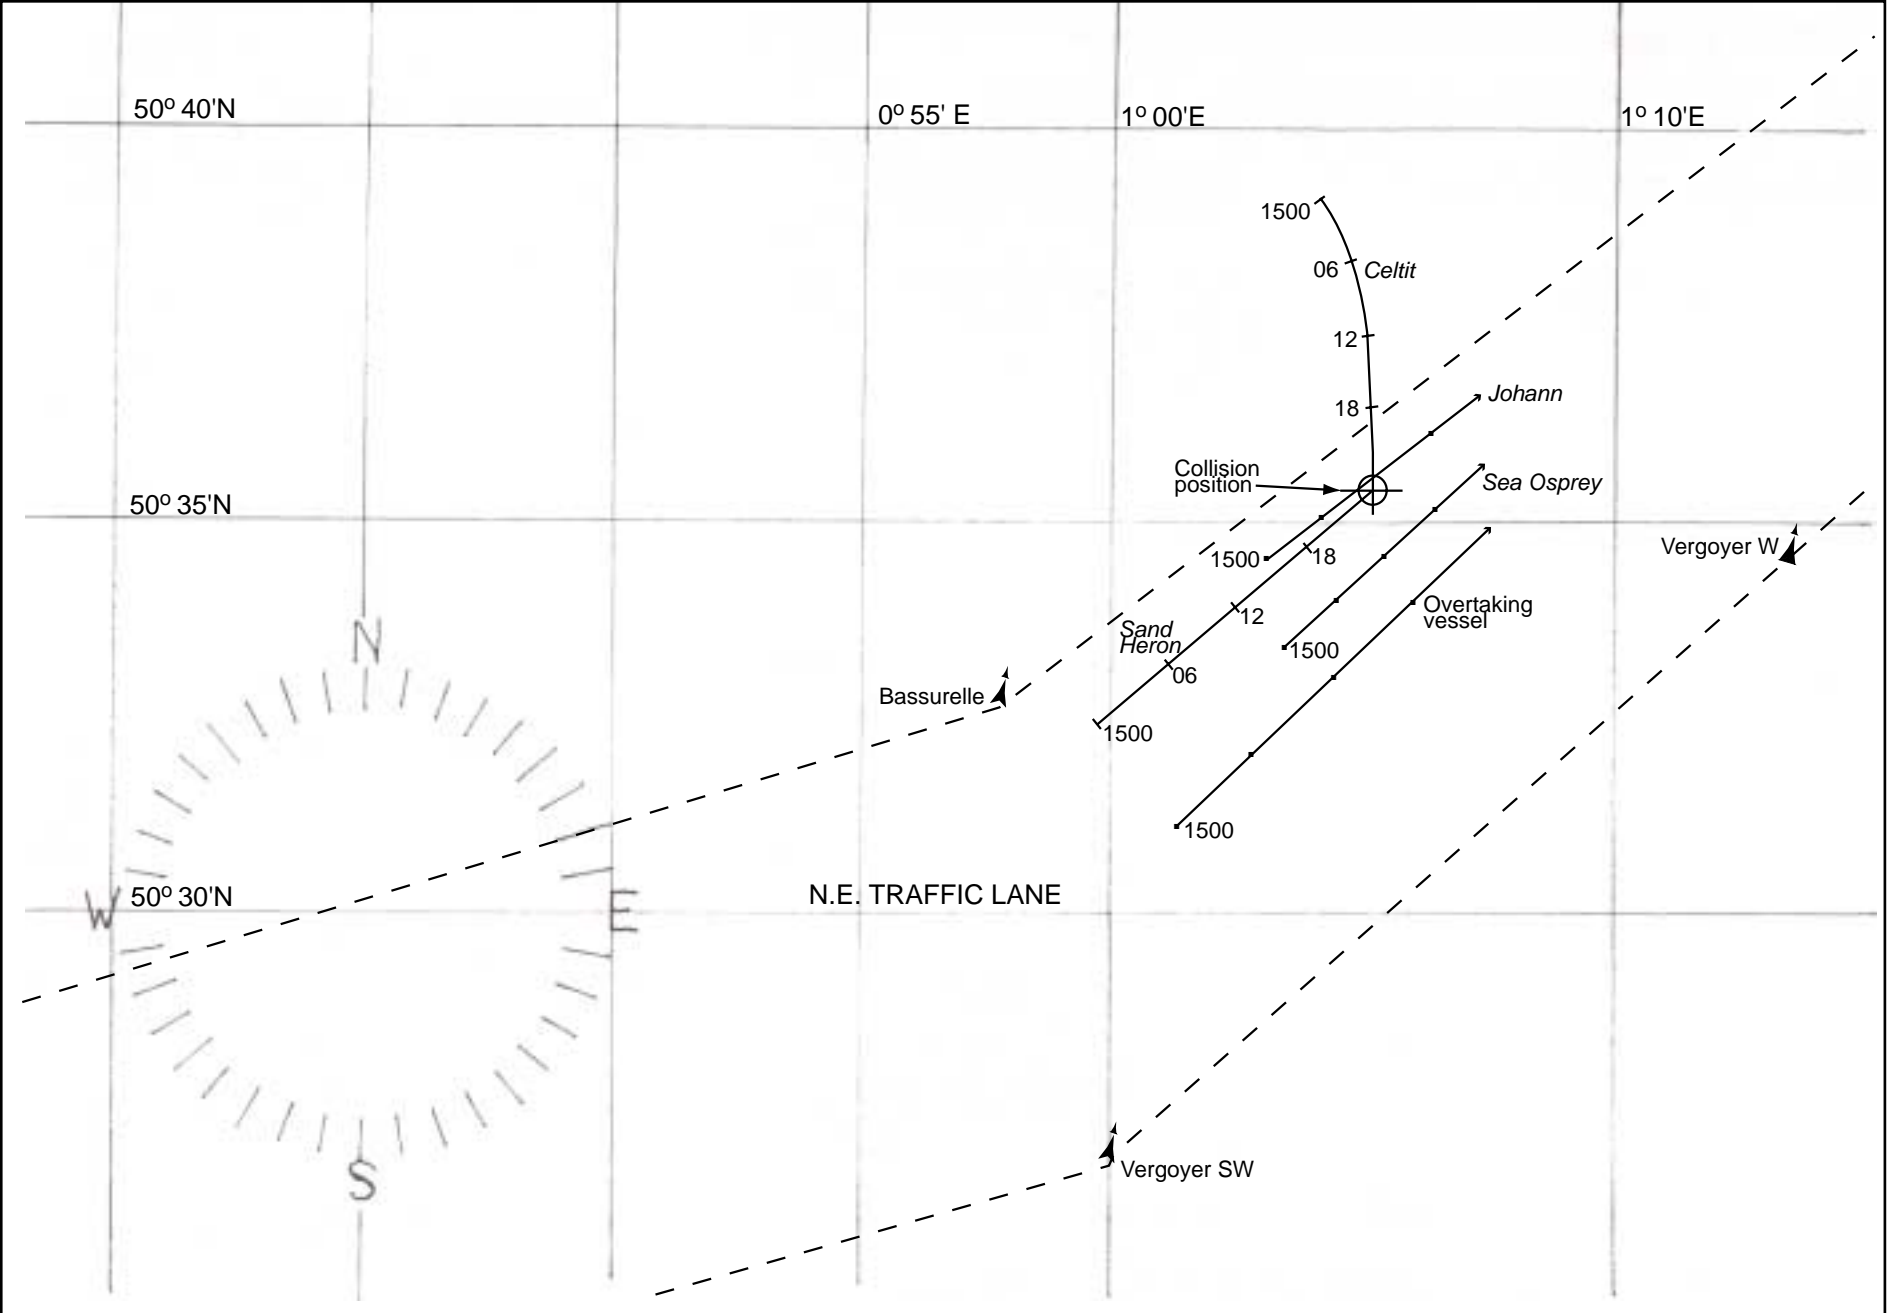
Figure 1

Track plot of Celtit and Sand Heron collision

The tracks of all those vessels in the vicinity of the collision were recorded by the CNIS at Dover (**see Figure 1**). It can be seen from the plot that at 1500 *Celtit* was shaping to cross the north-east traffic lane on a south-easterly course, at about right angles to the flow of traffic, which was in accordance with the Collision Regulations. At this time, she had a relative bearing of about 3 points on *Sand Heron*'s port bow at a range of 7.3 miles. Had the two vessels maintained their course and speed, *Celtit* would have passed clear ahead of *Sand Heron*. However, for an unexplained reason, possibly as avoiding action for the collision situation that existed with *Johann* and *Sea Osprey*, or simply to head for her home port of Dieppe, *Celtit* gradually altered her heading to starboard until, at about 1512, she was making good a course of about 175°. At that time, *Sand Heron* was bearing about 205°(T) from *Celtit* at a range of about 4 miles, and they were on a collision course.

The watchkeeper on *Celtit*, on the other hand, did not fully appreciate that risk of collision existed. The track plot recorded by CNIS clearly shows the two vessels on a collision course for the 10 to 12 minutes before the accident. *Celtit's* watchkeeper was not, therefore, maintaining a proper lookout.

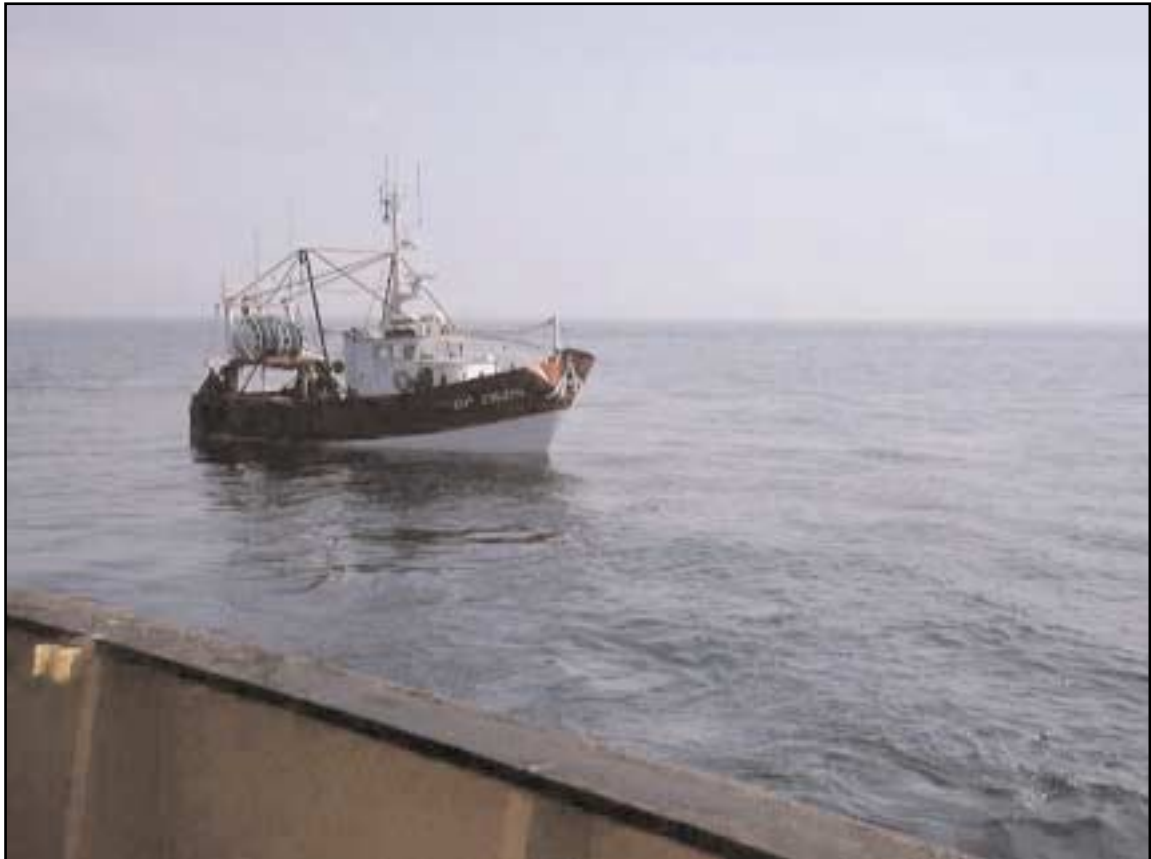
Photograph 1

The master had been alerted by the blowing of the ship's whistle, and had arrived on the bridge at about the time of the impact. *Sand Heron's* engine was stopped, and the vessel was manoeuvred towards *Celtit* to offer assistance if necessary. Radio contact between the two vessels was established, and it was learned that *Celtit* had a badly damaged bow, but was not in need of assistance (see photograph 1).

*Celtit* soon after the collision

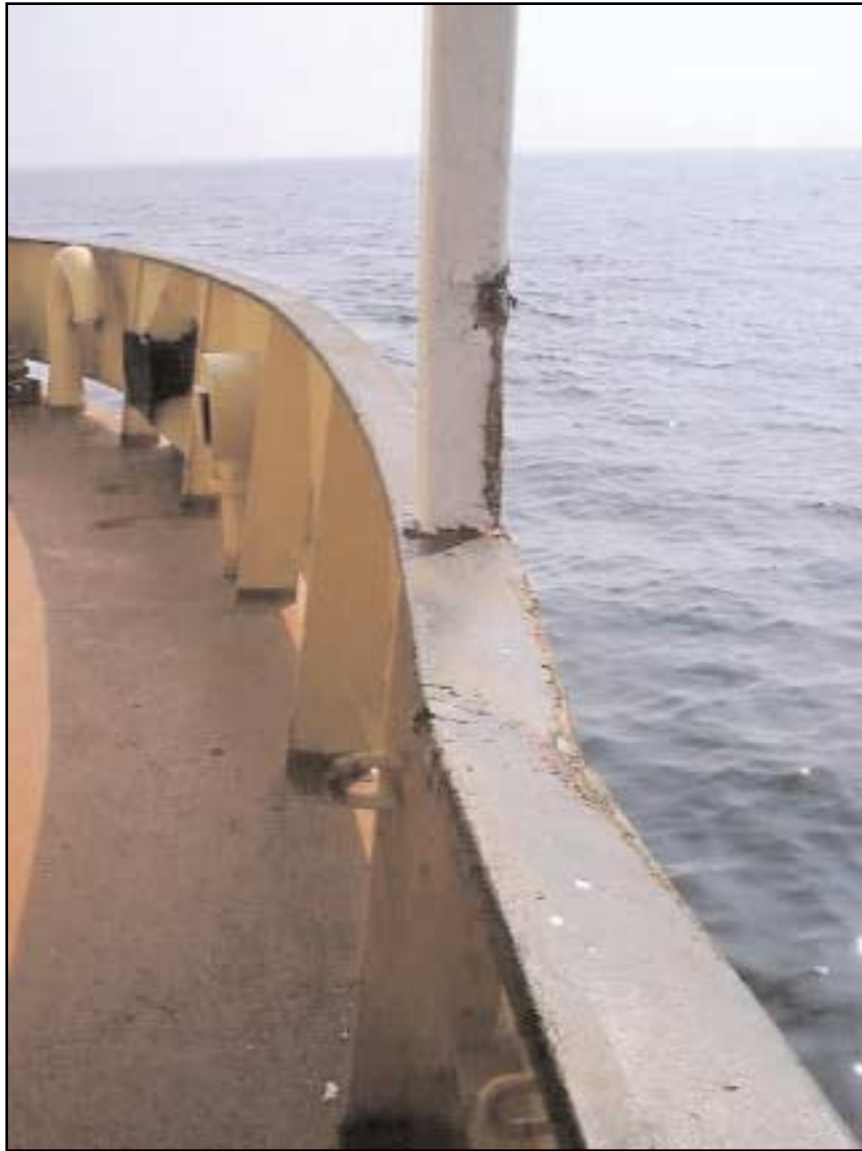
*Sand Heron* then continued her passage to Rochester, with the permission of Dover Coastguard. She arrived to anchor off the River Medway at 2340. Subsequent inspection revealed that *Sand Heron* had suffered only superficial damage to her port bulwark (**see photograph 2**).

Damage to *Sand Heron*

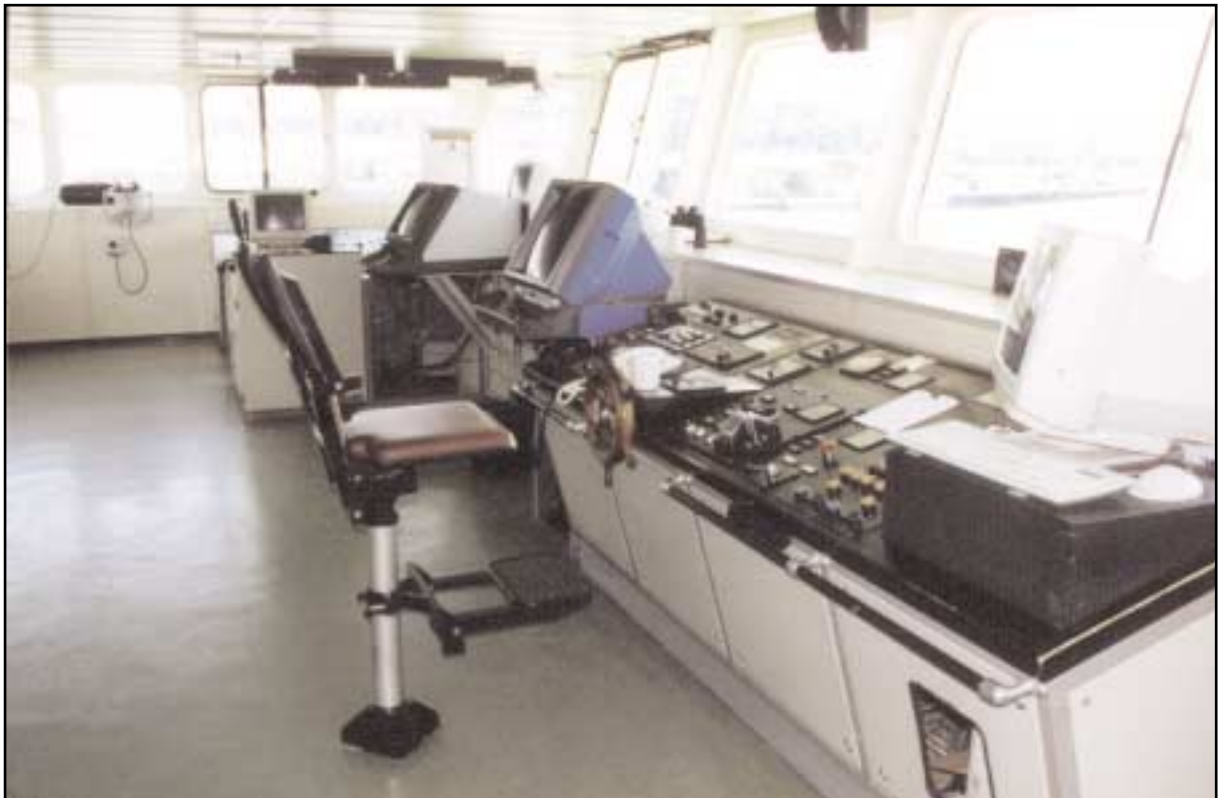
Photograph 3

*Sand Heron* was equipped with two radars, a Kelvin Hughes Nucleus 2 5000 ATA which was situated forward on the port side of the bridge adjacent to the bridge front window. The second radar, a Kelvin Hughes HR 3061, was sited more centrally on the port side, immediately outboard of the main central control console (**see photograph 3**). She had a Sperry gyro compass, a Robertson autopilot and a Sailor Compact VHF radio. Her Microplot 7 electronic chart system had inputs from one of the two DGPS navigators. Paper charts were carried and Admiralty chart 2451 (Newhaven to Dover) was in use at the time of the collision. There are three locations where whistle controls are sited, one on the central console and one on each bridge wing. An Aldis light was rigged ready for use on the port side of the bridge.

The vessel was fitted with a Doppler log which was not operational at the time of the accident. The Nucleus radar relied on a speed input to calculate the courses and speeds of acquired targets. The Doppler log was interfaced with the radar, but manual speed input was also possible. It is uncertain whether a manual speed had been set on the radar on 30 July. The second officer assessed risk of collision by reference to the relative vectors produced by the radar which were not reliant on speed input.

Bridge layout of *Sand Heron*
