Report on the investigation of  
the grounding and loss of  
the crabber

***Our Nicholas (SY811)***

near the entrance to Stornoway Harbour  
on 24 July 2001

**Report No 26/2002  
August 2002**

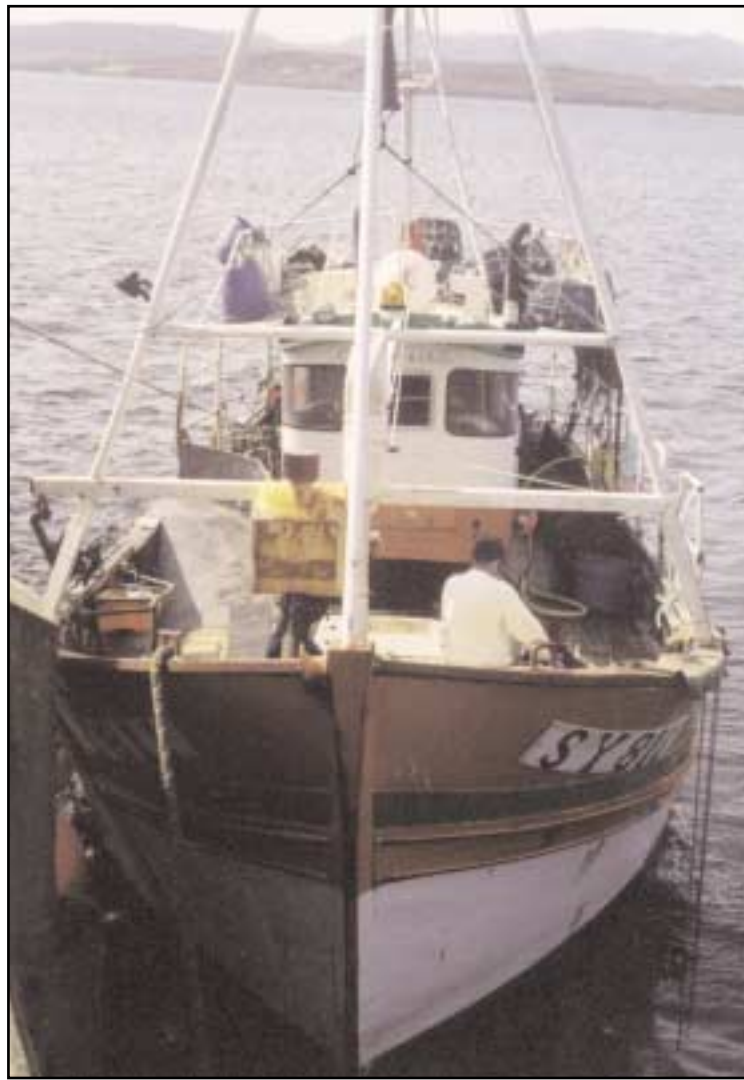
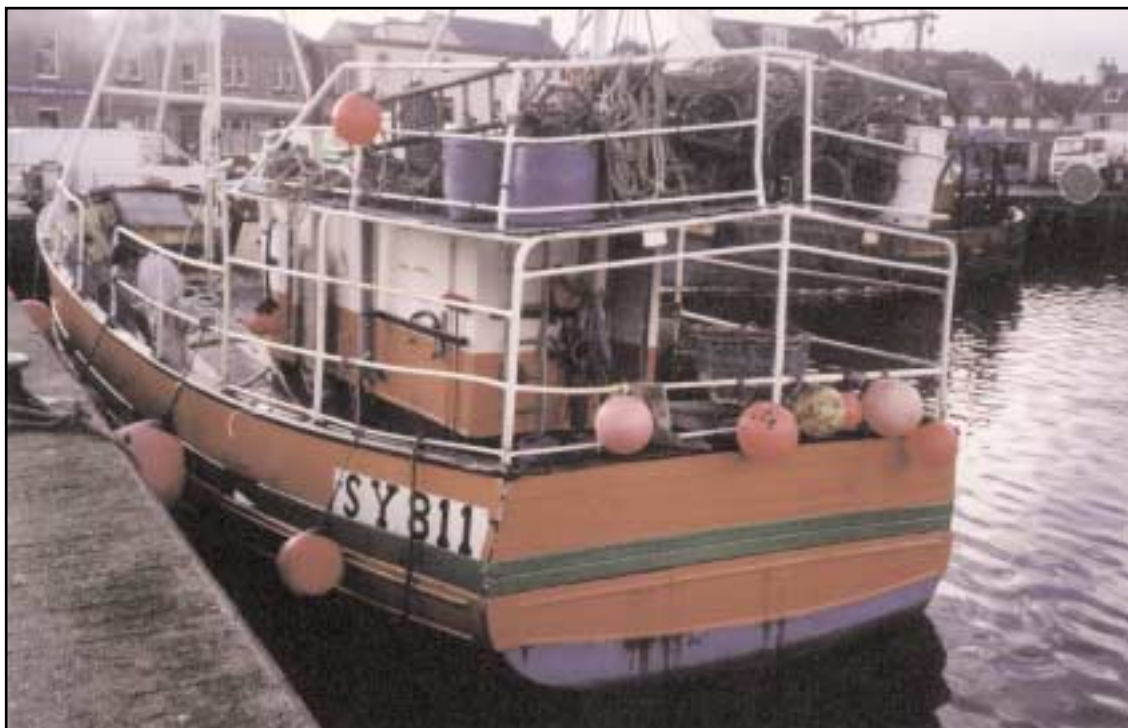
Photographs 1 & 2 - Fore and aft views of *Our Nicholas*

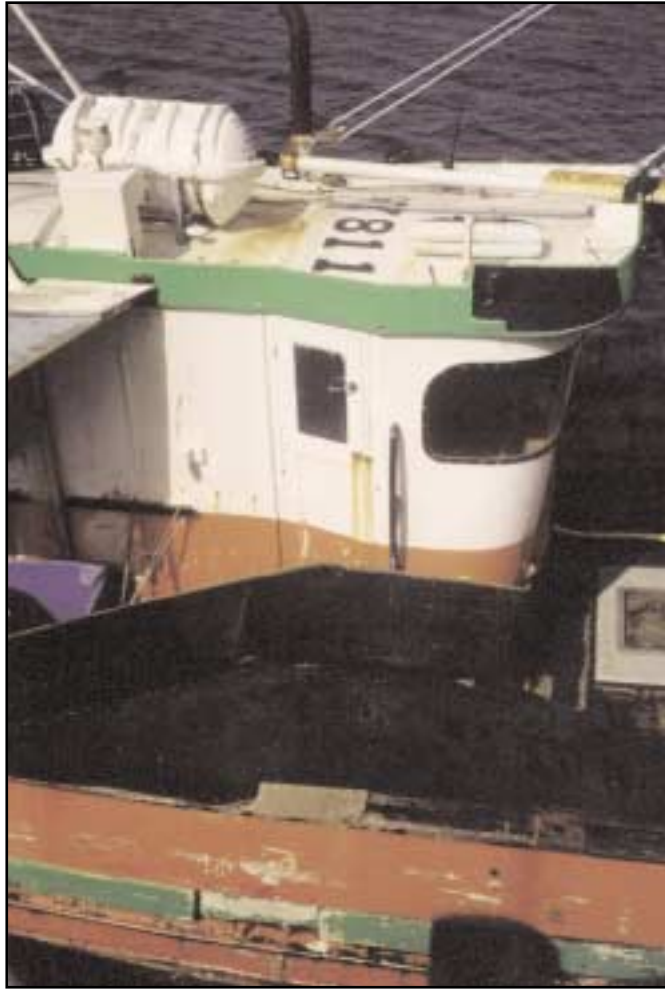
Photograph 3

Later, awoken by a loud noise, the skipper went straight up to the wheelhouse. When he arrived there, he saw, in the twilight, cliffs in front of him and that the vessel's bows were damaged. He placed the engine astern immediately and told deckhand 2 to call deckhand 3 who was still down below in the cabin. The vessel refloated and moved away from the rocks by the cliff and then began to sink rapidly. All the crew members went out through the starboard door and up to the top of the wheelhouse to release the liferaft manually (**see Photograph 3**). Before they could do this, the vessel foundered.

The wheelhouse top showing the liferaft stowage location and starboard door

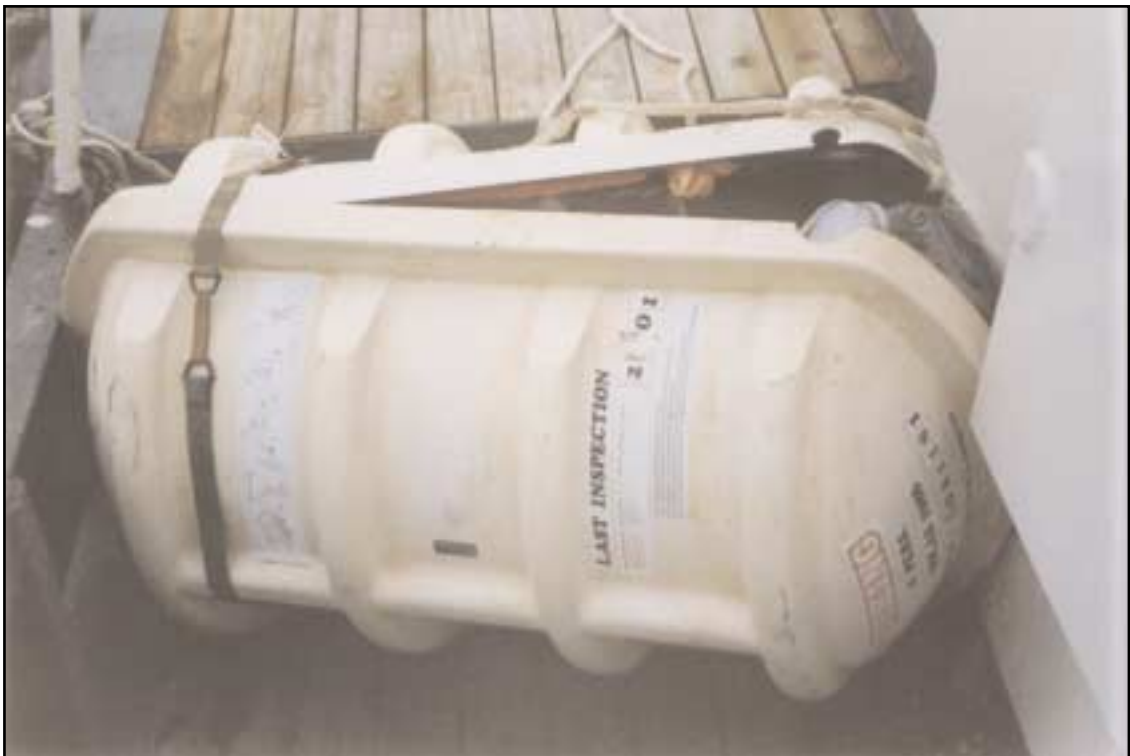
Photograph 4

The liferaft from *Our Nicholas* was recovered from the site of the wreck and it was found that, after it had been released from the vessel by the HRU, it had only partly inflated and was still in its canister (**see Section 1.6 and Photograph 4**).

The liferaft recovered from *Our Nicholas*

When *Our Nicholas* foundered, the HRU released the four-person liferaft. However, as **Photograph 4** shows, the liferaft inflated only sufficiently to break one of the two bursting straps, which held the two halves of the canister together. The inflation gas pressure was insufficient to inflate the liferaft and to release it from its canister.

6. Servicing records indicated that the loss of gas must have occurred since the last service. [2.3]
7. Mishandling during transportation or installation might have caused a significant impact, causing the spring and the knife to depress sufficiently to scratch the cylinder diaphragm and allowed gas to start to seep into the liferaft. [2.3]

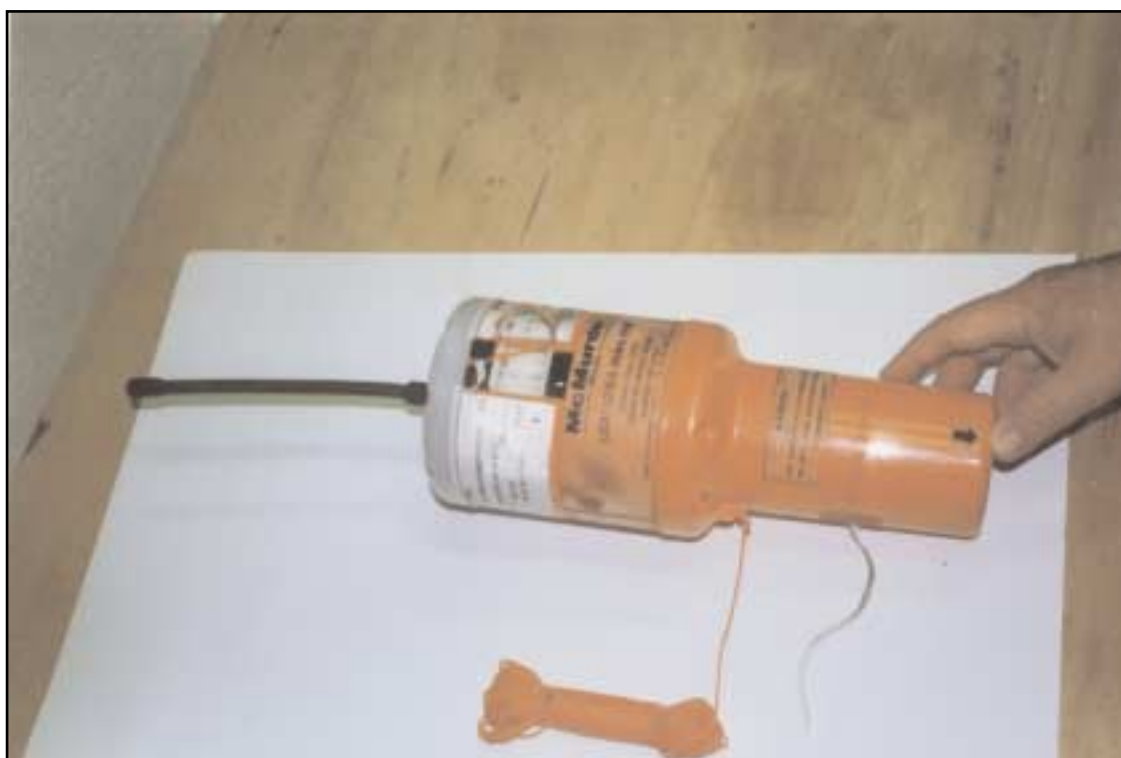
Photograph 5

The EPIRB recovered from *Our Nicholas*

In the “as received condition” at the time of testing, a small crack was found in the side of the top plastic moulding of the EPIRB, the strobe light was inoperative and the 406MHz beacon was below power.

The failure of the strobe light was probably caused by an ingress of a small amount of water on to the high-voltage circuit area of the printed circuit board. It is not known how the small crack occurred, but it should have been noted had a self-test been carried out.

8. The EPIRB's power output from the 406MHz beacon was substantially below specification, because of an intermittent circuit between the output pin and the printed circuit board, where the joint had not been soldered. No similar failures of the 406MHz beacon have been recorded, and the manufacturer considered the probability of similar occurrences to be low. [2.4]

9. The failure of the EPIRB's strobe light was probably caused by an ingress of a small amount of water on to the high-voltage circuit area of the printed circuit board. [2.4]

10. Both of the above failures should have been detected by self-tests on the EPIRB. [2.4]

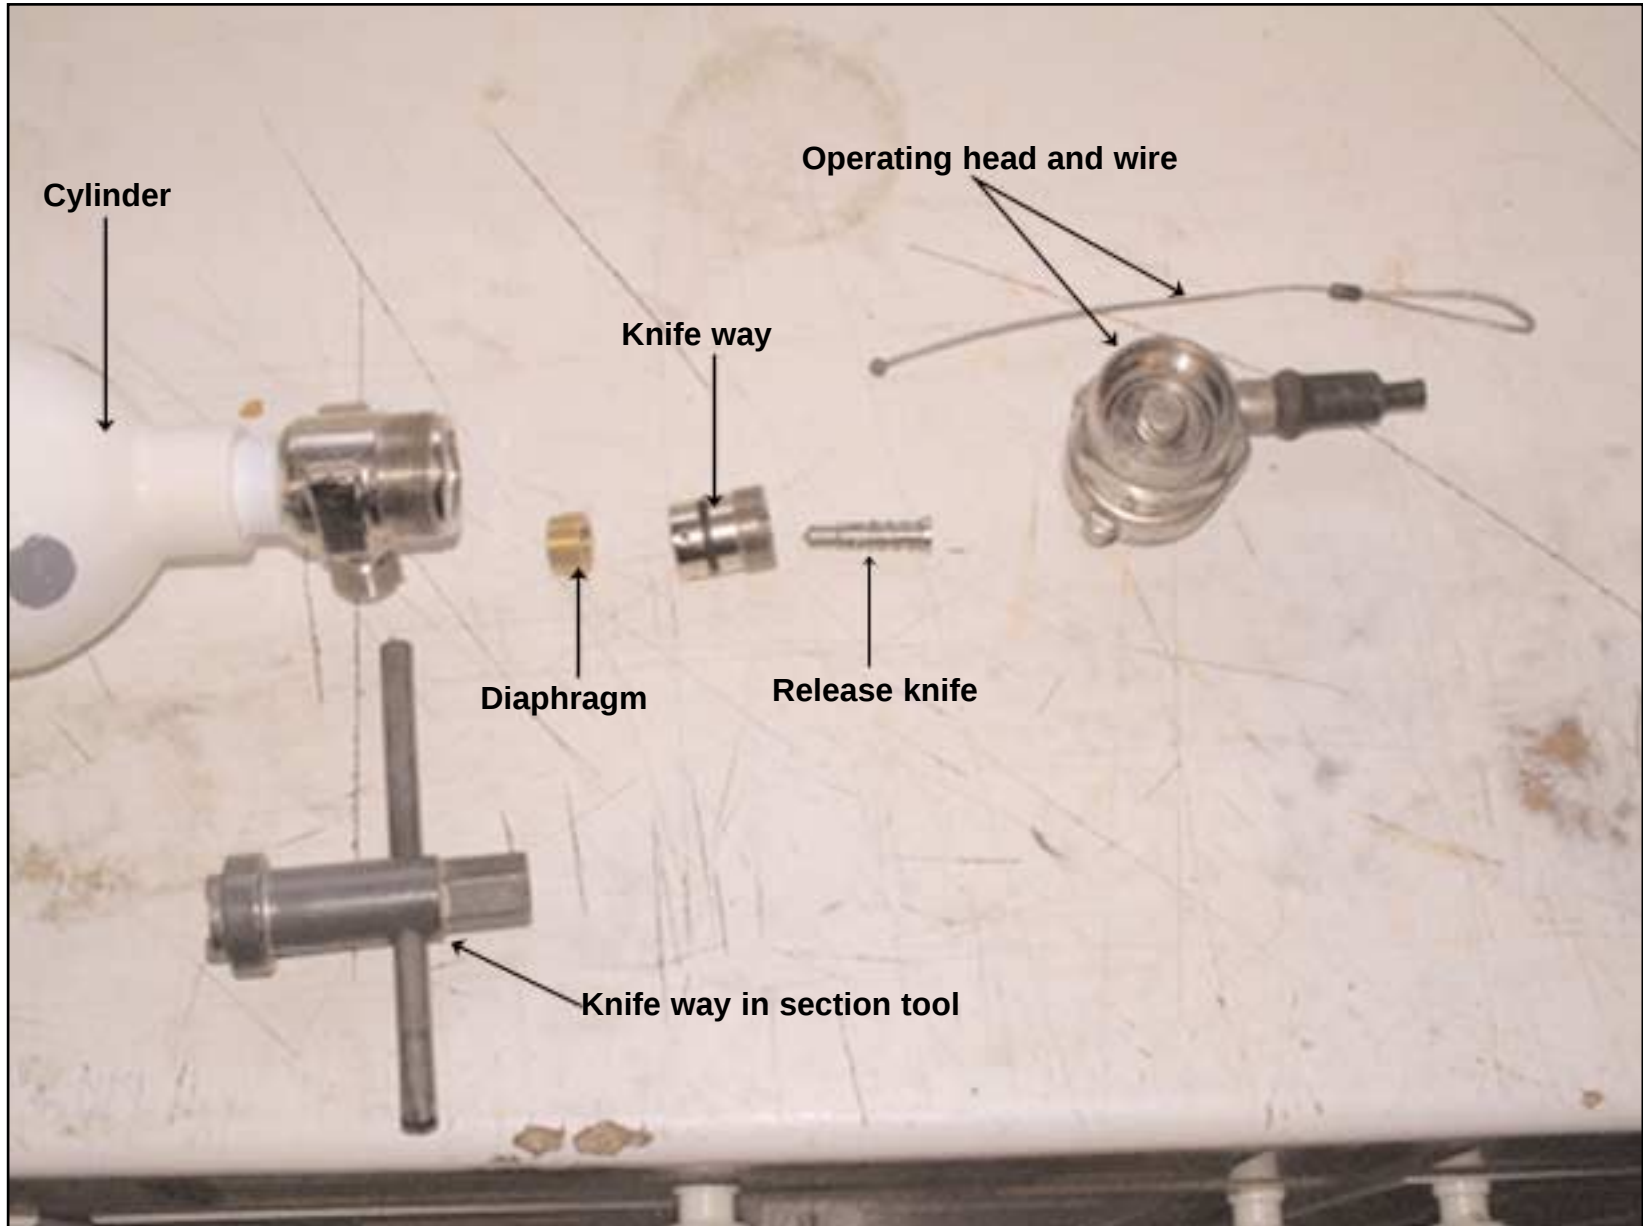
Photograph 6

Photograph showing the various parts of the gas release mechanism
