Report on the investigation of the loss of

***Vertrauen (BF 450)***

19 July 2001

**Report No 29/2002  
August 2002**

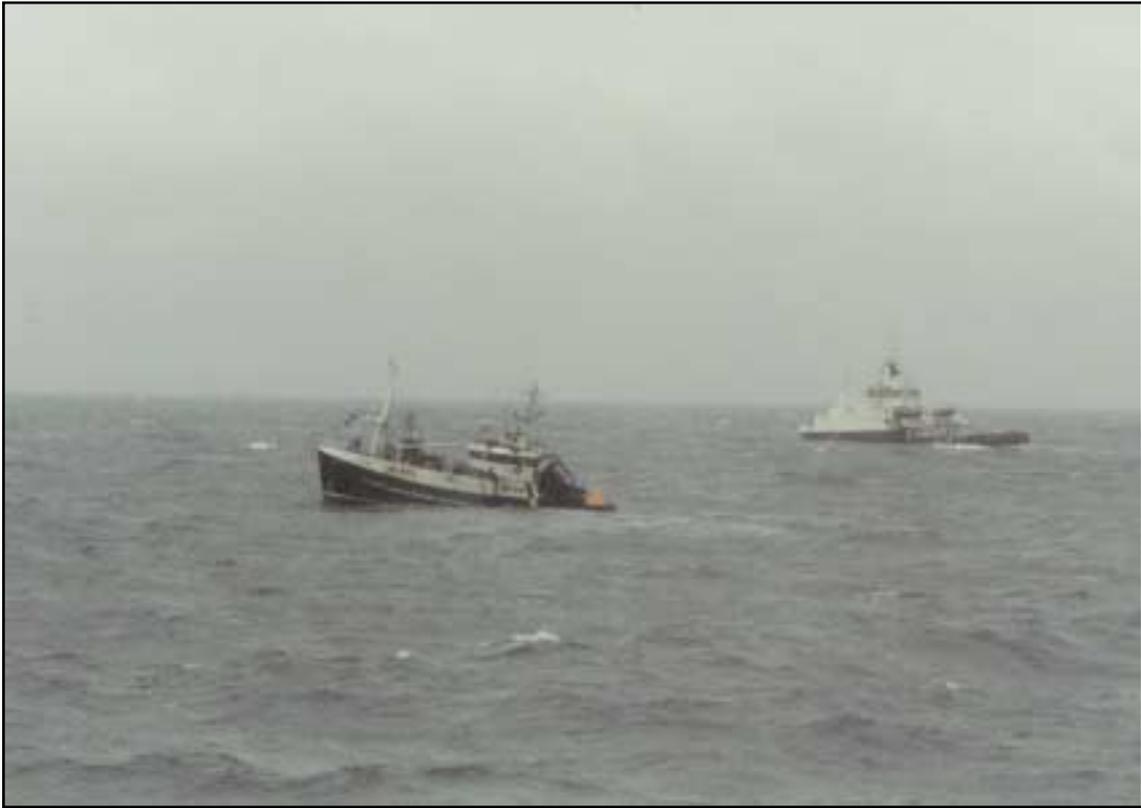
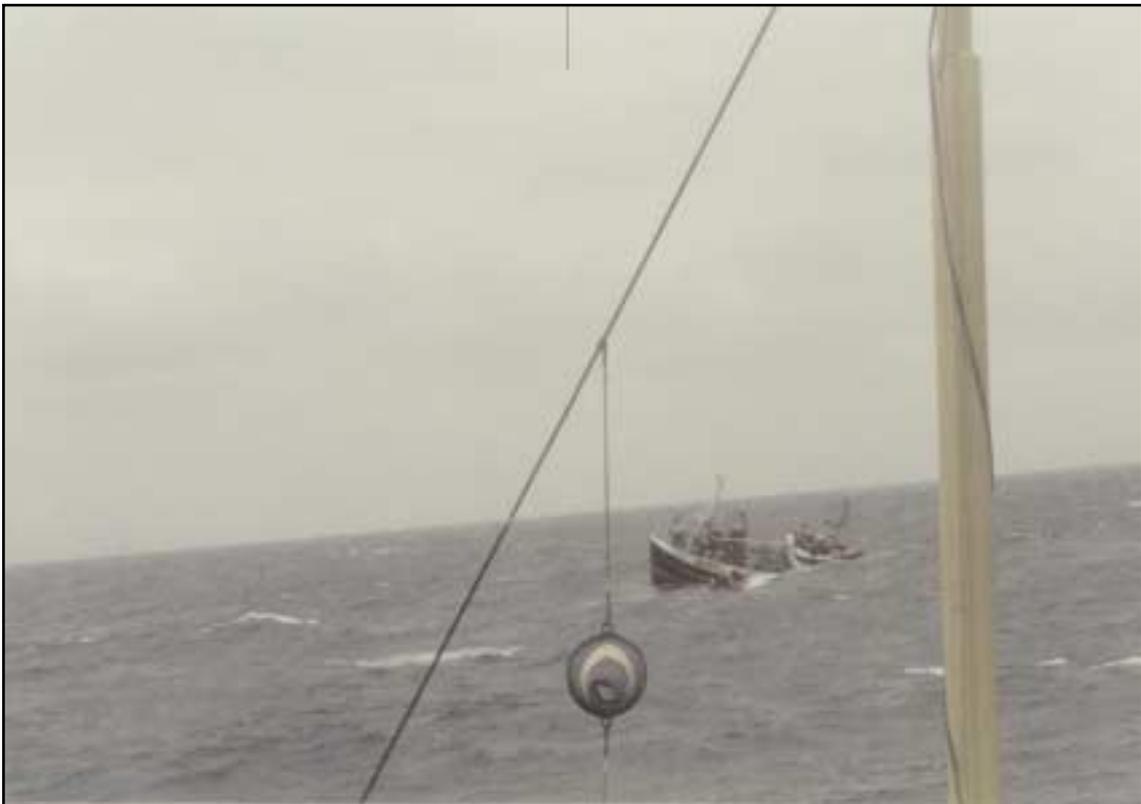
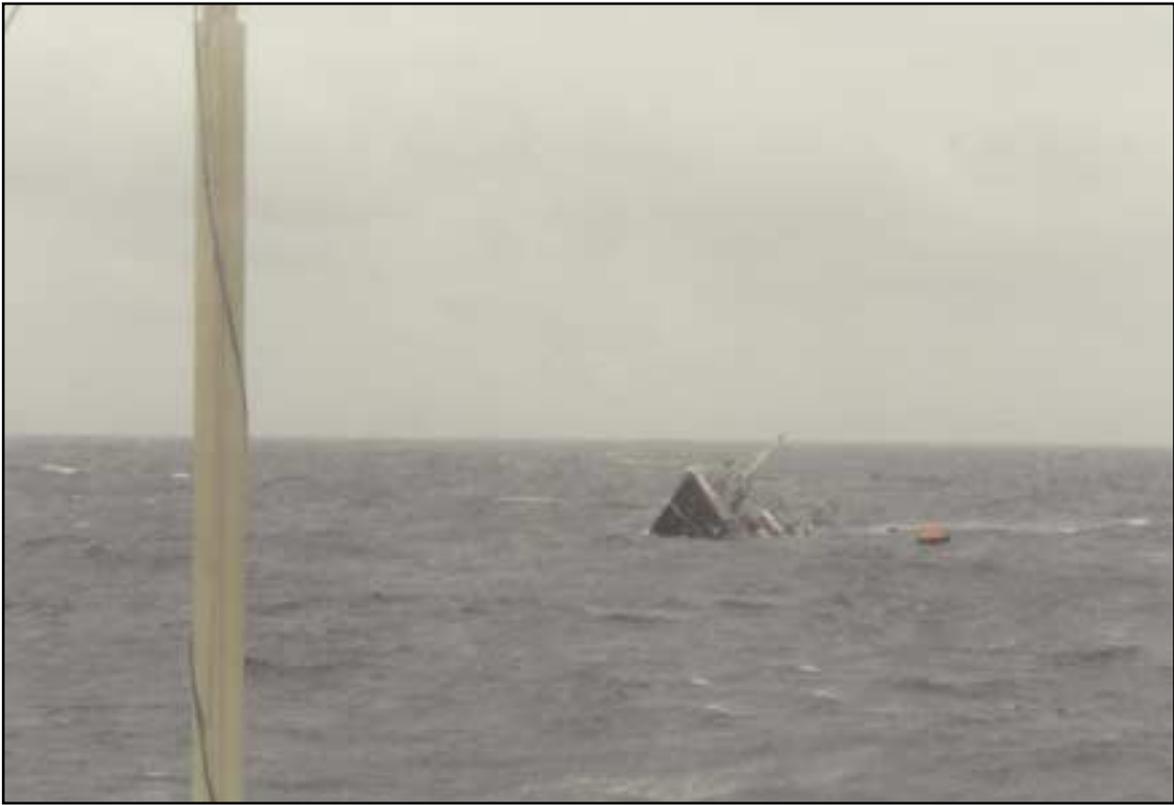
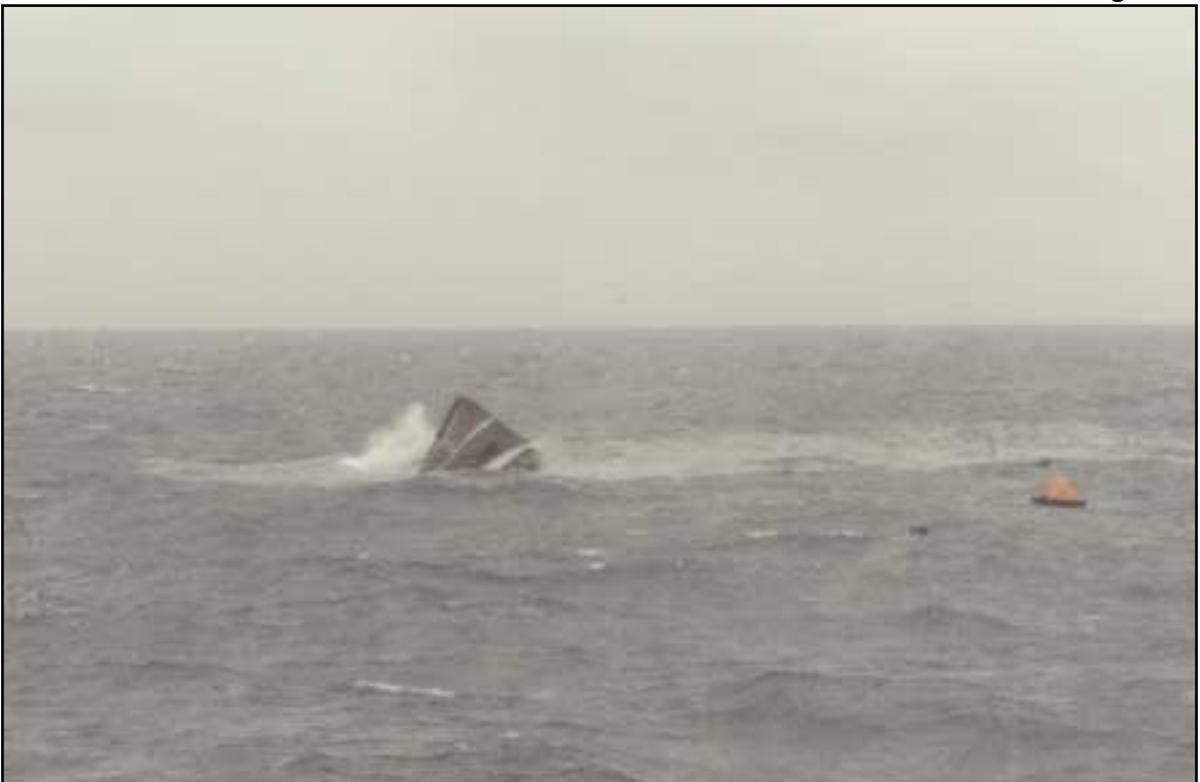
The stand-by vessel *Scott Protector* recovered the inflated liferafts after *Vertrauen* had sunk, and took photographs (**see Figures 4 - 7**).

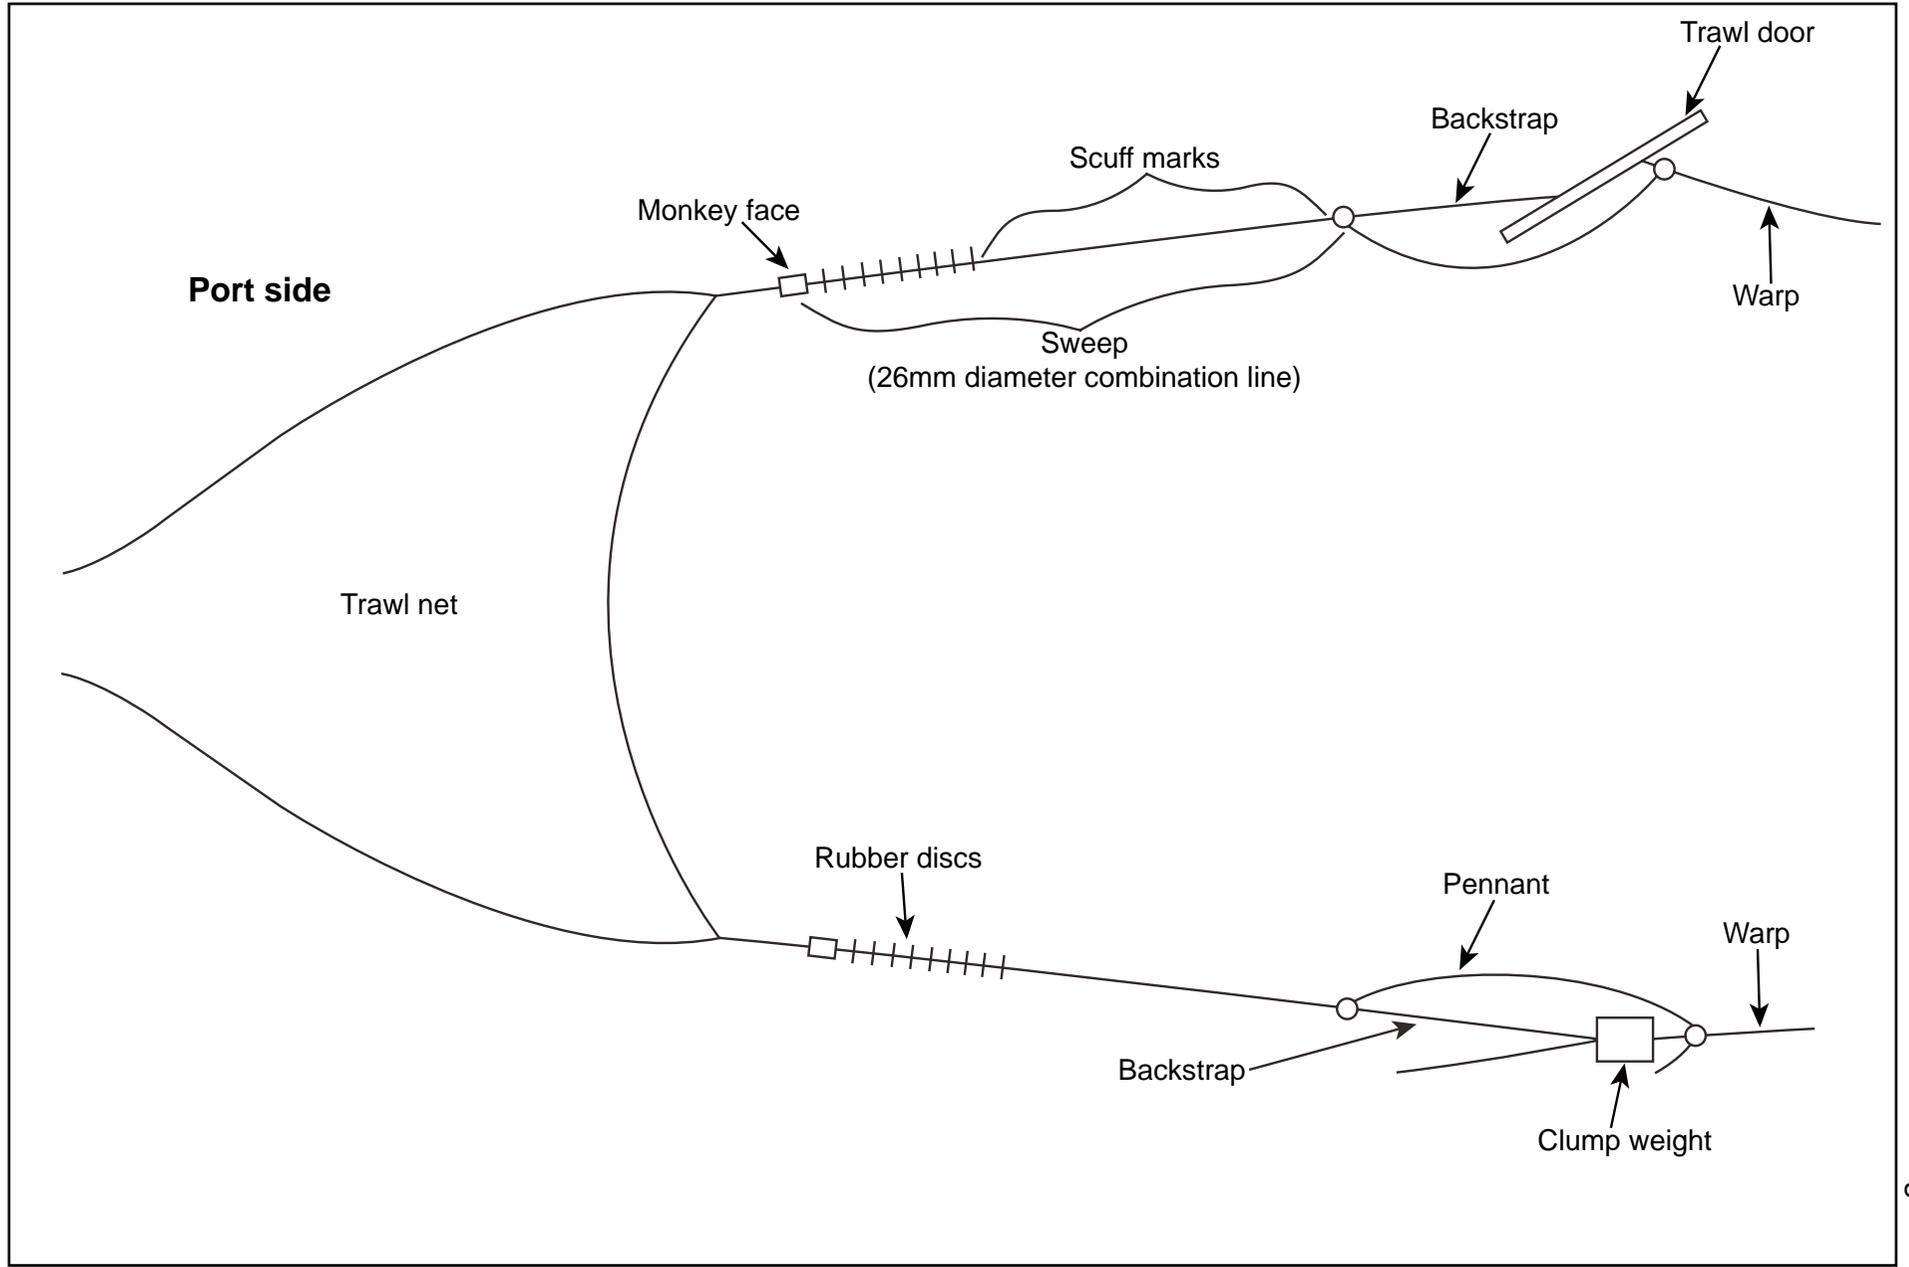
Diagram of the port half of the fishing gear

The port sweep of the port net (**Figure 9**) had scuff marks on it, indicating that it had been caught on the fastener. The scuff marks covered most of the sweep where no rubber discs were fitted. Because *Vertrauen* was making some way when the gear became snagged, the fastener was probably a heavy weight which was being dragged along the seabed.
