Report on the investigation of the loss of

Constant Faith

on 30 June 2001

**Report No 21/2002
June 2002**

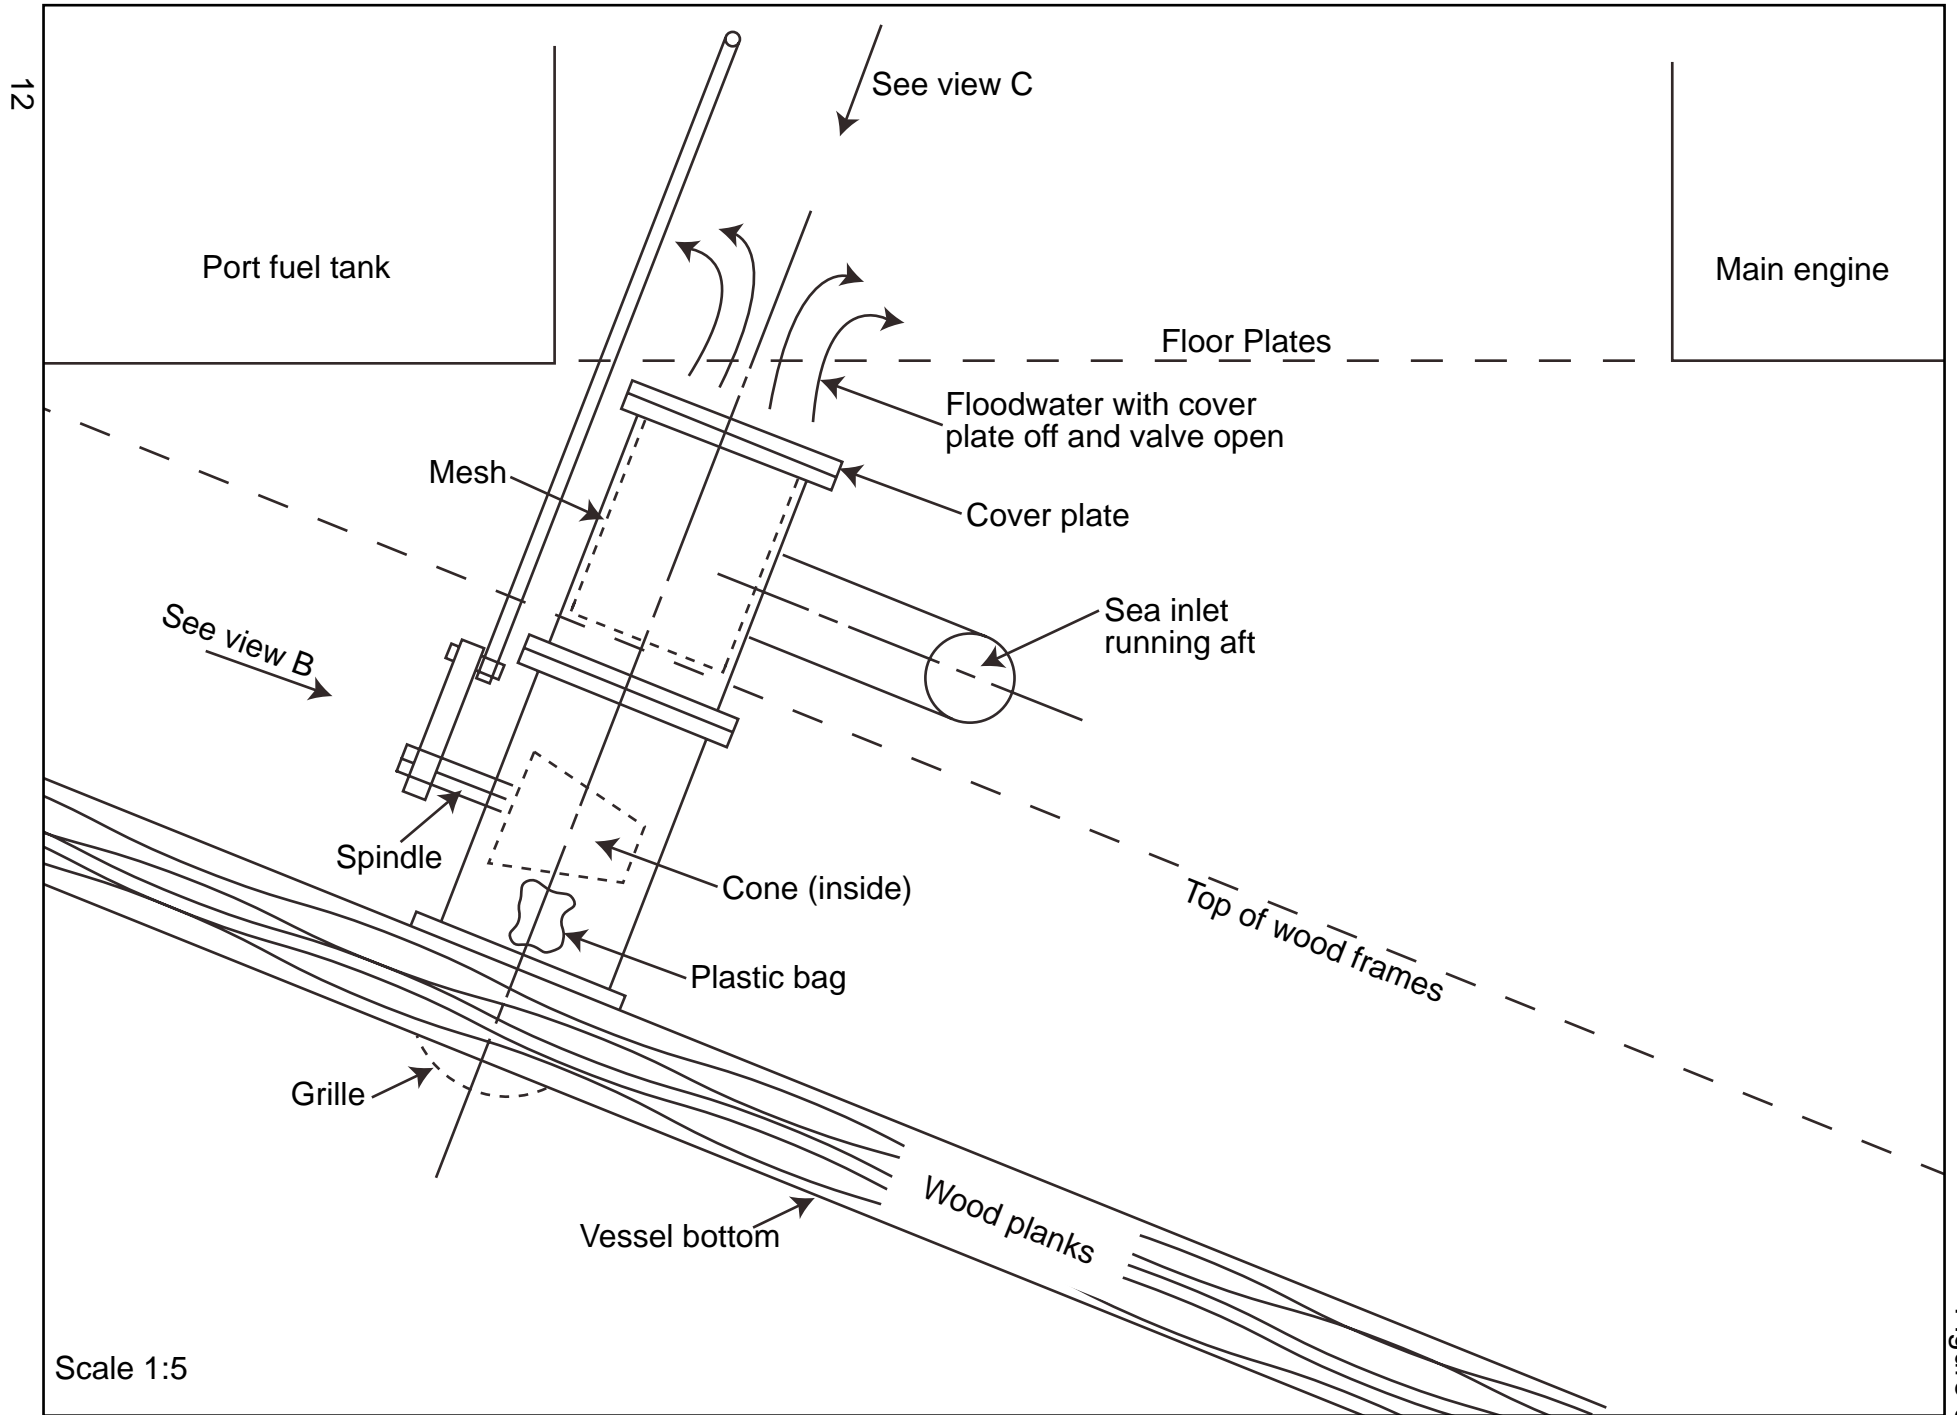
Figure 6

Drawings of the seacock, through which the flooding occurred, are shown in **Figures 6, 7 and 8**. They are based on sketches made by the mate, and were necessary because no other record of the valve existed. A section through the

port side of the engine room looking forward at the valve is shown in **Figure 6**. A drawing of the seacock looking inboard can be seen in **Figure 7**. **Figure 8** shows three different views looking down on the valve.

The seacock was a cone cock valve, which is sometimes referred to as a plug valve. The cone had an aperture, which allowed seawater to pass through when in line with the flow. When the cone was turned through 90° the flow was shut off. The cone was attached to a spindle with a square end. A lever fitted on the square end was used to turn the cone. On top of the seacock was a strum box, containing a strainer, which was a wire mesh open topped cylinder. This fitted snugly inside the strum box body. The strainer filtered seawater being fed to the main engine and the gearbox, and was held in place by the cover plate. When the cover plate was removed, the strainer could be extracted for cleaning. The pipe connected to the strum box, which carried the cooling water to the main engine and gearbox, had an internal diameter of 50mm. There was a grille over the sea inlet, consisting of a series of bars, flush with the outside surface of the hull. Although the grille would have prevented some types of debris from entering the seacock, it was not designed to stop a plastic bag from passing through.

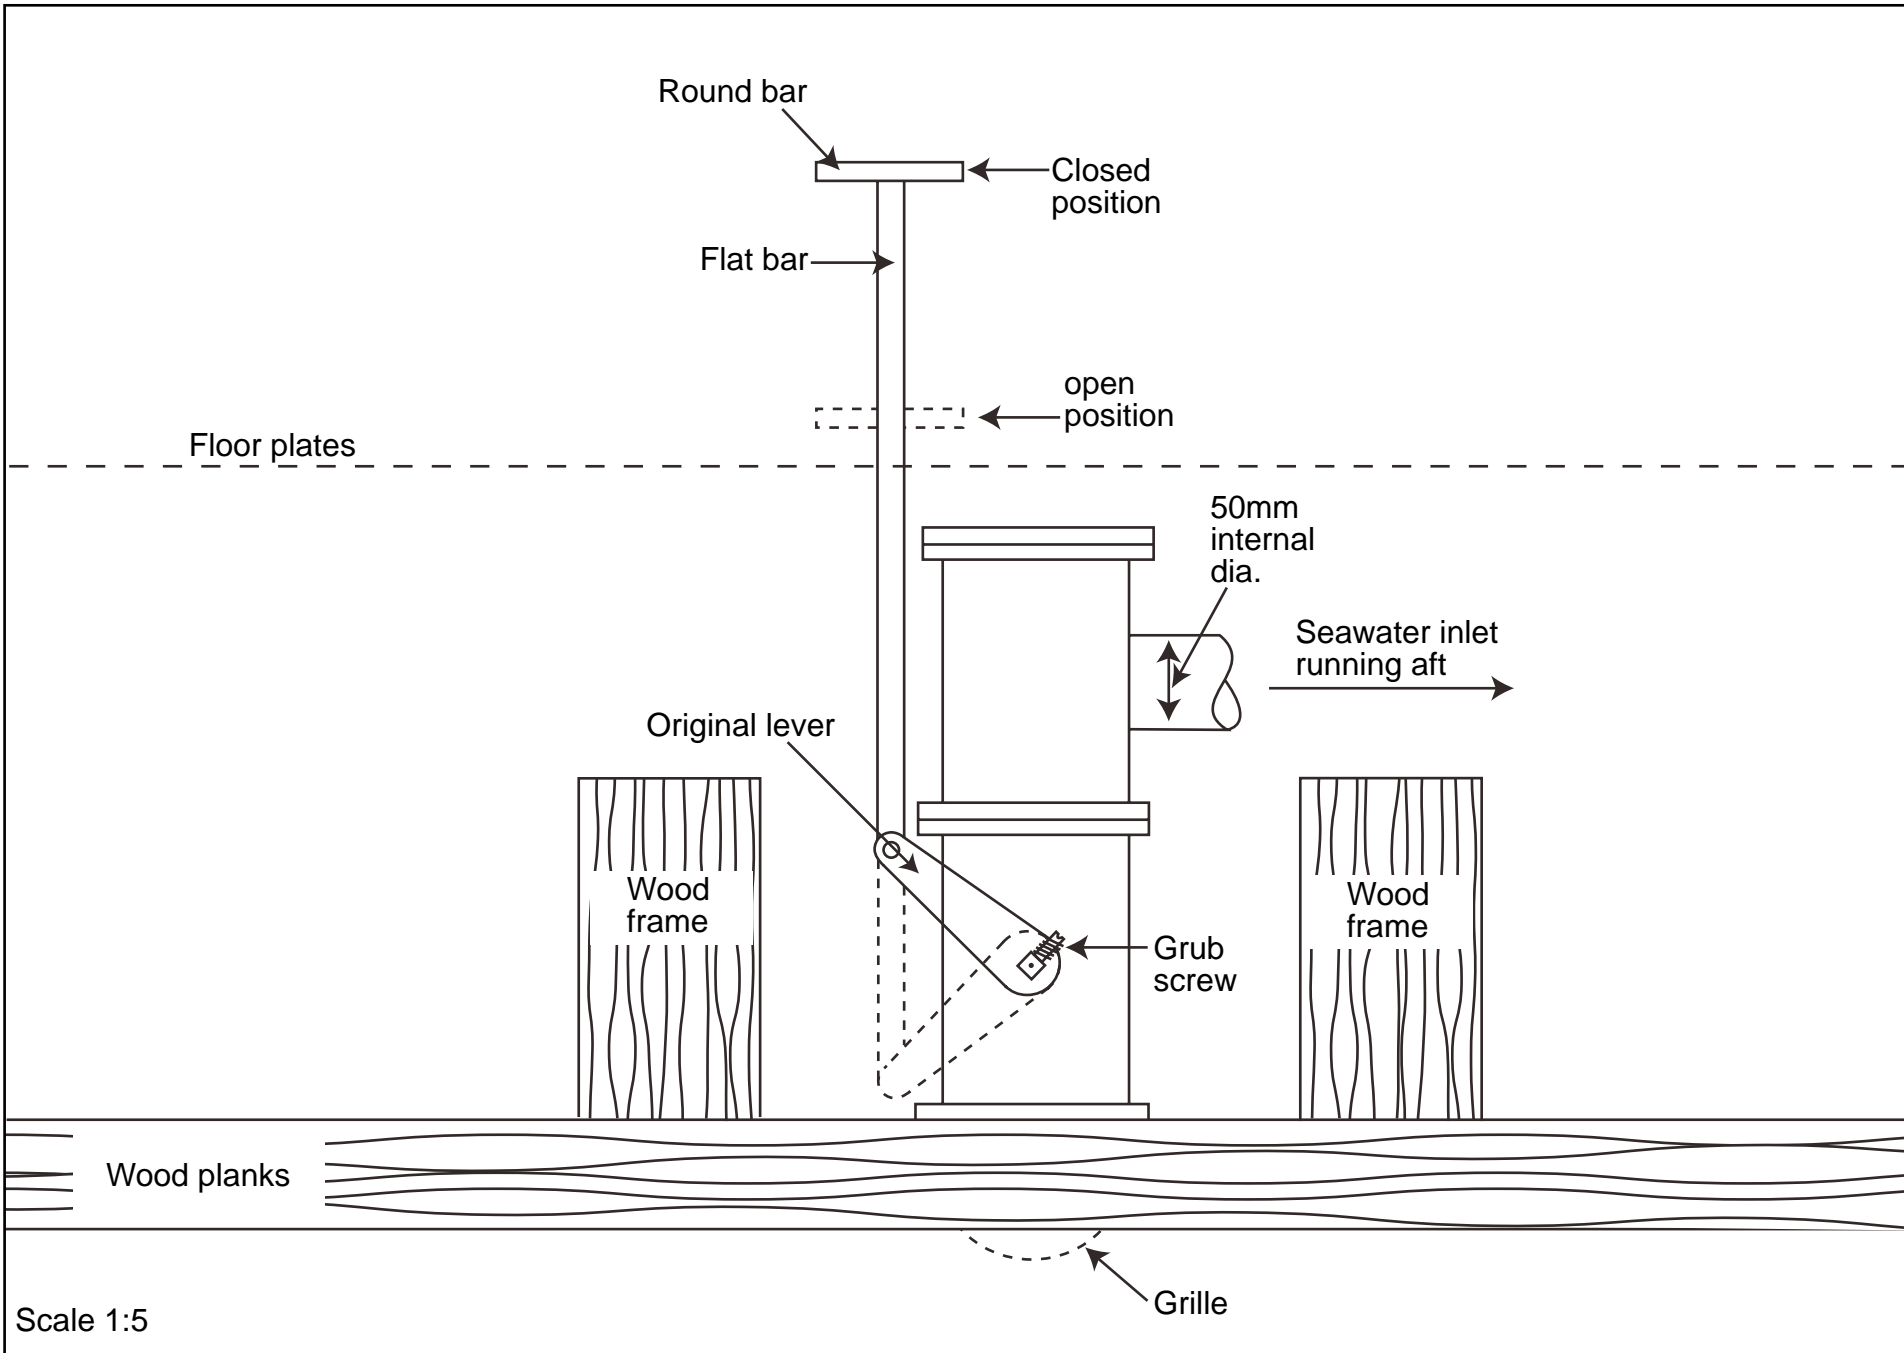
Figure 7

The mate recalls that the original lever was secured to the spindle with a grub screw. He does not know if this grub screw was refitted when the linkage was installed (**Figure 7**). Although the linkage enabled the seacock to be closed without lifting a floor plate, the mate was not entirely happy with the new arrangement. He preferred the old method, as he felt this provided a more positive way of operating the valve.

Fitting a linkage, to enable the seacock to be closed without lifting a floor plate, was a good idea in principle. The grub screw which tightened the lever on to the spindle, was crucial to this arrangement. The absence of this screw in the tightened position was one of the main causes of this accident. A linkage which provides an easier way of opening and closing a seacock is not much good if it falls off when it is needed in an emergency.

The ex-staff member of Richard Irvin Engineering and Fabrication believes that the grub screw was tightened on the valve spindle when the linkage was installed; more than two years before the accident. It is assumed that this screw had loosened, or fallen out, owing to vibration before the flooding which led to *Constant Faith's* loss.

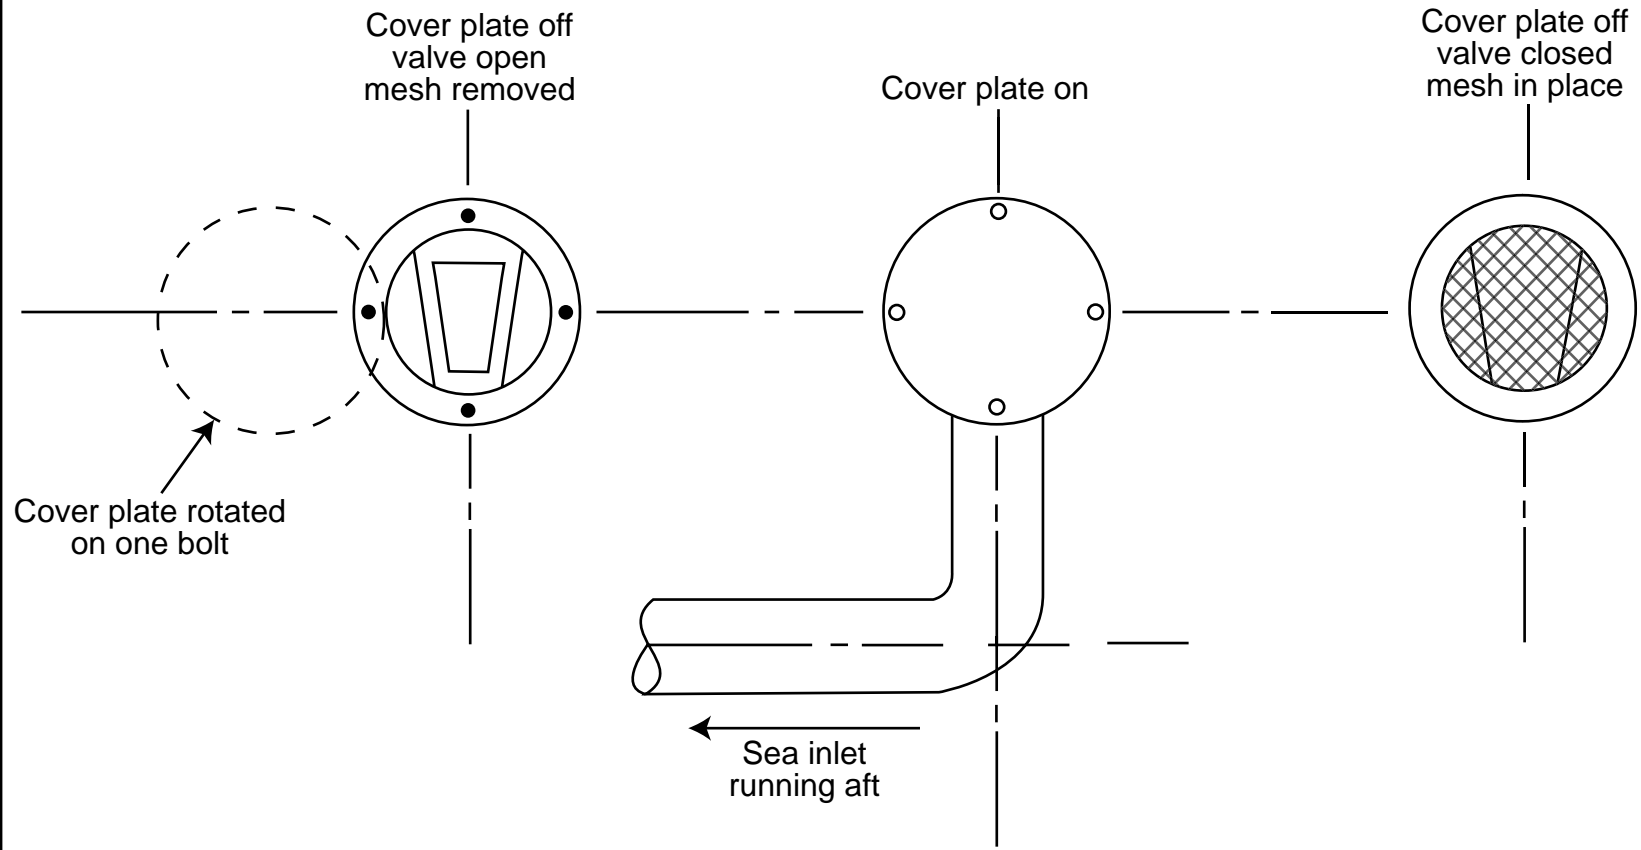
Looking down - View C

When the seacock was opened up, it would have been better to have left one loosened bolt in place, and then swivel the plate to one side around that bolt (**Figure 8**). When the plate needed to be refitted to stop the floodwater, it might have been possible to achieve this if one bolt was already in position. The plate could have been twisted back over the opening; the other bolts could then have been inserted and tightened up. However, the mate recalls that in this particular situation there was not enough room to swivel the plate to one side.

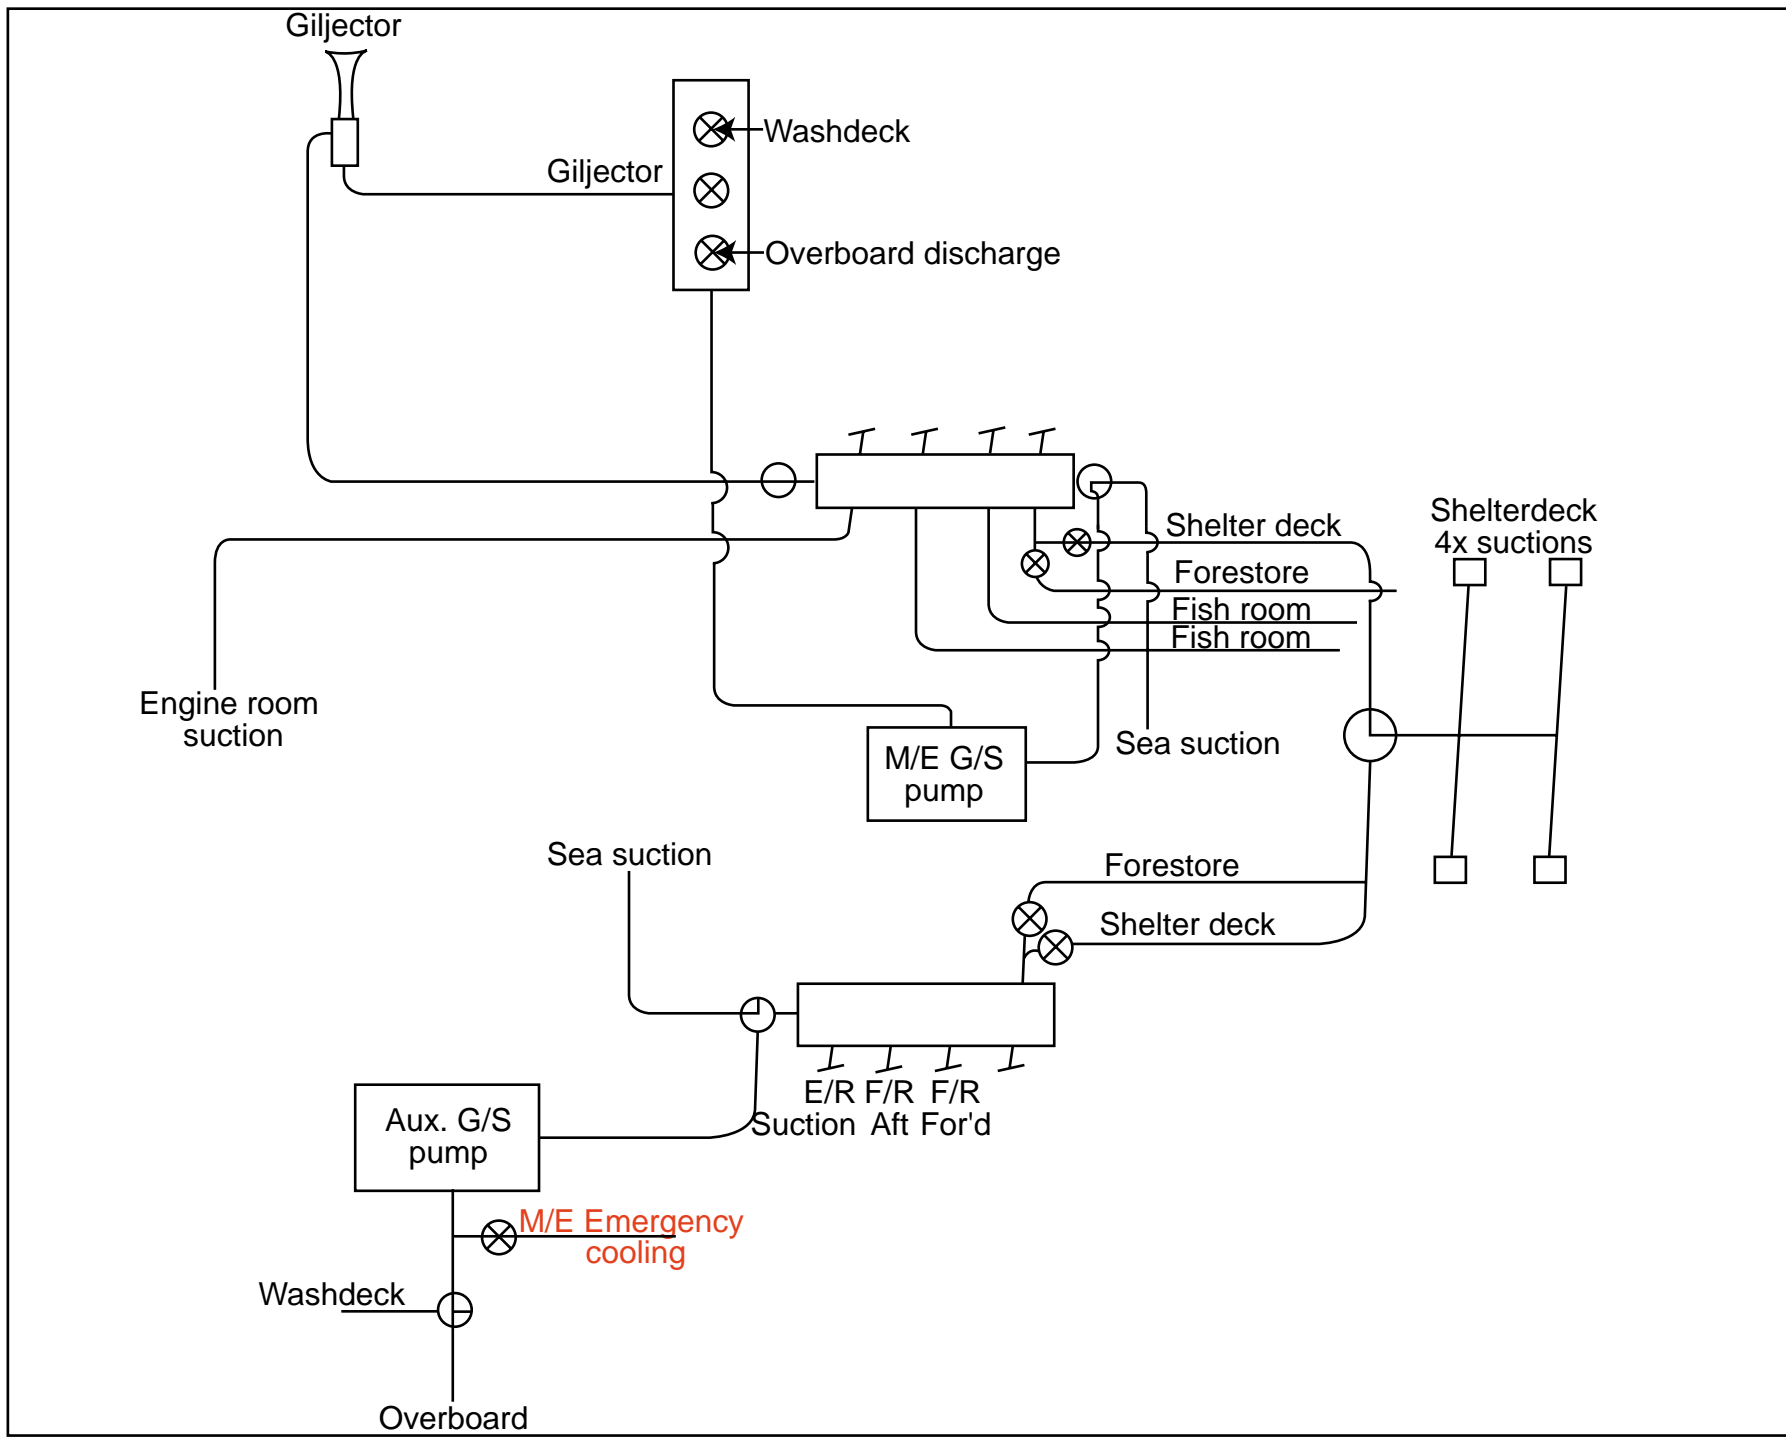
Figure 9

A pipe from the bilge system (**Figure 9**) could feed sea water directly into the main engine water jacket. (Seawater salt deposits can damage an engine if this method of cooling is used long term. It is, however, acceptable in an emergency as an alternative source of engine cooling.) The mate had never used this method of main engine cooling on *Constant Faith*. He knew of the supply pipe, but was unsure how the cooling water would discharge from the main engine once it had circulated around the jacket.

an emergency. The damage the salt would have done to the engine would have been a minor consideration, since the vessel was in danger of being lost. Additionally, this means of engine cooling could have been used to get the vessel back to harbour, if it had been decided to unblock the seacock there.

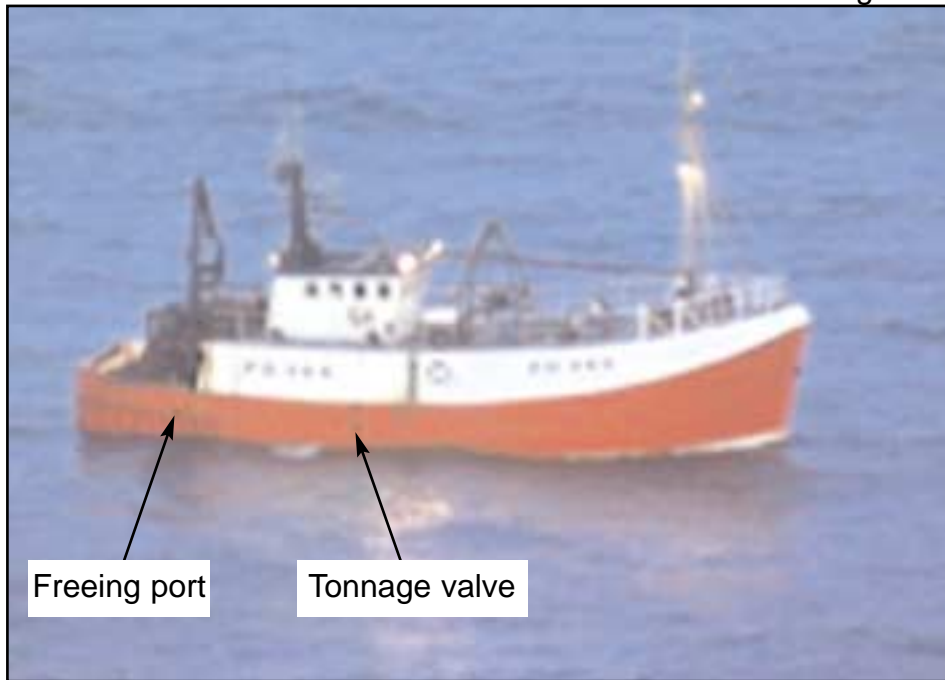
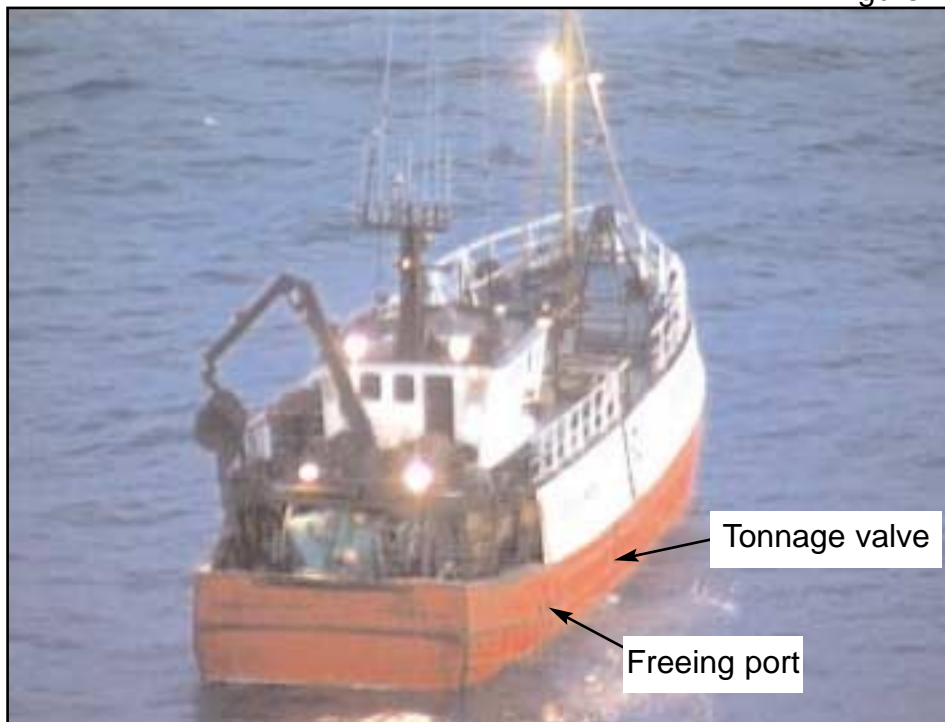
0238. *Constant Faith*, with her skipper and mate still on board, is shown in **Figures 10 and 11**. The tonnage valve and freeing port on the starboard side are above the waterline. **Figures 12 to 14** show *Conquest* manoeuvring in and taking off the skipper and mate. *Conquest* is shown manoeuvring away in **Figure 15**. All the figures show that the sea was fairly calm.

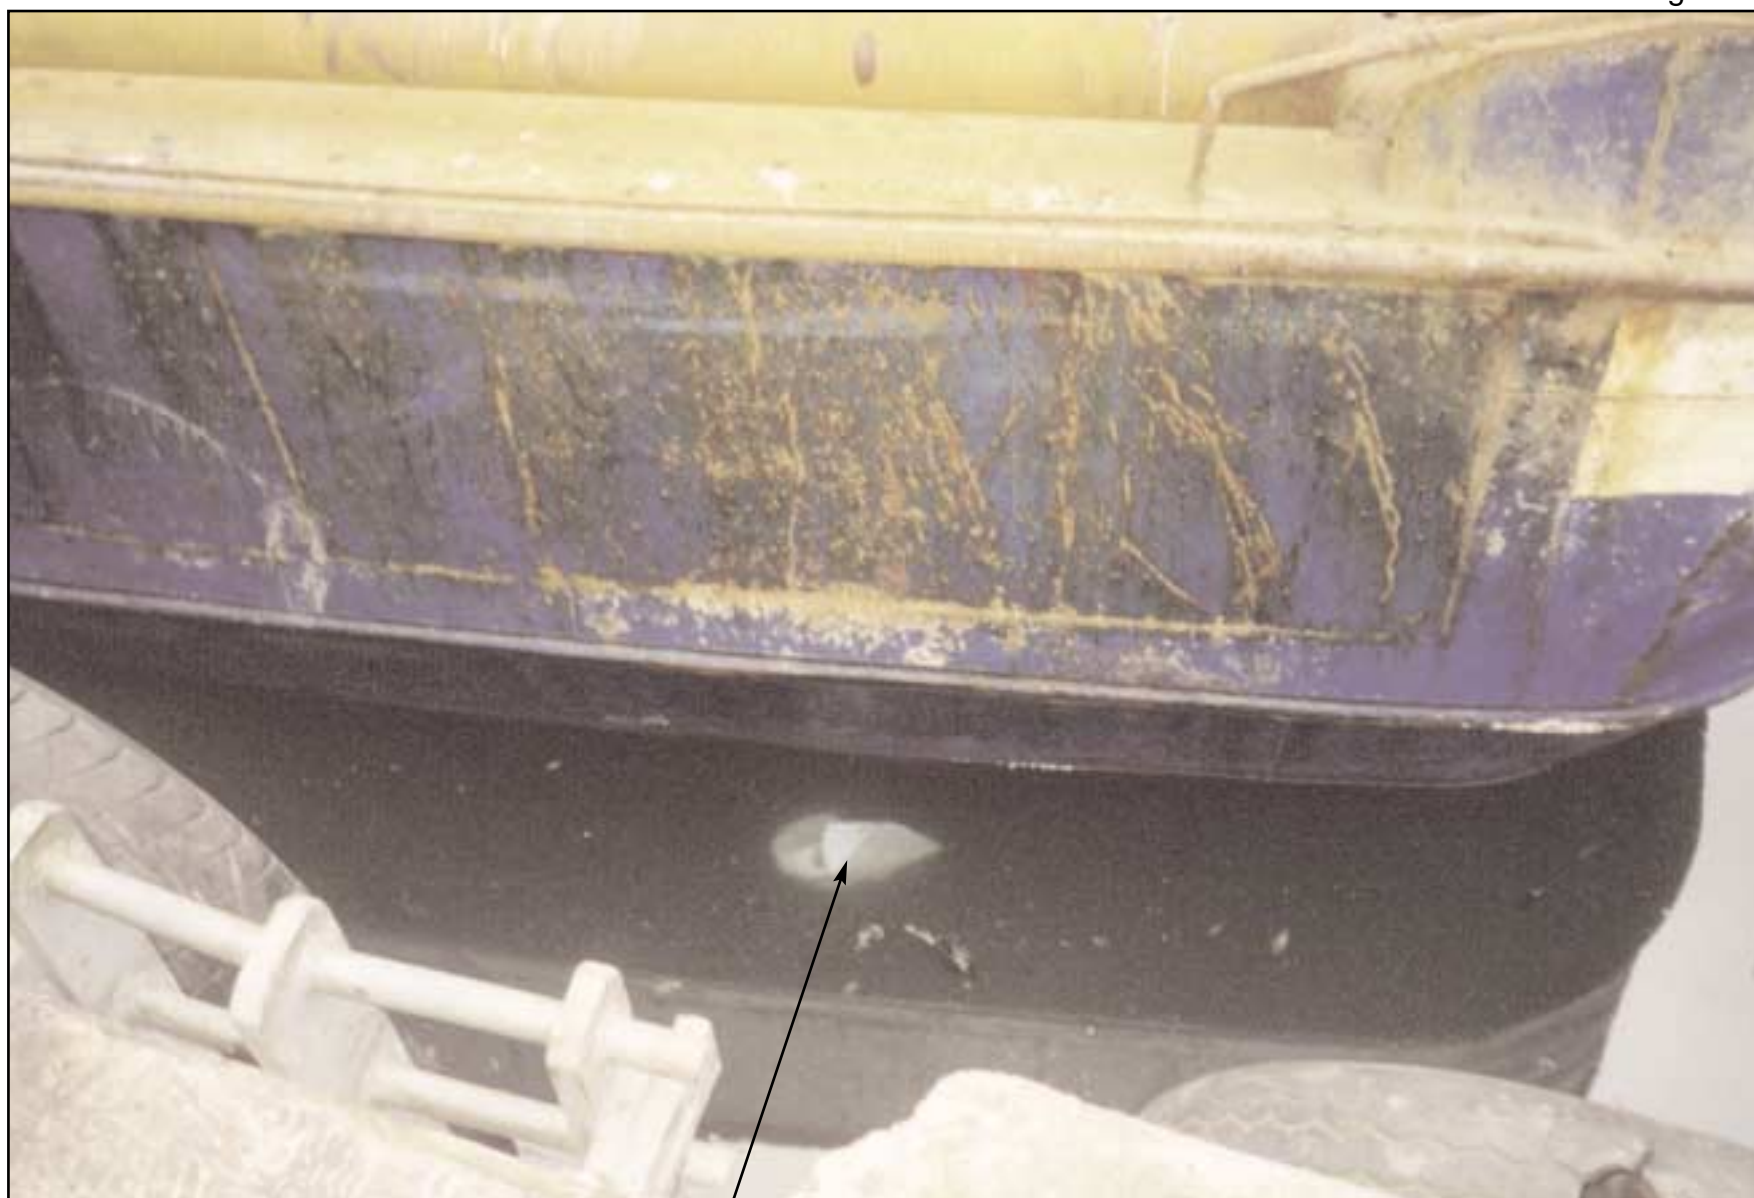
Figure 16

Skips are provided in the fish market for the disposal of fish papers and other debris. Notices are displayed in the market to remind users of this. At sea, fish are stowed in fish boxes. Plastic or paper sheets (known as fish papers), are laid on top of the full boxes and then ice is shovelled on top to keep the catch fresh. When the fish boxes are taken to market, the ice is disposed of by pulling away the fish papers, to reveal the fish to potential buyers. The fish papers sometimes blow about in the market and then end up in the water. A plastic fish paper floating in Peterhead harbour is shown in **(Figure 16)**. Such an item could easily be sucked into a sea water inlet of the vessel shown in the picture. Plastic fish papers are a similar hazard to the plastic bags; it was a plastic bag which was sucked into *Constant Faith's* seacock.
