Report on the investigation of the loss of

Constant Faith

on 30 June 2001

**Report No 21/2002
June 2002**

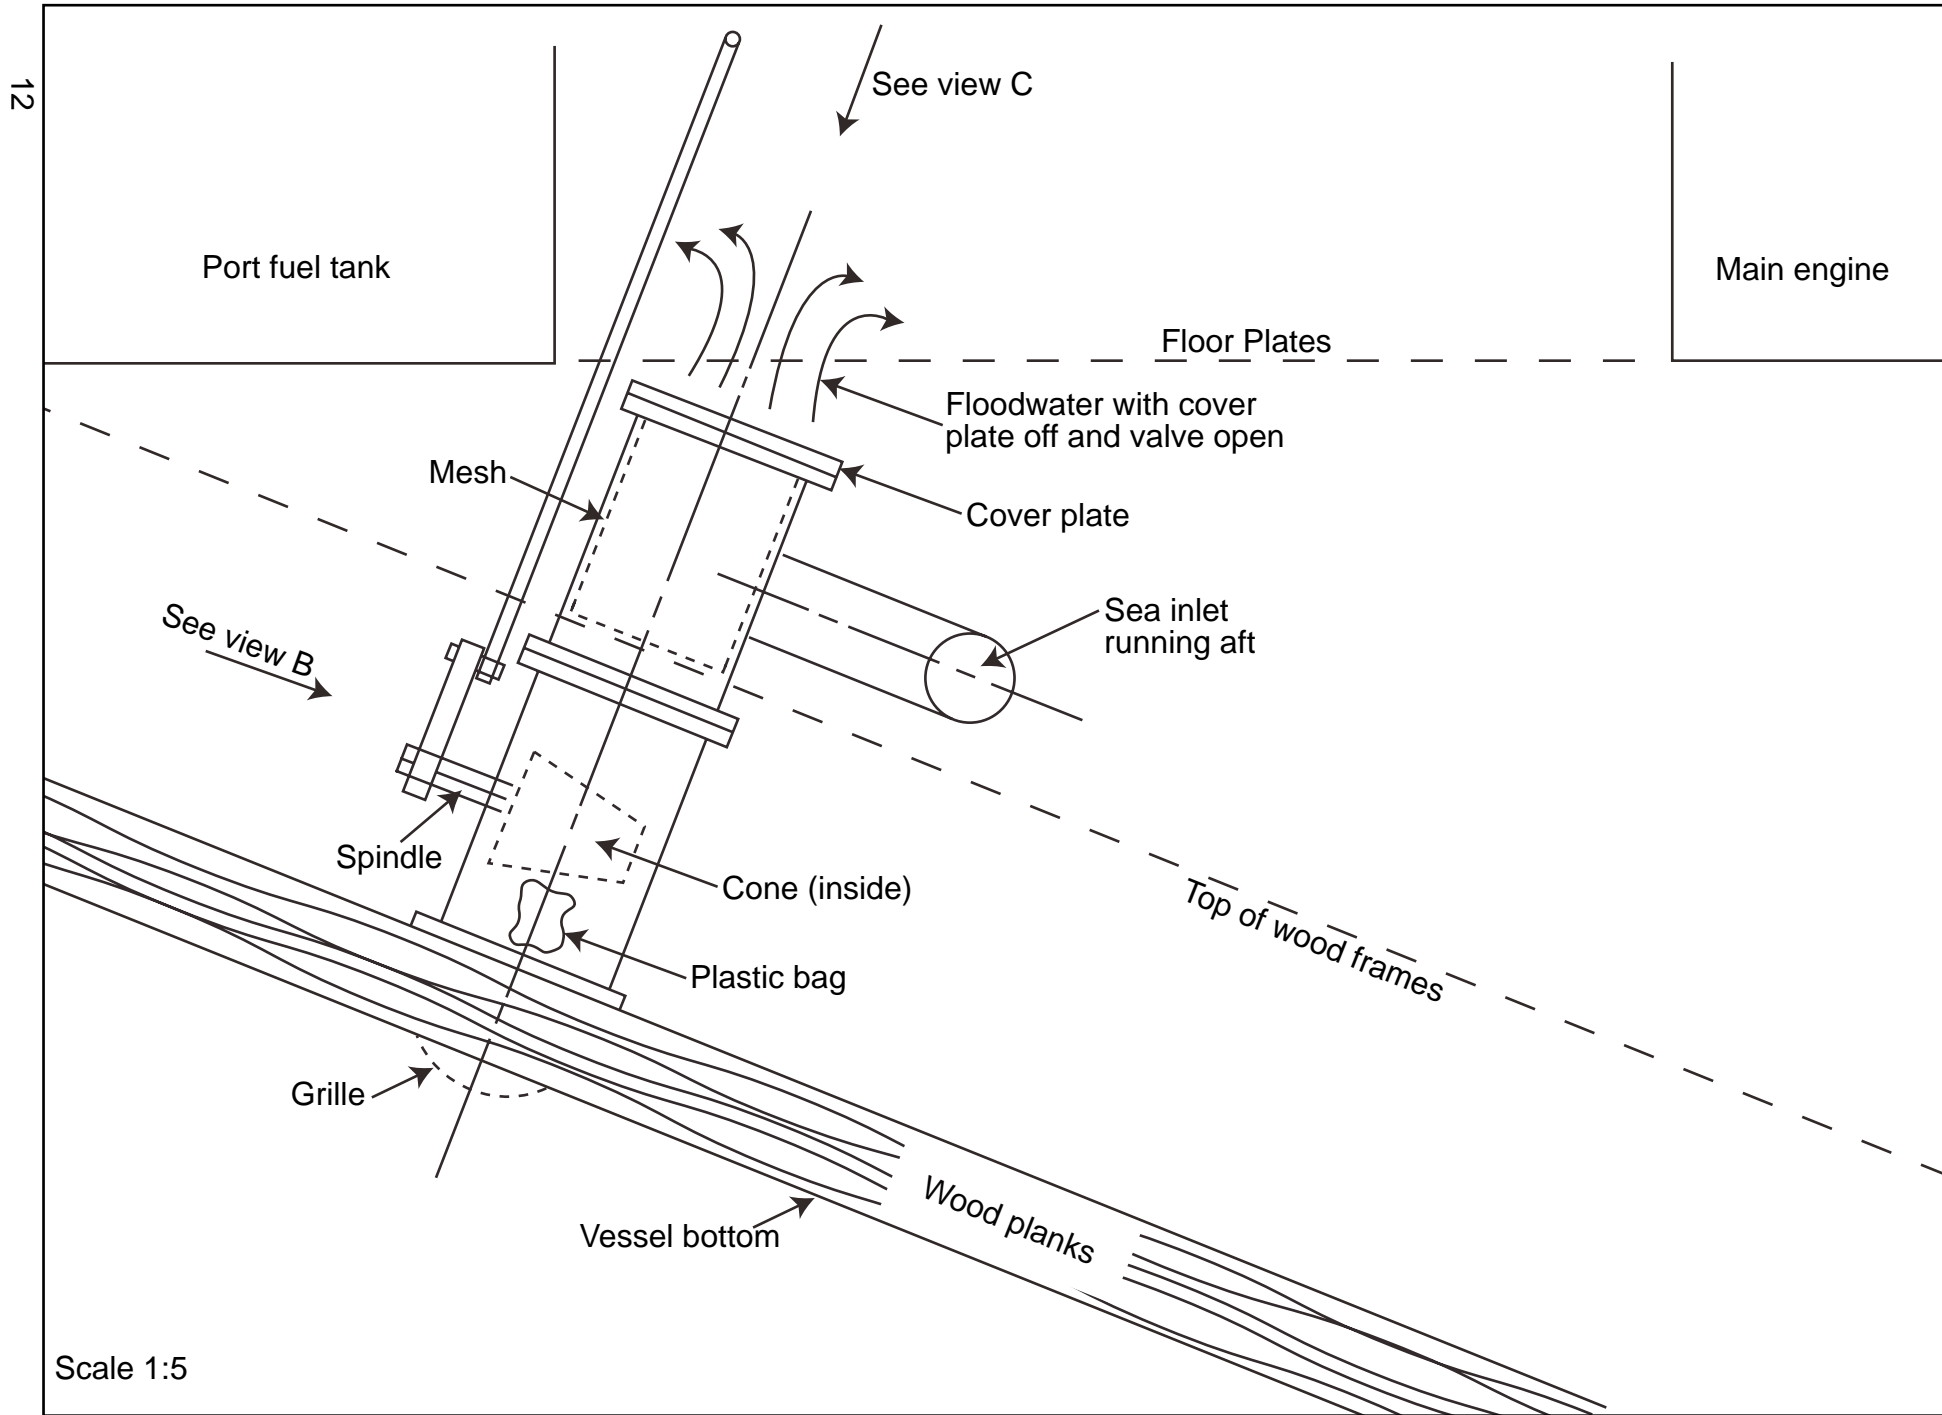
Figure 6

Drawings of the seacock, through which the flooding occurred, are shown in **Figures 6, 7 and 8**. They are based on sketches made by the mate, and were necessary because no other record of the valve existed. A section through the

port side of the engine room looking forward at the valve is shown in **Figure 6**. A drawing of the seacock looking inboard can be seen in **Figure 7**. **Figure 8** shows three different views looking down on the valve.

The seacock was a cone cock valve, which is sometimes referred to as a plug valve. The cone had an aperture, which allowed seawater to pass through when in line with the flow. When the cone was turned through 90° the flow was shut off. The cone was attached to a spindle with a square end. A lever fitted on the square end was used to turn the cone. On top of the seacock was a strum box, containing a strainer, which was a wire mesh open topped cylinder. This fitted snugly inside the strum box body. The strainer filtered seawater being fed to the main engine and the gearbox, and was held in place by the cover plate. When the cover plate was removed, the strainer could be extracted for cleaning. The pipe connected to the strum box, which carried the cooling water to the main engine and gearbox, had an internal diameter of 50mm. There was a grille over the sea inlet, consisting of a series of bars, flush with the outside surface of the hull. Although the grille would have prevented some types of debris from entering the seacock, it was not designed to stop a plastic bag from passing through.

Originally the seacock was closed by lifting a floor plate, reaching down into the bilges, and operating the lever. At the request of an MCA surveyor, a linkage was fitted to enable the valve to be closed from above the floor plates. Richard Irvin Engineering and Fabrication fitted the linkage in February 1998. The linkage made use of the original lever; a length of flat bar was bolted to the lever, and at the top of the flat bar a short length of round bar was welded on. The skipper recalls the MCA surveyor checking the operation of the linkage after it was fitted, but the surveyor does not remember. (MCA surveyors see many valves on many fishing vessels).

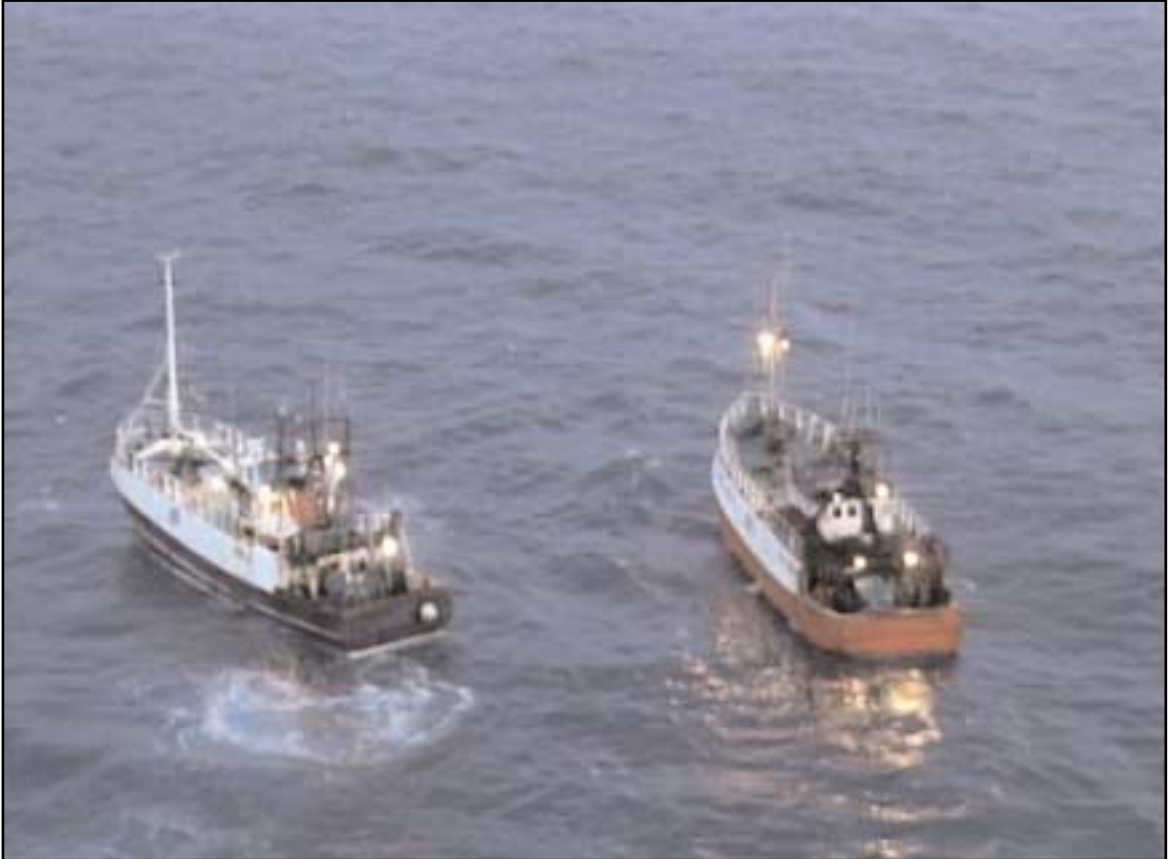
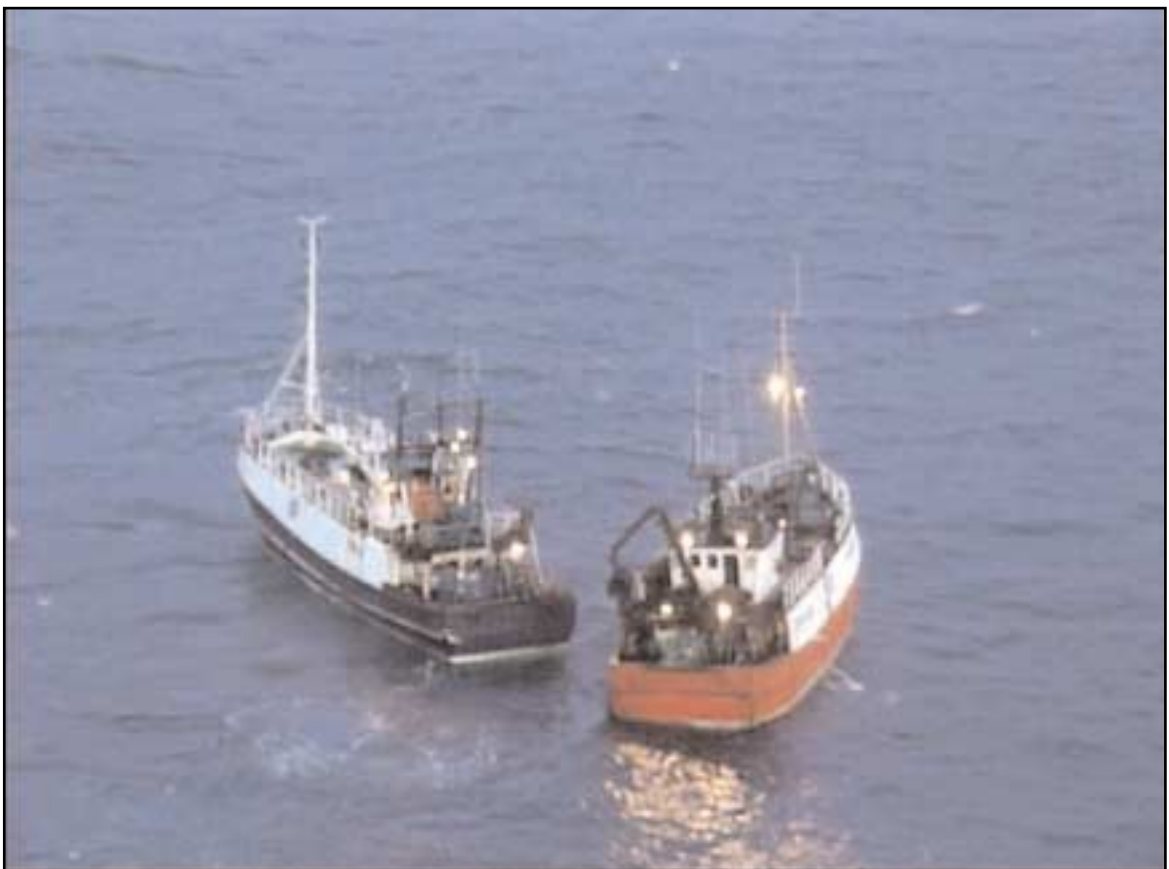
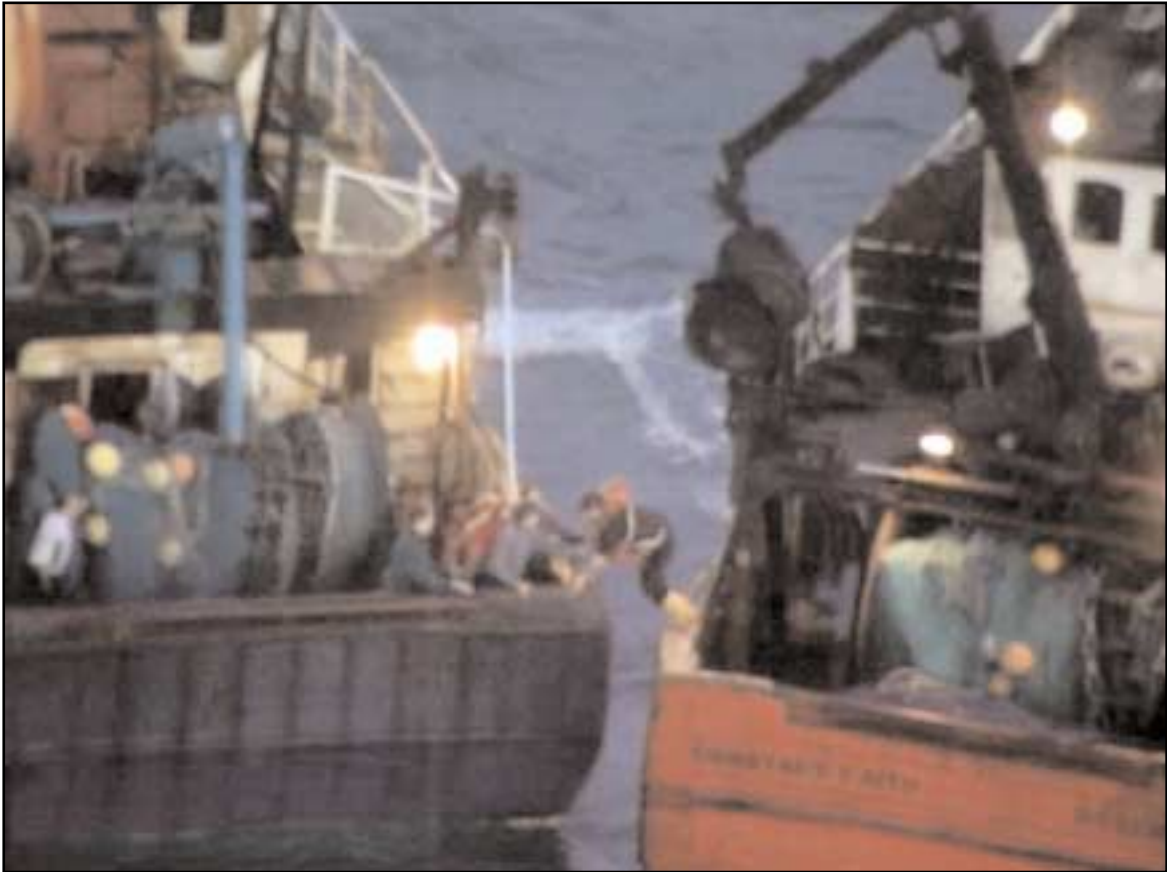
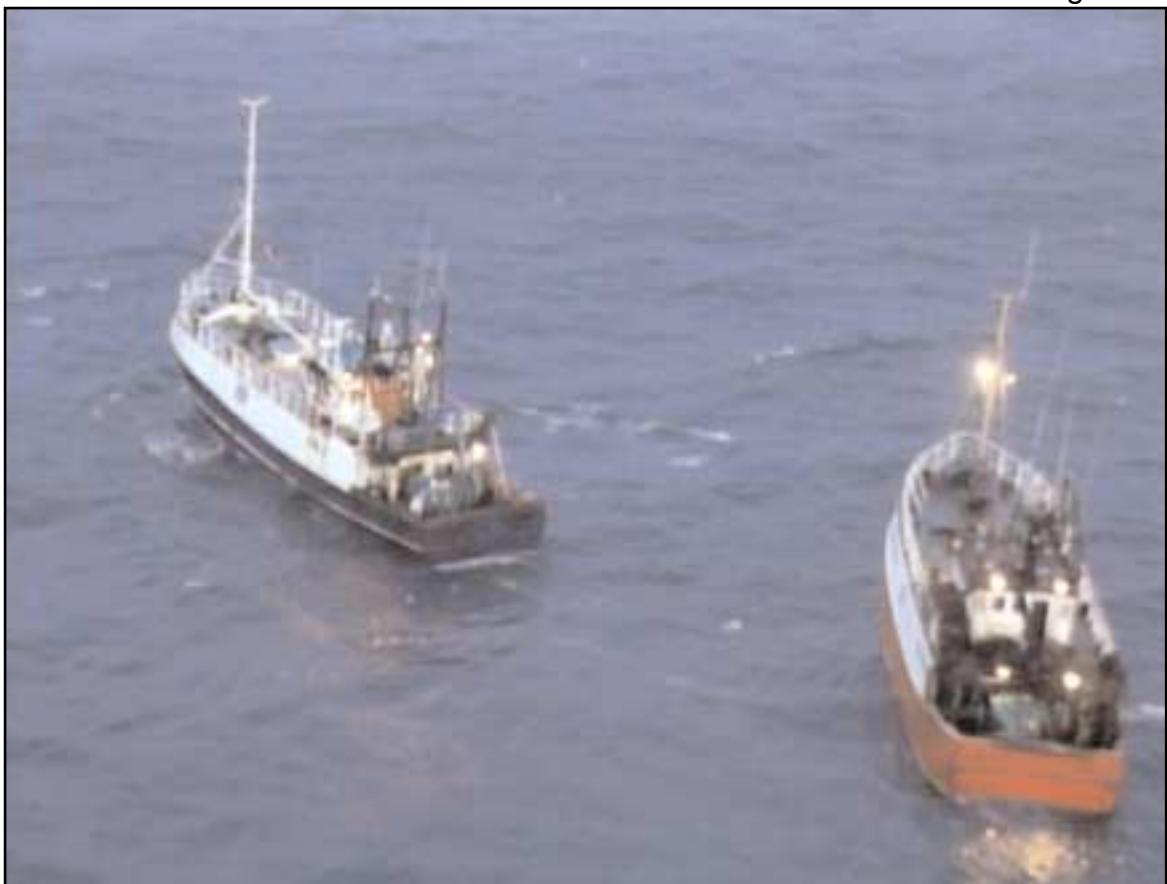
The coastguard helicopter was fitted with a video camera. Still frames taken from the video are shown in **Figures 10 to 15**. They are in chronological order. All the video footage was taken after the winchman returned to the helicopter at

0238. *Constant Faith*, with her skipper and mate still on board, is shown in **Figures 10 and 11**. The tonnage valve and freeing port on the starboard side are above the waterline. **Figures 12 to 14** show *Conquest* manoeuvring in and taking off the skipper and mate. *Conquest* is shown manoeuvring away in **Figure 15**. All the figures show that the sea was fairly calm.

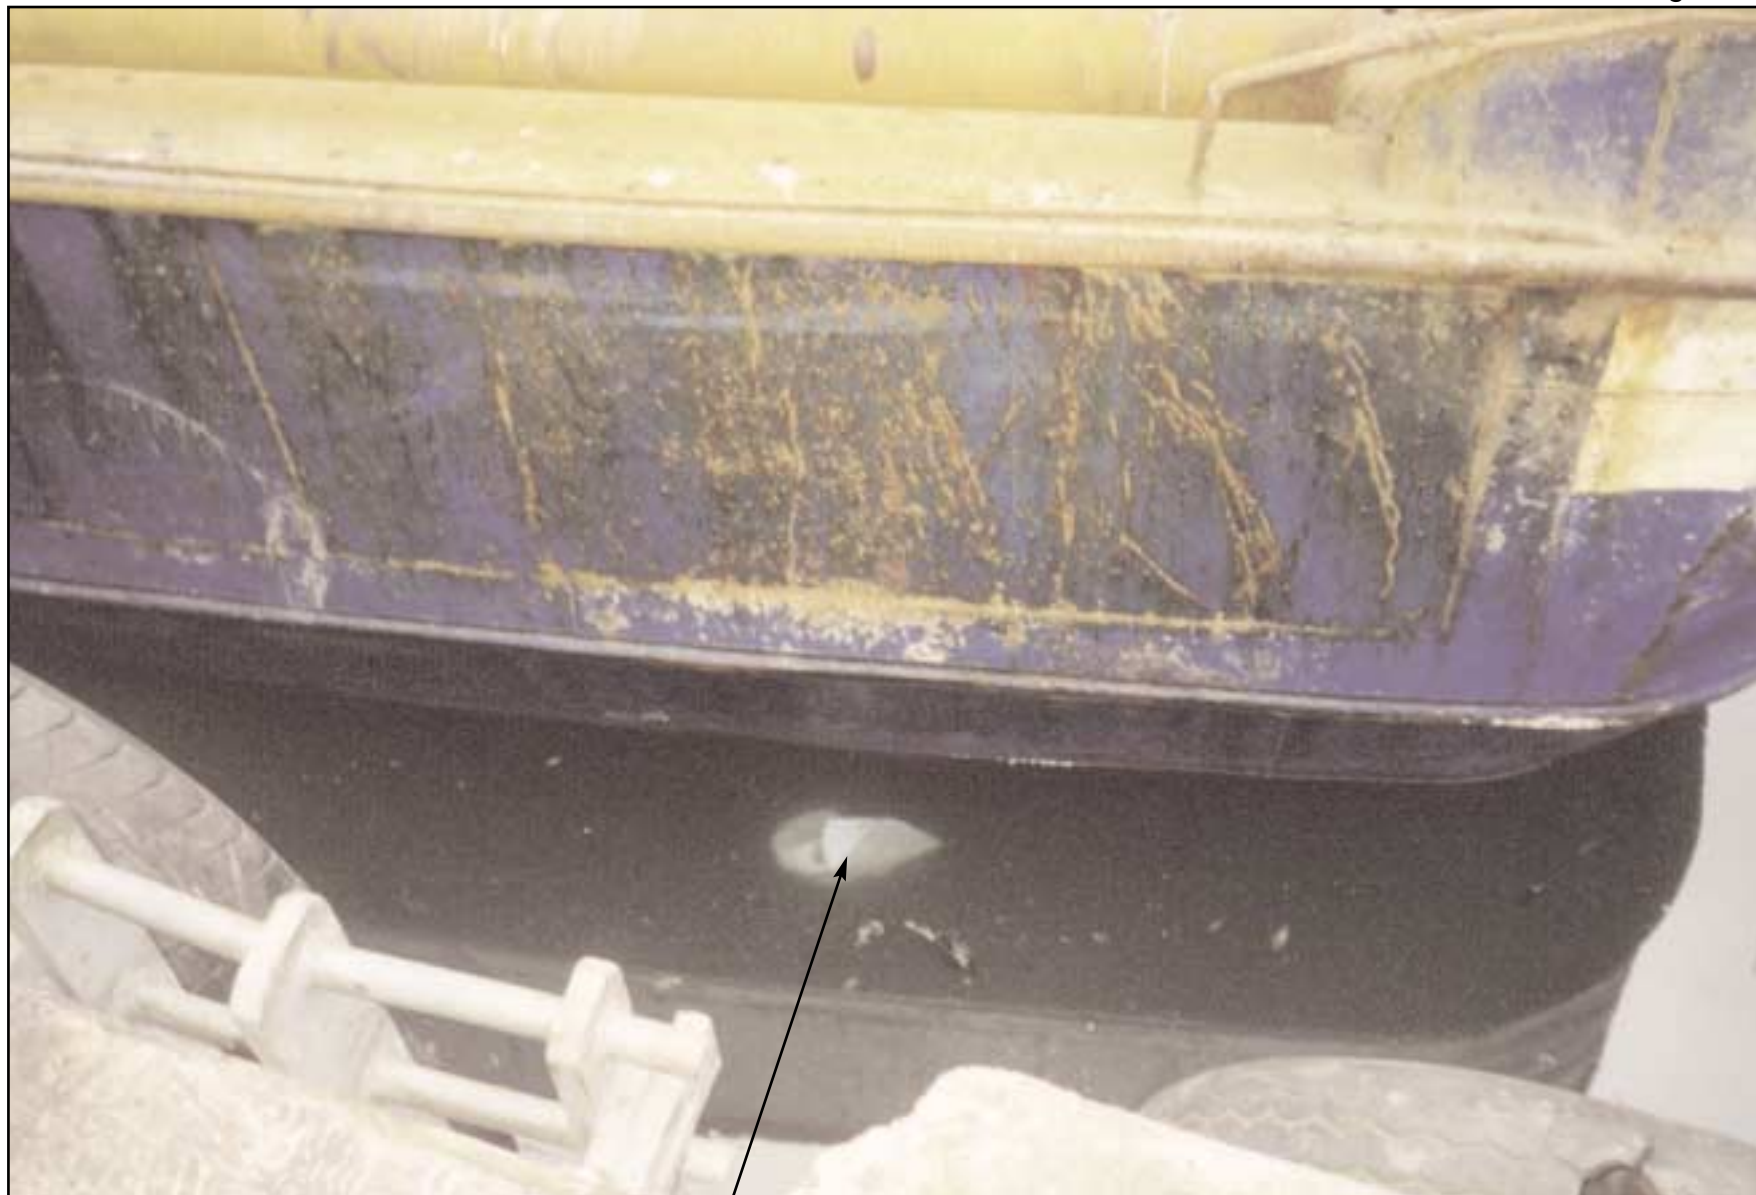
Figure 16

Skips are provided in the fish market for the disposal of fish papers and other debris. Notices are displayed in the market to remind users of this. At sea, fish are stowed in fish boxes. Plastic or paper sheets (known as fish papers), are laid on top of the full boxes and then ice is shovelled on top to keep the catch fresh. When the fish boxes are taken to market, the ice is disposed of by pulling away the fish papers, to reveal the fish to potential buyers. The fish papers sometimes blow about in the market and then end up in the water. A plastic fish paper floating in Peterhead harbour is shown in **(Figure 16)**. Such an item could easily be sucked into a sea water inlet of the vessel shown in the picture. Plastic fish papers are a similar hazard to the plastic bags; it was a plastic bag which was sucked into *Constant Faith's* seacock.

Plastic fish paper
