Report on the investigation of  
the near miss incident between  
***Mathilda and Lady Hamilton of Helford***  
7 miles east-south-east of Lizard Point, Cornwall  
on  
28 June 2001

**Report No 11/2002  
March 2002**

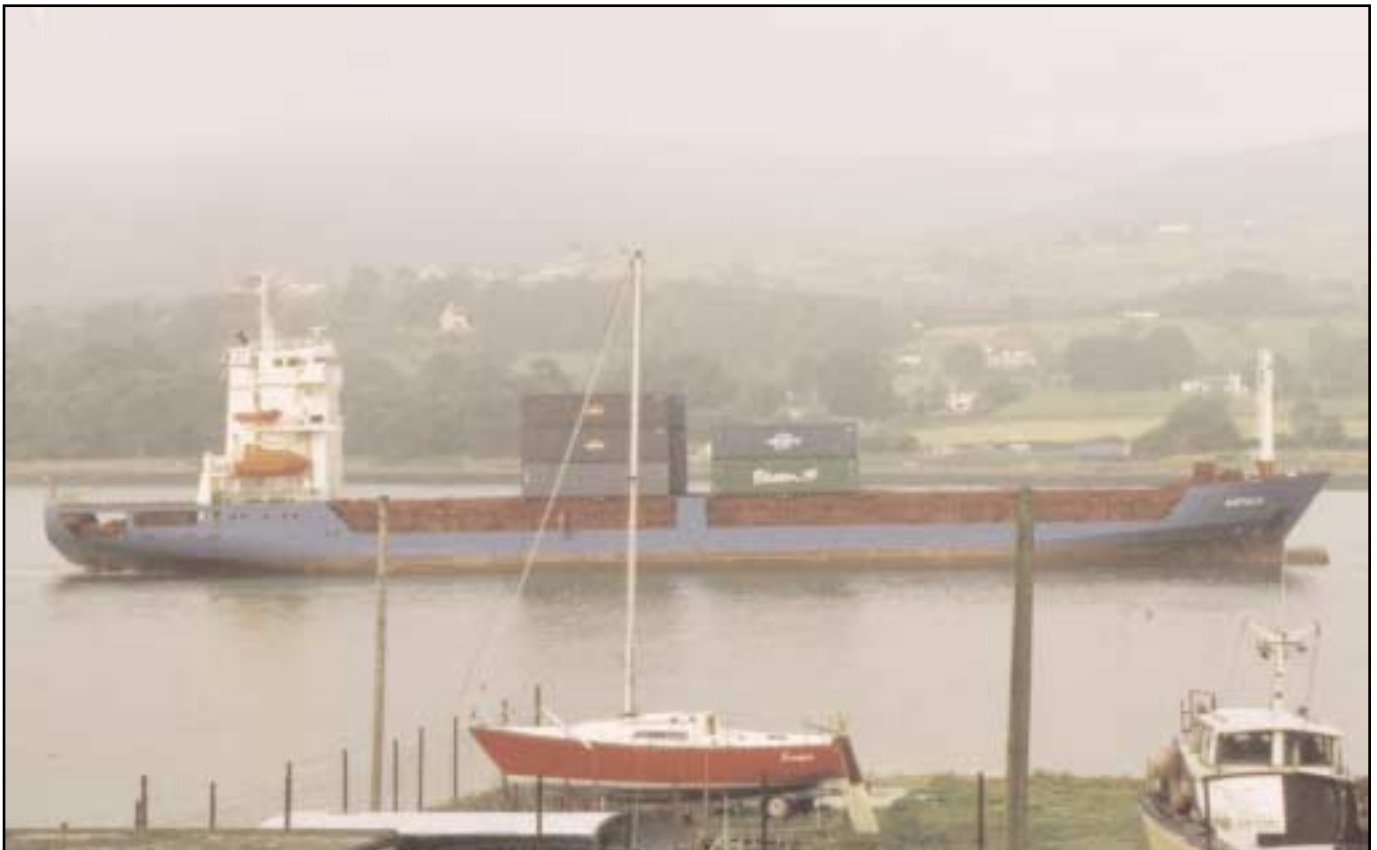
Figure 1

*Mathilda*, built of steel in 1994 as a general cargo vessel, was capable of carrying 448 teu containers. The vessel had one deck above the waterline and two cargo holds. The accommodation and engine room were situated aft (**Figure 1**).

*Mathilda*

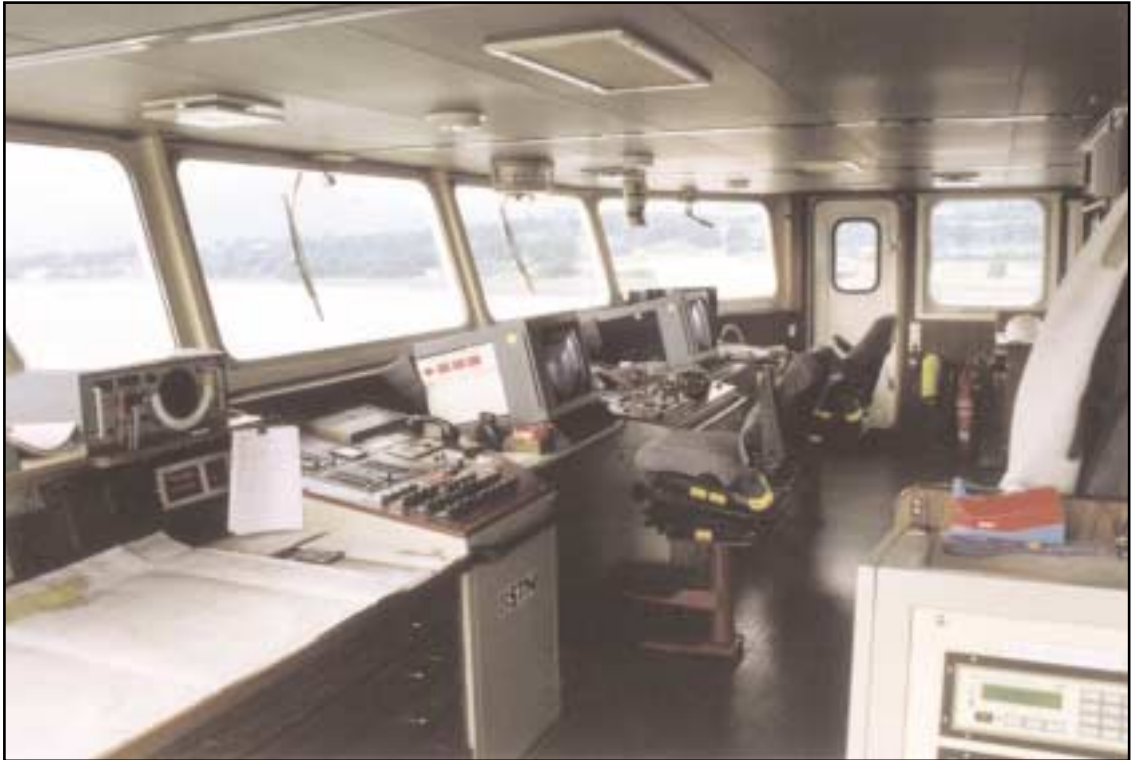
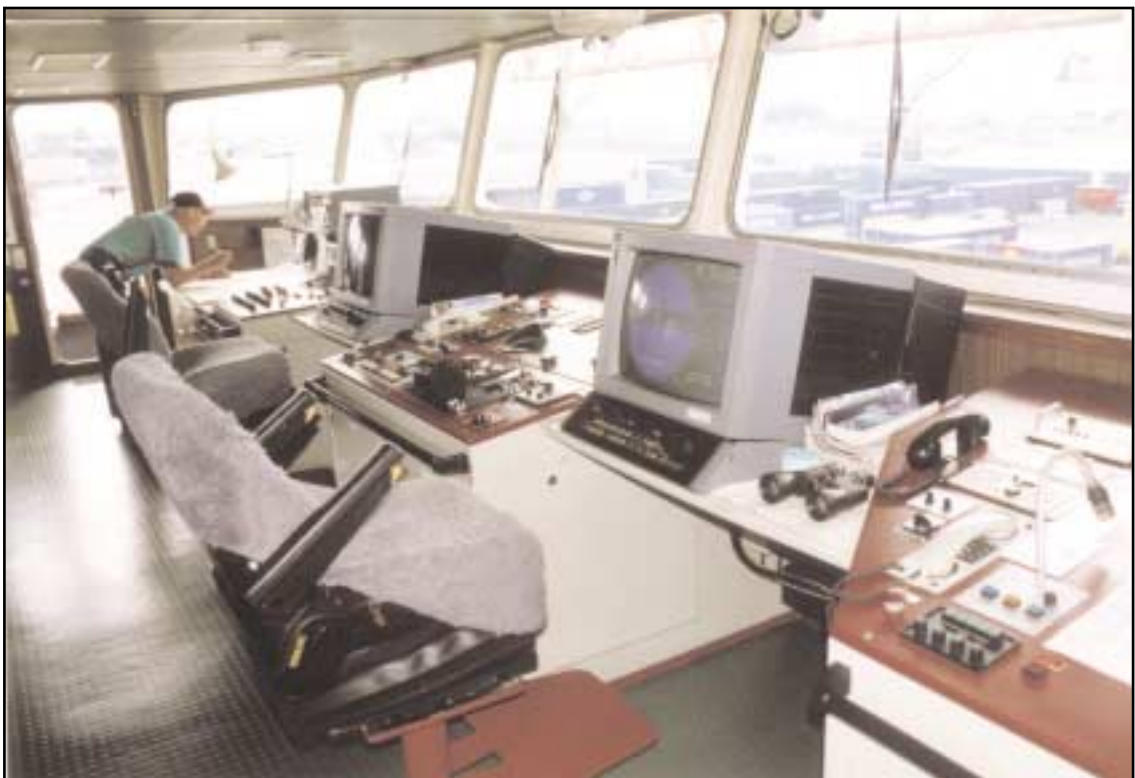
Figure 2

Most of the navigational equipment was strategically housed in an operating console positioned centrally forward on the bridge. In the centre of the console were the tiller and main engine controls. On the port side of the console was a chart table. In front of each of the two radars was a chair (**Figure 2**).

*Mathilda* - bridge

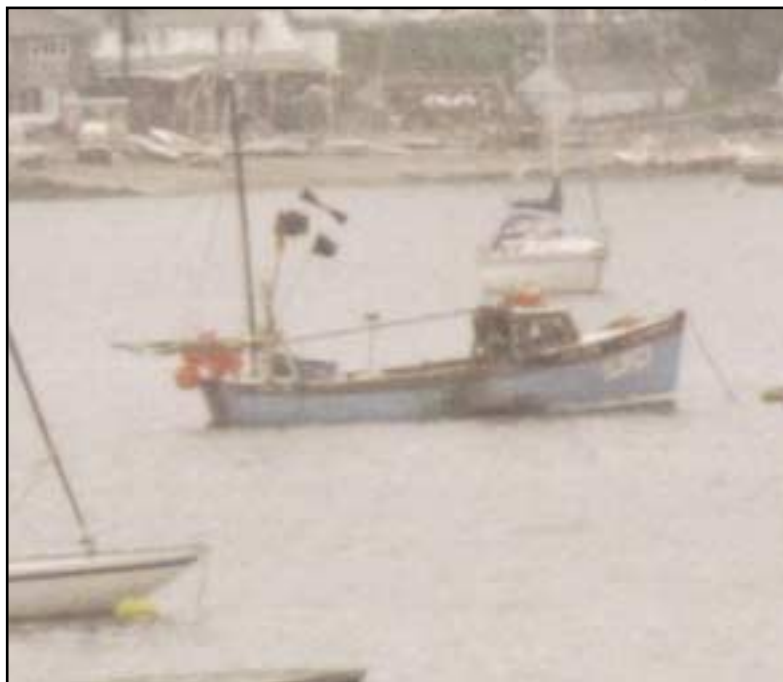
Figure 3

*Lady Hamilton of Helford* was built in 1972 at Looe in Cornwall. Constructed of wood, the design incorporated one deck above the waterline. A wheelhouse/whaleback was situated forward, with the working deck aft. A gill net hauler was positioned on the starboard side of the deck forward (**Figure 3**).

*Lady Hamilton of Helford*
