Report on the investigation of
the grounding of
fv Primrose
on the Island of Rhum
on 15 June 2001

Report No 13/2002
April 2002

On 15 June 2001, the MAIB was informed that the stern trawler *Primrose* had grounded on the Isle of Rhum. An investigation started that day.

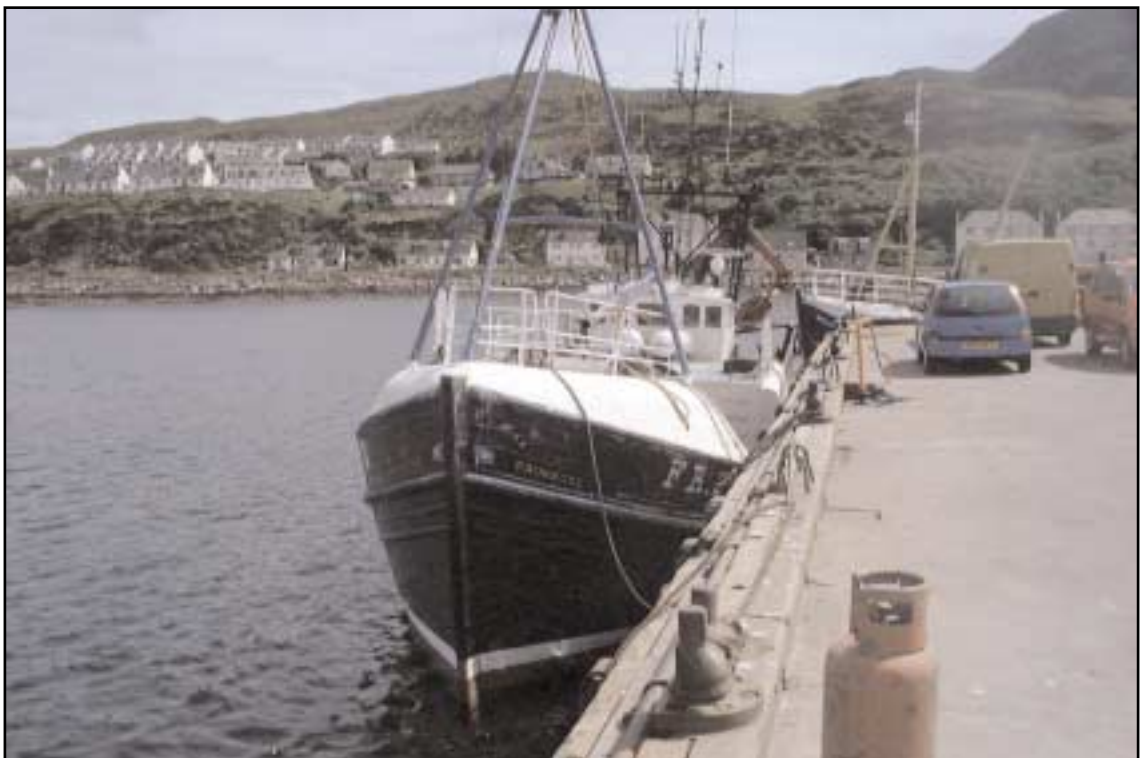
Figure 1

fv *Primrose*

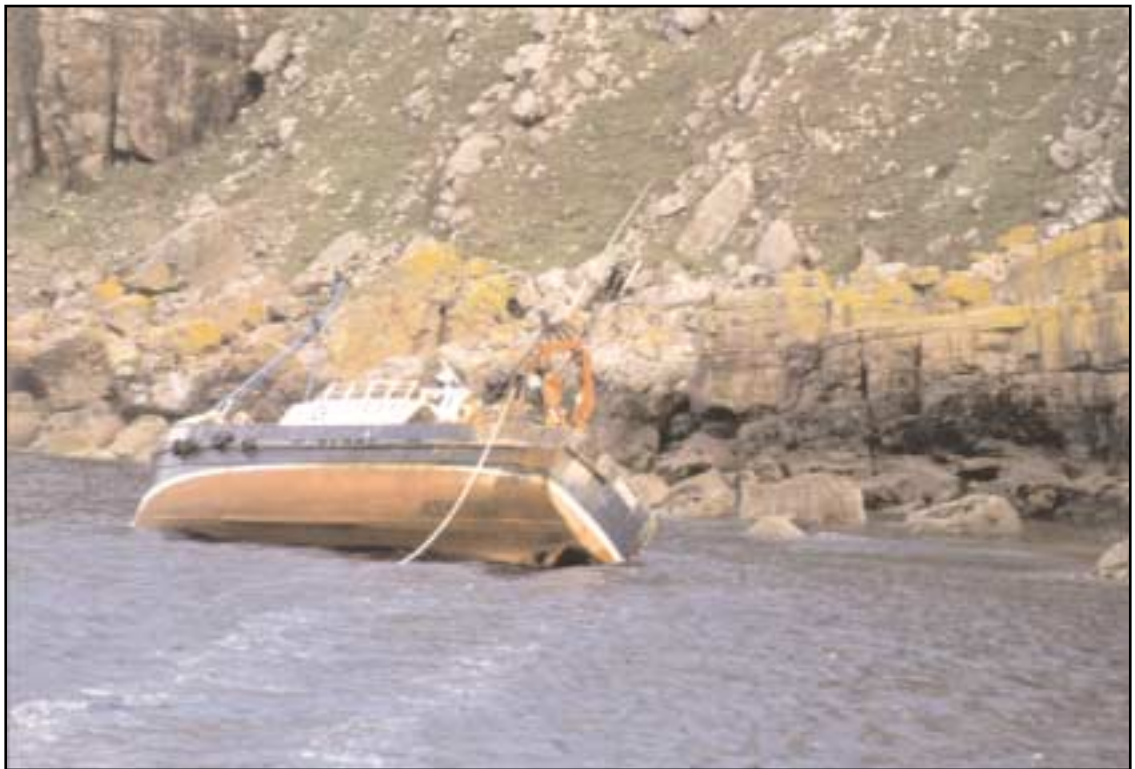
Figure 2

With the tide ebbing and the vessel's position becoming more precarious, the crew were all taken off *Primrose* by the lifeboat. The vessel started to list to starboard on the falling tide. The angle of heel was about 45° at one point, and water began pouring through the forward hatch and accommodation openings. The lifeboat secured a rope and heaved on it to keep the boat close to the upright (**see Figures 2 and 3**).

Primrose aground

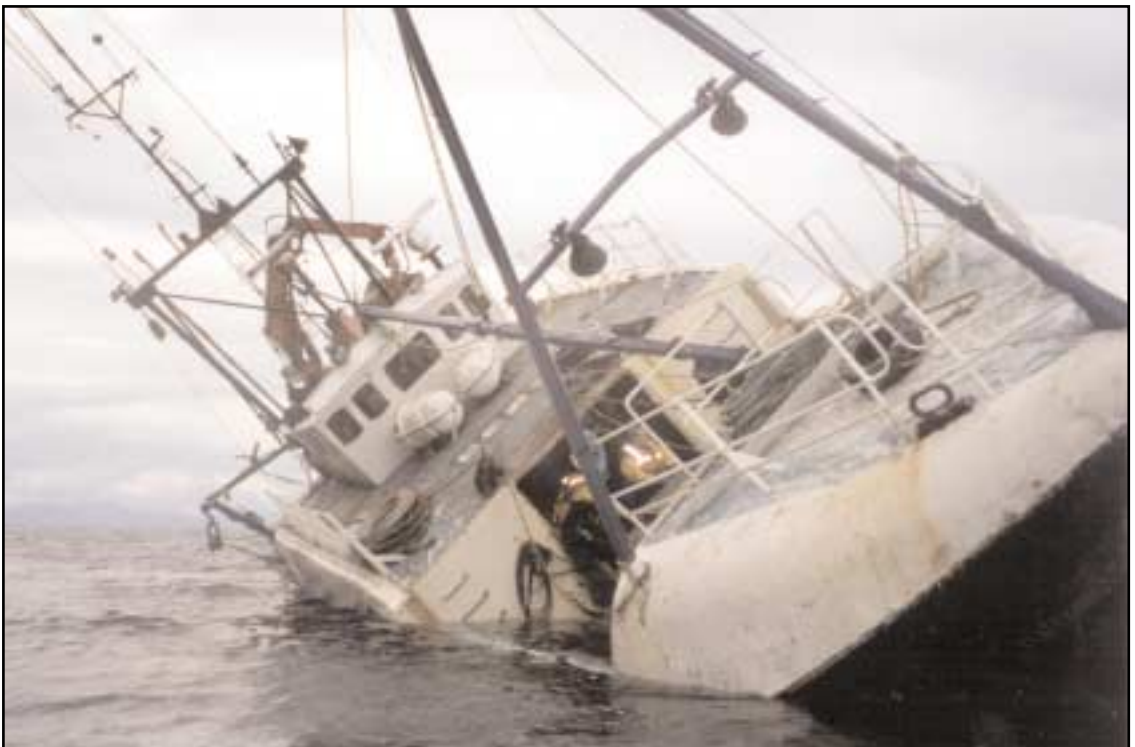
Figure 3

After low water had passed, the vessel started falling over to port on the rising tide. The skipper reboarded her to attempt to restart the engines in preparation for refloating at high water. The boat then started to heel further to port, so the skipper returned to the lifeboat.

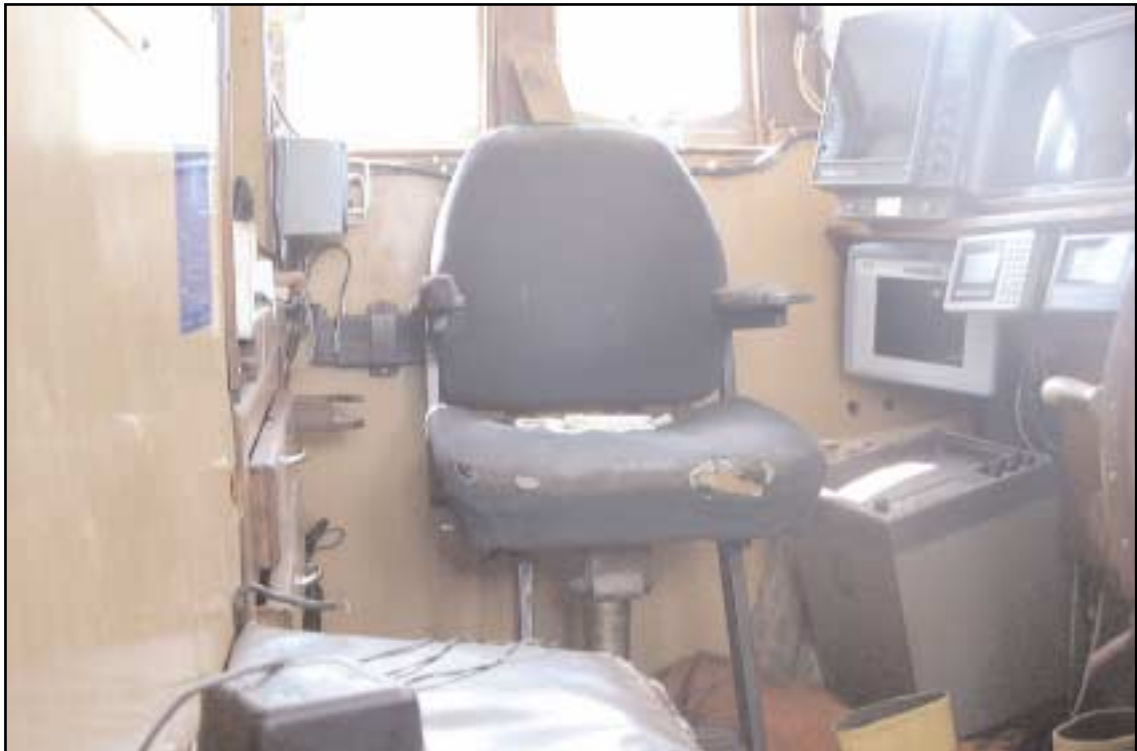
Figure 4

Two seats were fitted in the wheelhouse; one was a stool, the other, on the port side, a chair (**see Figure 4**). There was no external door to the wheelhouse, however, an internal door, on the starboard side, led down to the accommodation.

Wheelhouse chair

He was aware he was tired when he came on watch, and decided to sit down in the wheelhouse chair. He also knew there was no watch alarm. The decision to sit down further exacerbated any tendency for him to fall asleep. Due to the tiredness he was feeling, and the absence of a watch alarm, he should have moved around frequently to remain alert. This would have been in accordance with the advice given in MGN 84 (F).

7. The deckhand chose to sit down on watch, contrary to the advice given in MGN 84 (F), despite his being aware he was tired, and knowing the watch alarm was not fitted. [2.2.2]

8. The temperature was high in the wheelhouse, mainly because of the proximity of the engine exhaust. [2.2.2]

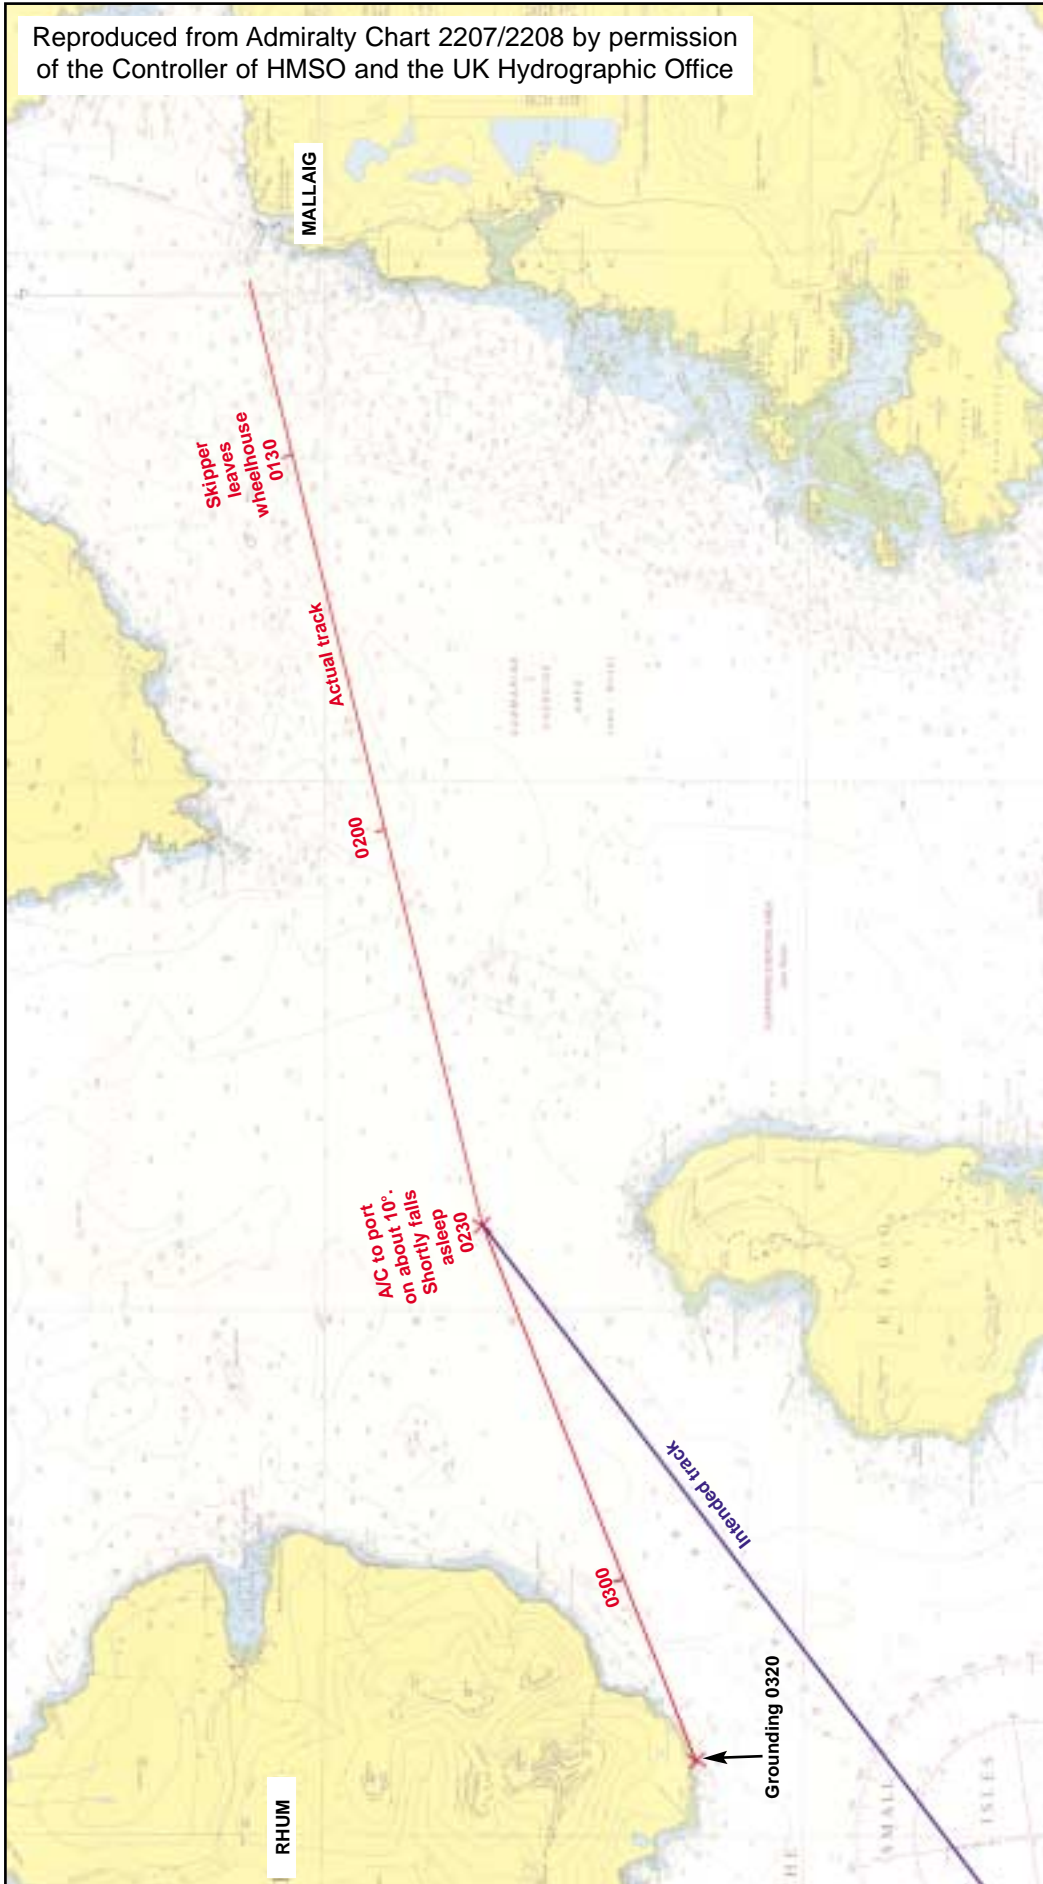
Figure 5

On departure Mallaig, vessels bound for the south pass between Rhum and Eigg. A straight course from Mallaig leads to a waypoint where an alteration of course is required (**see Figure 5**). If this alteration is missed, the vessel will eventually ground on Rhum.

The deckhand was still awake when the vessel arrived at the waypoint, and would have made the full alteration but, because of the close proximity of a vessel on his port side, which he was overtaking, he only altered course to port by about 10 degrees, fully intending to make the full alteration once the other vessel was passed and clear. Unfortunately, he fell asleep shortly after making the small alteration. The vessel therefore continued on this course and grounded on the southern tip of Rhum.

1. The person on watch in the wheelhouse falling asleep and failing to make the required alteration of course. [2.2.4]
2. The proximity of another vessel, which did not allow the full alteration to be made upon arrival at the waypoint. [2.2.4]
3. The decision to alter course by only 10° because of the proximity of the other vessel. [2.2.4]
