Report on the investigation of
the collision between
Thelisis and Our Sarah Jayne
in the
Thames Estuary
20 June 2001

Marine Accident Investigation Branch
First Floor
Carlton House
Carlton Place
Southampton
United Kingdom
SO15 2DZ

**Report No 9/2002
February 2002**

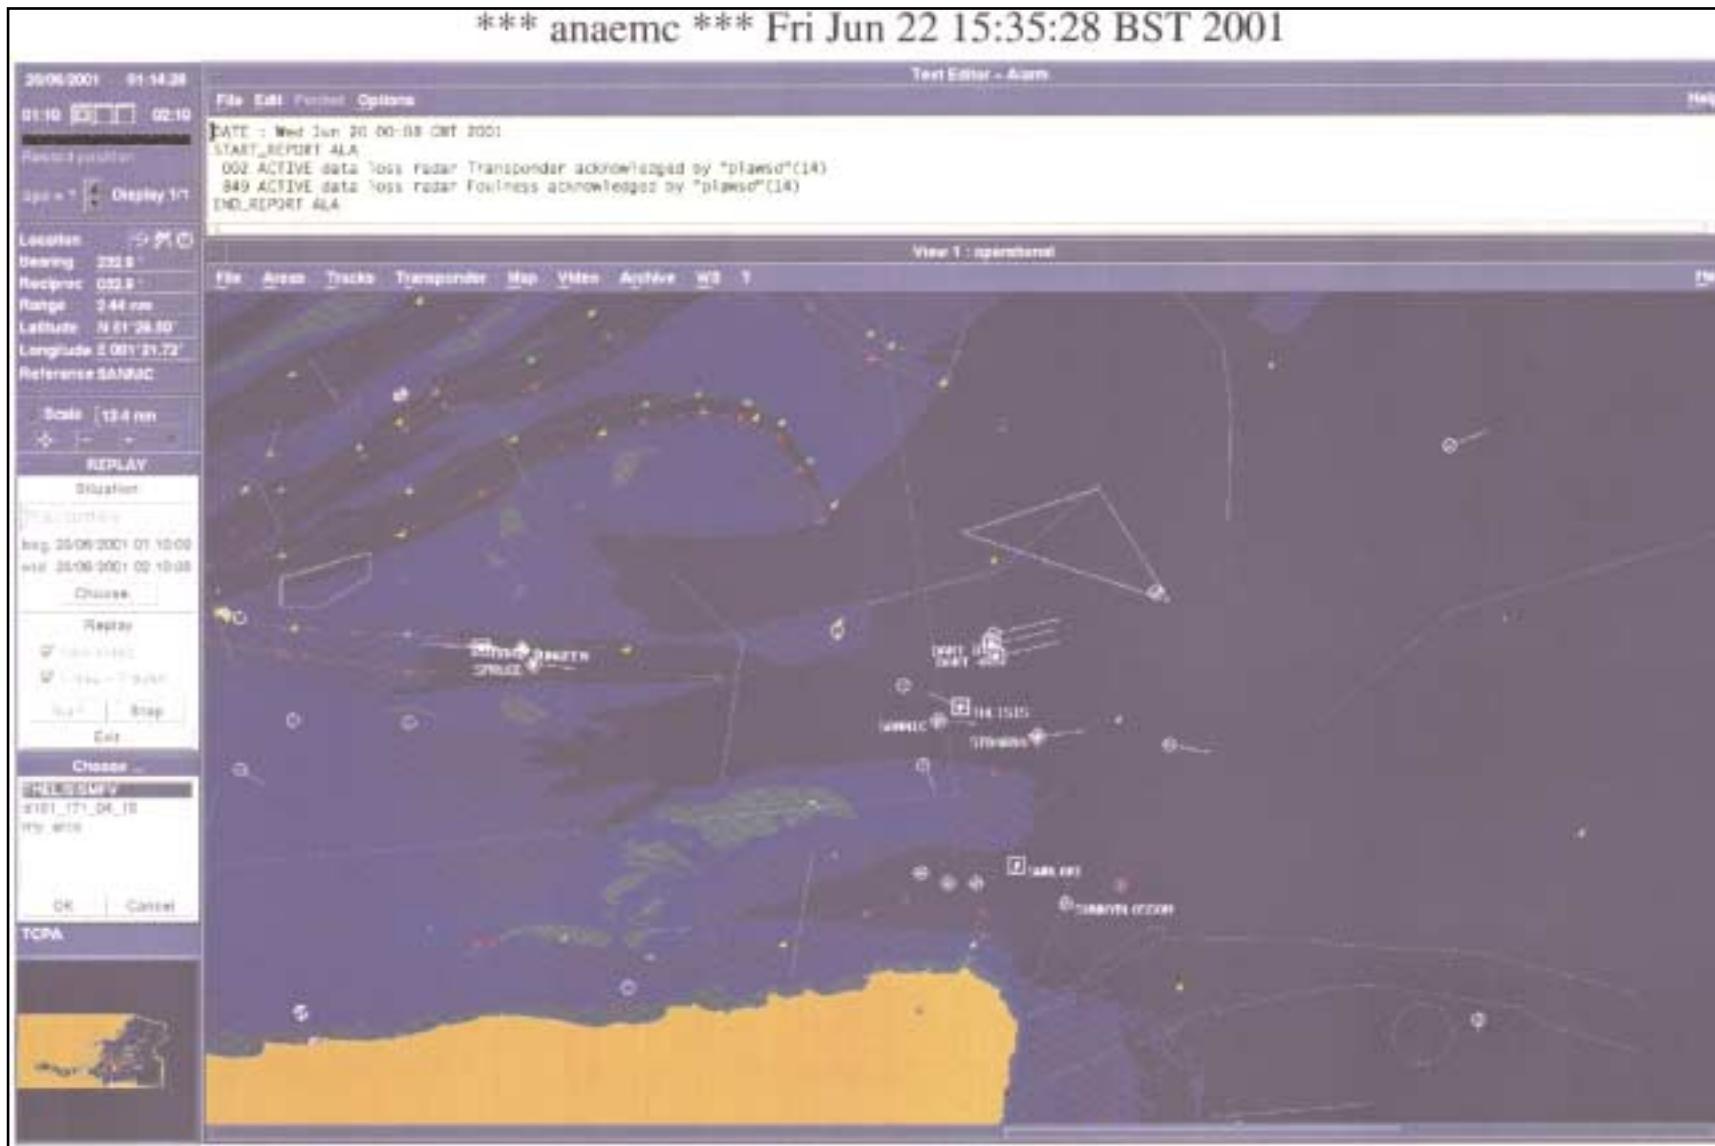
Figure 5

The position of the accident is within the coverage area provided by Thames VTS. The events leading up to the accident were recorded both on radar and VHF radio channel 12 **(Figures 4 & 5) (Annex 1)**.

Thames VTS radar recording

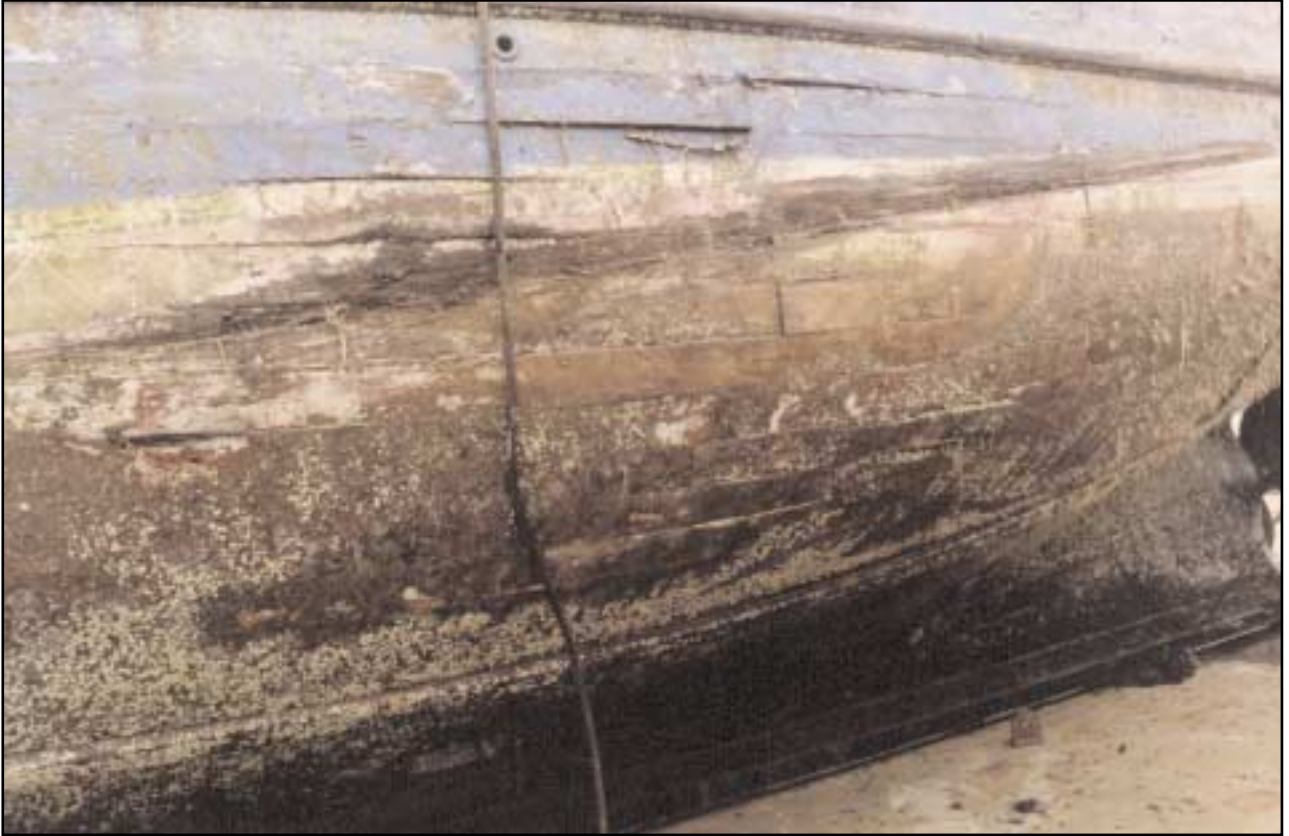
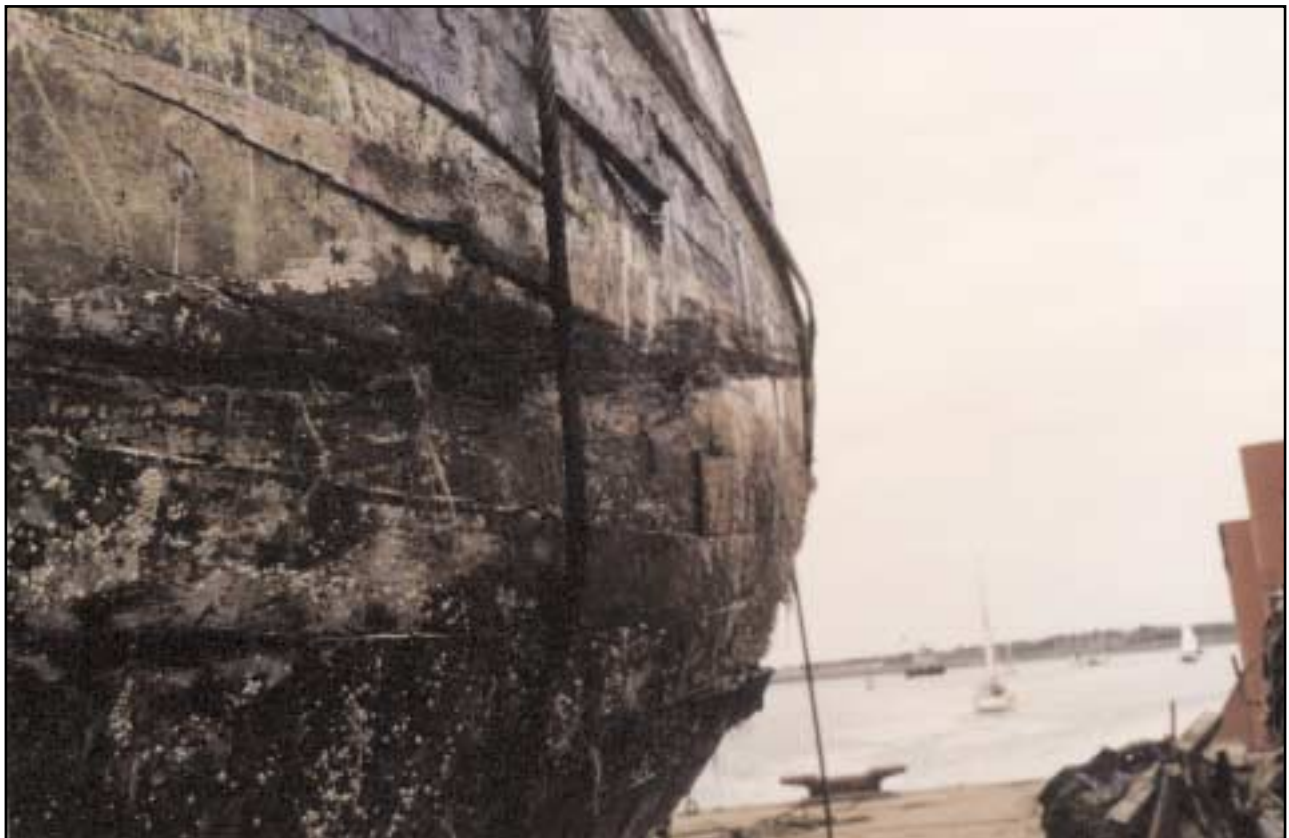
Figure 6

The port side of the hull was damaged above and below the waterline, consistent with a collision (**Figures 6 & 7**); the hull planking which was carvel laid, was sprung in several places. Internally there was damage to the frames and bulkheads in the engine room and fish room.

Collision damage *Our Sarah Jayne*

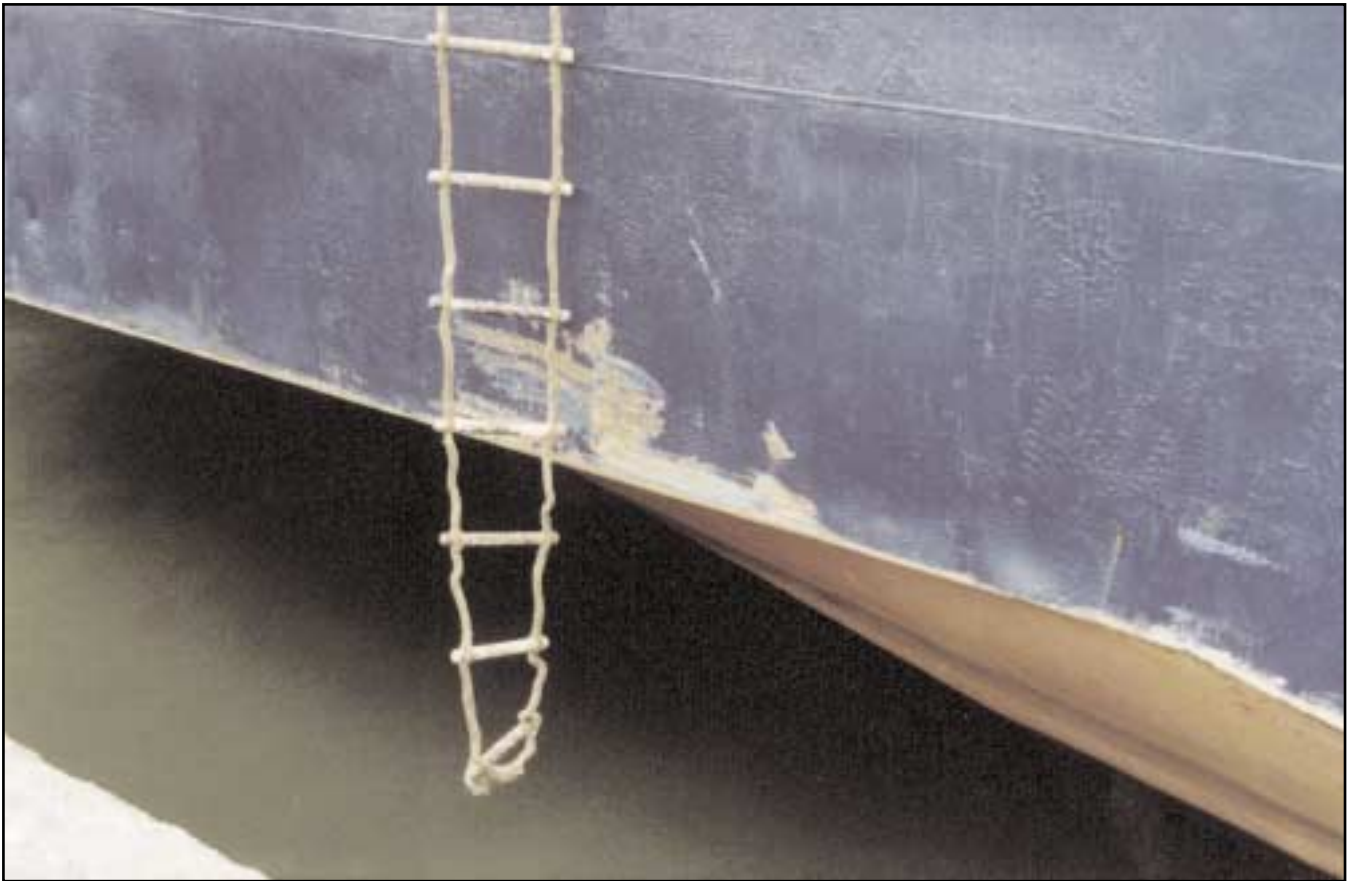
Figure 8

The damage to *Thelisis* was minimal. Her hull plating on the starboard quarter just above the waterline was slightly damaged where the paint had been removed (**Figure 8**).

Damage to *The Isis*
