Report on the investigation of
the collision between
Thelisis and Our Sarah Jayne
in the
Thames Estuary
20 June 2001

Marine Accident Investigation Branch
First Floor
Carlton House
Carlton Place
Southampton
United Kingdom
SO15 2DZ

**Report No 9/2002
February 2002**

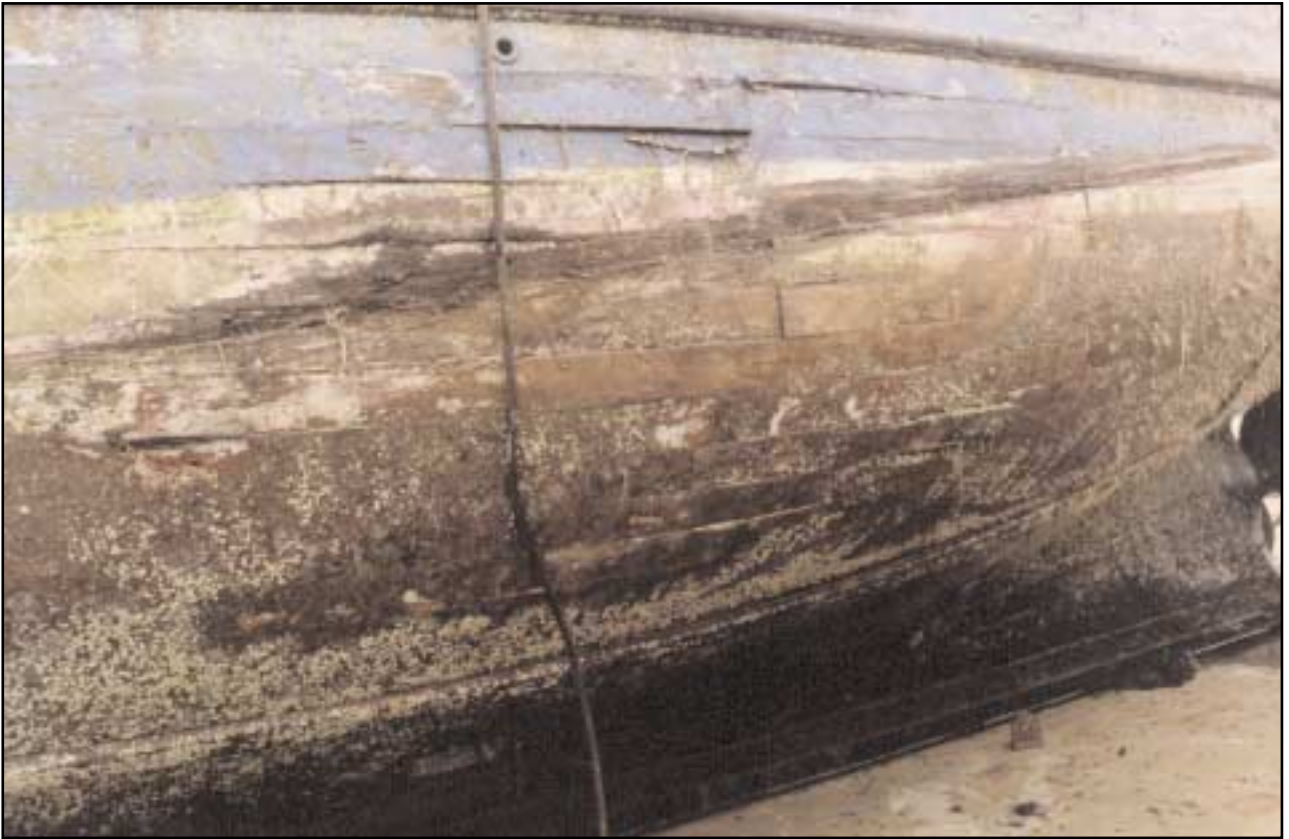
Figure 6

The port side of the hull was damaged above and below the waterline, consistent with a collision (**Figures 6 & 7**); the hull planking which was carvel laid, was sprung in several places. Internally there was damage to the frames and bulkheads in the engine room and fish room.

Collision damage *Our Sarah Jayne*

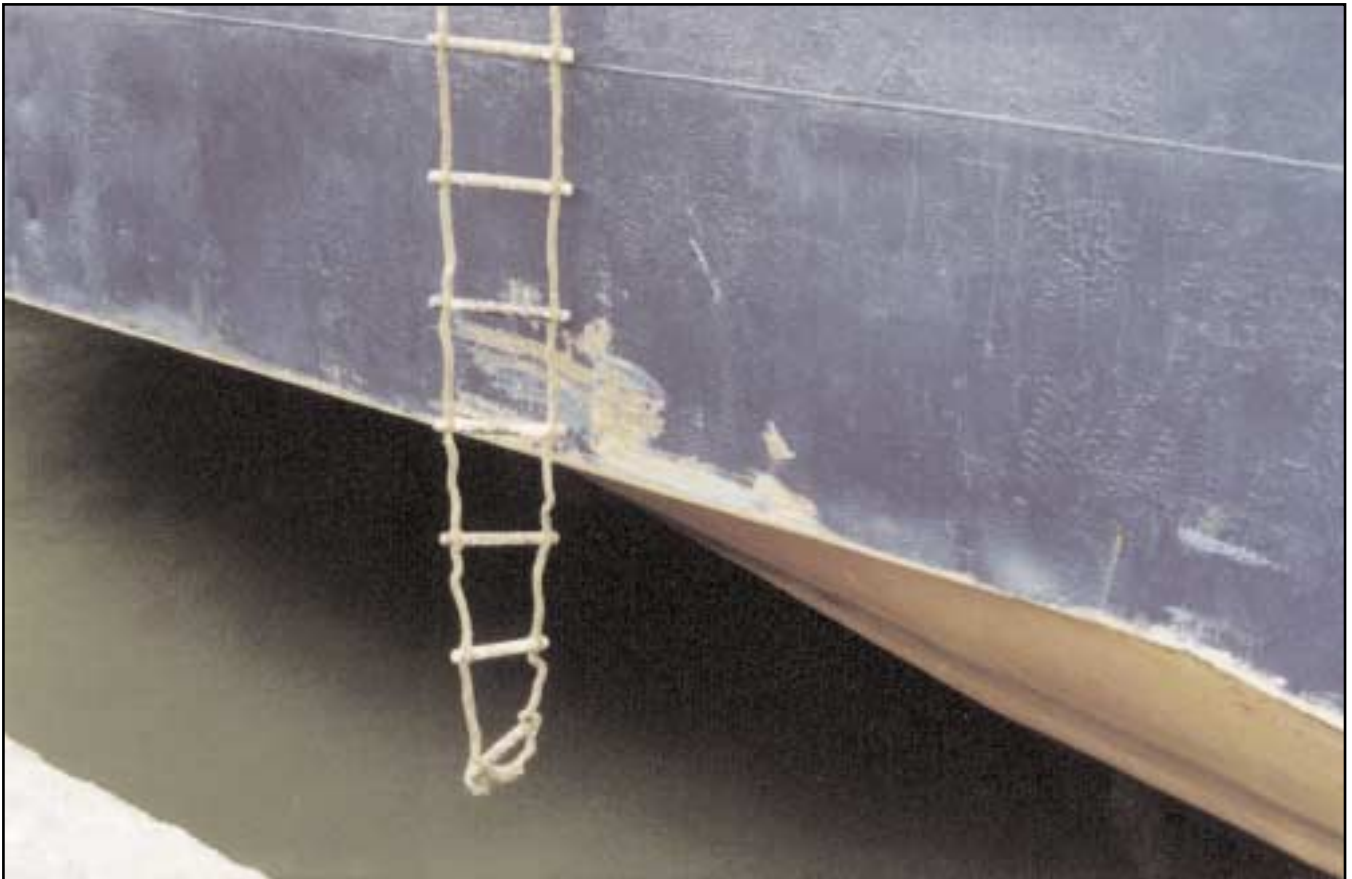
Figure 8

The damage to *Thelisis* was minimal. Her hull plating on the starboard quarter just above the waterline was slightly damaged where the paint had been removed (**Figure 8**).

Damage to *Thelisis*
