Report on the investigation of  
the collision between  
***Thelisis and Our Sarah Jayne***  
in the  
Thames Estuary  
20 June 2001

Marine Accident Investigation Branch  
First Floor  
Carlton House  
Carlton Place  
Southampton  
United Kingdom  
SO15 2DZ

**Report No 9/2002  
February 2002**

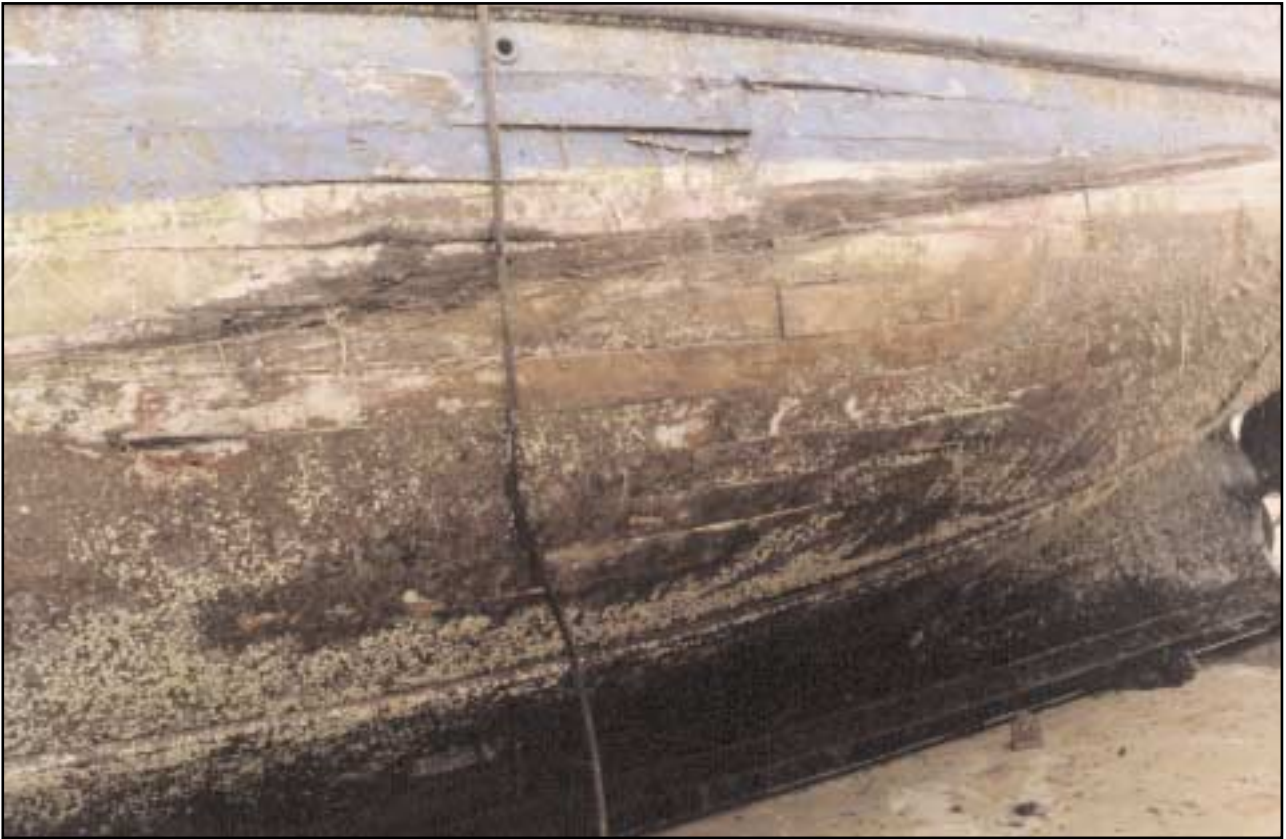
Figure 6

The port side of the hull was damaged above and below the waterline, consistent with a collision (**Figures 6 & 7**); the hull planking which was carvel laid, was sprung in several places. Internally there was damage to the frames and bulkheads in the engine room and fish room.

Collision damage *Our Sarah Jayne*
