Report on the investigation of
the collision between
Thelisis and Our Sarah Jayne
in the
Thames Estuary
20 June 2001

Marine Accident Investigation Branch
First Floor
Carlton House
Carlton Place
Southampton
United Kingdom
SO15 2DZ

**Report No 9/2002
February 2002**

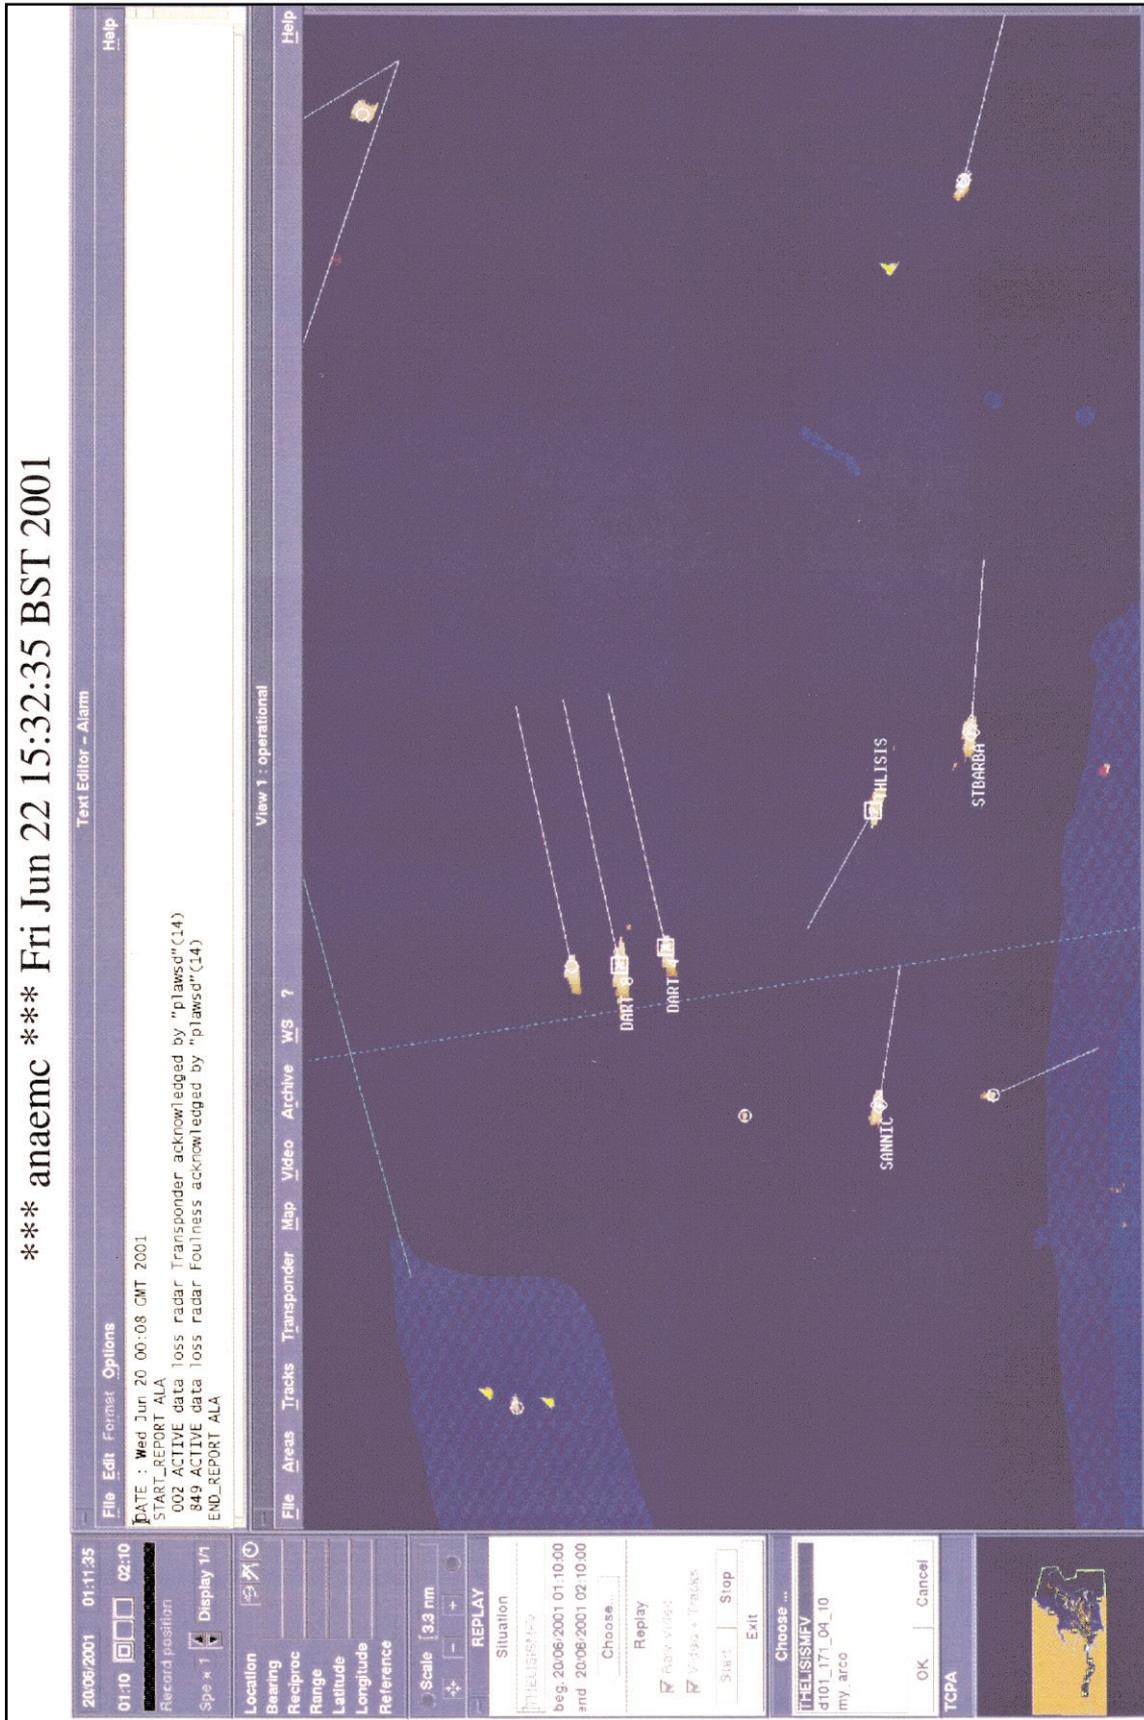
Figure 4

The position of the accident is within the coverage area provided by Thames VTS. The events leading up to the accident were recorded both on radar and VHF radio channel 12 **(Figures 4 & 5) (Annex 1)**.

Thames VTS radar recording

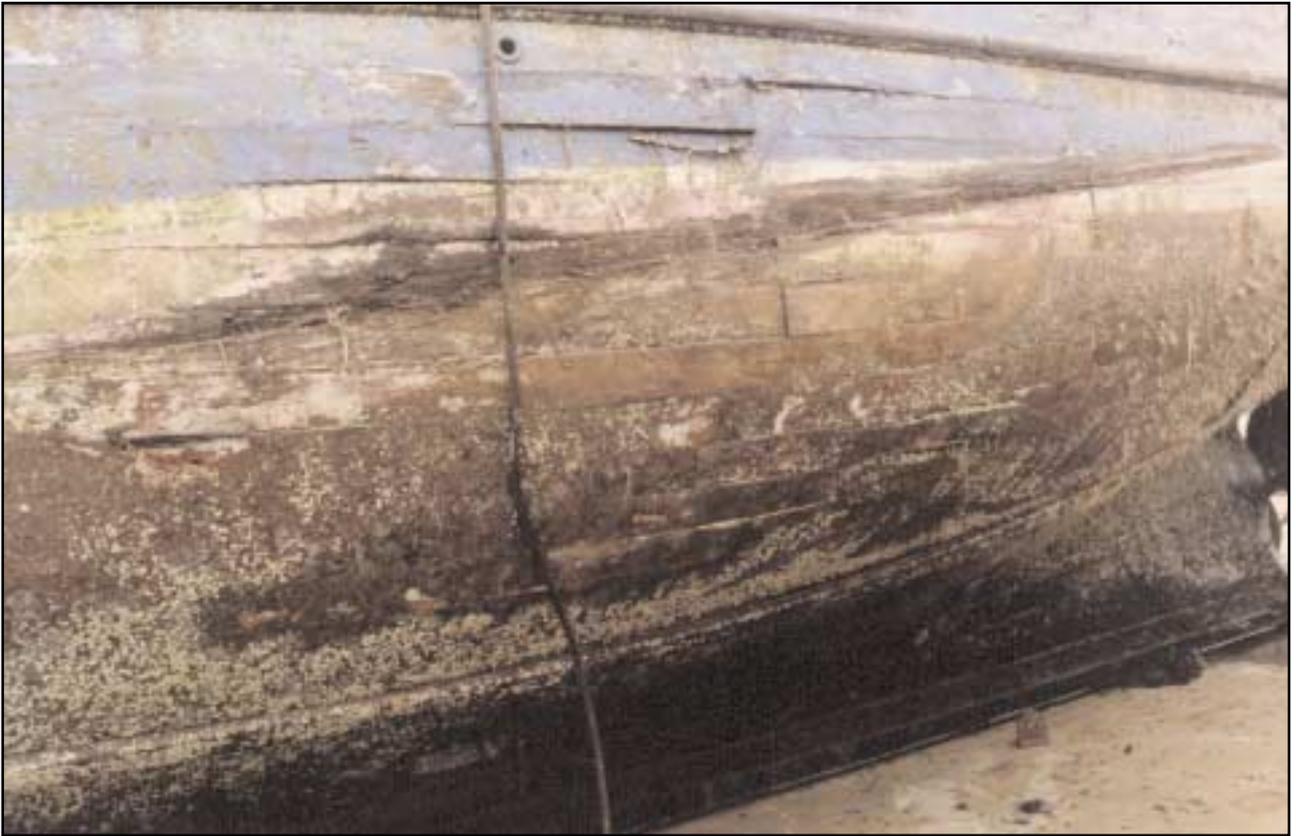
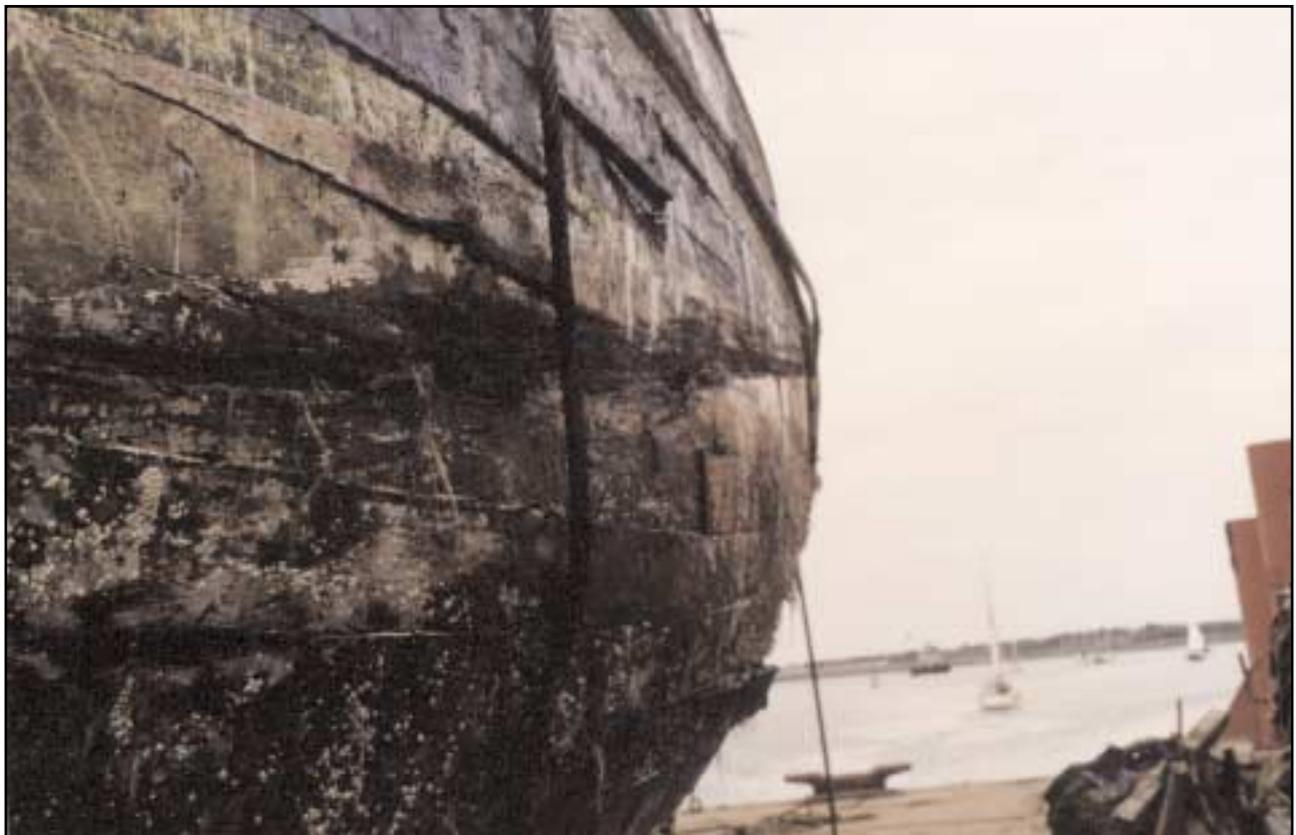
Figure 6

The port side of the hull was damaged above and below the waterline, consistent with a collision (**Figures 6 & 7**); the hull planking which was carvel laid, was sprung in several places. Internally there was damage to the frames and bulkheads in the engine room and fish room.

Collision damage *Our Sarah Jayne*

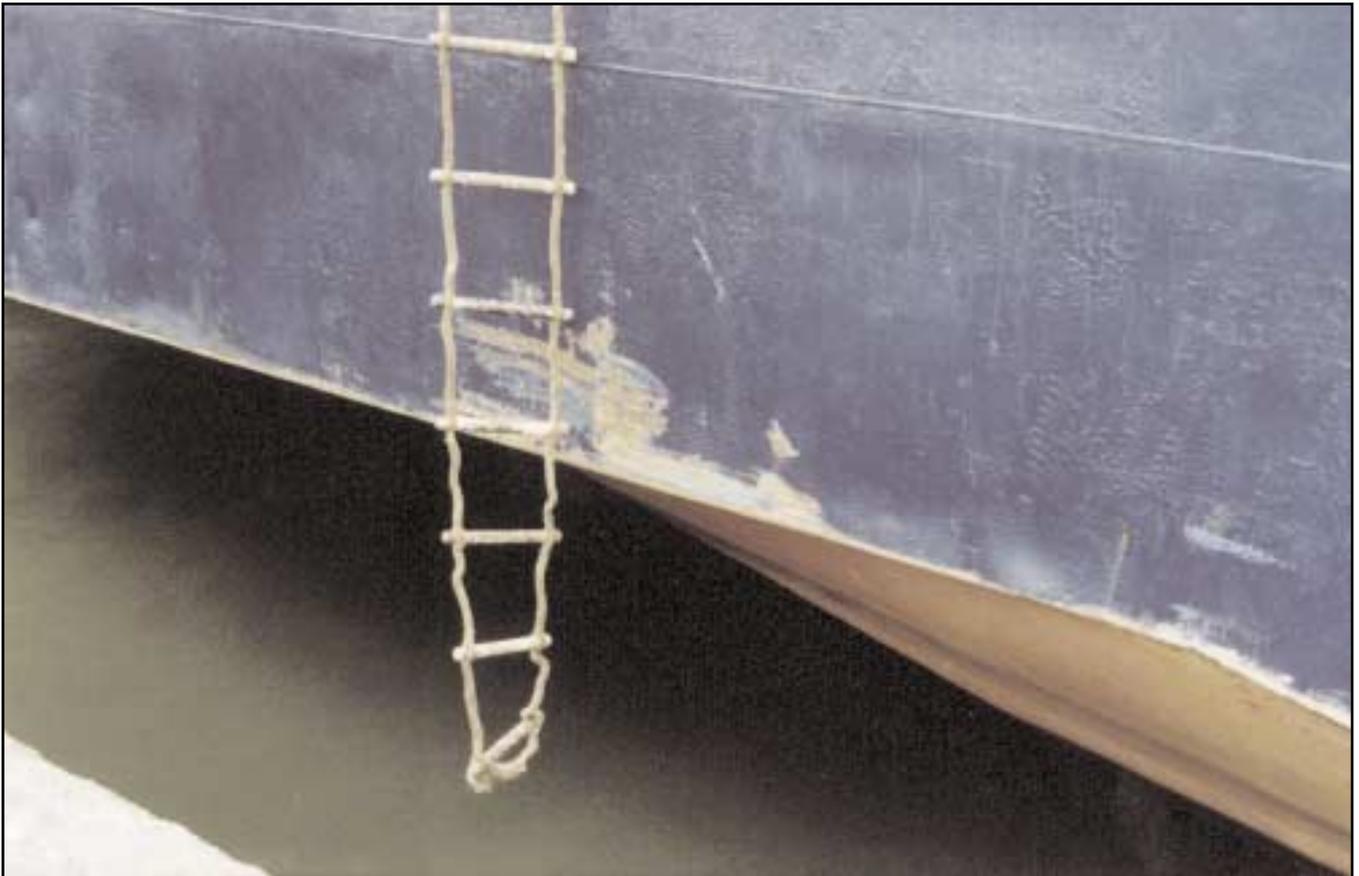
Figure 8

The damage to *Thelisis* was minimal. Her hull plating on the starboard quarter just above the waterline was slightly damaged where the paint had been removed (**Figure 8**).

Damage to *The Isis*
