Report on the investigation of
the grounding of
mfv *Lomur*
in the approaches to Scalloway, Shetland Islands
14 June 2001

**Report No 7/2002
February 2002**

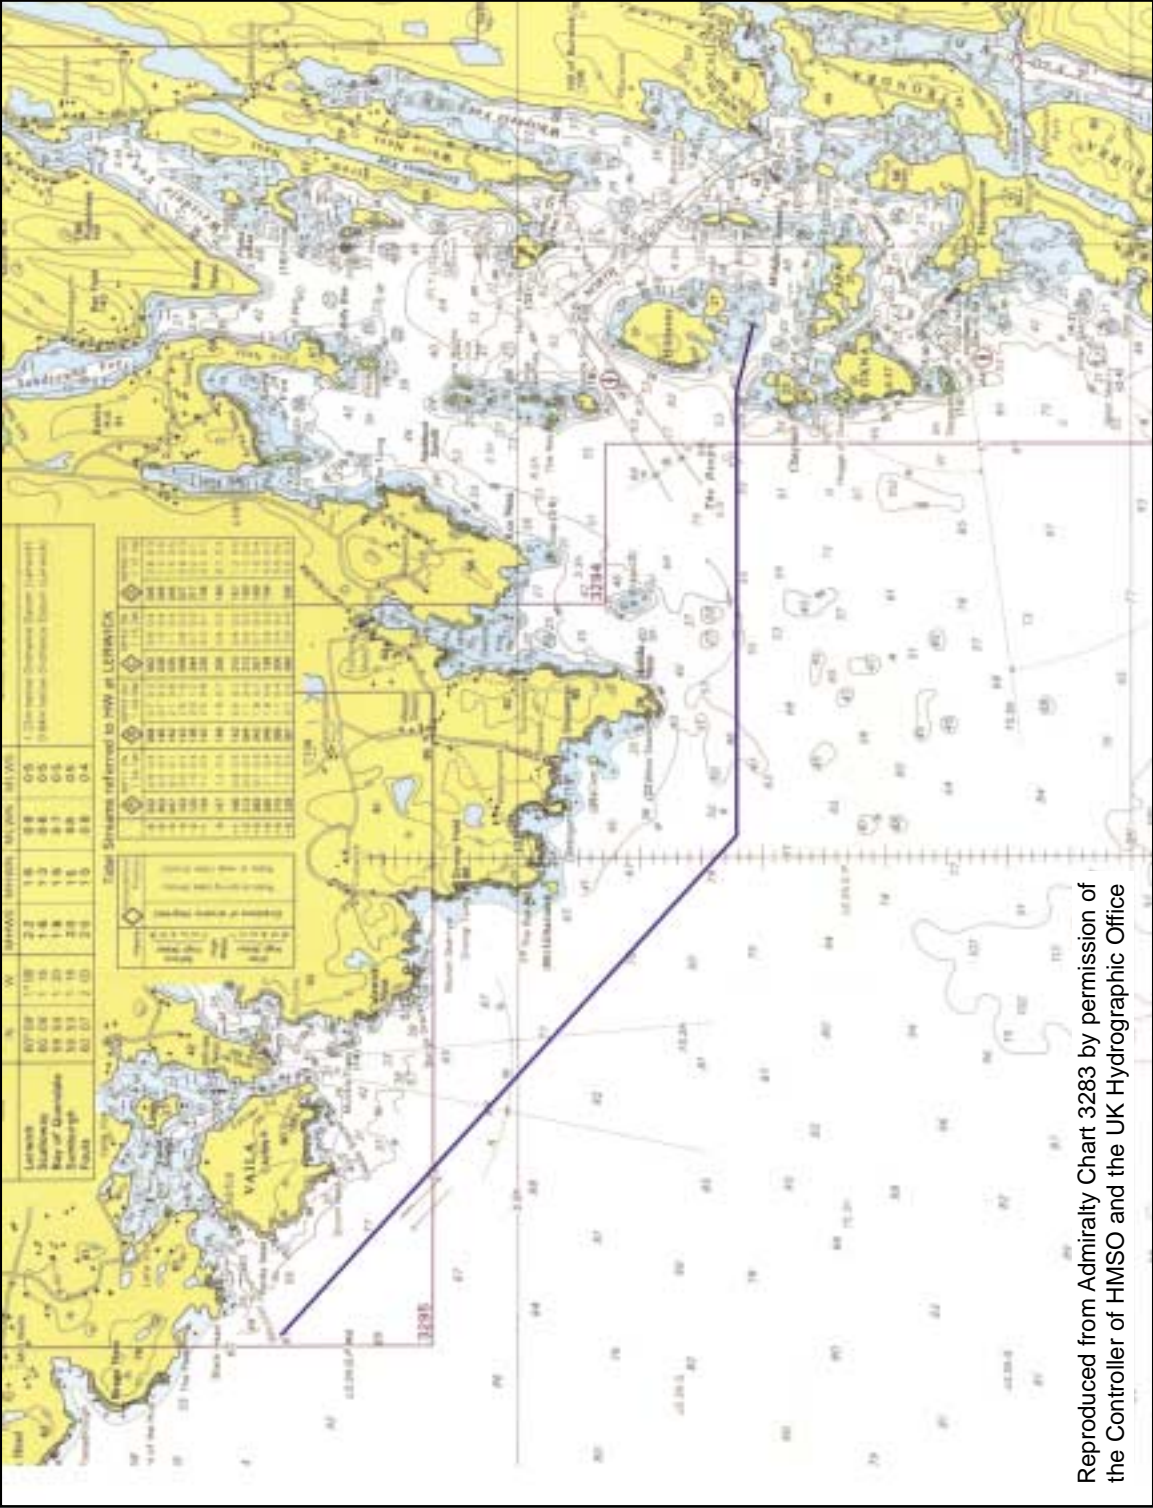
Figure 1

Lomur hauled her nets at 0530 on 14 June 2001 and started a 16-mile passage towards Scalloway from a position to the west of Vaila. Course was about 130° at a speed of 9 knots (**Figure 1**), and steering was by autopilot. The skipper was on watch in the wheelhouse and read several telex messages before sitting in the starboard wheelhouse chair at about 0540. The remaining crew worked the fish until about 0600, then joined the skipper in the wheelhouse to discuss fish tallies and to smoke cigarettes. Several minutes later, the deckhand went to bed, and the engineer went down below to check the engines. He then drank a cup of coffee in the mess room. Alone again in the wheelhouse, the skipper called the fish market in Scalloway via mobile telephone for about 5 minutes to advise them of the catch he would be landing that morning.

At about 0610, the vessel passed Skelda Ness and altered course to port, to head towards the entrance to the Middle Channel. Course was now about 090°. About 20 minutes later, as *Lomur* passed the northern point of the Cheynies, course was adjusted several degrees to starboard to enter the Middle Channel, and the watch alarm was reset. The skipper remained seated and kept the vessel in autopilot during both of these alterations and, soon after the second, he fell asleep. *Lomur* continued on the course set on the autopilot until she grounded on Hoe Skerry at about 0635. The skipper was woken by the noise of the vessel grounding, and was thrown from his chair. Immediately, he put the pitch control to zero on the aft control position, then applied 60%-70% pitch astern. As this had no effect, and *Lomur* remained firmly aground, the engine was then taken out of gear (**Figure 2**).

Chart showing the approximate tracks of Lomur

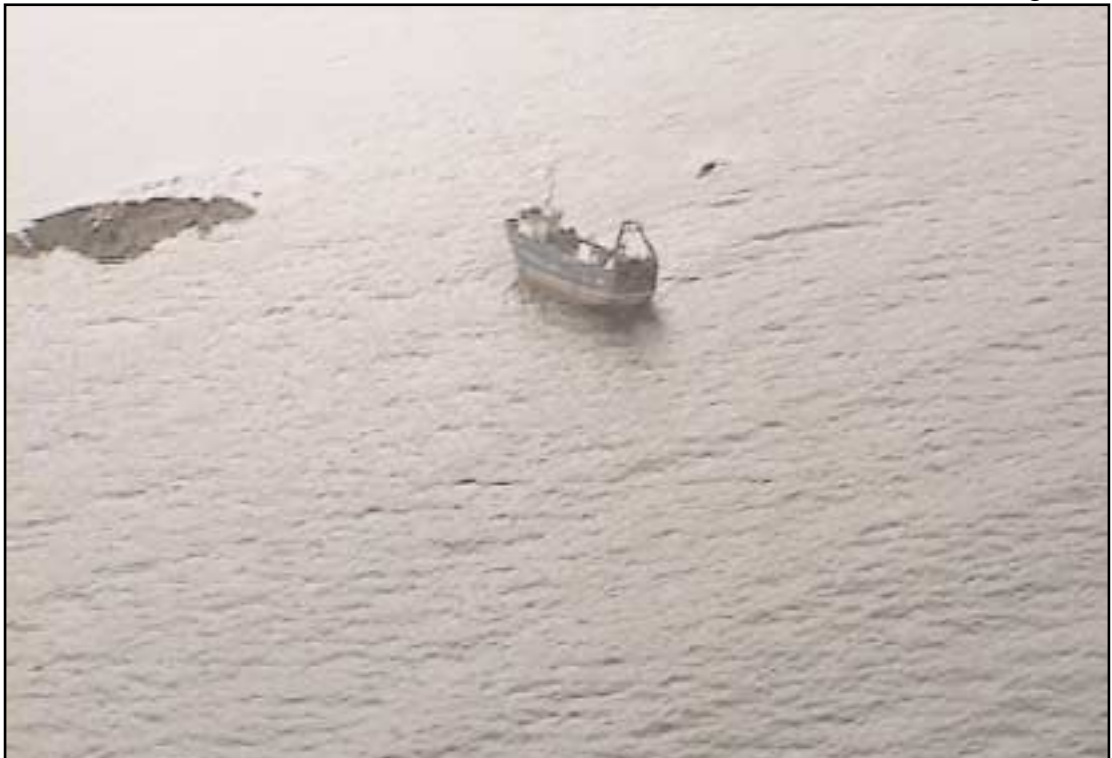
Time and date	:	0635(UTC-1) 14 June 2001
Location of incident	:	60° 08.7N 001° 21.44W Hoe Skerry, 2 miles west of Scalloway, Shetland Islands
Persons on board	:	Three
Injuries/fatalities	:	None
Damage	:	Buckled hull plating

Lomur aground on Hoe Skerry

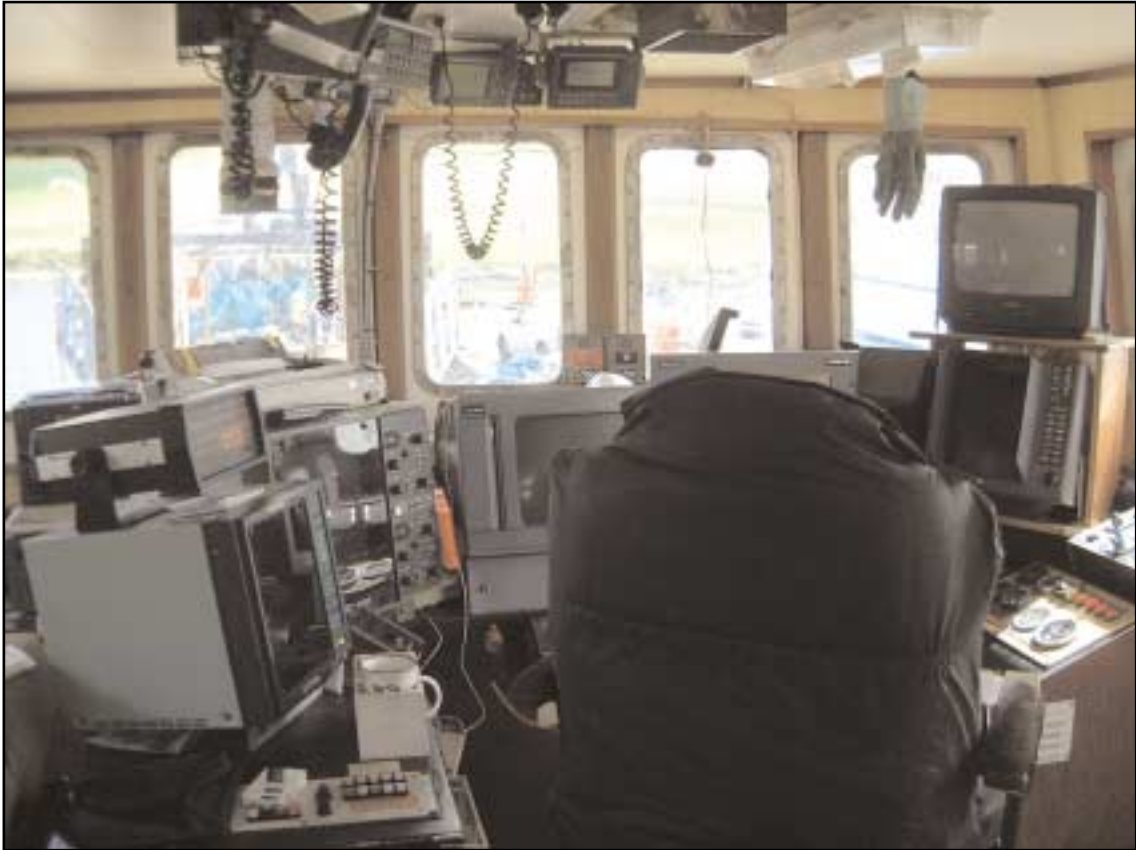
The navigation equipment fitted in the wheelhouse included: a Furuno radar, two Fishmaster video plotters, two GPS receivers, a Koden echo sounder, an autopilot, and a watch alarm. The watch alarm had to be reset every 10 minutes, but was not integral to the autopilot and could be disabled by the use of a switch. The wheelhouse had a chair fitted either side of the centre line, but nearly all of the wheelhouse equipment, including the watch alarm, engine controls and instrumentation, was located around the starboard chair in a cockpit-like configuration (**Figure 3**). An aft-facing engine control console was also fitted. Recreational electronic equipment fitted in the wheelhouse included a television and a radio-cassette player, neither of which were in use at the time of grounding.

Following the grounding, the watch alarm was replaced with an alarm with a 3-minute interval, although it was still not integral to the autopilot.

Lomur - photograph of the inside of the wheelhouse

9. The watchkeeper could reset the watch alarm while remaining seated in the starboard wheelhouse chair. [2.3.3]
10. The period from when the skipper fell asleep, to the vessel grounding, fell within the 10-minute interval of the watch alarm. [2.3.3]
