Report on the investigation of
the grounding of
Resplendent
in Bluemull Sound
Shetland Islands
13 June 2001

Marine Accident Investigation Branch
First Floor, Carlton House
Carlton Place
Southampton
United Kingdom
SO15 2DZ

Report No 10/2002
March 2002

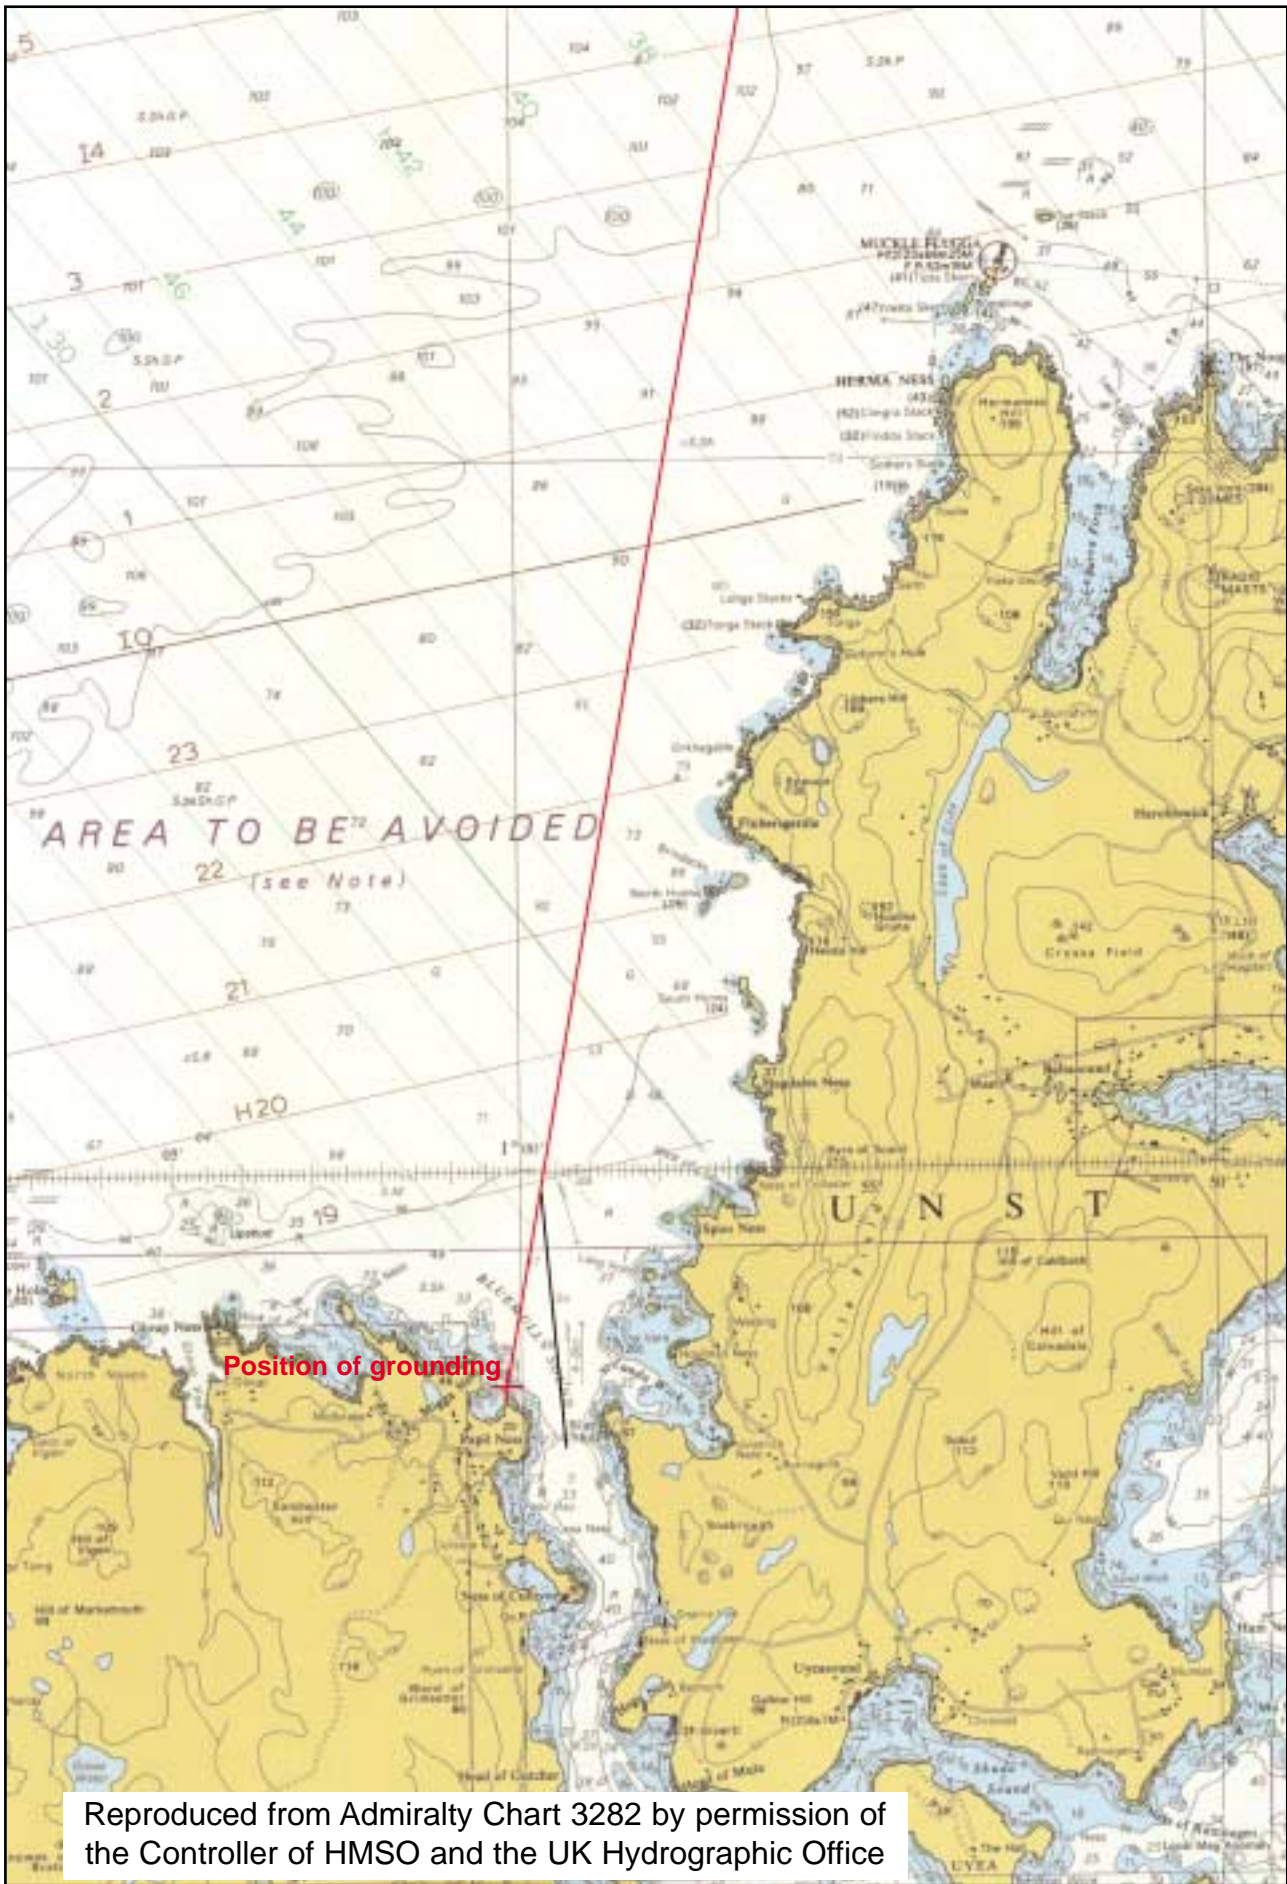
Resplendent passed the north-western side of Unst at about 0245 on 13 June on a course of about 190°, and at a speed of between 8 and 10 knots (**Figure 1**). As she continued towards the entrance to Bluemull Sound, the skipper saw another fishing vessel to the west, about 1 mile from land; this was the only other vessel in the immediate vicinity. He also talked to a friend via mobile telephone. Towards the end of this conversation, which lasted for about 10 minutes, the fish room's bilge alarm sounded in the wheelhouse. The skipper informed the engineer of this alarm immediately, using the wheelhouse/factory deck intercom.

Chart showing an approximation of *Resplendent's* track

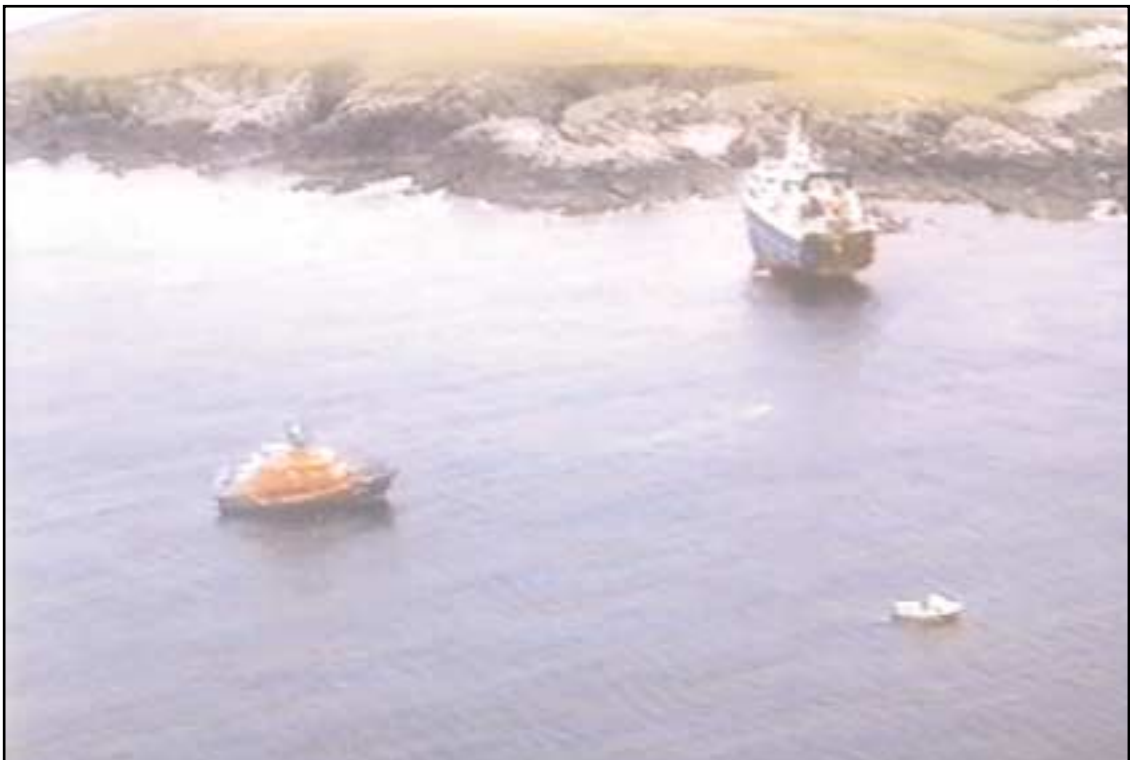
Figure 2

Assuming that there was a fault with the steering, the skipper moved across the wheelhouse to check the autopilot and steering controls. Before he could take any action, however, *Resplendent* ran aground at about 0325 on the western side of the entrance to Bluemull Sound (**Figure 2**).

Resplendent aground

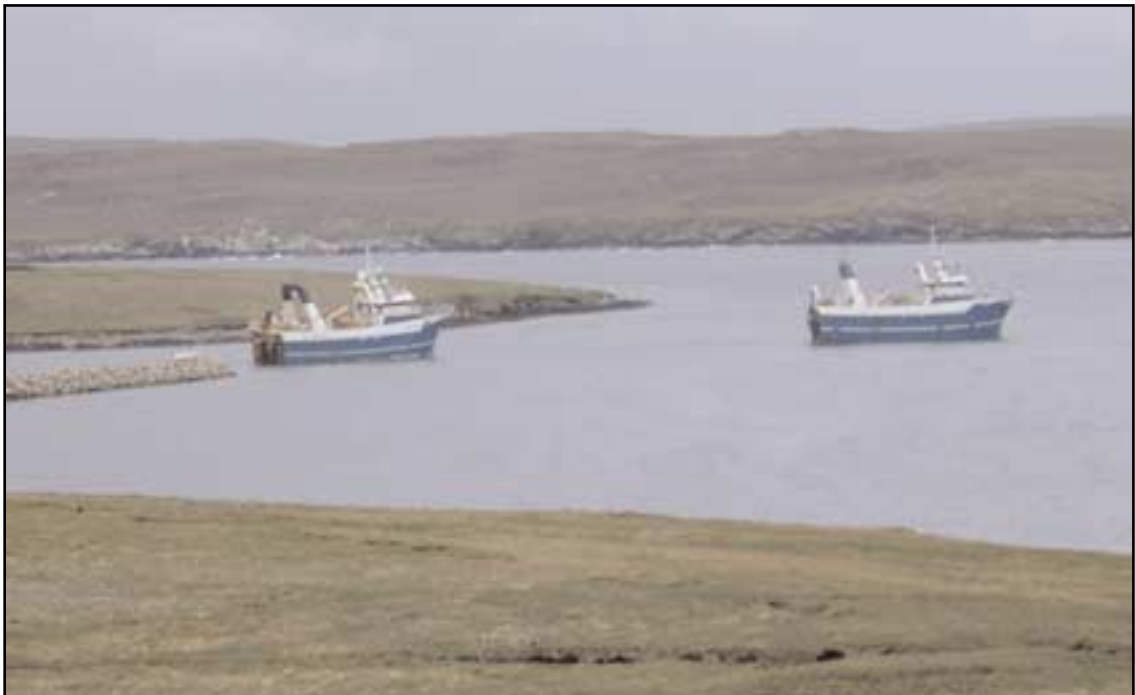
Figure 3

Resplendent under tow from Cullivoe

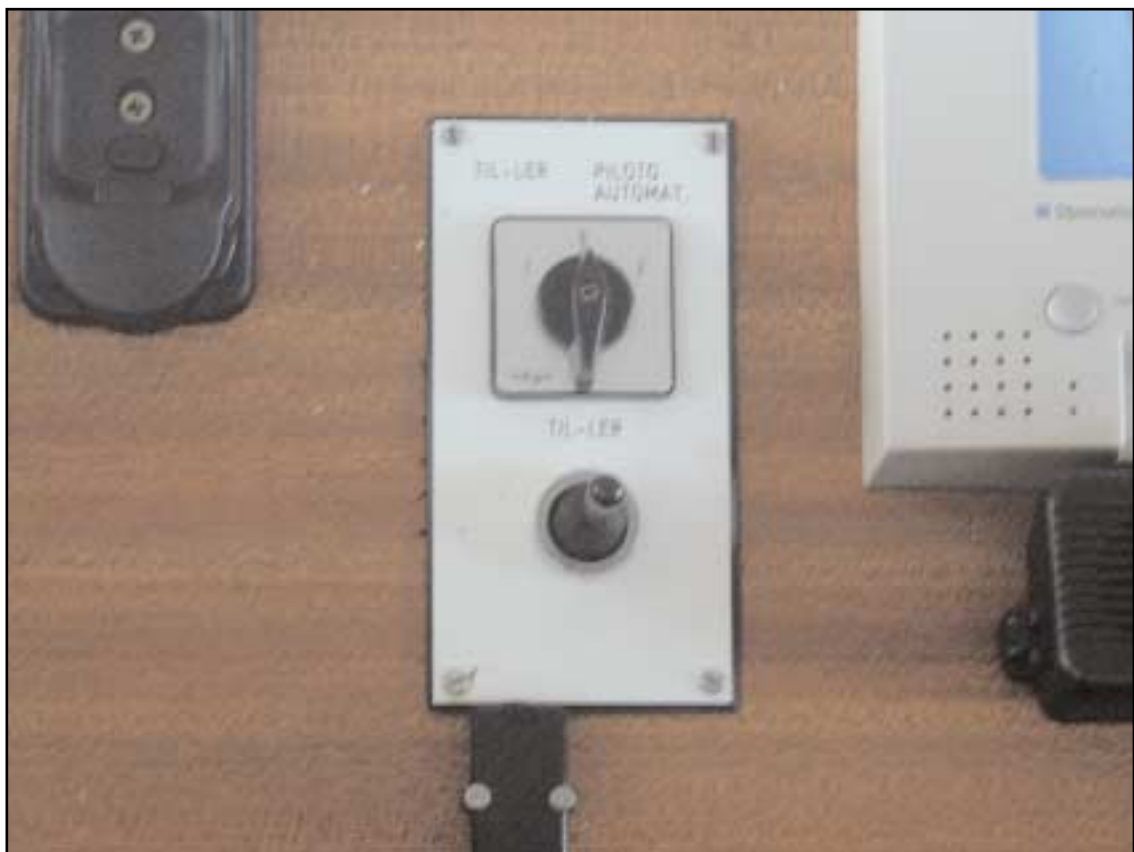
Figure 4

Other than the position of this switch, there were no indications showing the status of the steering equipment. The vessel was normally operated in either hand or automatic steering. The position of this switch at the time of grounding is not known.

The steering changeover switch

Unfortunately, since the positions of the switches on both the master changeover, and automatic steering units, when *Resplendent* grounded are not known, the status of her steering equipment cannot be determined. However, as neither mechanical failure, nor misjudgment by the skipper, were likely to have caused the rudder to be at the amidships position after the skipper had attempted to apply port rudder via the joystick, it is considered that the ineffectiveness of the joystick to control the rudder was caused by manual steering not being selected.

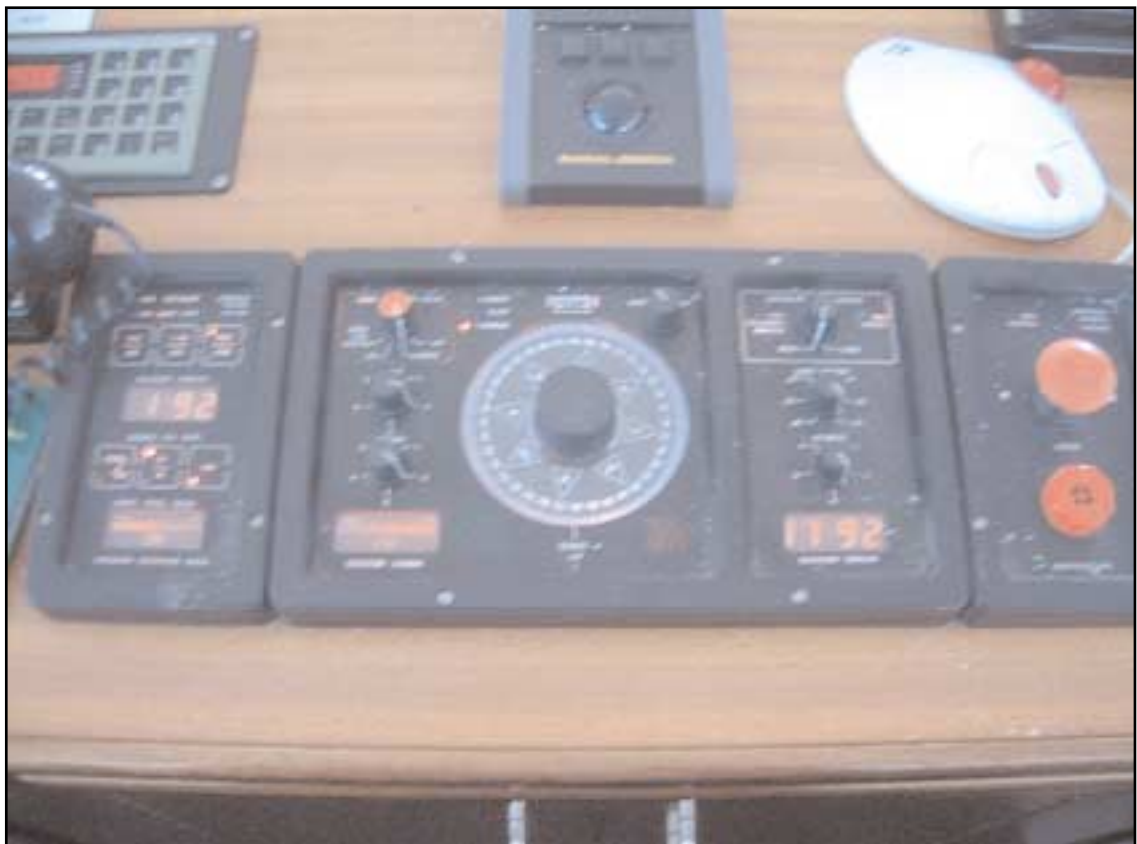
Figure 5

To steer by autopilot, Position 2 had to be selected on the master changeover switch, and the autopilot had to be switched to 'On' or 'Perm Helm off/reset'. The position of the autopilot switch at the time of grounding is not known. After sailing from Peterhead on 31 May, the vessel experienced an automatic steering failure; her second since February 2001. On both occasions, repairs were effected by changing a relay circuit, and no further problems were reported before or immediately after the grounding.

The autopilot (looking aft)

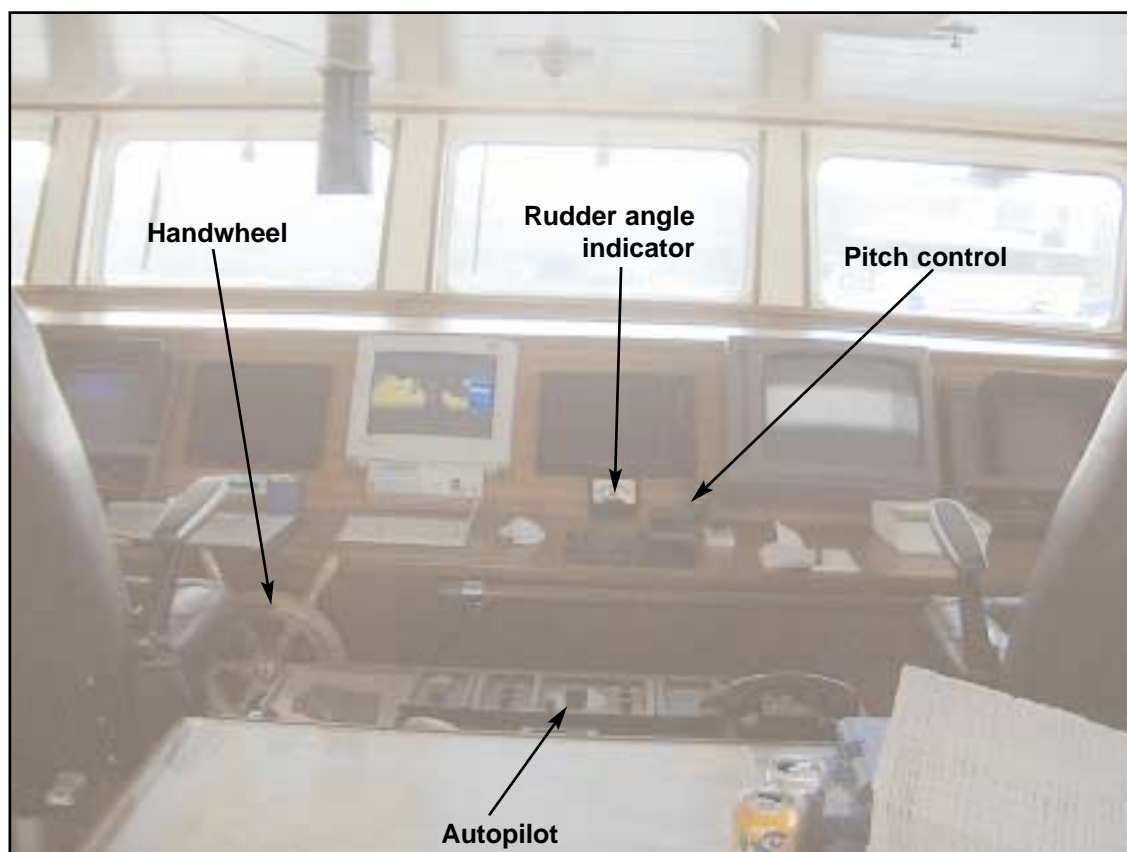
View of the centreline control position and autopilot

Joysticks were situated in three positions in the wheelhouse: immediately below the master changeover switch (**Figure 4**), at the aft control position, and at a control position in the port, forward corner of the wheelhouse. The aft and port control positions were also equipped with main engine and bow thruster controls, and a rudder angle indicator. The engine and bow thruster controls, and rudder angle indicator nearest to the joystick below the master changeover switch, were located in the centre of the front console, a few metres away (**Figure 6**).

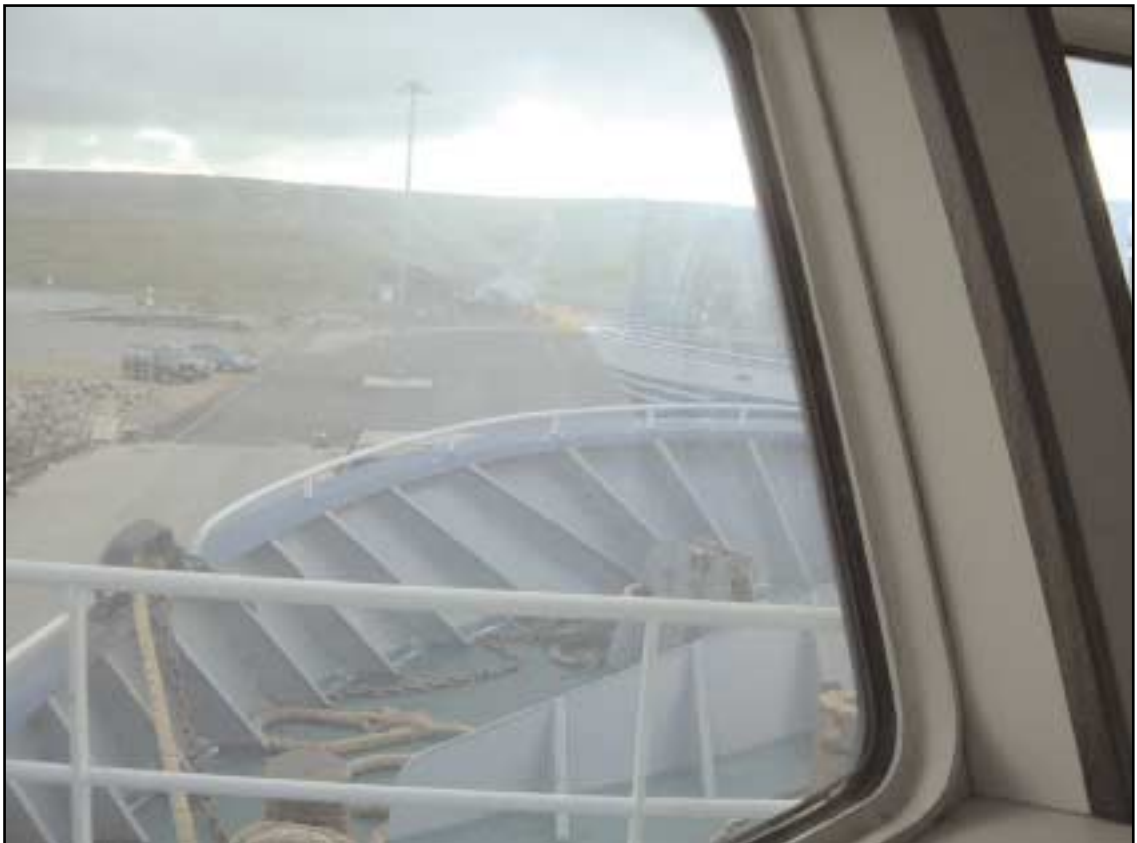
Figure 7

View from the port control position

From the port control position, the skipper could see ahead (**Figure 7**) but could not see either of the radar displays, which would have helped him to monitor the turn to port and measure the distance from the shore. The only means readily available to the skipper to check that *Resplendent* was turning, was by visually monitoring the vessel's head relative to the sea and shoreline. However, although the sensitivity of this method would have been reduced because the skipper was standing off the centreline and the vessel had a short deck forward of the wheelhouse, had the skipper been more alert, the vessel's failure to turn to port as intended, and the closing dangers ahead, should still have been quickly apparent.

9. The skipper was unable to monitor either of the radar displays from the port control position. [2.4.3]

8. Review, and where deemed necessary, adjust wheelhouse ergonomics to optimise watchkeeping and navigational efficiency.

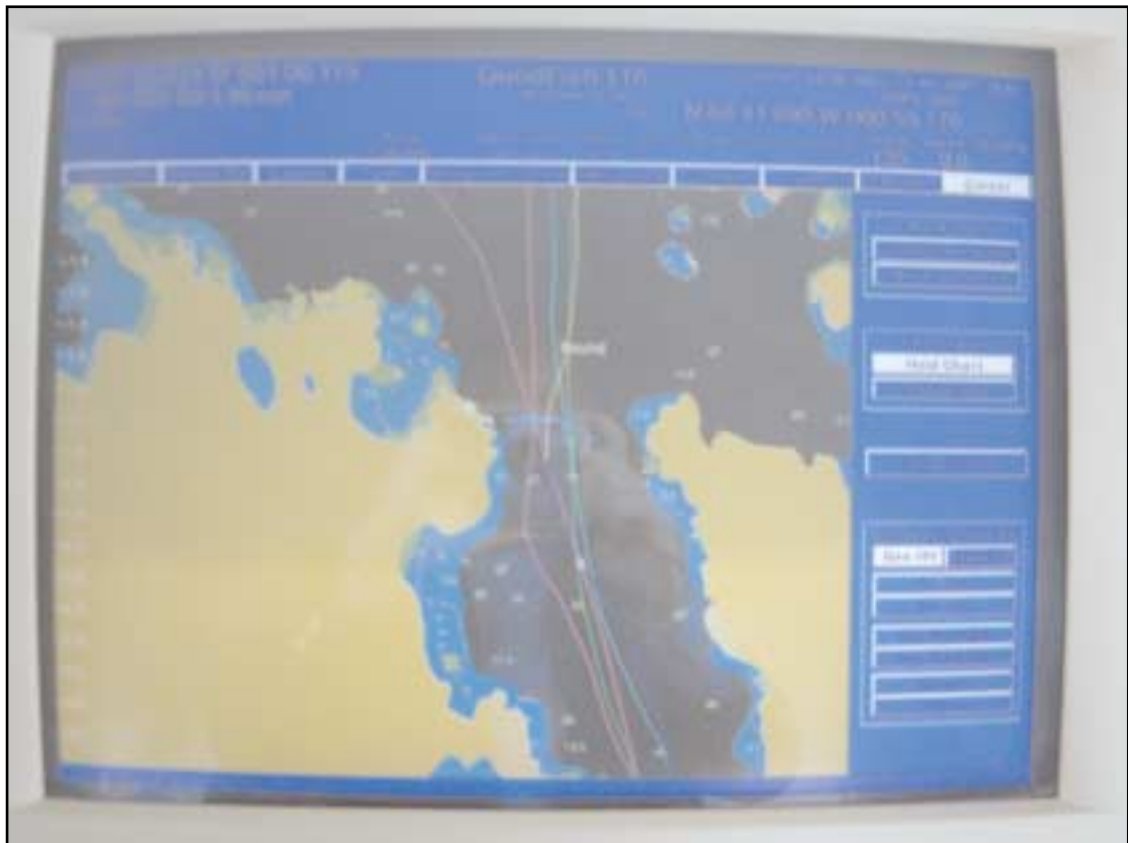
Figure 8

The Quodfish video plotter showing previous tracks

The skipper relied on radar and eye for the safe navigation of his vessel; he was not following any of the tracks available in the video plotter and, therefore, did not have a planned alteration of course. Also, without the aid of a large-scale paper chart, the skipper might not have had a full appreciation of the navigational hazards. Navigating in this way relies on the judgment and local knowledge of the watchkeeper, which may be appropriate in some circumstances. In this case, however, where the skipper was tired and had not visited the area for 2 years, it is considered to have been inappropriate.

6. Provide appropriate large-scale charts on board its vessels.
7. Encourage its skippers to use all available navigation aids, particularly in or approaching shoal waters.
