Report on the investigation of the
collision between
Hampoel and Atlantic Mermaid
in the Dover Strait
on 7 June 2001

Marine Accident Investigation Branch
First Floor
Carlton House
Carlton Place
Southampton
United Kingdom
SO15 2DZ

Report No 12/2002
March 2002

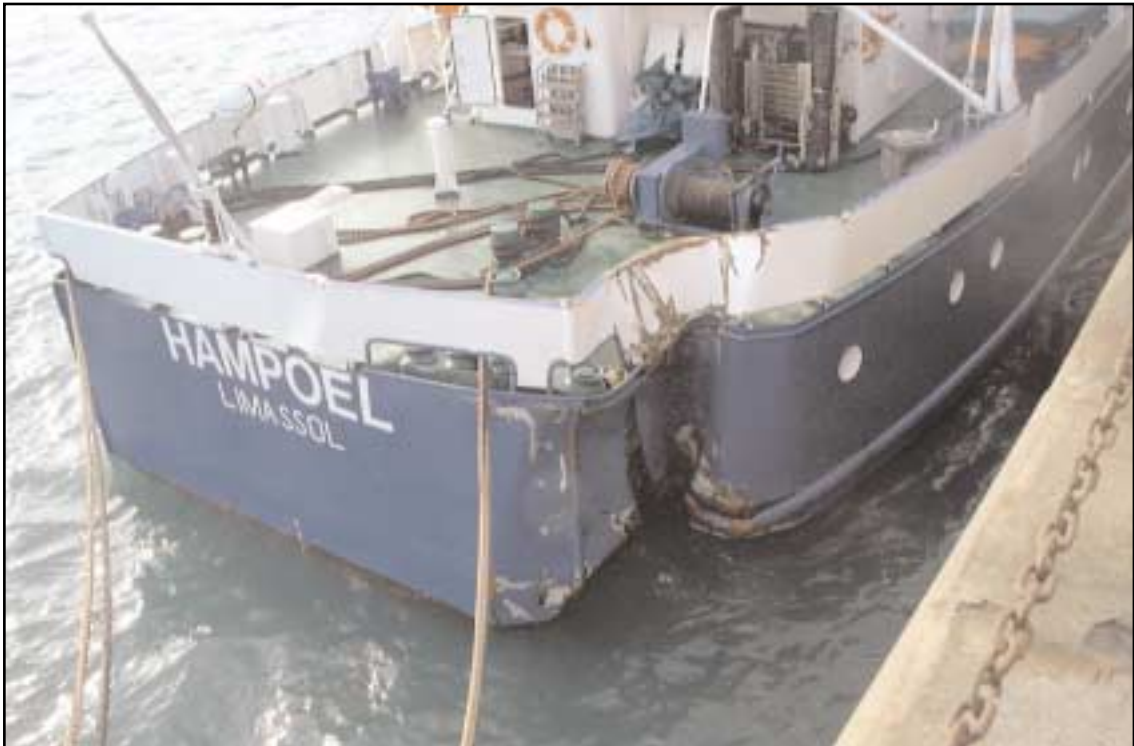
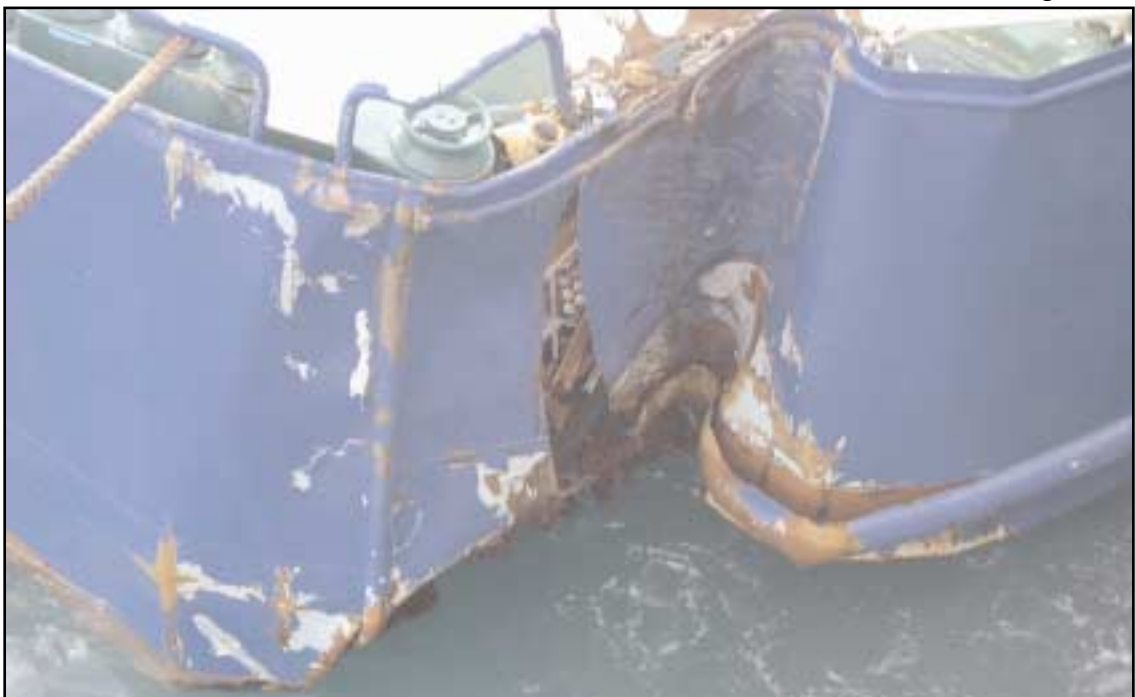
Figure 2

At 0335, *Hampoel* entered Dover harbour. She had suffered substantial damage to her starboard quarter (**see Figures 2,3 & 4**), which included opening the steering gear and engine room to the sea. The sleeping seaman's cabin and the vessel's propeller were also badly damaged. The seaman suffered slight injuries to his foot.

Hampoel damage

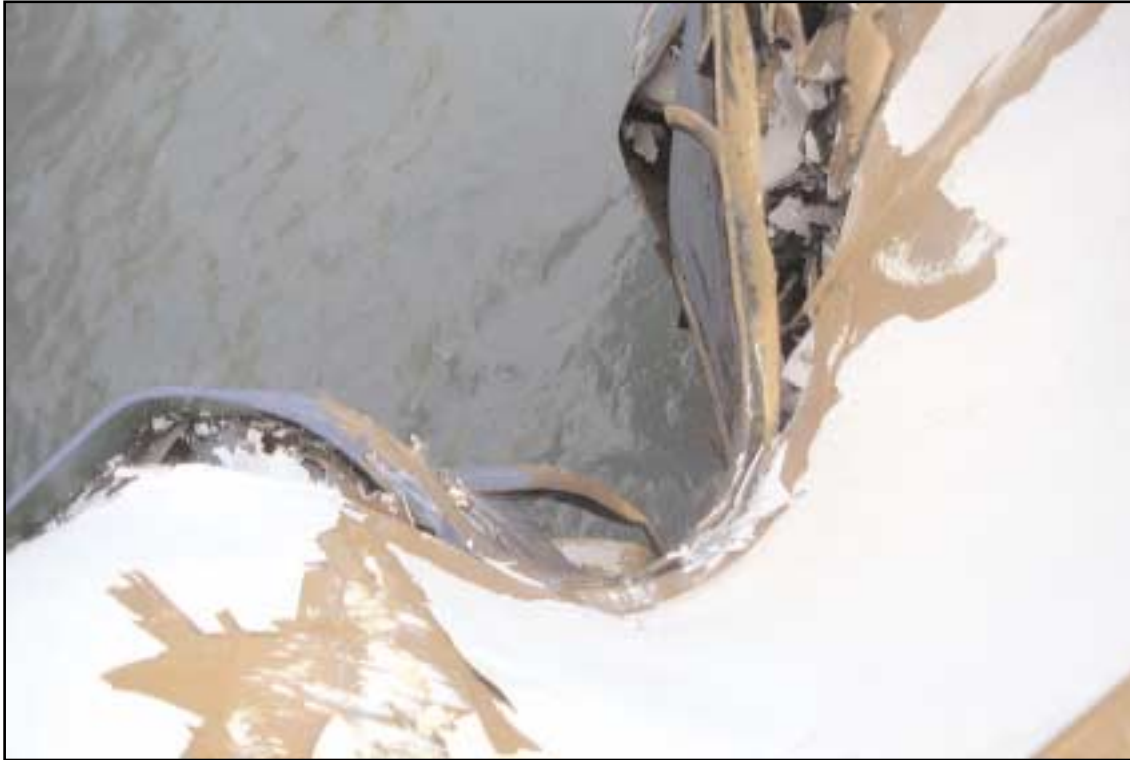
Figure 4

Hampoel damage (looking down from poop)
(Note shape of *Atlantic Mermaid's* bow embedded in stern of *Hampoel*)

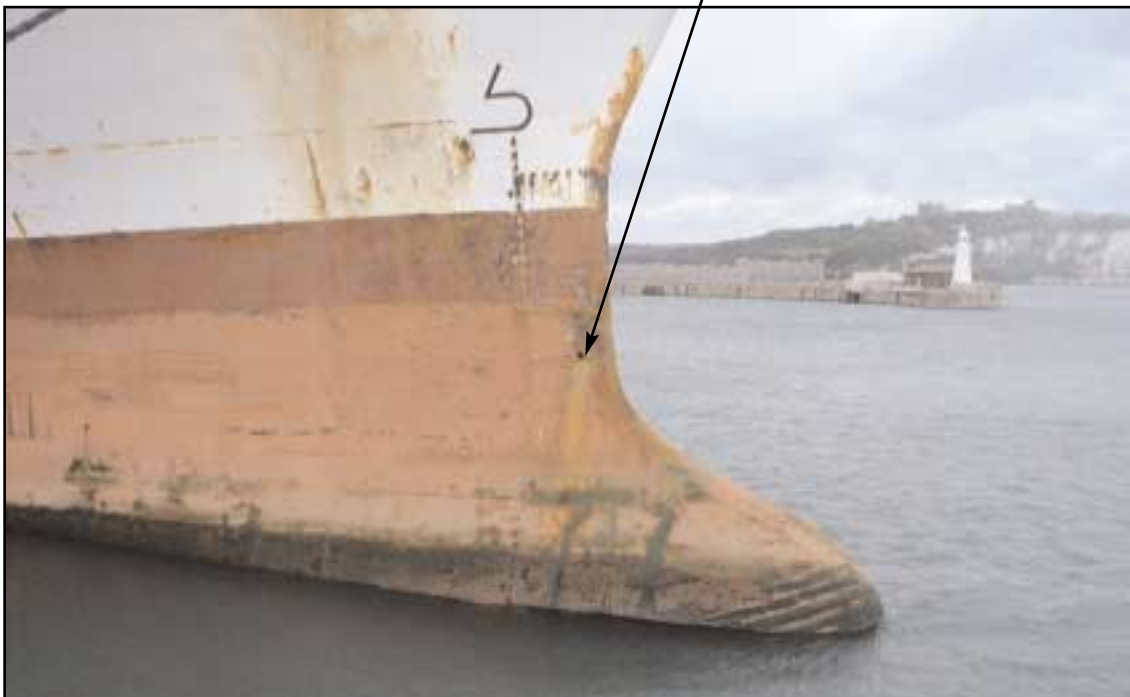
Figure 5

At 0401, *Atlantic Mermaid* anchored off Folkestone. At 0914, she entered Dover harbour. She had sustained a 15cm hole to her bow and some minor buckling (**see Figure 5**).

Hole in bow

Atlantic Mermaid damage

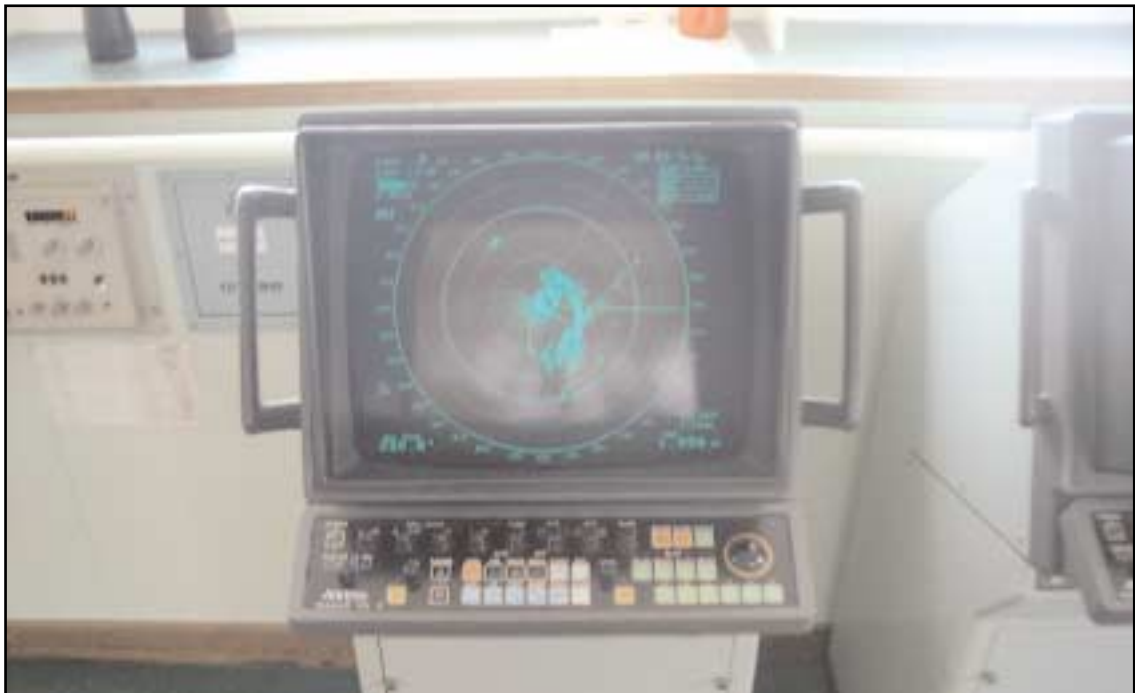
Figure 7

Although not ARPA radars they were capable of acquiring and tracking targets. They were situated next to each other at the front of the bridge, to starboard of the centreline. No 2 radar (port) (**see Figure 7**) had had an intermittent fault for at least the 12 months before the collision. The fault occurred apparently only on ranges below 12 miles and on short pulse. Stabilisation became lost and, with the heading marker remaining in the correct position, all targets rotated clockwise around the screen. Entries concerning No 2 radar were made in the radar logbook at periodic intervals; the last entry before the collision was made by the second officer at 0001 on 6 June stating: "*poor reception on short range*".

A pilot who had recently been on the vessel described the radars as "*appalling*" and "*difficult to use*". He had observed the sea clutter controls on both radars full on without reducing any clutter on No 1 and having only some effect on No 2. He described the overall quality of radar picture as "*poor*" and had to work on longer ranges than he normally would have, to obtain a clear picture. He said that if he had been on the vessel in restricted visibility he would have considered anchoring the vessel because of the condition of her radars.

From the evidence, it is clear that the radars were not ideal for use in conditions with rain and sea interference, and that their overall condition might have been below that required to enable a satisfactory radar watch to be maintained. It is also possible that *Hampoel* was not detected at all on either radar because of their condition and the effectiveness of the clutter controls.

5. The possibility that the radar clutter controls had been turned up to an extent where a small vessel at close range could not be detected. [2.2.1]
6. The overall condition of the radars might have been below that required to enable a satisfactory radar watch to be maintained. [2.2.1]

1. Ensure that all of its vessels are fitted with radars which are in good working order, such that a proper radar watch can be kept.
2. Ensure that identified deficiencies to navigational equipment on its vessels are promptly and effectively rectified.
3. Ensure that there are sufficient bridge watchkeepers on its vessels at all times.
4. Ensure that the ability to keep a proper watch is not constrained by:
 - Additional tasks to watchkeeping
 - Lack of movement for all round visibility
 - Fatigue
 - Reduced vigilance

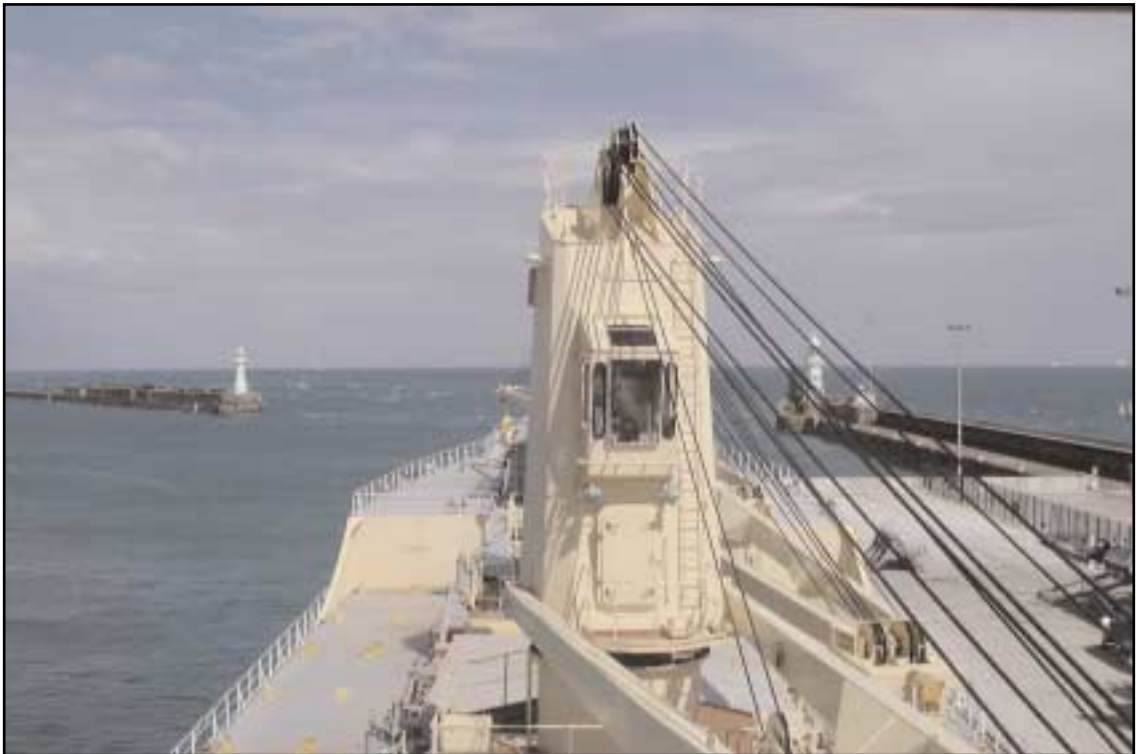
Figure 10

vessels fine on the port bow, because they are obscured by the deck cranes (see Figure 10). It is likely that the master, intentionally or otherwise, spent a large proportion of his time in the vicinity of the radars, and therefore was prevented from seeing vessels fine on the port bow.

3. The deck cranes obscuring vessels fine on the port bow from where the master probably spent a large proportion of his time. [2.2.1]
4. The visual lookout being hampered by the weather conditions. [2.2.1]
