Report on the investigation of
the collision between the chain ferry

Bramble Bush Bay

XOD class yachts

**Report No 20/2002
June 2002**

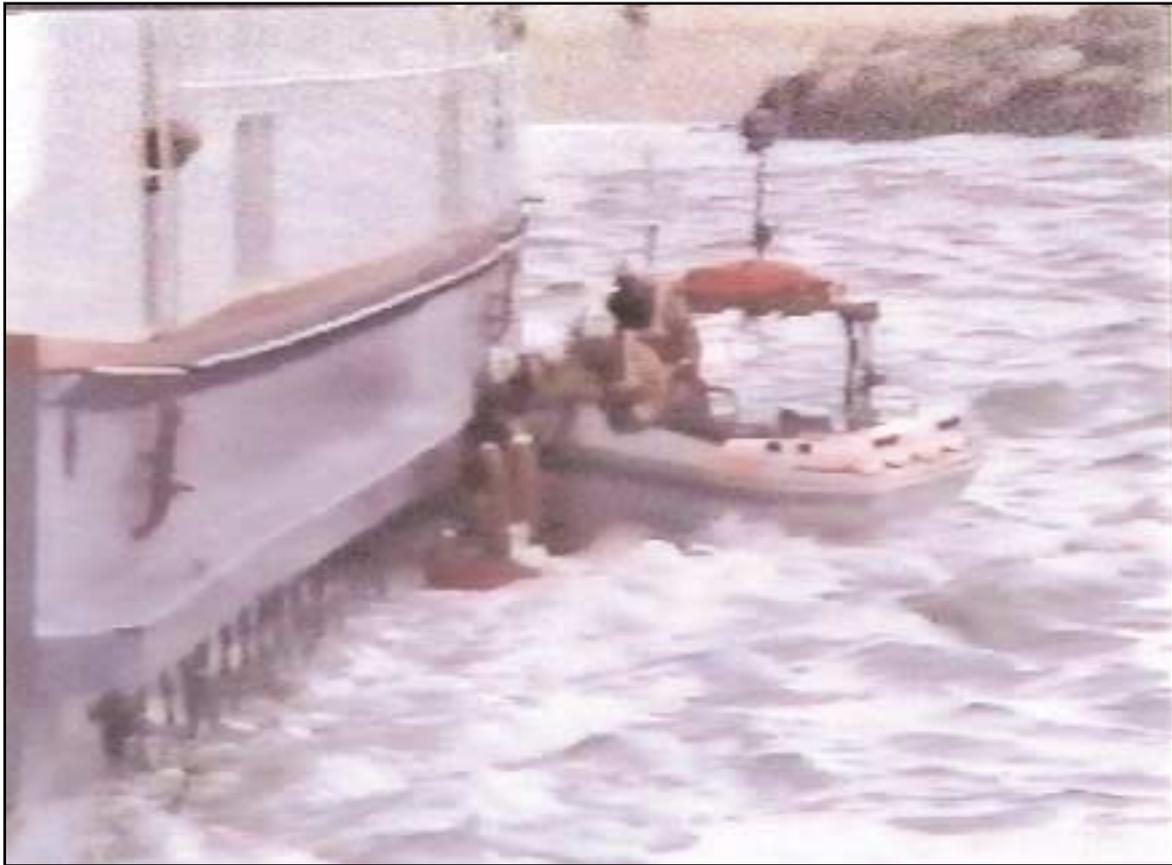
Photograph 7

The inshore lifeboat tried to recover the owner and his other crew member, who were in danger of being swept under, by going alongside the chain ferry (**see Photograph 7**). One of the crew was able to hold on to the owner and a line was placed around him. The owner's crew member held on to the chain ferry's lifebuoys, which had been lowered to him from above. The lifeboat had returned to the other side and, seeing that the inshore lifeboat was also in danger of being swept under the chain ferry, and could not manoeuvre away from her side, a towline was passed, and the inshore lifeboat was towed off (**see Photograph 8**). Once free of the chain ferry, the owner was then pulled aboard the inshore lifeboat (**see Photograph 9**).

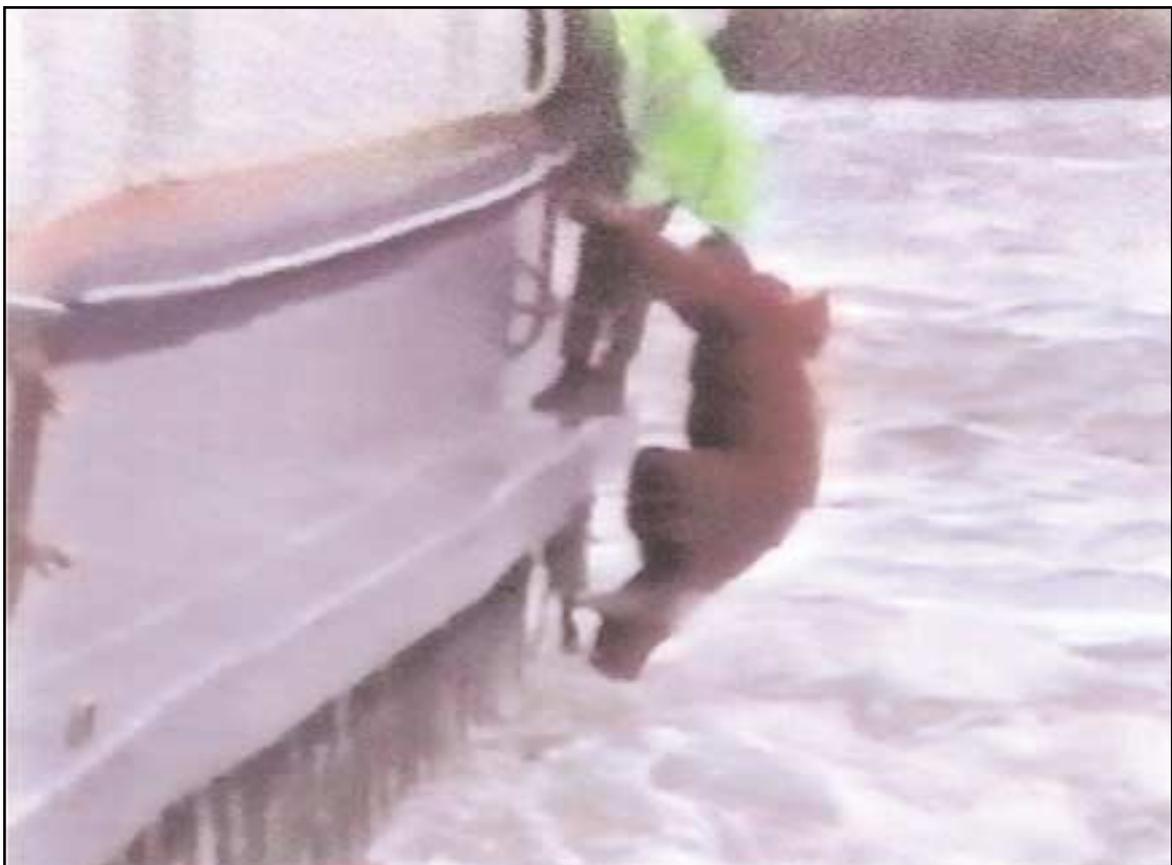
Photograph 10

The owner's crew member had moved along the grab lines to a side ladder, and he was able to climb on to the sponson and enter the chain ferry through a shell door (**see Photograph 10**).

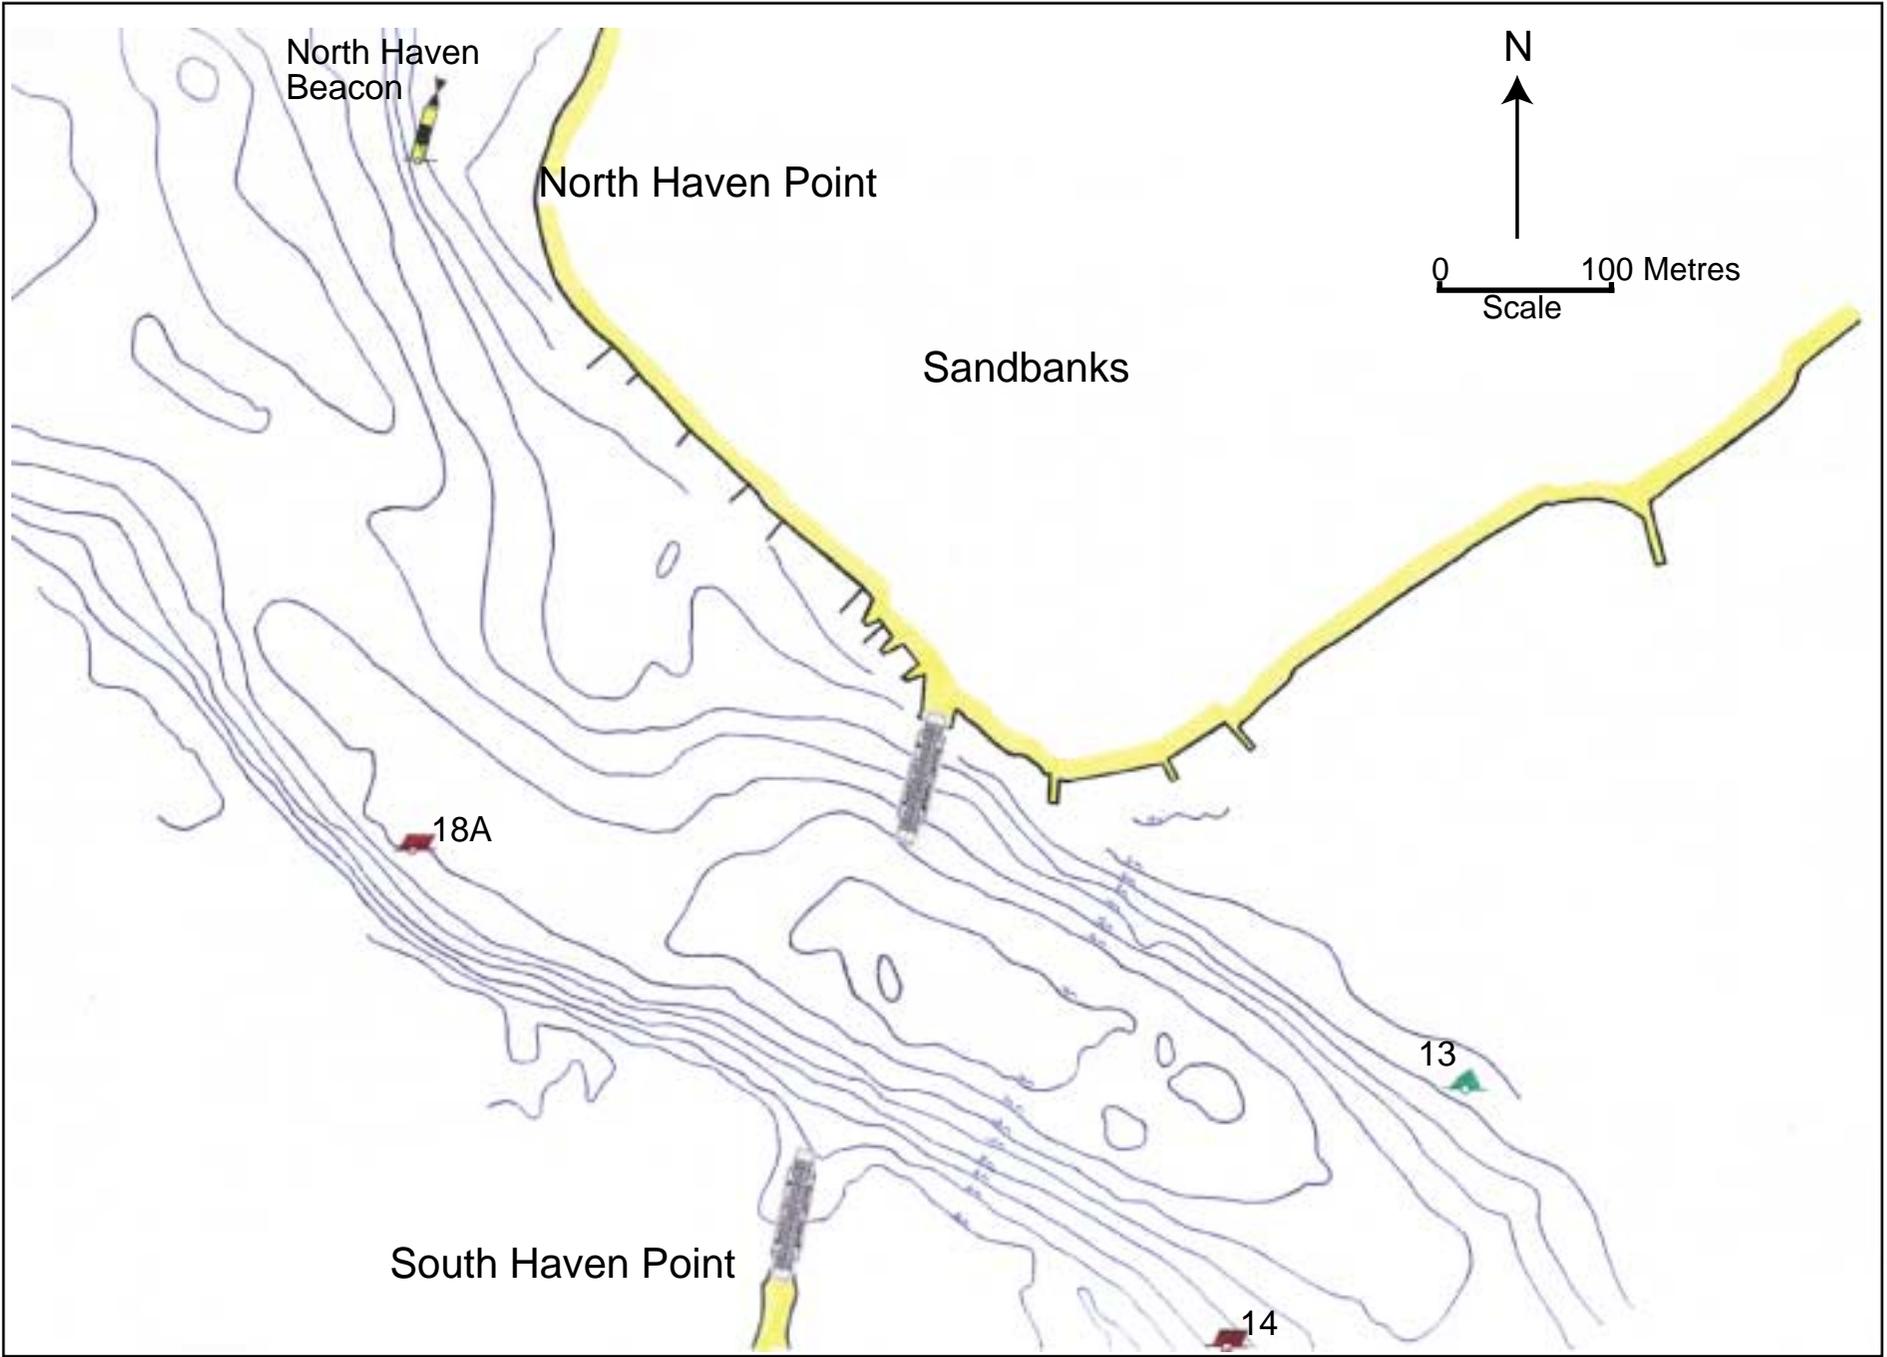
Diagram 2

The skipper maintains contact with Poole Harbour Port Control by VHF radio to learn of all commercial shipping movements. When the high-speed ferries enter or leave the harbour, the skipper informs them by VHF radio, on which side of the entrance the chain ferry is. When a large conventional ferry enters or leaves, the chain ferry remains at South Haven Point, as she does not protrude into the entrance as much as on the Sandbanks side (**see diagram 2**).

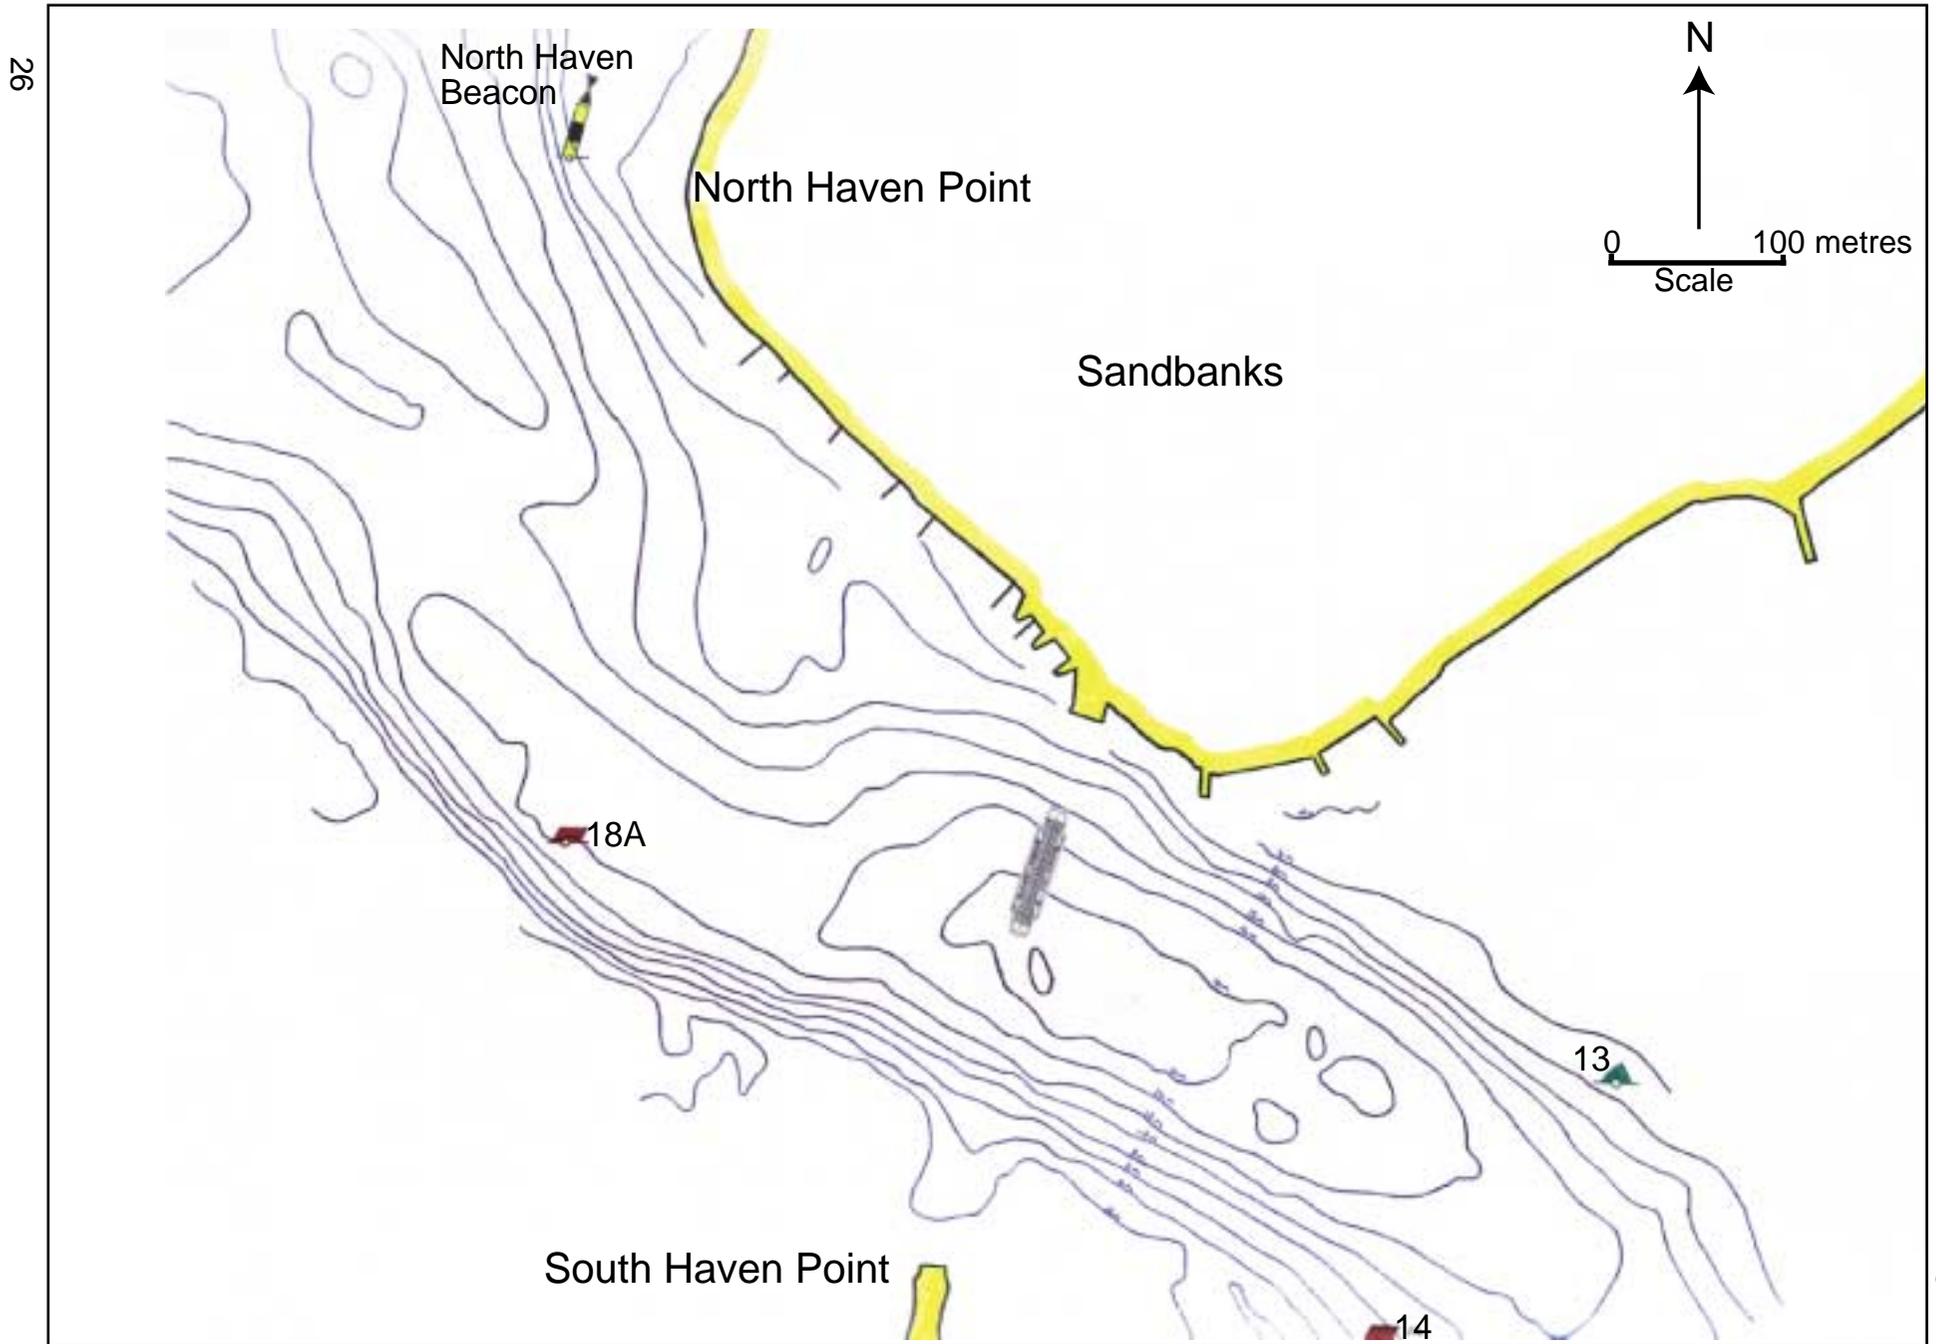
The position of *Bramble Bush Bay* when the incident occurred

2. The north-easterly wind caused a lee close to the Sandbanks shore and the XODs to lose steerage way, while approaching the chain ferry. [2.3]
3. The chain ferry's skipper's decision to leave the slipway and to head for a gap between the leading group of XODs and the rest of the fleet. [2.3]
