Report on the investigation
of shift of cargo containers,
involving dangerous goods on

Dutch Navigator

25 - 26 April 2001

**Report No 37/2002
November 2002**

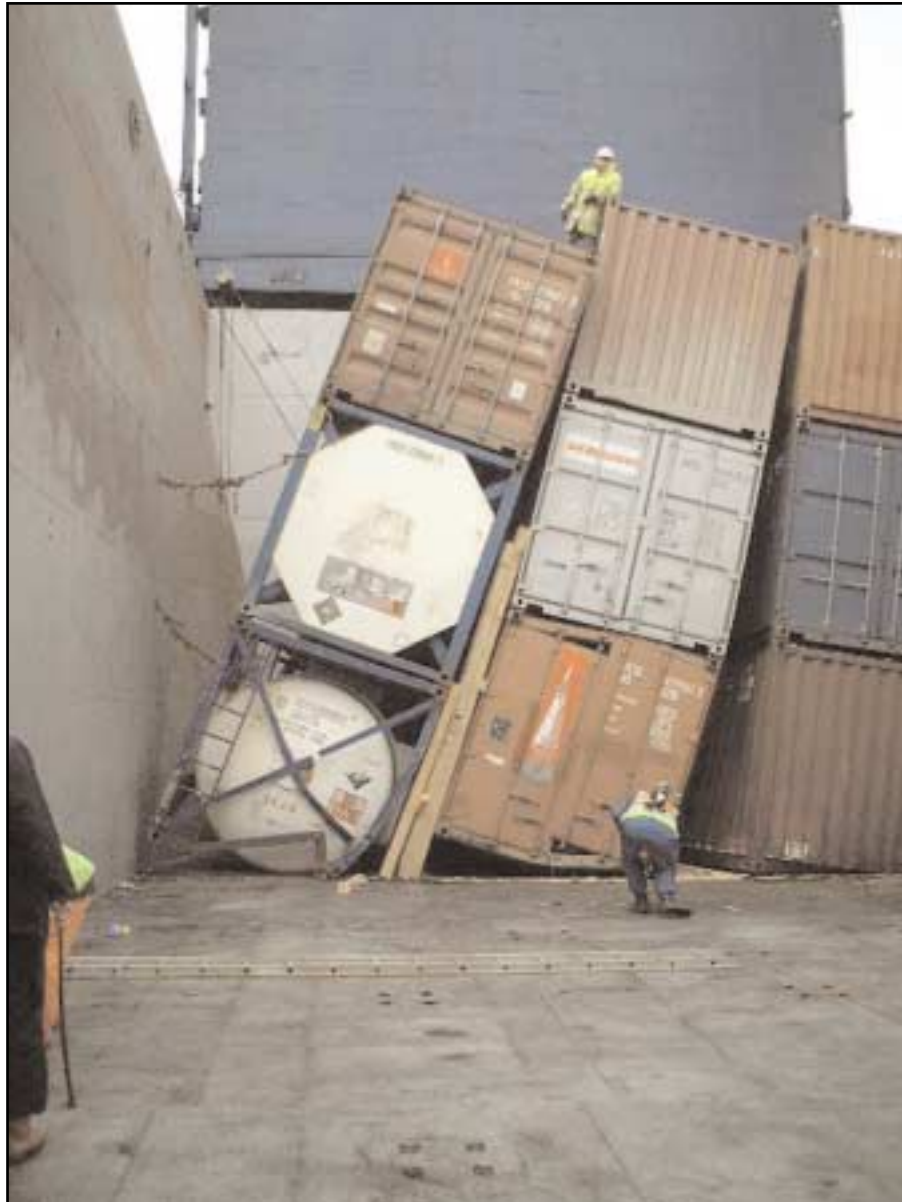
Figure 3

All the containers in the foremost underdeck bay, Bay 1 just forward of a portable bulkhead, were found to have shifted to starboard and/or to have been damaged to some degree (**see Figure 3**). Discharging continued, allowing a closer examination of the affected containers. By 1530, Bristol Port Company (BPC) had become concerned about the safety implications of the shifted stow. Advisers on the properties of the dangerous goods in the two tank containers were on scene at 1545. Following a meeting with their technical advisers, BPC declared a "Port Emergency" at 1710.

View of stow in Bay 1 looking forward

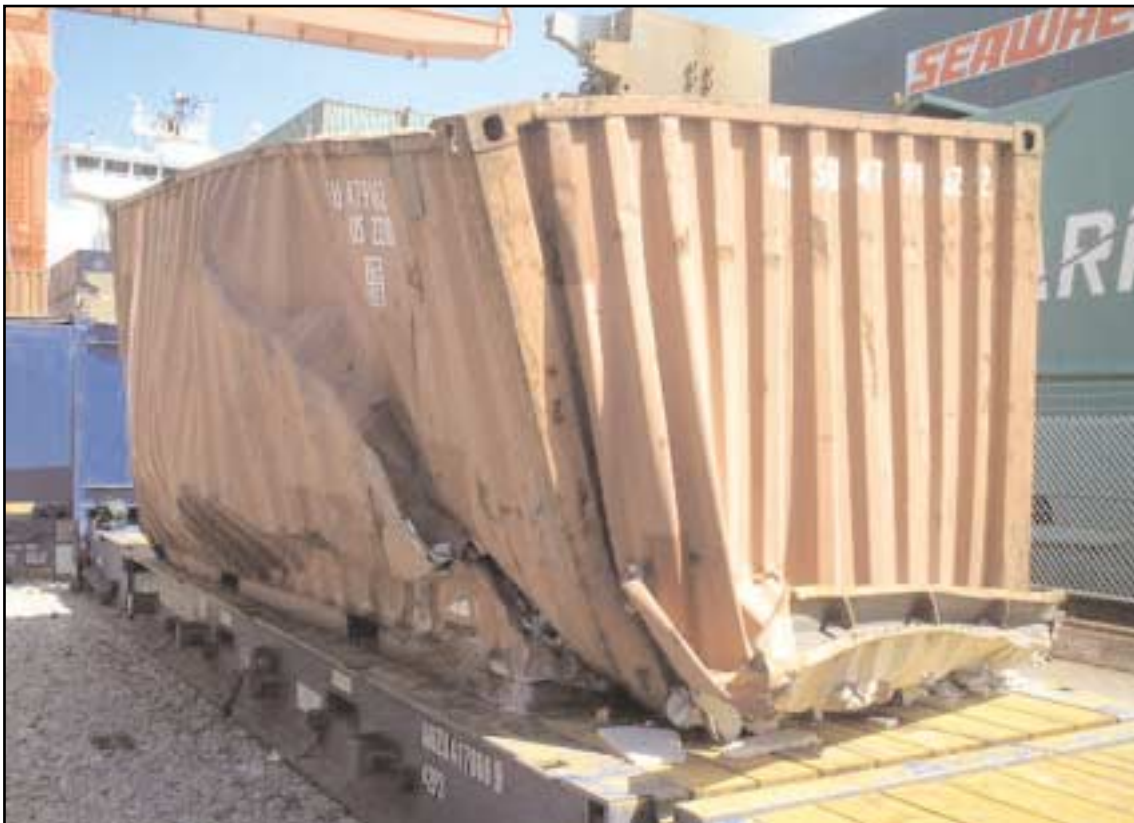
Figure 5

All three lower containers showed signs of damage because of racking and, to varying degrees, crushing.

Box containers from Bay 1

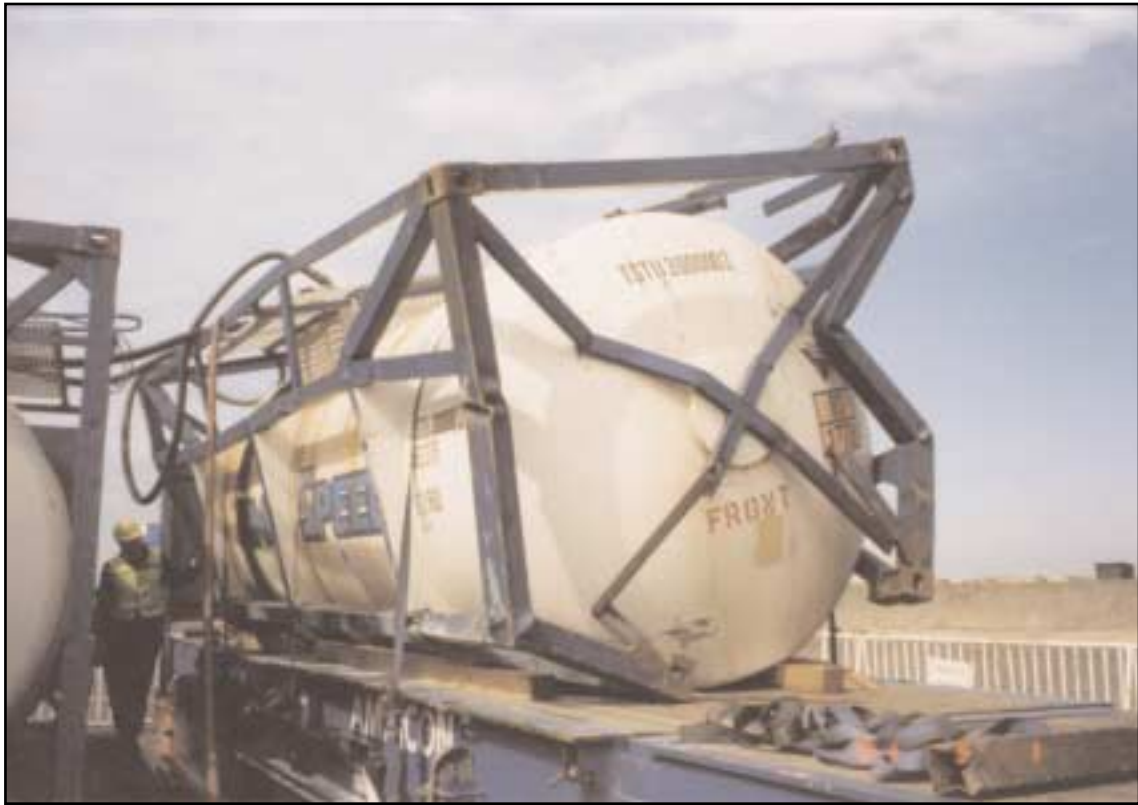
Figure 12

The diagonal members, or cross-bracing, of both end frames had failed. Those on the front frame both showed signs of failure because of compressive loading resulting in buckling. One diagonal member had fractured at the site of a butt-welded repair. The lower horizontal cross-member had separated from the front corner castings, at welded joints, and both corner posts had buckled.

Damaged front end frame

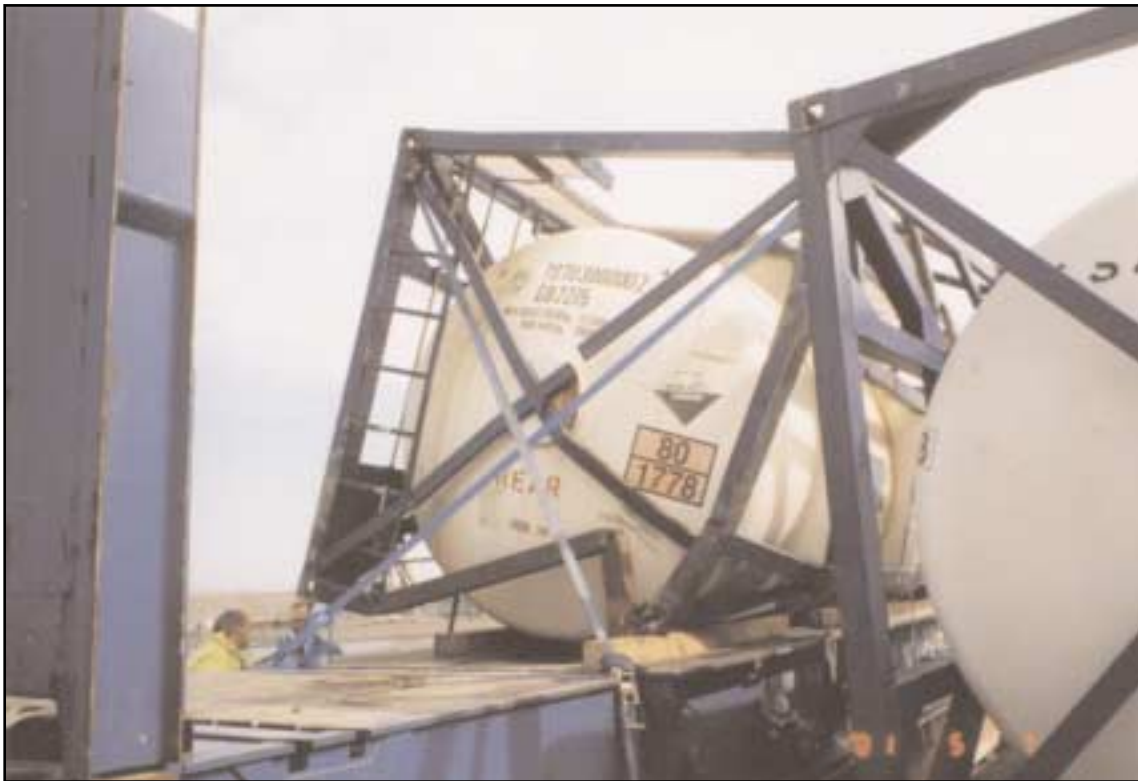
Figure 13

On the rear frame, the diagonal members each showed signs of failure by different types of loading; one due to compression, the other tension. One had fractured, again at a butt-welded repair. A corner post was badly bent as was the lower cross-member.

Damaged rear end frame

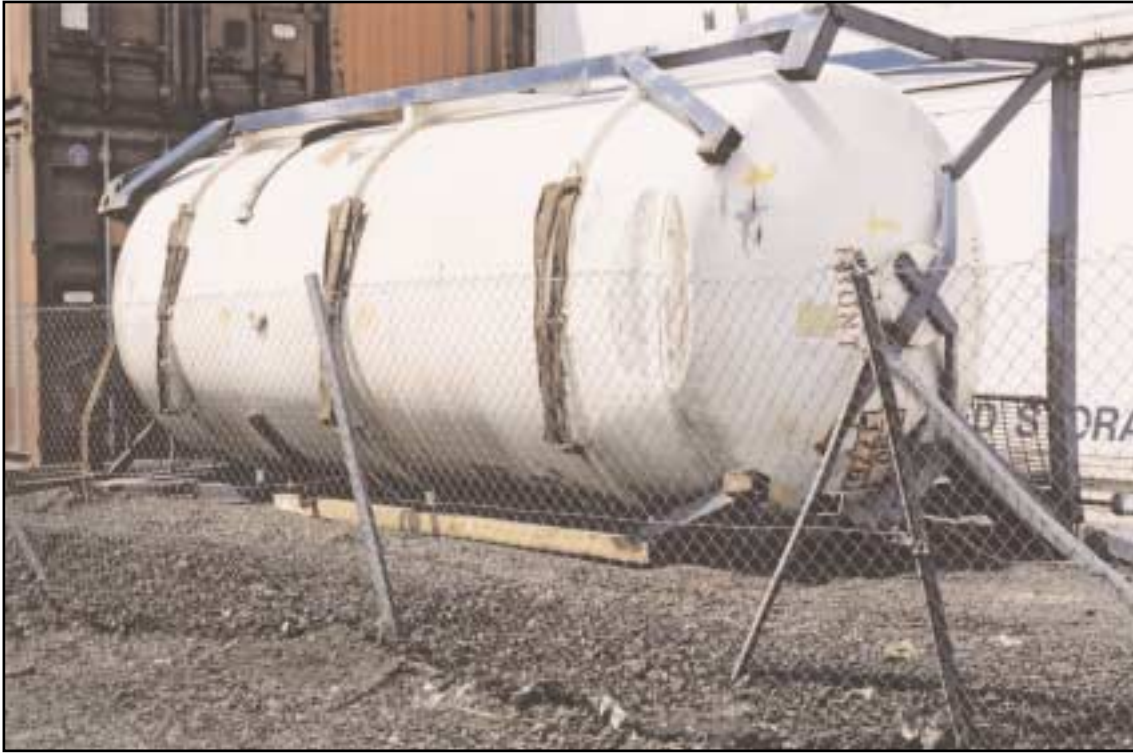
Figure 14

The frame had suffered deformation and fracturing damage, which was severe in the end frames. As a consequence of the collapse of the frame, the tank barrel had come into contact with the tank top of *Dutch Navigator*, causing deformation damage to the barrel (see Figures 12, 13, 14 & 15).

This deflection of the barrel was sufficient to cause the sump dome to make contact with the end of the dip tube. This effectively sealed the dip tube, making it impossible to empty the tank by normal means. This was why a separate pump was used to remove the acid after the container was landed ashore.

Damage to bottom of barrel

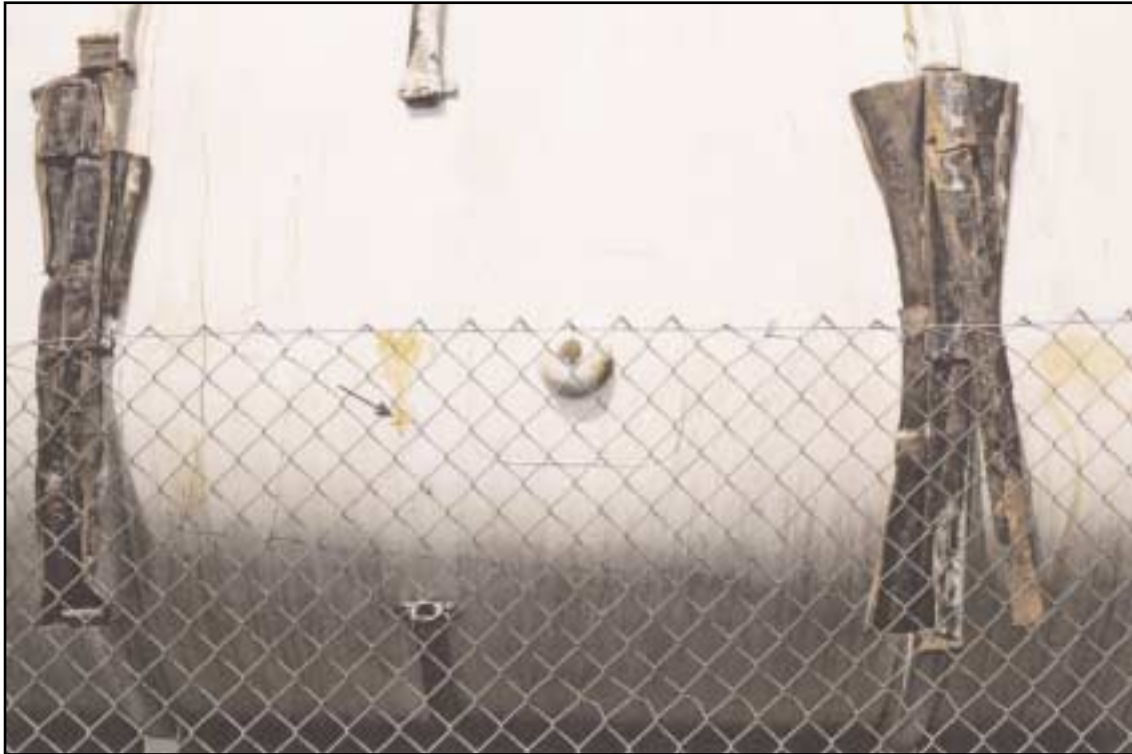
Figure 16

The first leak site investigated was adjacent to the sump dome (**see Figures 16 & 17**).

Site of leakage, shown arrowed

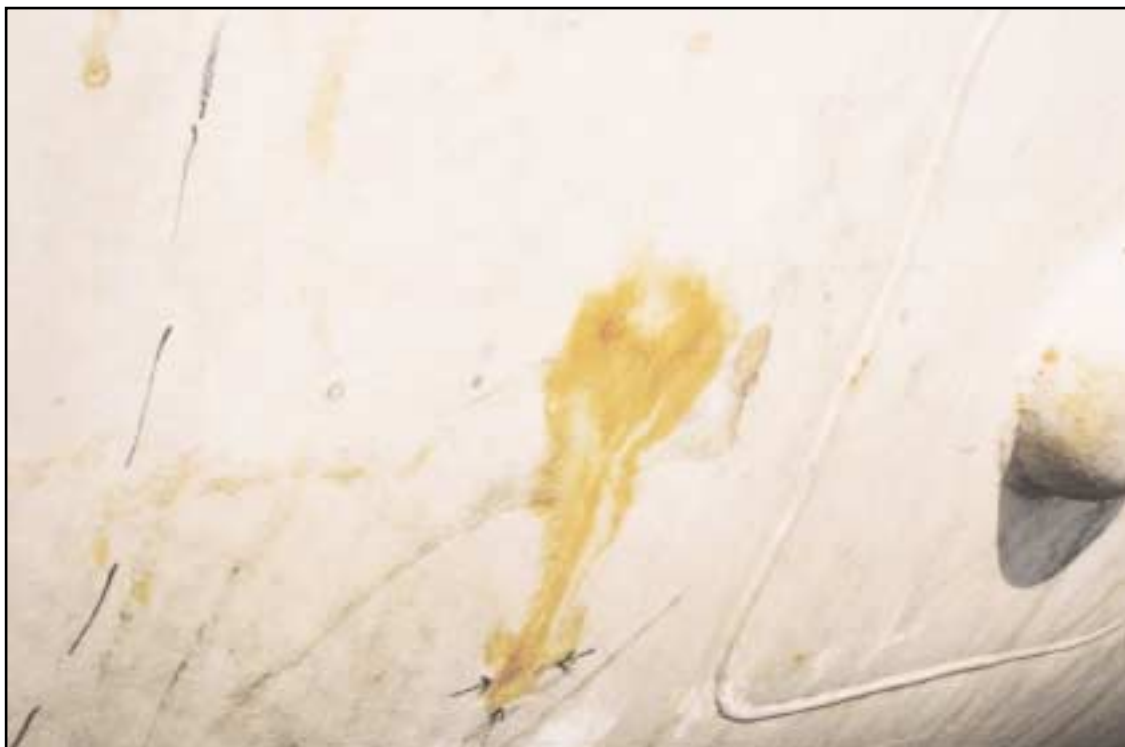
Figure 17

Site of leakage and associated rust staining

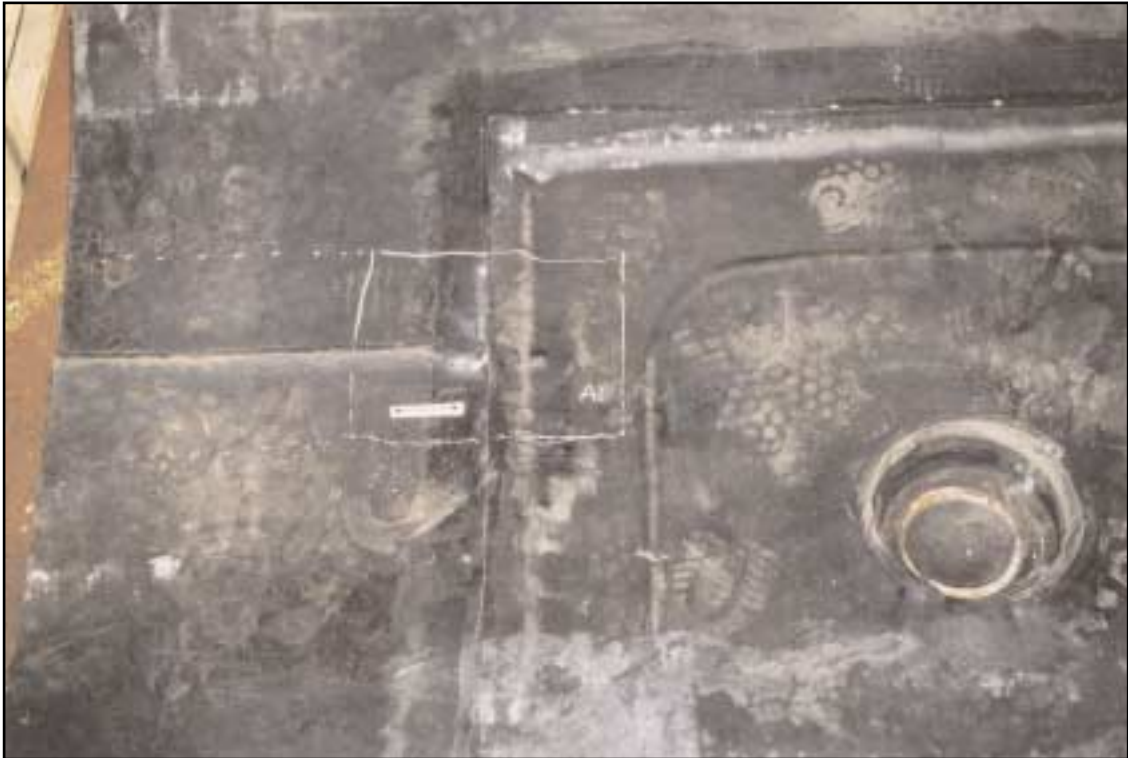
Figure 18

This leak site was located close to a 'T' joint in the liner, where a longitudinal seam intersected a rectangular insert or patch around the drain sump (**see Figure 18**). A sharp cut in the liner coincided with this leak site. This cut was 21mm long and extended from the patch's edge in the tank's longitudinal direction (**see Figure 19**).

'T' joint in liner

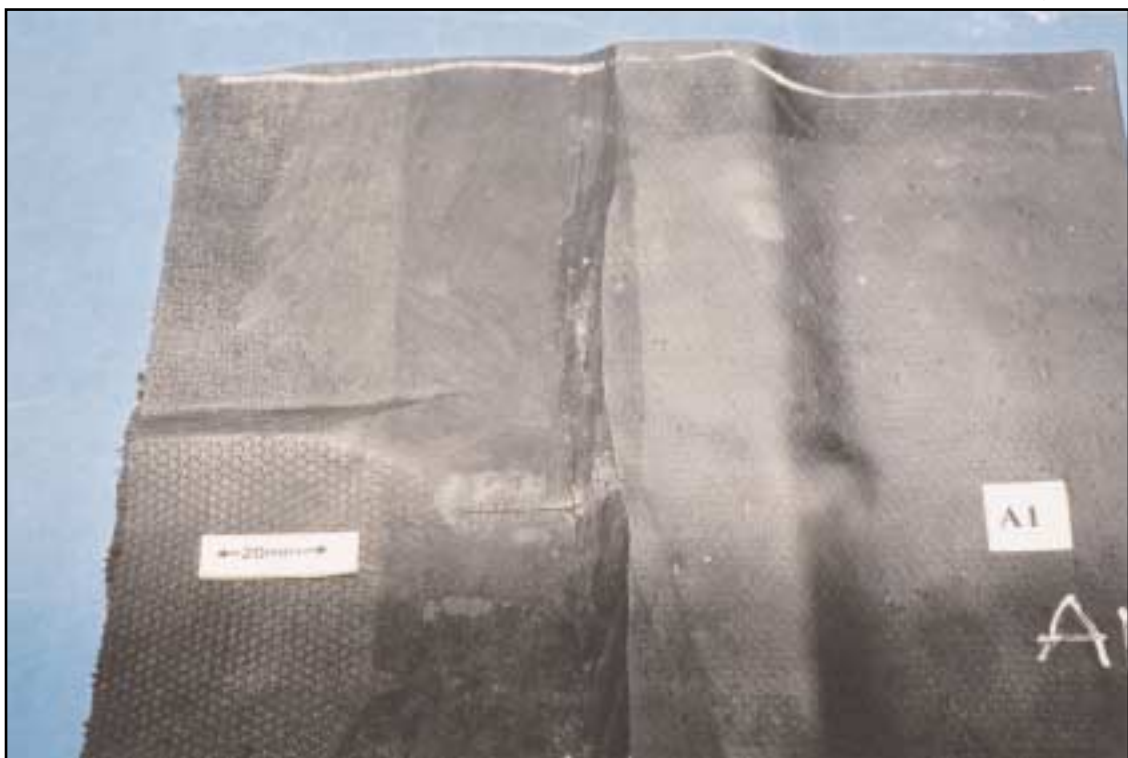
Figure 19

Cut in butyl liner
(lower centre of figure)

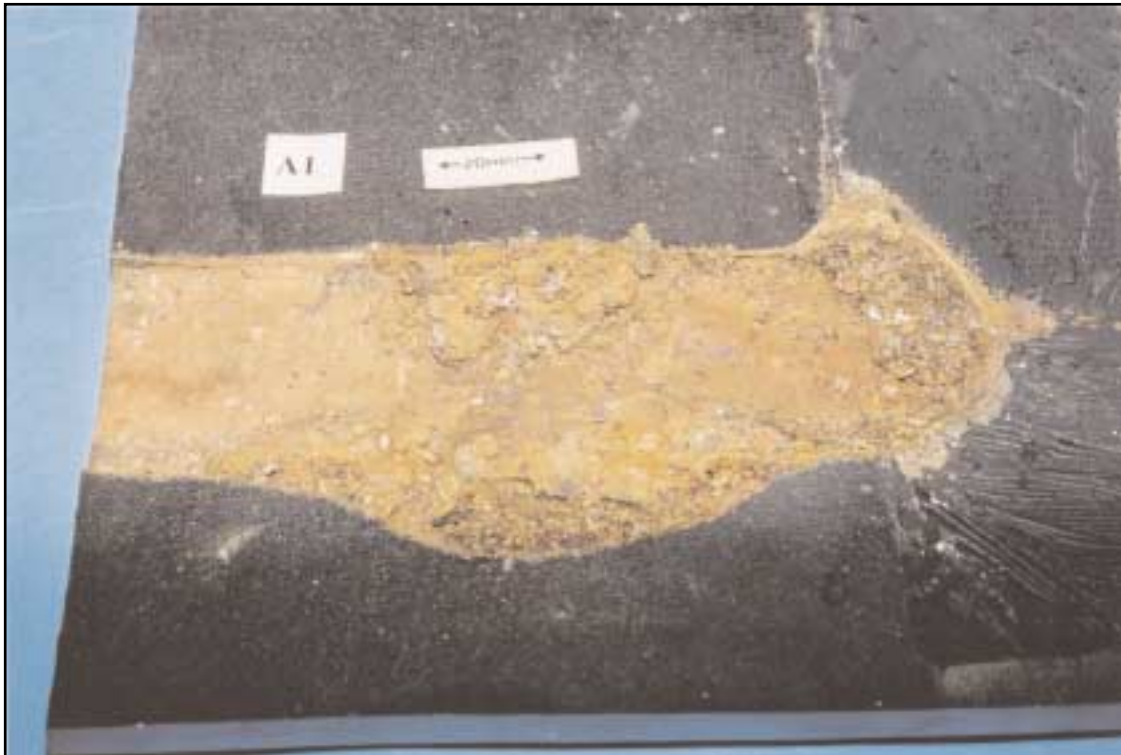
Figure 20

The liner was stripped from this part of the shell to examine the liner/shell interfaces. The shell showed some corrosion (**Figure 20**). Sections taken through this damage show the leak site (**Figure 21**) and areas where corrosion extended over 50% through shell thickness (**see Figure 22**).

Shell corrosion in region of liner's 'T' joint

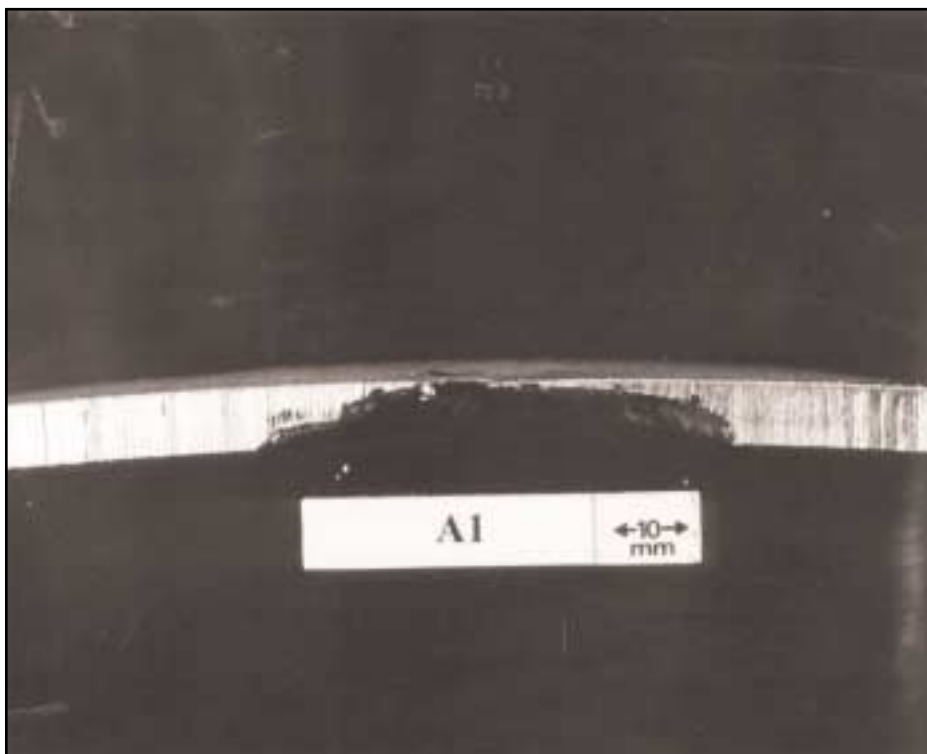
Figure 21

Section through corroded part of shell under liner's 'T' joint showing leak site

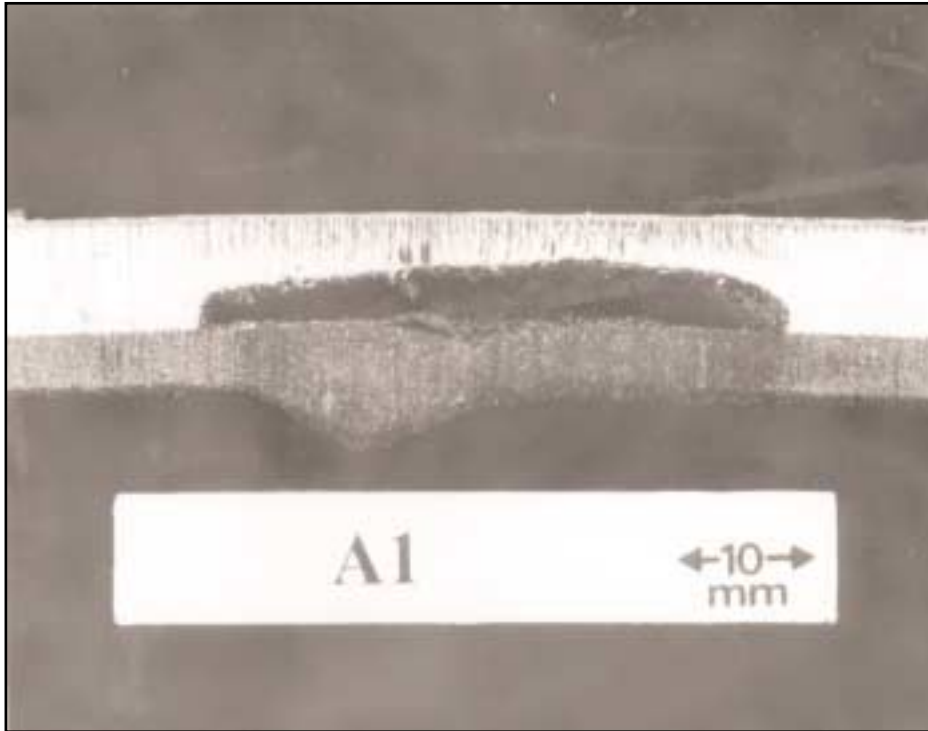
Figure 22

Under-liner corrosion damage

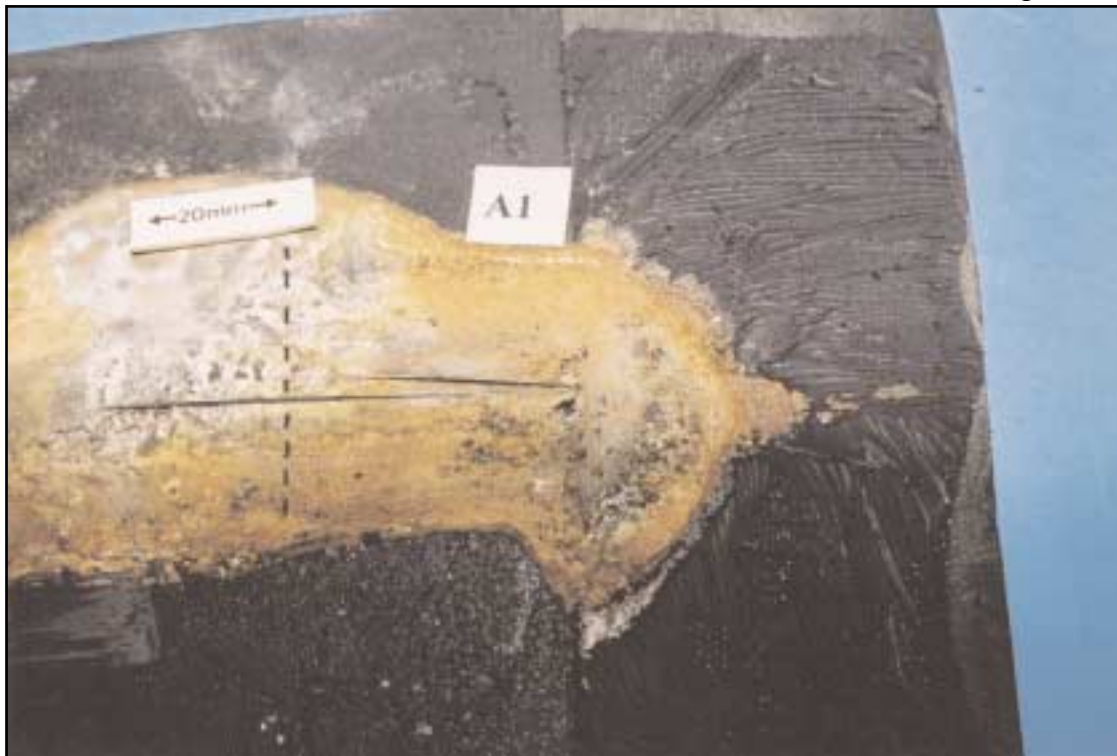
Figure 23

Cuts in underside of butyl liner

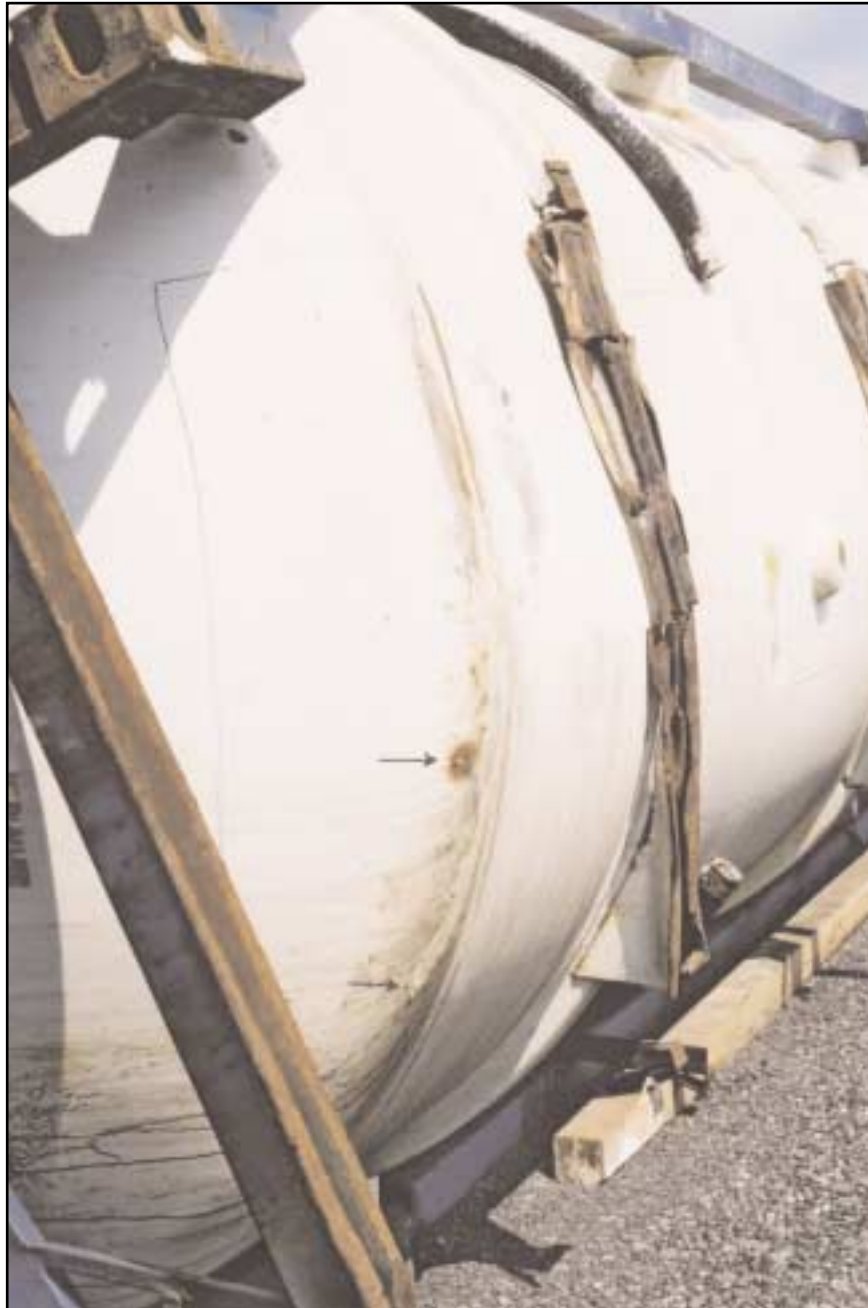
Figure 24

Suspected second leak site and corrosion damage - both arrowed

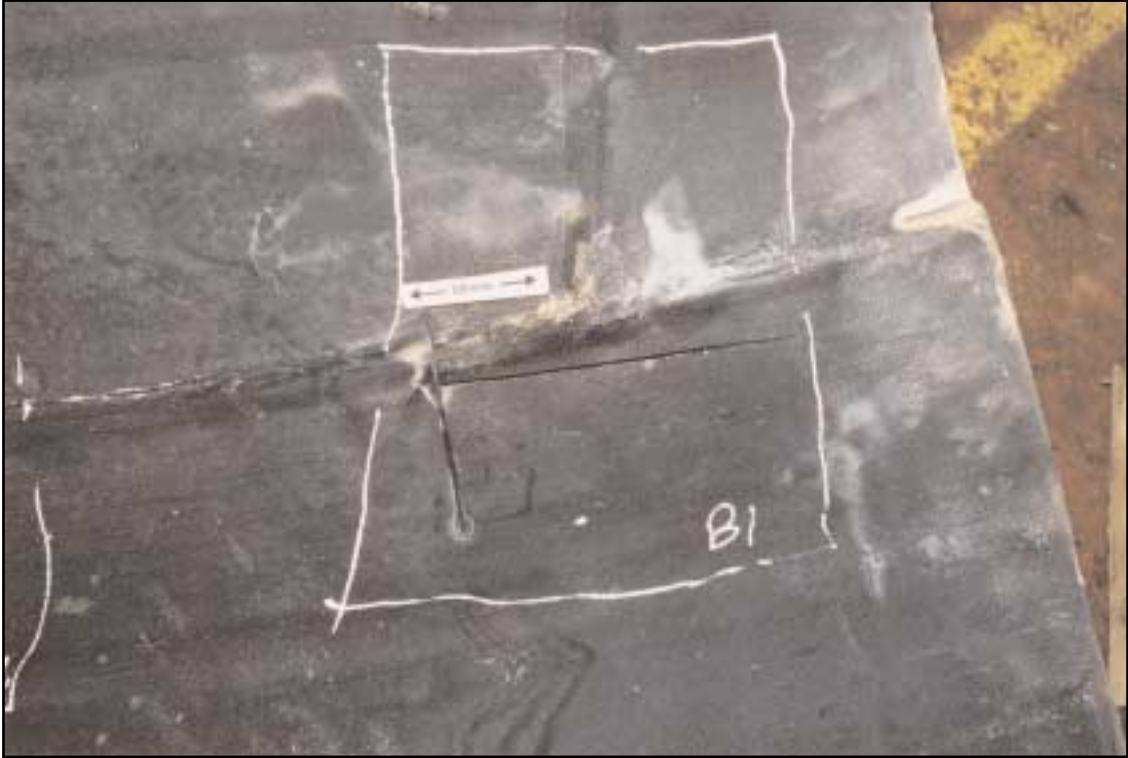
Figure 25

However, the second leakage site coincided with another "T" joint in the liner (**Figure 25**). Removal of the liner in this area confirmed local corrosion damage (**Figures 26, 27 & 28**). A corresponding defect in the liner joint was found using a dye penetrant technique (**Figure 29**). It was through this defect that acid had been able to come into contact with the shell plating.

Second leak site

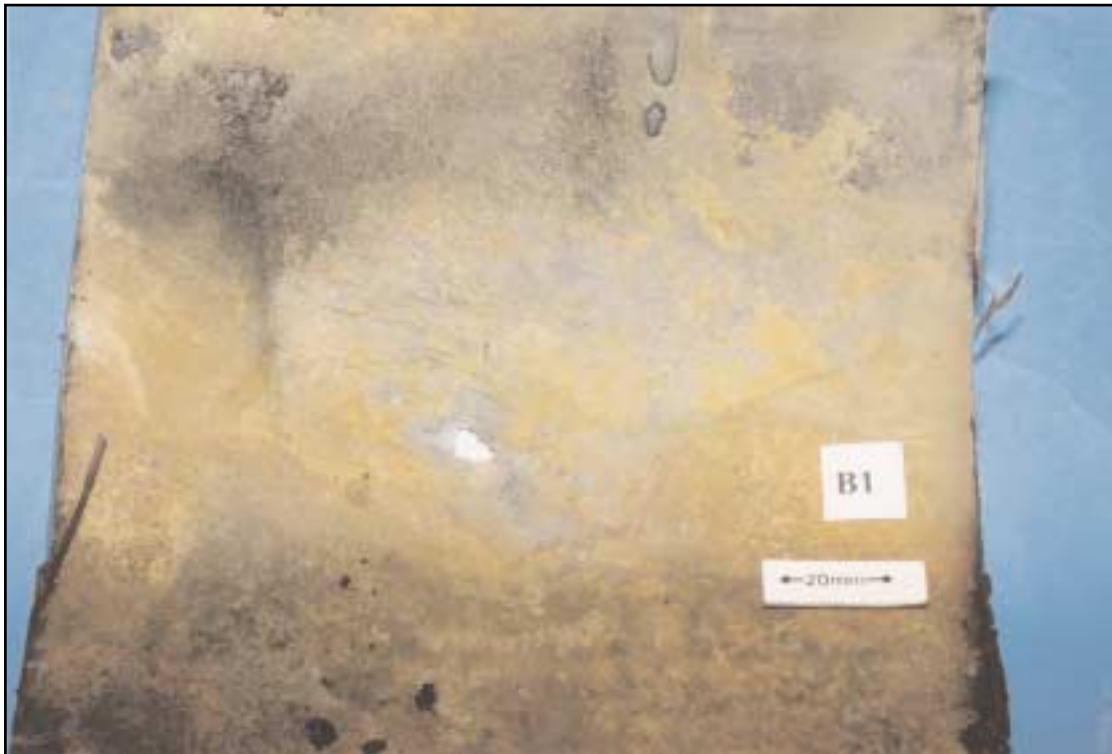
Figure 26

Second leak site - view on inner surface

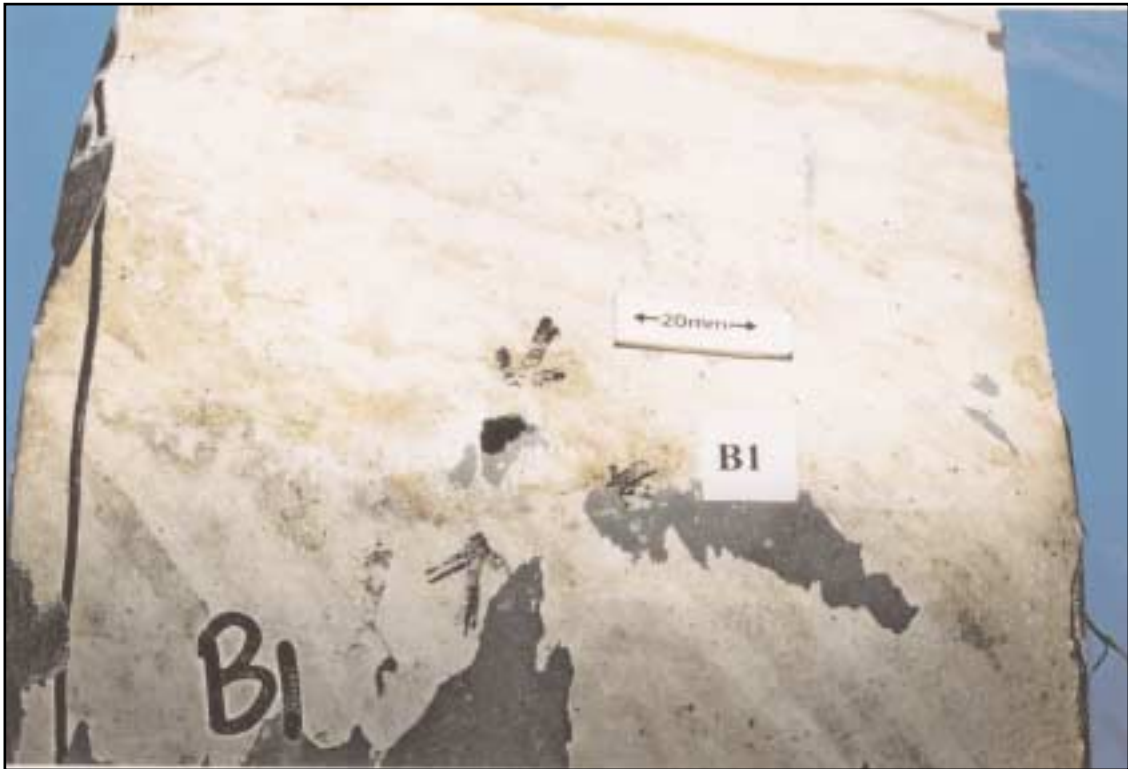
Figure 27

Second leak site - view on outer surface

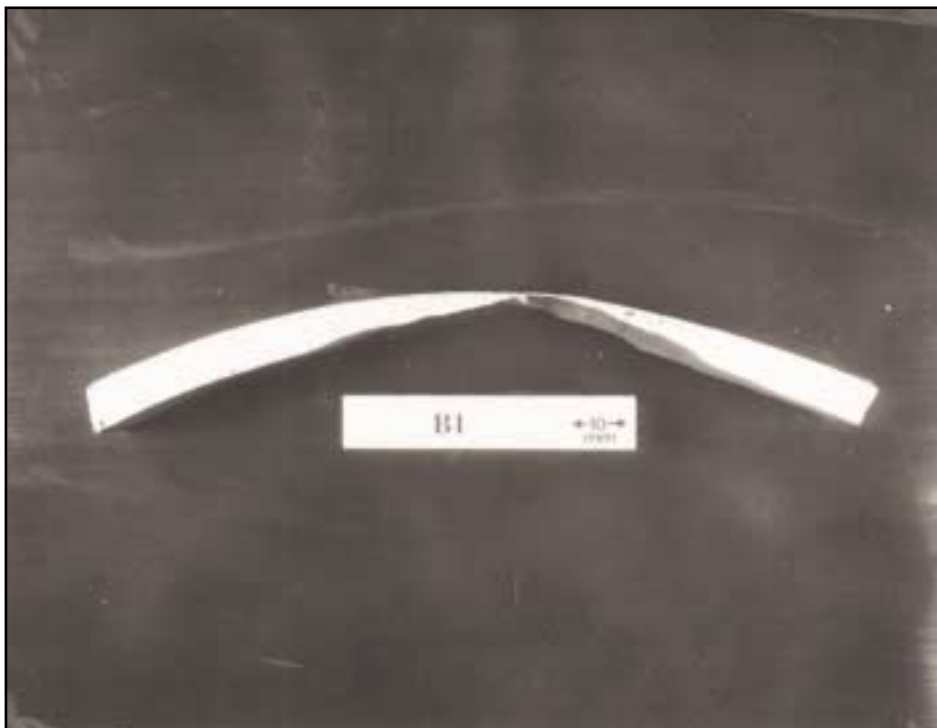
Figure 28

Section through second leak site

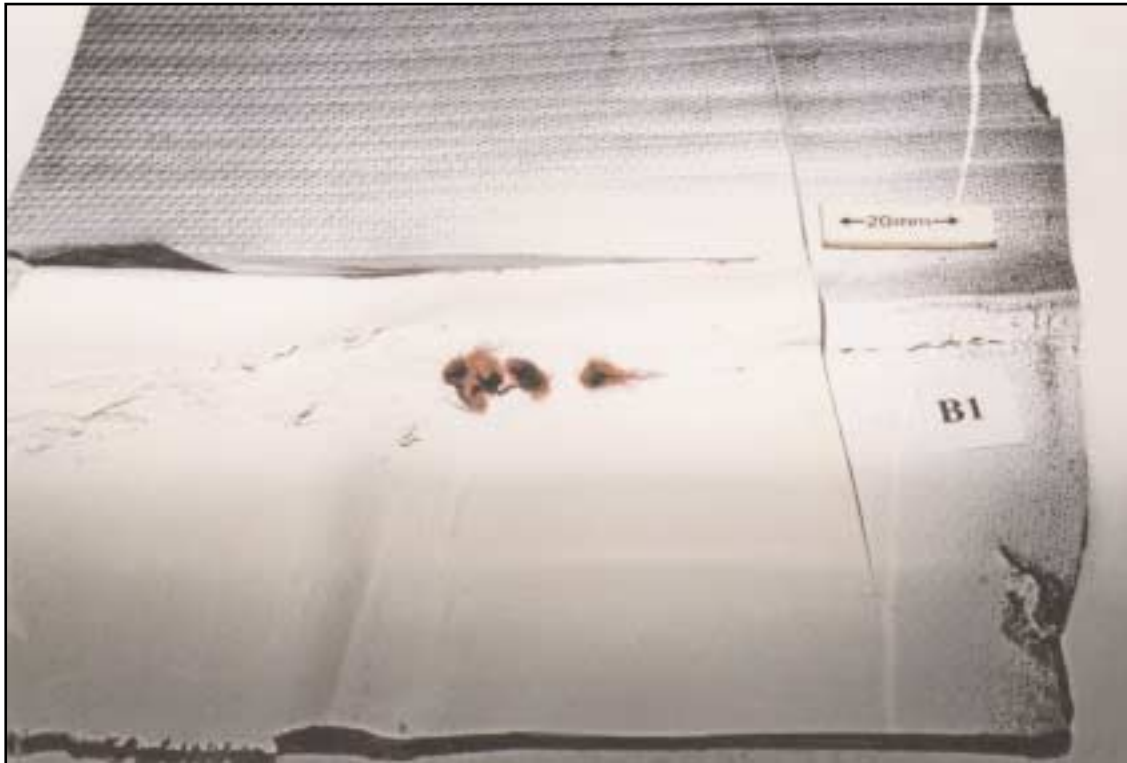
Site of liner perforation identified by dye penetrant test

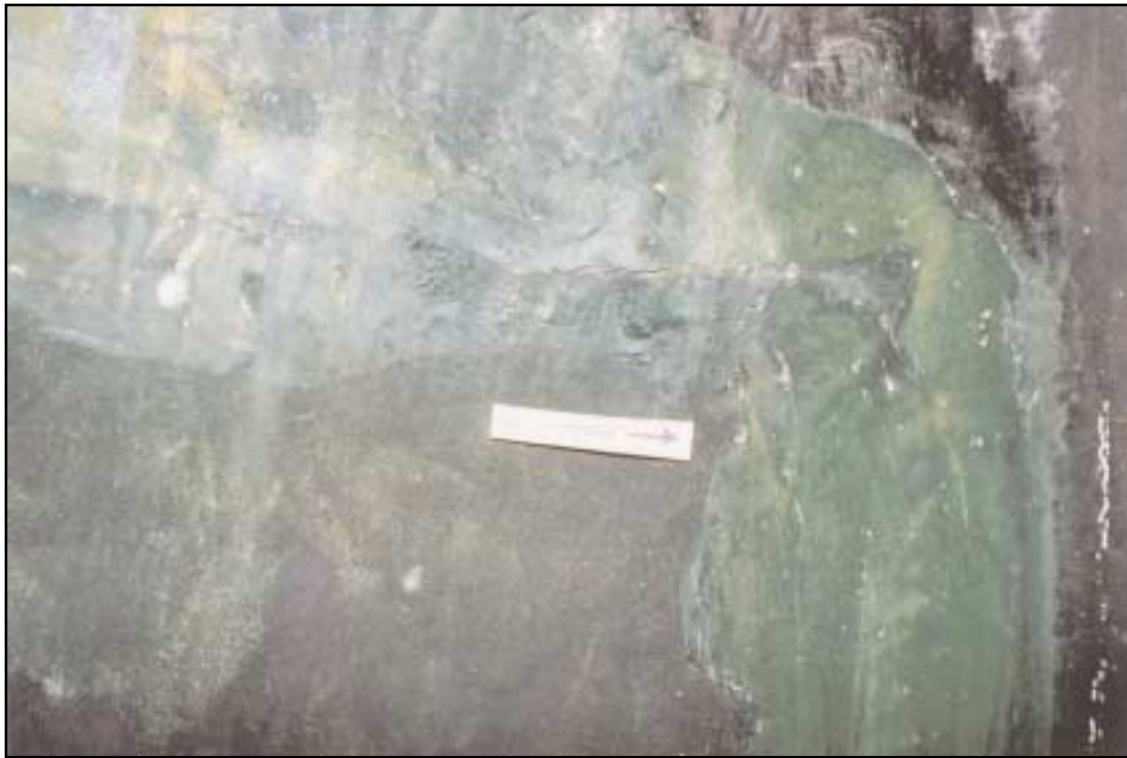
Figure 30

Another feature of the liner was noted during these examinations. Efforts had been made to perform surface repairs to the liner in this region. These consisted of over-painting the liner with a hard brittle resin which showed extensive post-application cracking (**Figure 30**). However, the examination showed no evidence of liner debonding, or defects in the liner's jointing in these regions of resin application. Samples of this resin were examined, and it showed the characteristics of an epoxy resin of the type commonly marketed under the name 'Araldite' (**Figure 31**).

Cracking in resin material used for repairs

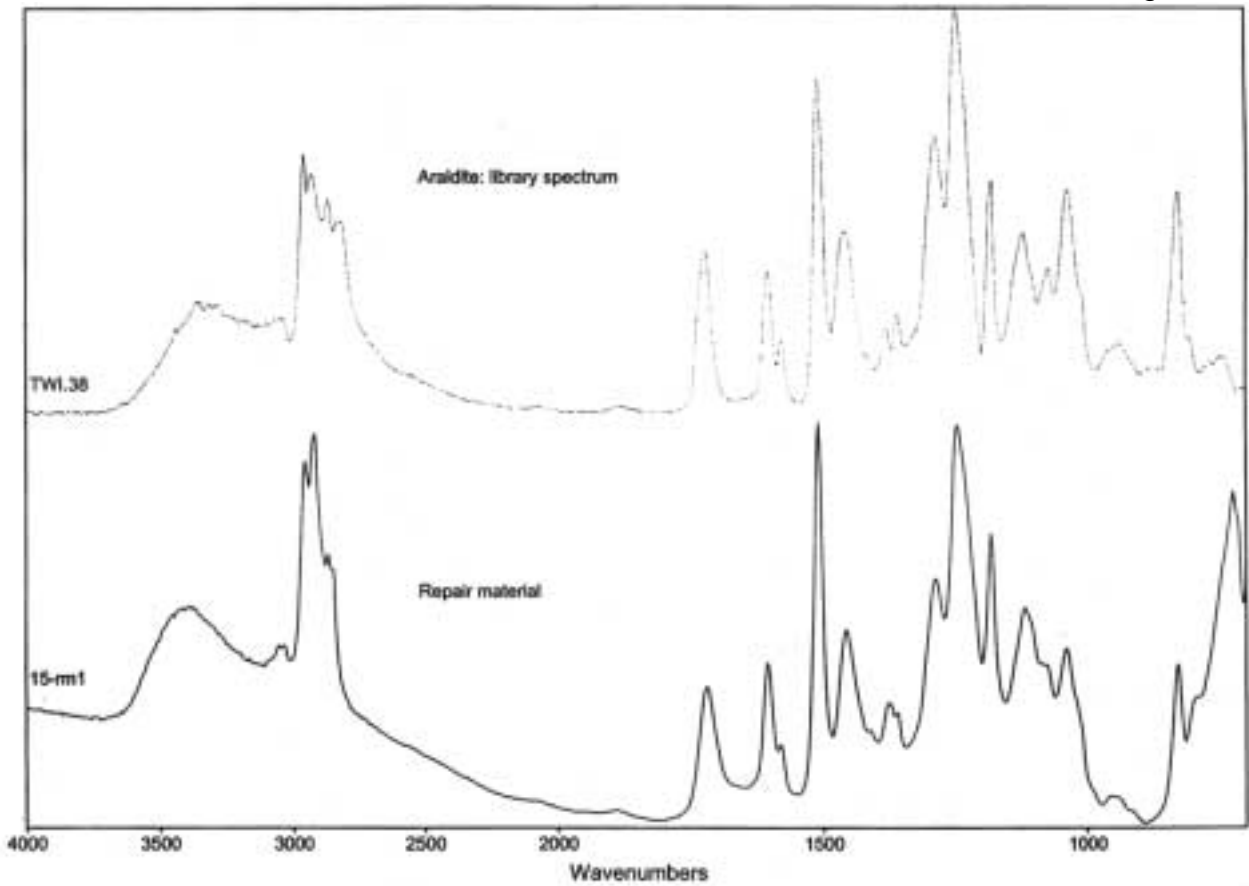
Figure 31

Comparison of repair material and epoxy resin

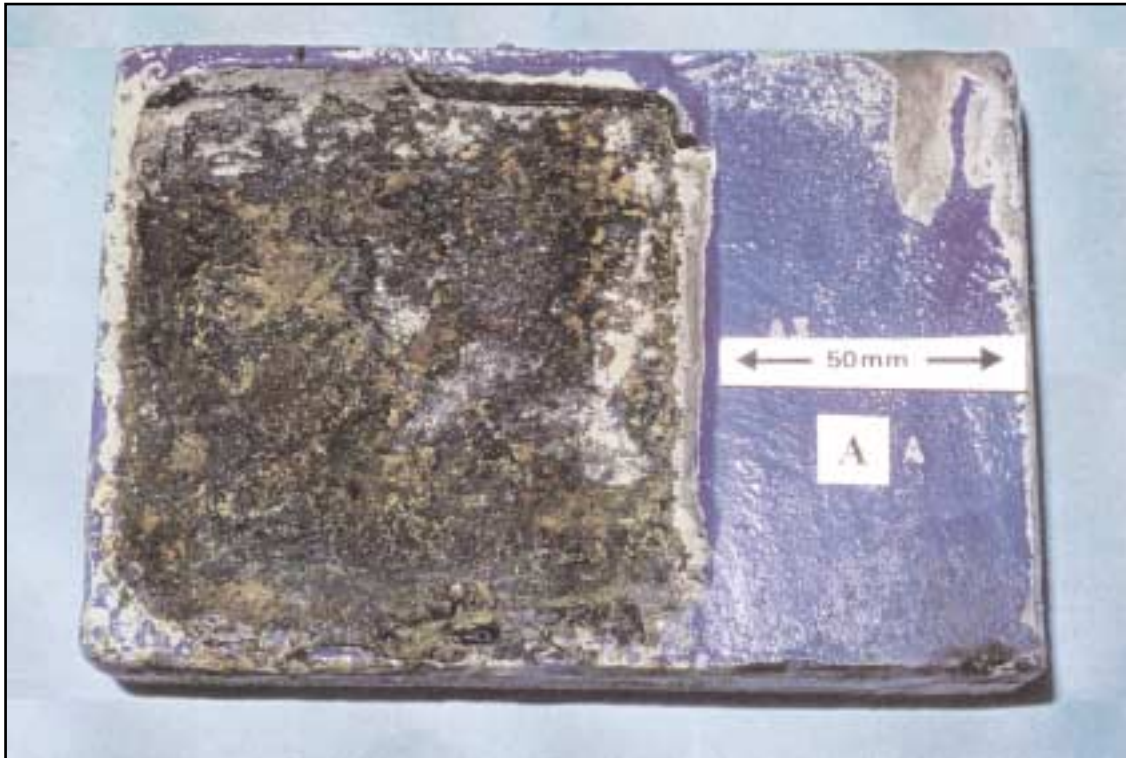
Figure 32

Front left corner post

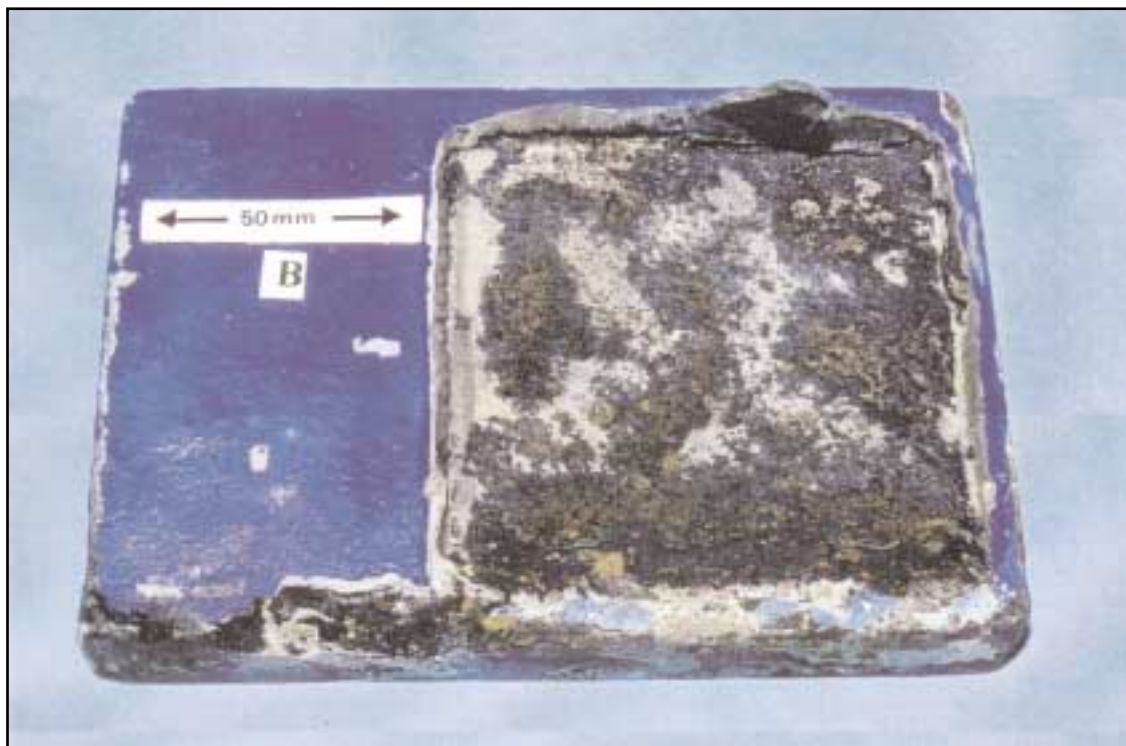
Figure 33

Front right corner post

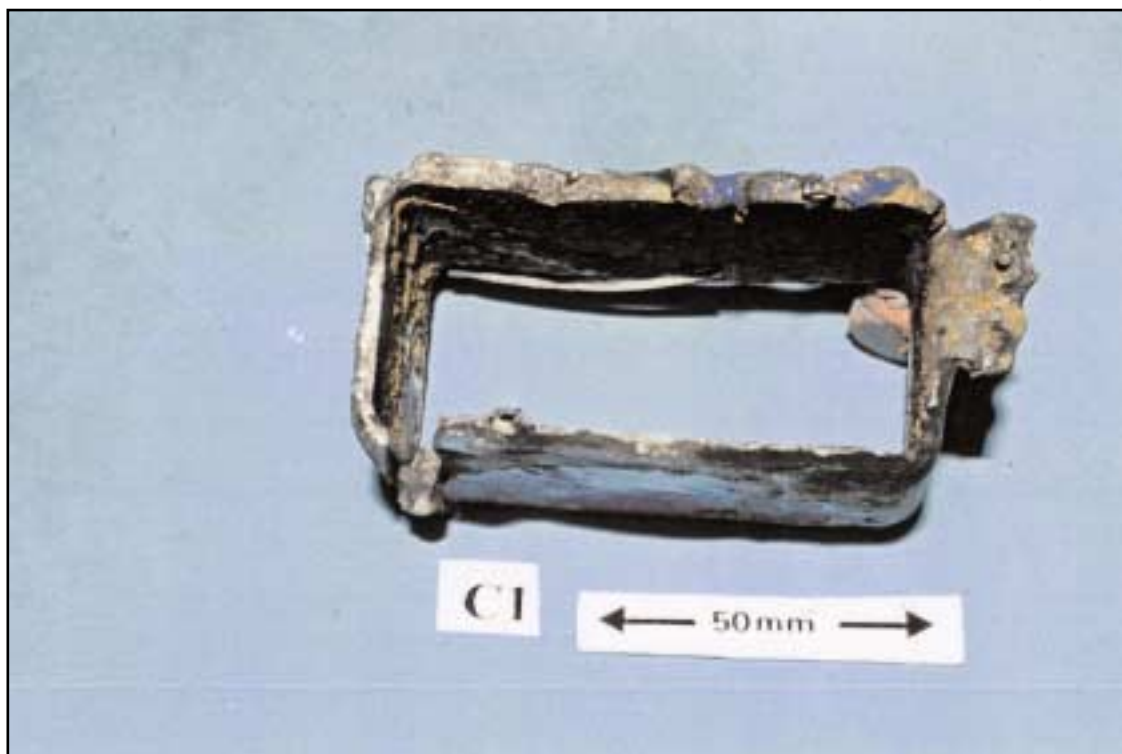
Figure 34

Failed weld repair on front diagonal

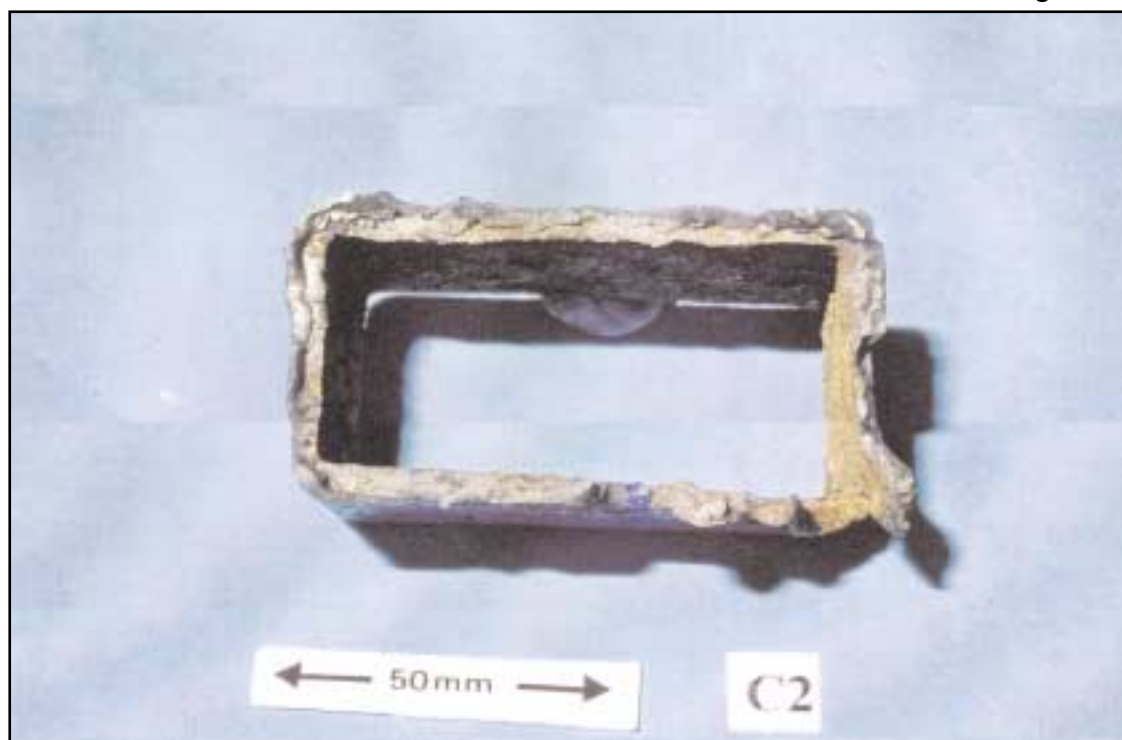
Figure 35

Mating surface to failure shown in Figure 33
