Report on the investigation
of shift of cargo containers,
involving dangerous goods on

Dutch Navigator

25 - 26 April 2001

**Report No 37/2002
November 2002**

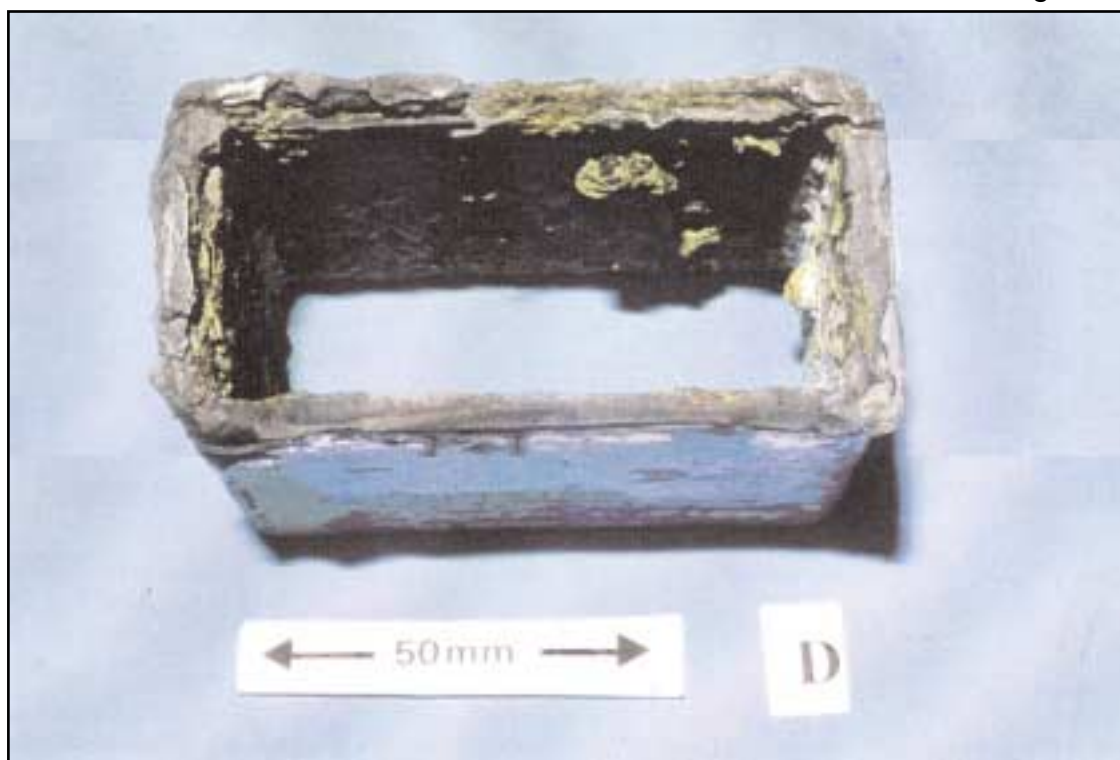
Shown in **Figure 36** is one fracture surface from the diagonal of the rear frame. The welds forming the repair were found to have poor penetration, and had suffered from corrosive attack. Some features also suggested that cracks had been present in parts of these welds before the failure which occurred on *Dutch Navigator*.

Failed weld repair on rear diagonal
