Report on the investigation of the loss of

***Crimond II***

on 24 April 2001

**Report No 8/2002  
February 2002**

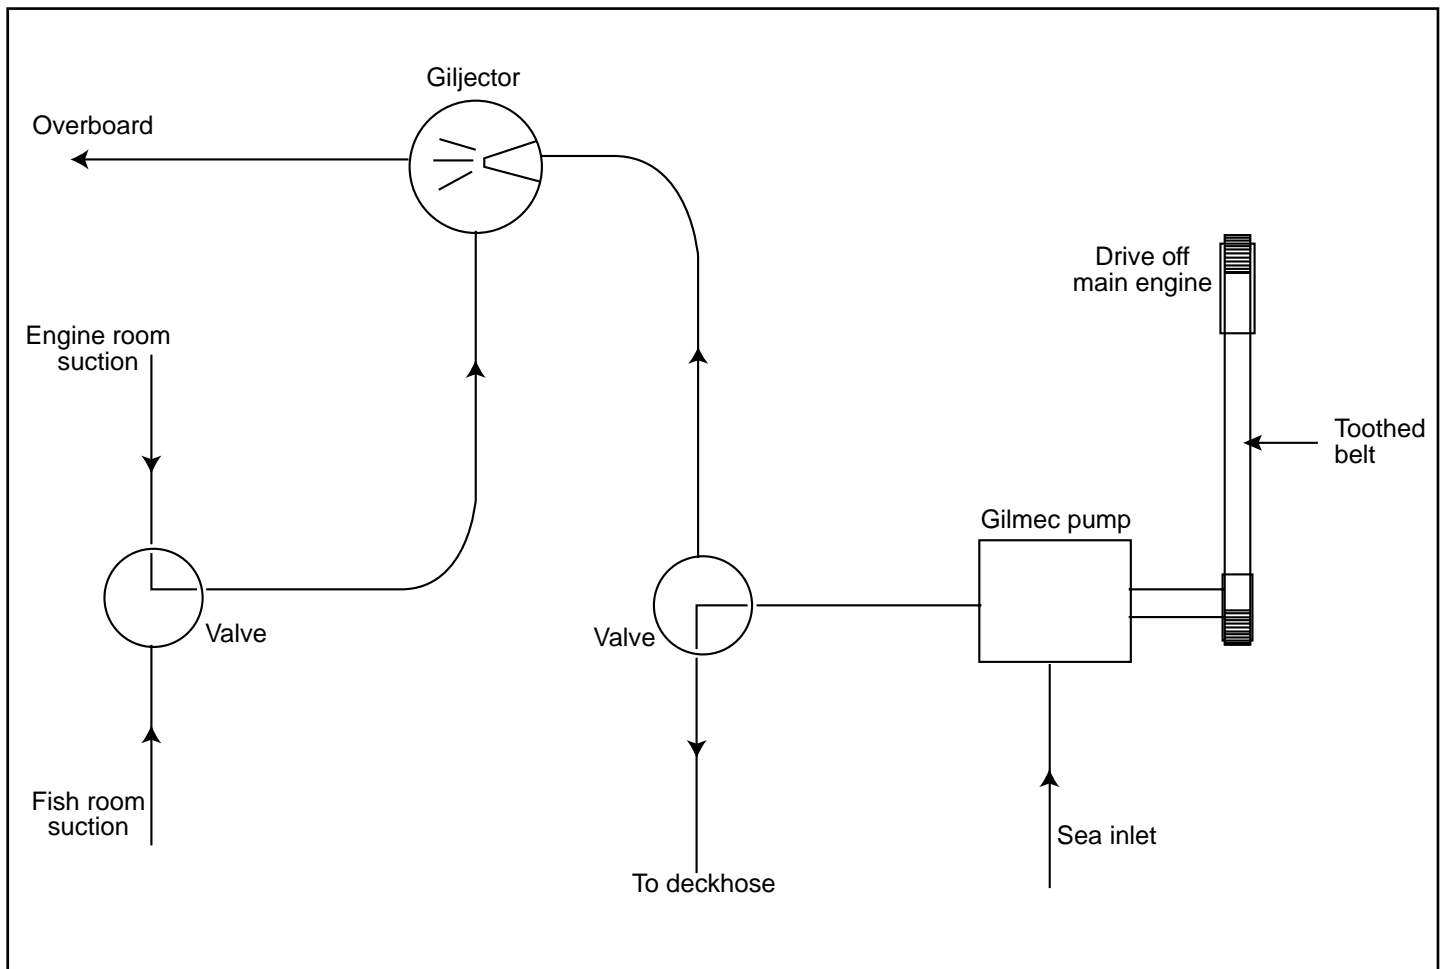
Figure 6

The main bilge pump was an eductor, with the trade name Giljector. The Giljector could evacuate water from the engine room or the fish room (**Figure 6**). The Giljector was powered by water supplied from a pump driven by the main engine, with the trade name Gilmec. The Gilmec pump also supplied the deckwash hose. The changeover valve for Giljector/deckwash was located at the forward end of the engine room. The Gilmec could not be declutched from the main engine, so it was running all the time the main engine was running.

The Gilmec pump, via the Giljector, was only used for pumping out large quantities of bilge water. Bilge water was normally pumped out using the electric pumps. The Gilmec pump supplied the deckhose, which was used for fish washing. If the Gilmec pump was used for bilge pumping, the valve had to be switched over, which meant a visit to the engine room. Another visit to the engine room was necessary to switch the valve back when fish washing was required. It was not normally necessary to visit the engine room very often. The main engine was fairly new, needed little attention, and did not burn much oil.

Illustration of bilge and deckhose system

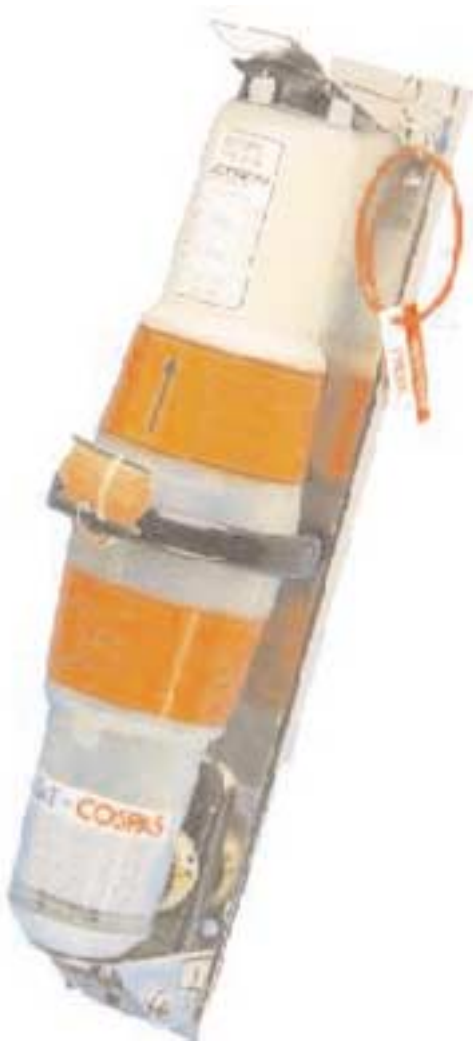
Figure 7

The EPIRB was type TRON 30S Mk II (**Figure 7**), manufactured by Jotron. It was attached to a post, which was about 750mm high on the starboard side of the wheelhouse top; the attachment included an HRU. The HRU must have activated when *Crimond II* sank, because the EPIRB floated to the surface. When the crew got hold of the EPIRB there was no clear indication that the unit was transmitting, apart from the pin being out. The skipper assumed that the pin had been pulled out when the unit was released. He thought that with the pin out the unit should be transmitting. The pin was still attached by a thin cord, so he tried replacing it briefly, to see if that made any visible difference. It did not. The doubt as to whether the EPIRB was transmitting caused the crew some distress, until the helicopter arrived.

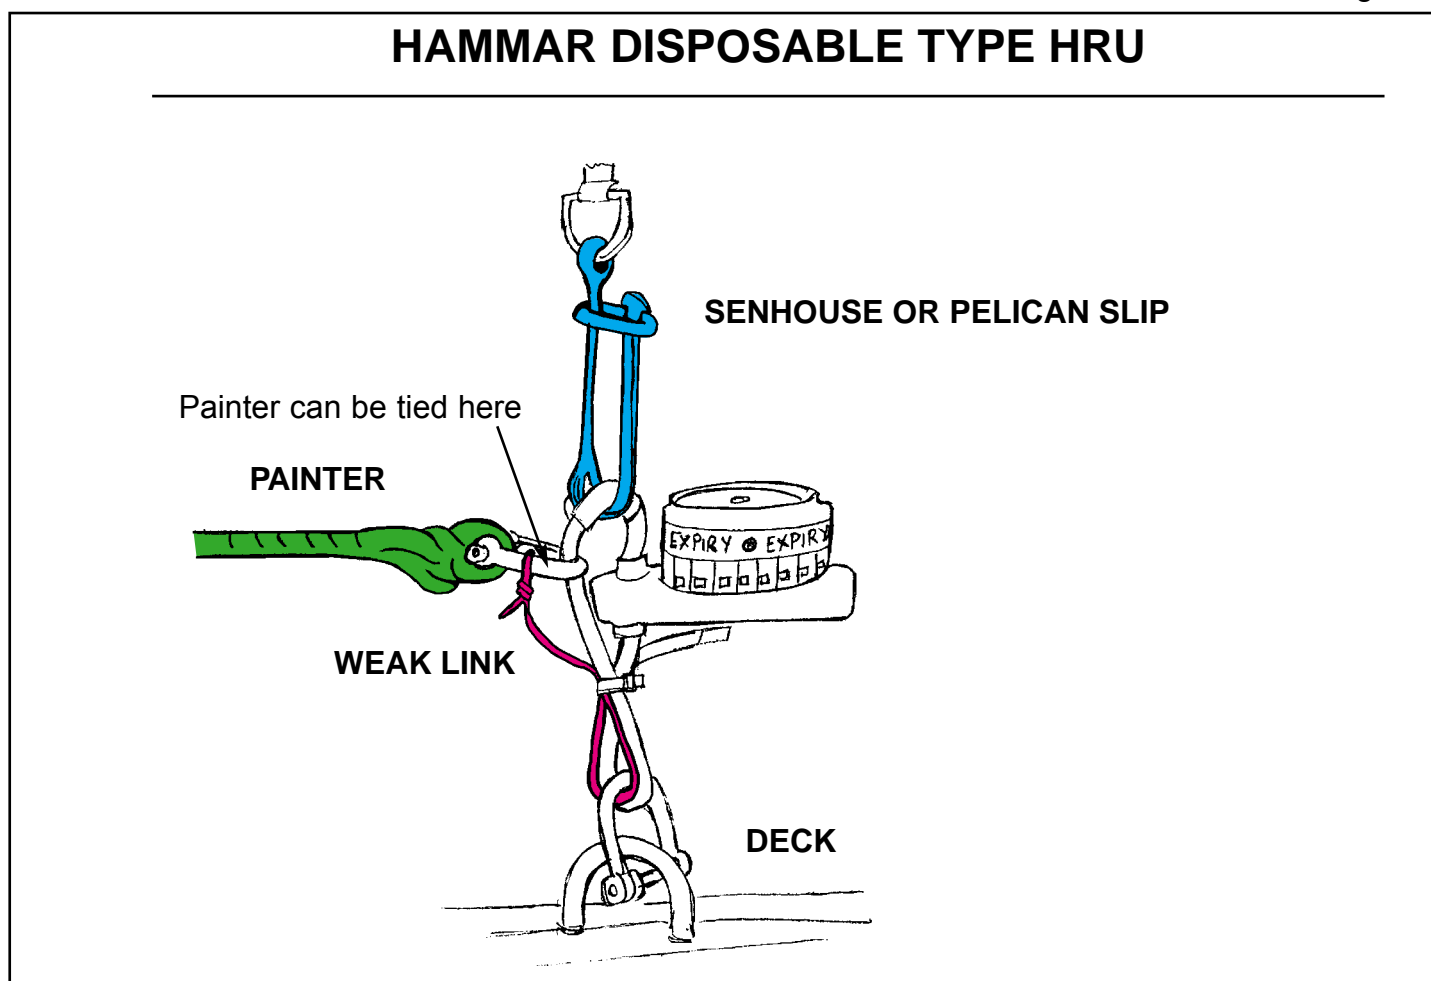
Figure 8

The deckhand should not have untied the painter. The end of the painter, if correctly fitted, is secured to the vessel by a weak link. After a vessel has sunk, the buoyancy of the liferaft canister puts enough load on the painter to initiate inflation, and once the liferaft is inflated there is sufficient buoyancy to break the weak link such that the liferaft floats to the surface. When the painter is untied, the liferaft canister can drift away once it is in the water. Also there is no automatic inflation.

When the skipper arrived at the liferaft he realised that the painter should not have been untied, so he wound the end around a guardrail to stop it drifting away. When the vessel sank, the liferaft was pulled down too, perhaps because of this. It is also possible that the painter got snagged around the mast, or another part of the vessel's structure.
