Report on the investigation of
the collision between
Gudermes
and
Saint Jacques II
in the Dover Strait
on 23 April 2001

Marine Accident Investigation Branch
First Floor
Carlton House
Carlton Place
Southampton
United Kingdom
SO15 2DZ

Report No 5/2002
February 2002

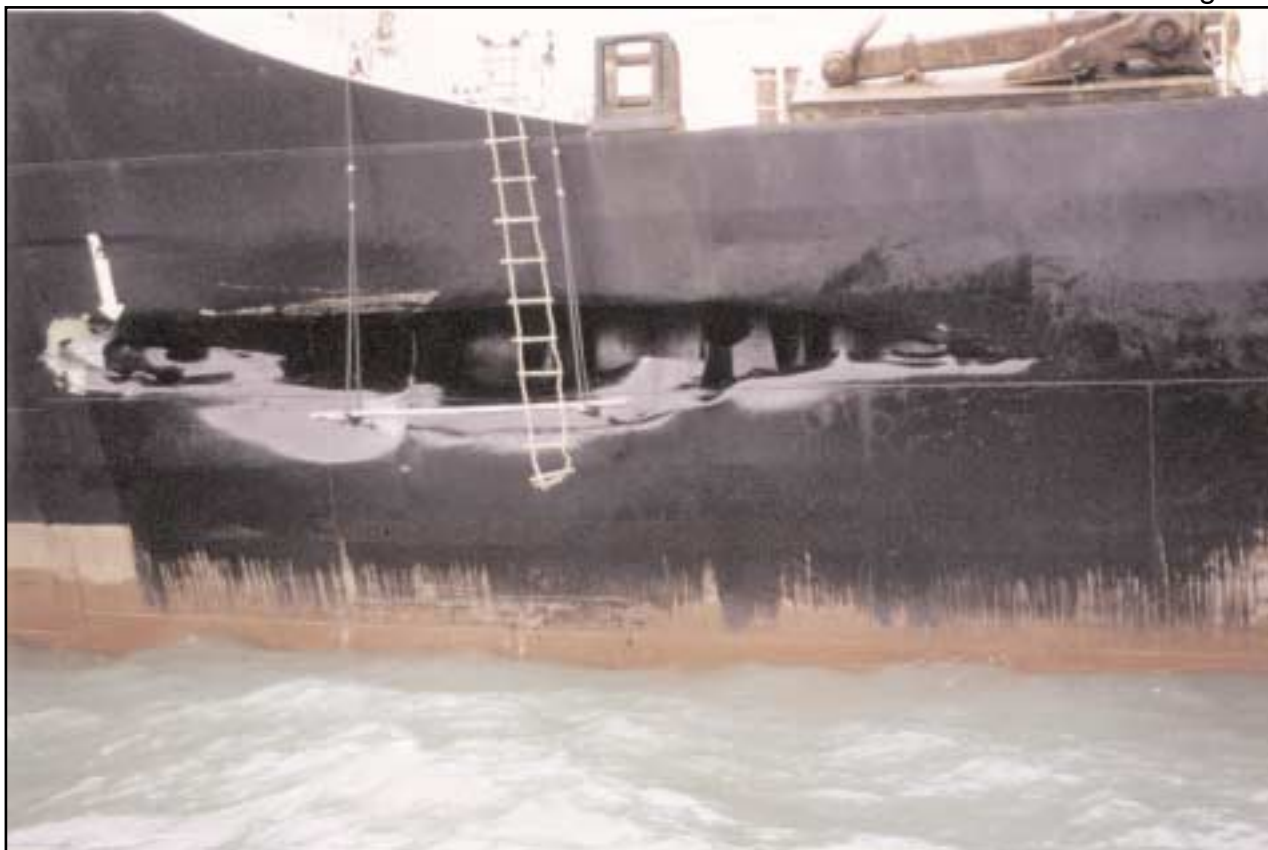
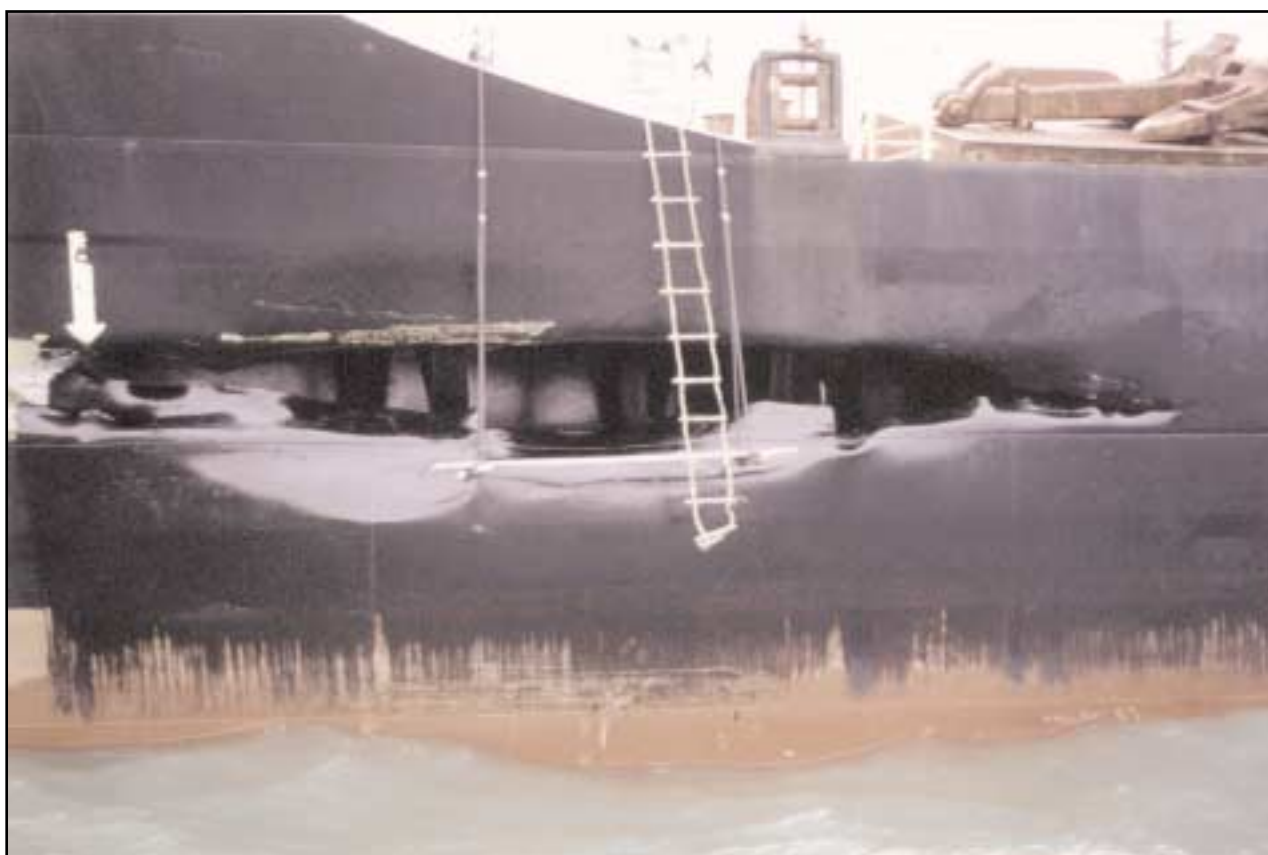
Damage to *Gudermes*

| Damage | : | 6m x 2m gash above the waterline in No 1 tank, port |

Immediately following the collision the general alarm was sounded and oil was seen leaking from No 1 tank (port) into the sea. Speed was gradually reduced to Dead Slow Ahead and the oil in No 1 tank (port) was transferred to other tanks. The cofferdam was also inspected for damage. Several attempts were made to contact *Saint Jacques II* via VHF channel 16, but without success. The fishing vessel was seen to have sustained damage to her bow and to maintain her course to the north-east. No attempt was made to inform Dover Coastguard of the collision or pollution. This information was only passed when Dover Coastguard called *Gudermes* at 0449. *Gudermes* anchored off Dover at 0810 for a damage survey, and then sailed to Southampton the following day to conduct a permanent repair.

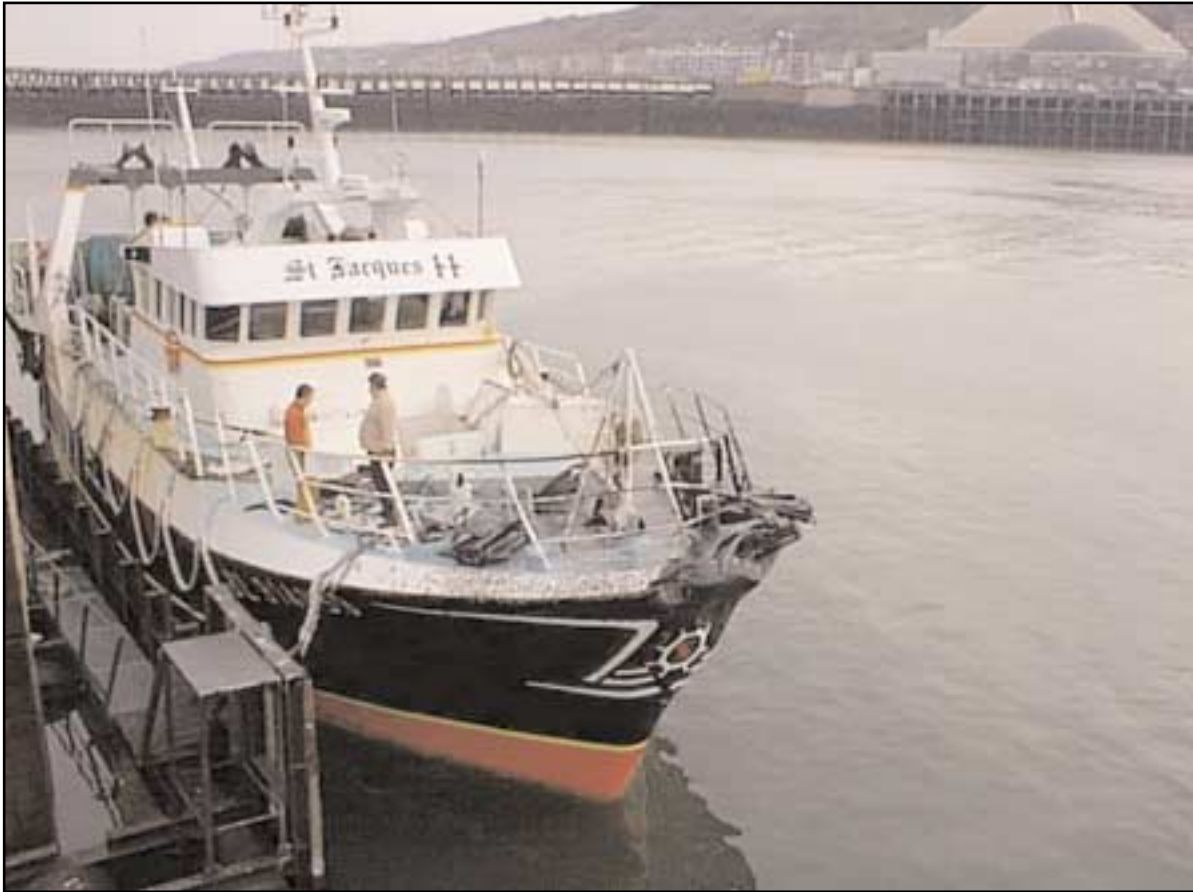
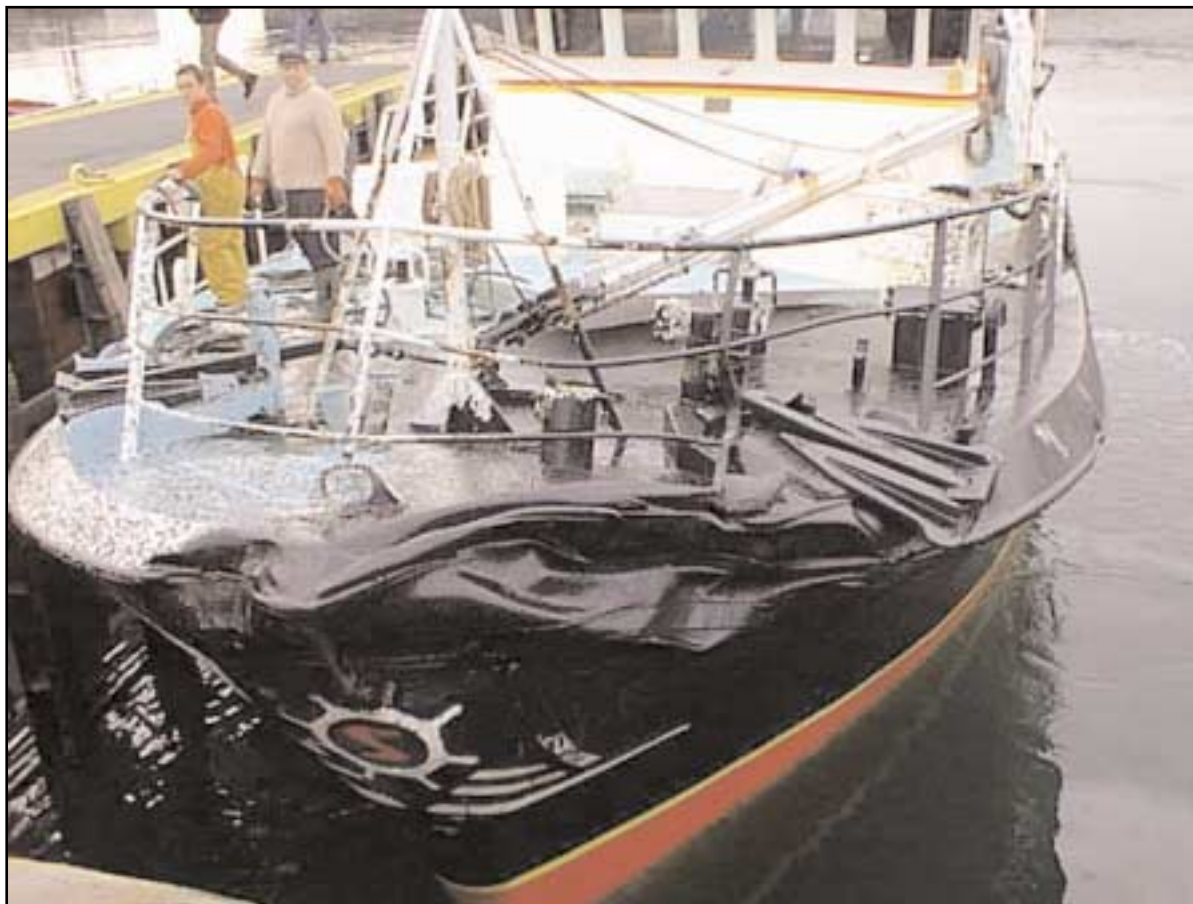
Damage to *Saint Jacques II*'s stem

Time and date : 0429 UTC on 23 April 2001
Location of incident : 51°11.5N, 001°41.4E - 3.5 miles ESE of East Goodwin Light
Persons on board : 7
Injuries/fatalities : None
Damage : Buckled and ruptured plating on the port bow, a distorted anchor, and oil contamination of the upperdeck.

The deckhand reacted by turning the helm to starboard but, as automatic steering was selected, there was no response. No further action was taken and *Saint Jacques II* continued on her course and struck *Gudermes* with her stem (**Figure 2**).

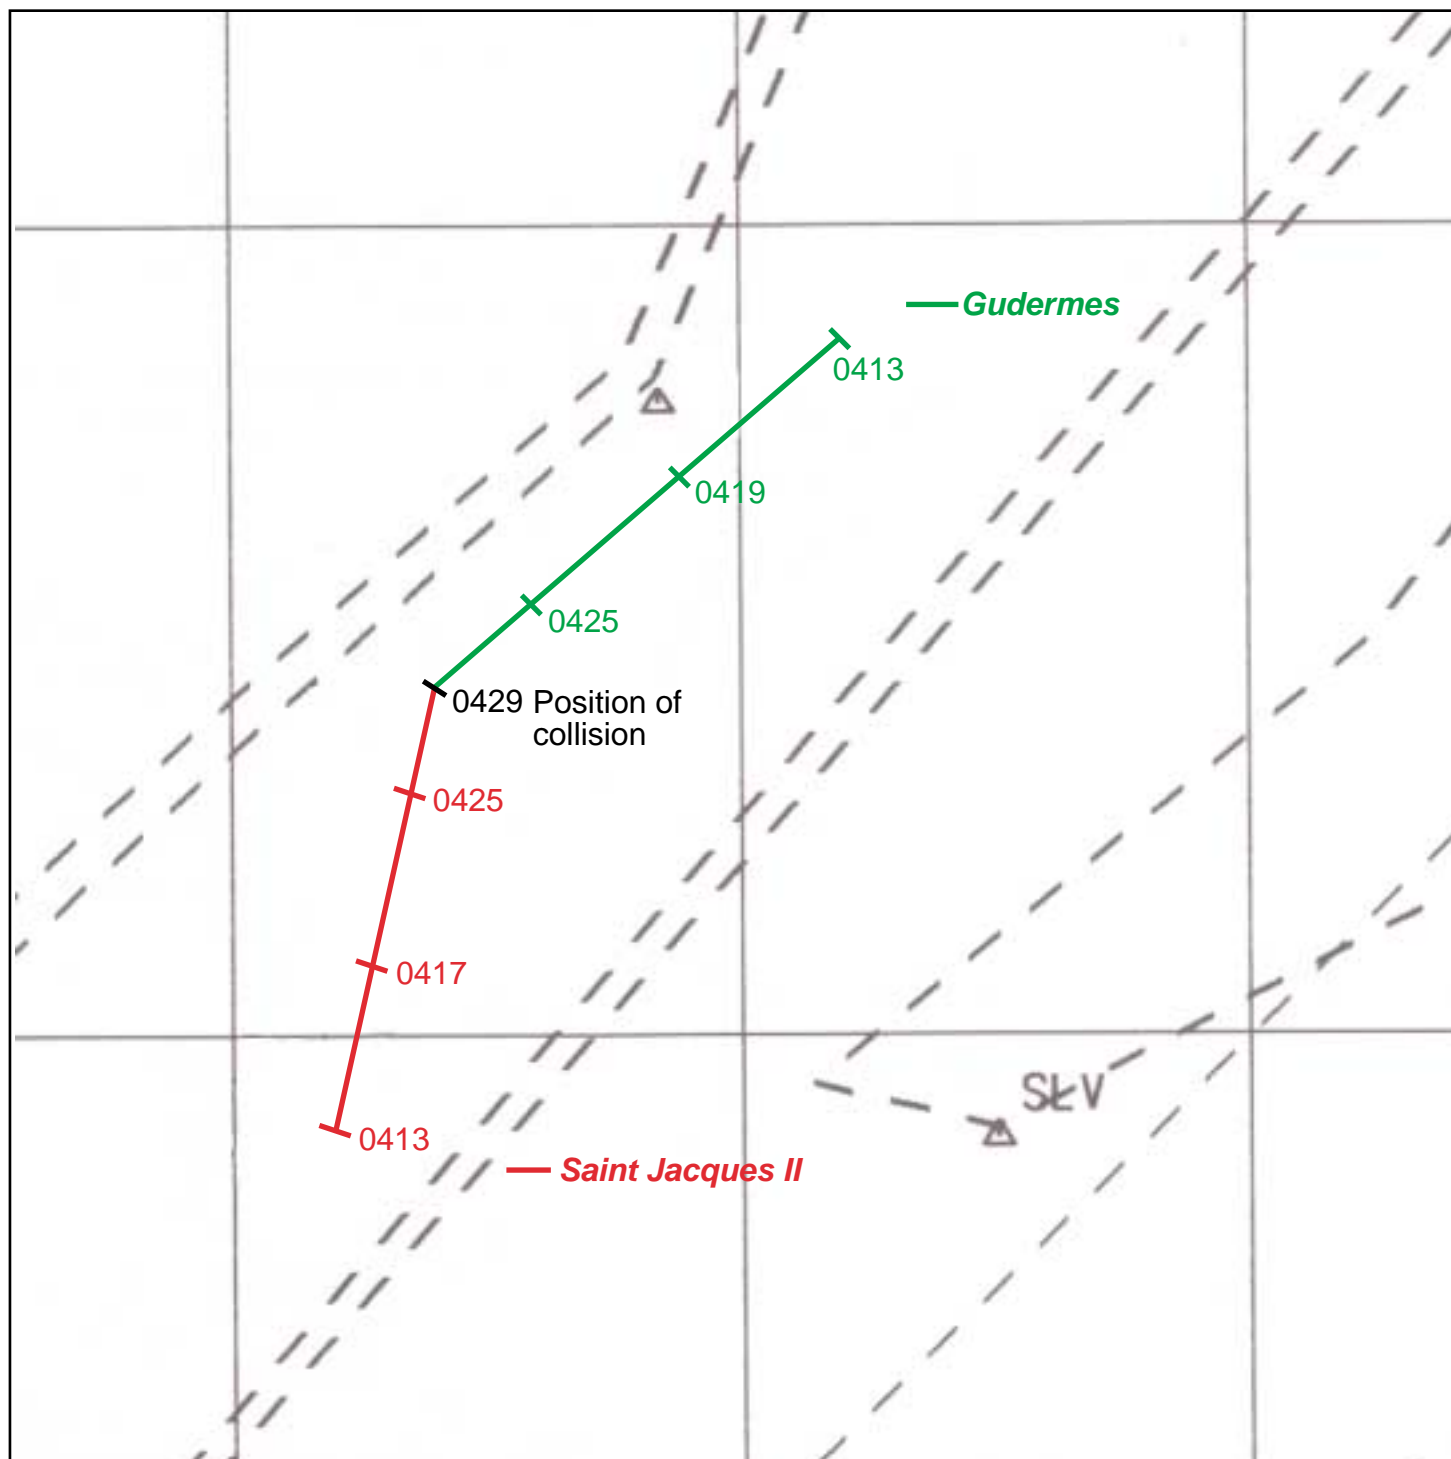
Figure 3

The radar plot showing the ground tracks of *Gudermes* and *Saint Jacques II* is at **Figure 3**.

Radar plot showing the tracks of *Gudermes* and *Saint Jacques II*

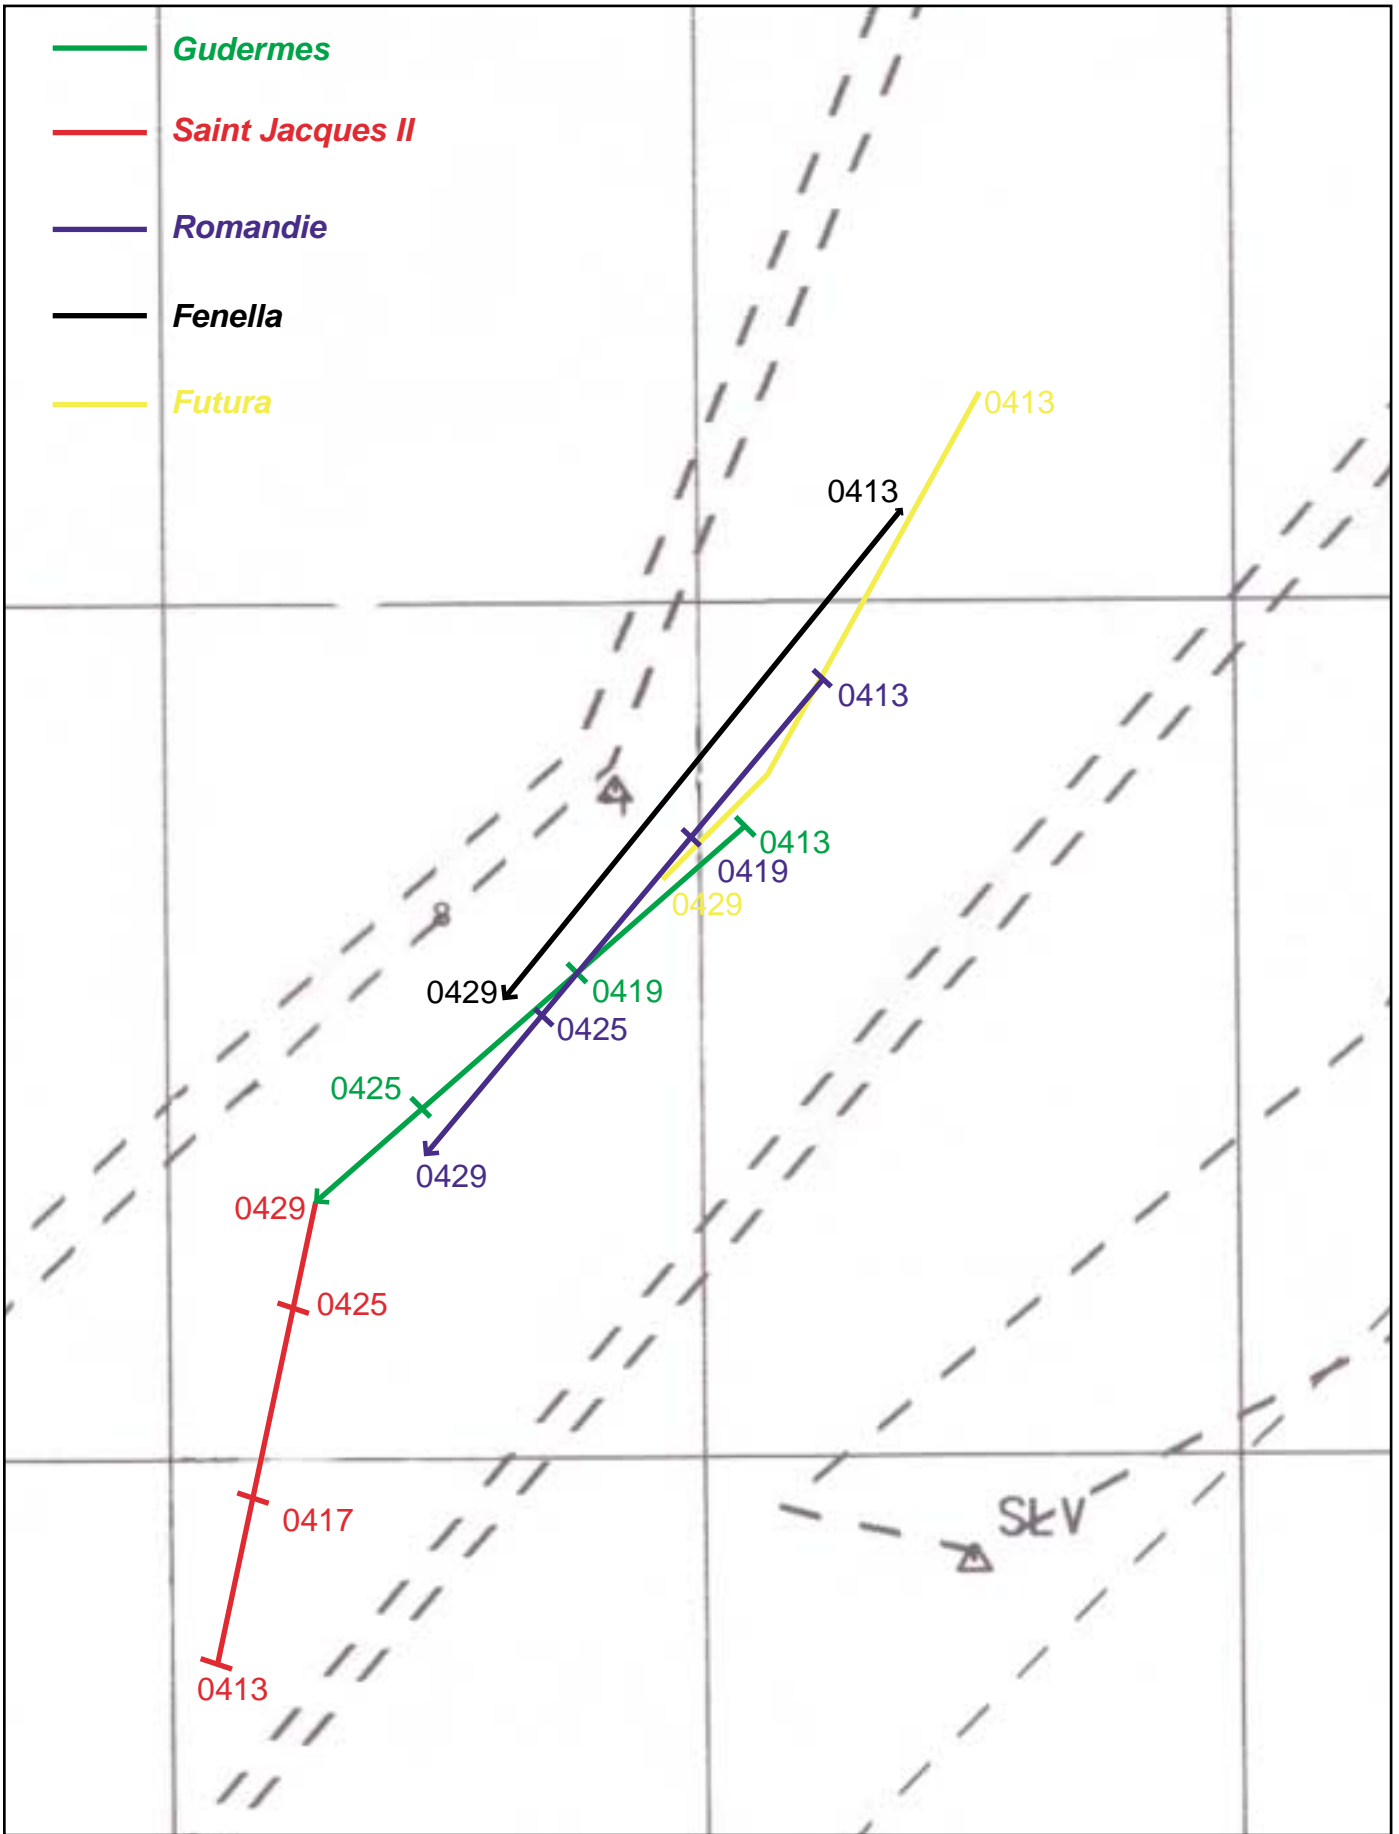
Figure 4 shows the tracks of three additional vessels: *Romandie*, *Fenella* and *Futura*, which were following *Gudermes* in the south-west traffic lane. *Romandie*, a 39,422gt bulk carrier with an overall length of 225m, was the closest to *Gudermes*. An extract of *Gudermes*' course recorder is at **Figure 5**; it is estimated that times are accurate to within 2 minutes.

Radar plot showing the tracks of other vessels in the vicinity

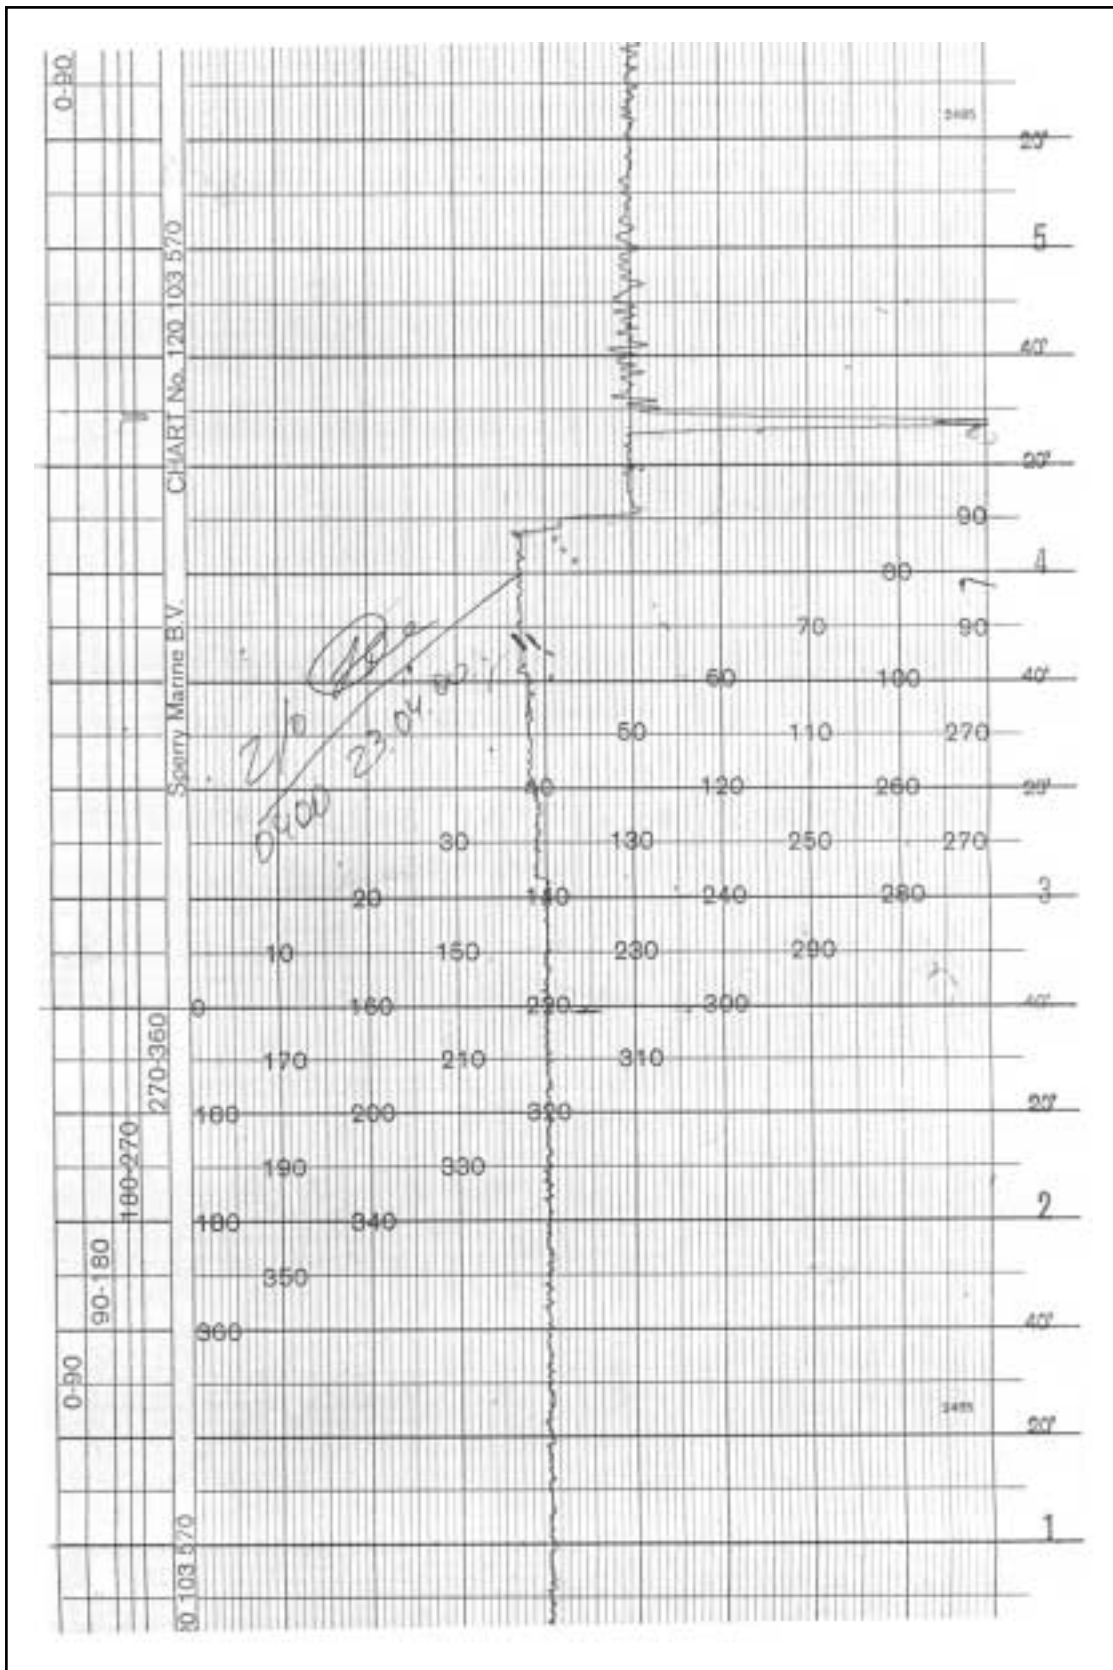
Figure 5

Extract of *Gudermes'* course recorder

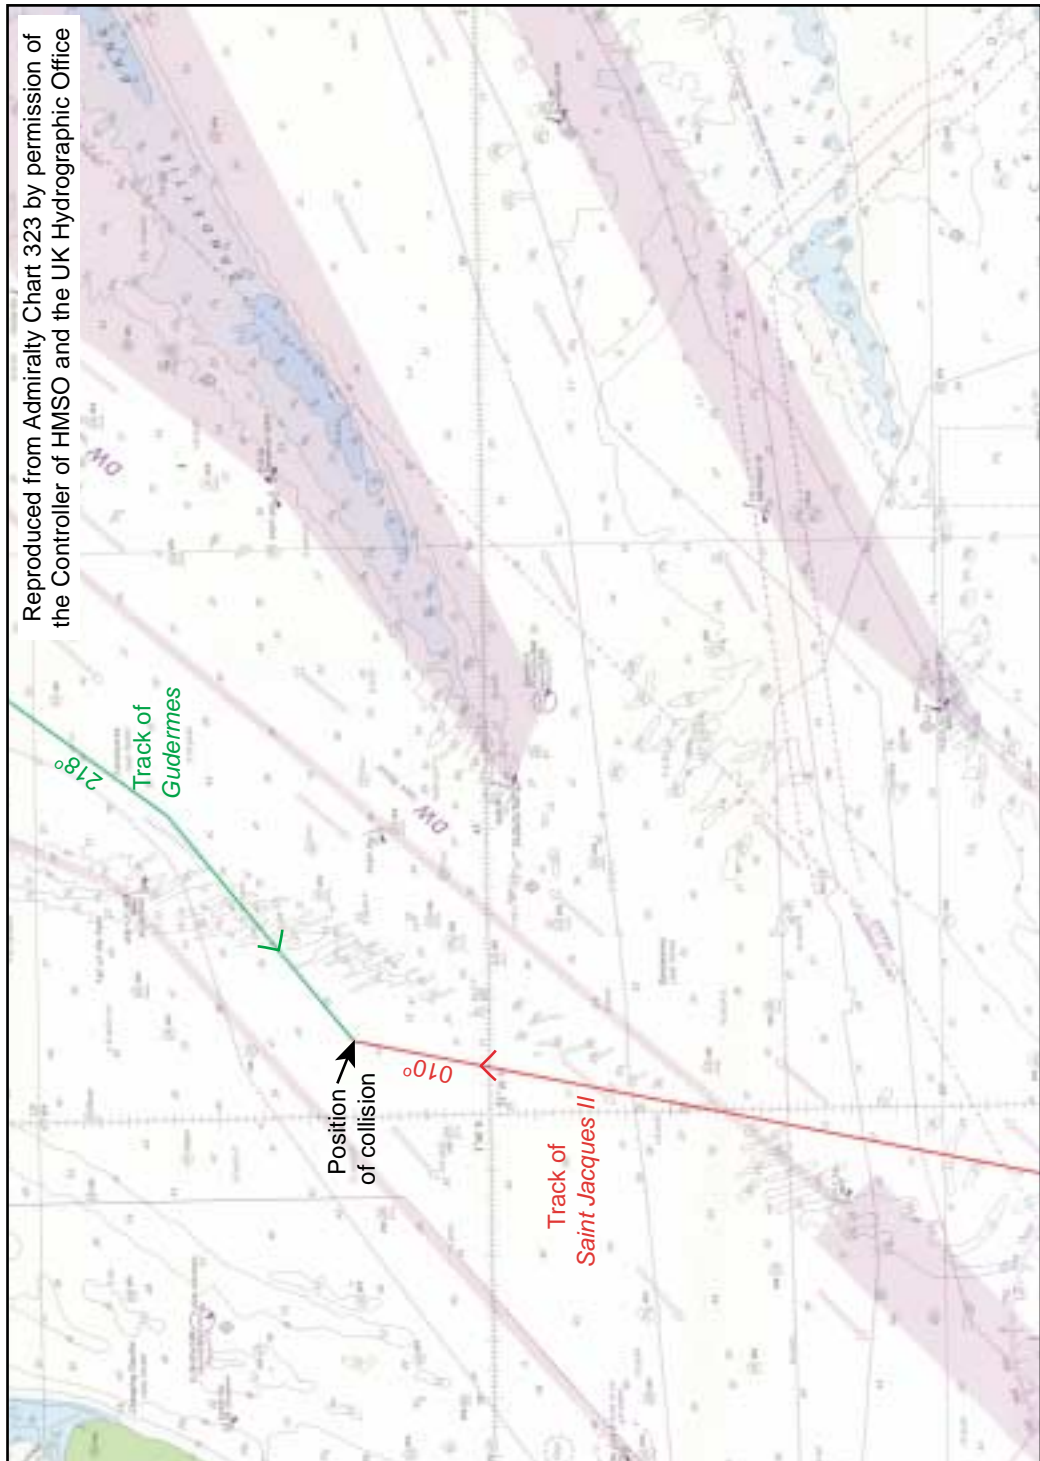
Figure 6

The planned track of *Gudermes* followed the axis of the south-west bound lanes in the Dover Strait while *Saint Jacques II*'s was the direct route between Cap Gris Nez and the South Falls Buoy (**Figure 6**). The skipper and deckhand on *Saint Jacques II* were aware that their track through the south-west bound lane of the Dover Strait TSS contravened the Collision Regulations. The skipper, however, was prepared to do this in order to arrive at the fishing grounds before other vessels which had left Boulogne at about the same time.
