Report on the investigation
of the loss overboard of a fisherman
from the fishing vessel
Van Dijck
while fishing 30 miles
south-west of Guernsey
on 16 April 2001

Marine Accident Investigation Branch
First Floor, Carlton House
Carlton Place
Southampton
SO15 2DZ
Report No 35/2001
October 2001

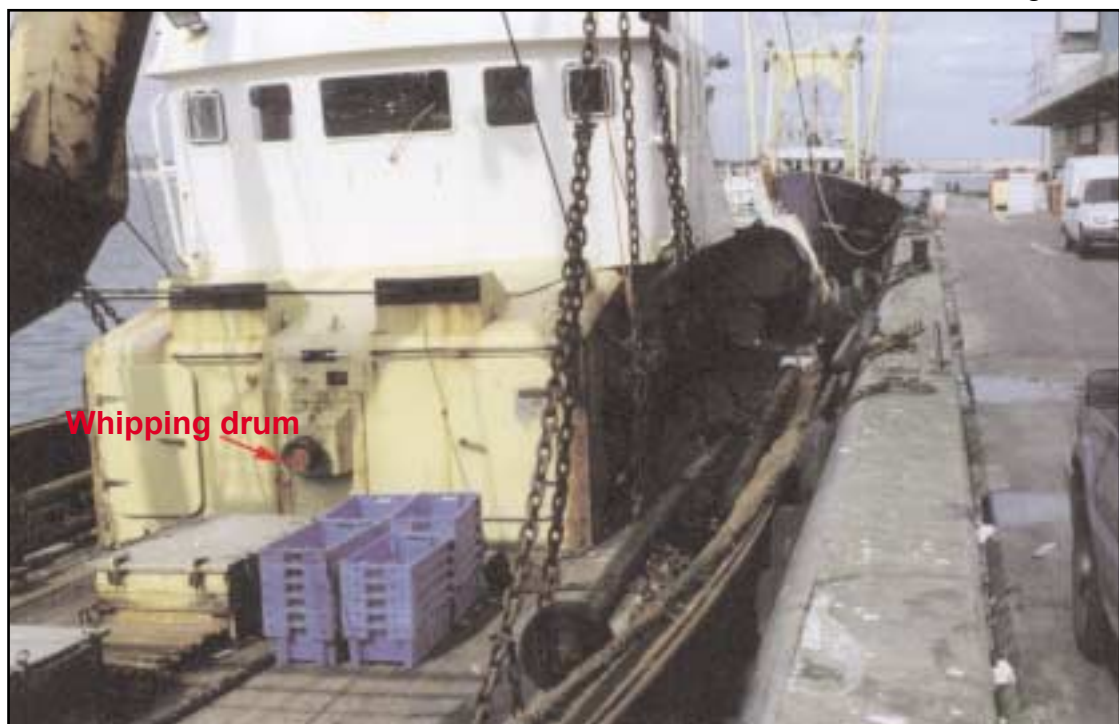
Figure 1

At 2240 the gear was hauled again; Mark operating the whipping drum to swing the dredges inboard, while Francis stood in a safe position behind him (**Figure 1**). Once inboard, it was obvious that more repair work would be necessary before the dredges could be reshot. Once the dredges had been emptied on to the deck, the skipper carried out further welding work. This was completed at 2335 and the gear reshot. Once it was over the side, Mark and Francis returned to sorting out the debris as before.

General view of wheelhouse and winch house.
Note central position of the whipping drum (painted red).
