Report on an investigation
of a propulsion failure
and subsequent beaching of the
Class V amphibious passenger craft
Beatrice
on 31 March 2001,
opposite the River Thames Fire Station, Lambeth

Marine Accident Investigation Branch
First Floor, Carlton House
Carlton Place
Southampton
SO15 2DZ

**Report No 3/2001
January 2002**

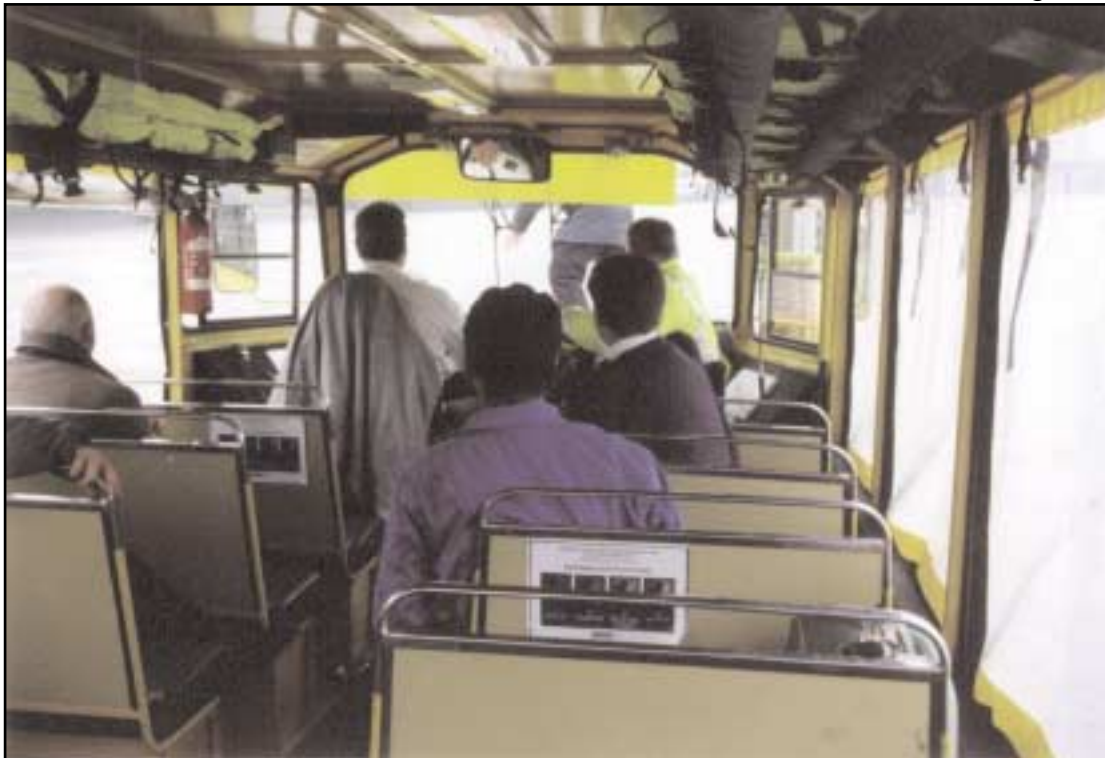
Interior of *Beatrice* showing locations of lifejackets and instructions for use

- 2.2.4 The comment by a passenger that there were insufficient instructive notices regarding the donning of lifejackets is not considered a justifiable criticism. Not

only are instructions attached to the lifejacket itself, but several additional notices are attached to the back of a number of passenger seats.

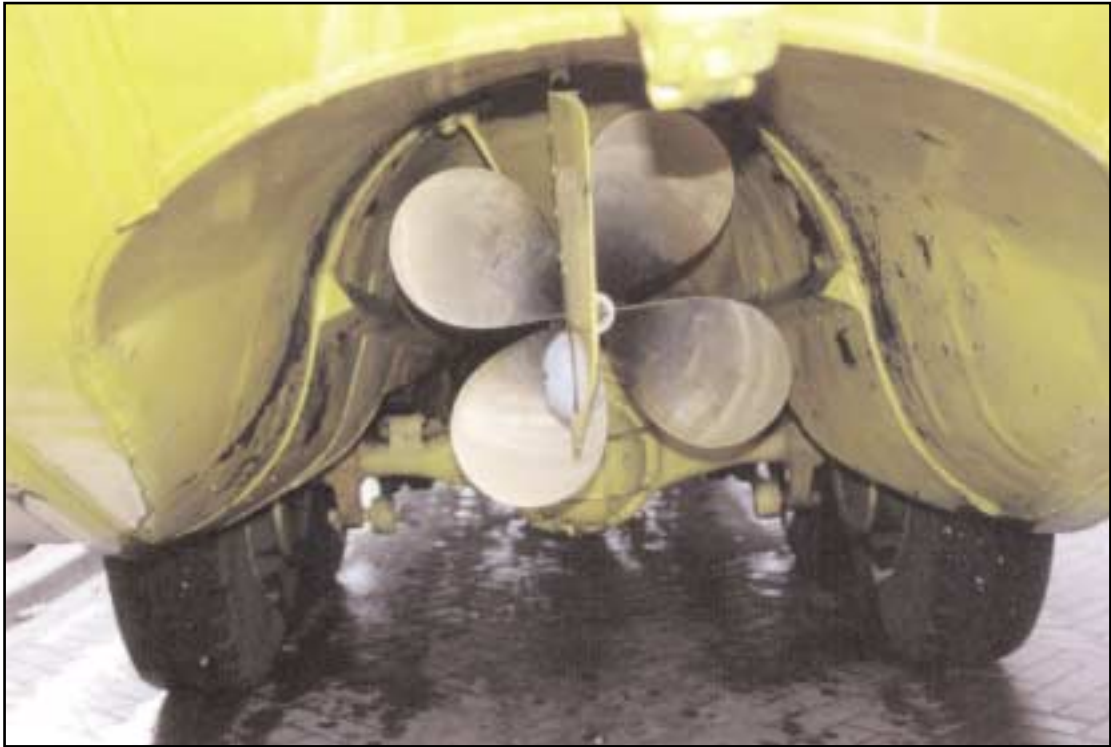
Rear of *Beatrice* showing propeller and rudder in recessed propeller duct

The craft suffered severe underwater damage when the propeller shaft either hit an underwater object when close to the bank, or when a large object was drawn into the propeller duct and became wedged between the propeller and the duct plating.

Given the shape of the propeller duct, and the apparently undamaged outer lower wings of the duct and aft wheel axle, it is considered that the damage was more likely caused through a hard floating object, such as a bulk of timber, being drawn into the propeller duct during the early part of the passage. With the propeller rotating at a relatively high speed, the sudden insertion of a solid object among the blades will cause shock loading and distortion on the blades, together with torsional shock loading on the “A-frame support”.

1. Consider fitting some form of open mesh grid round the propeller duct to prevent the entry of large pieces of debris, without significantly reducing the efficiency of the propeller.
2. Consider providing further guidance to operating staff and crew members on the handling of passengers during emergency situations.

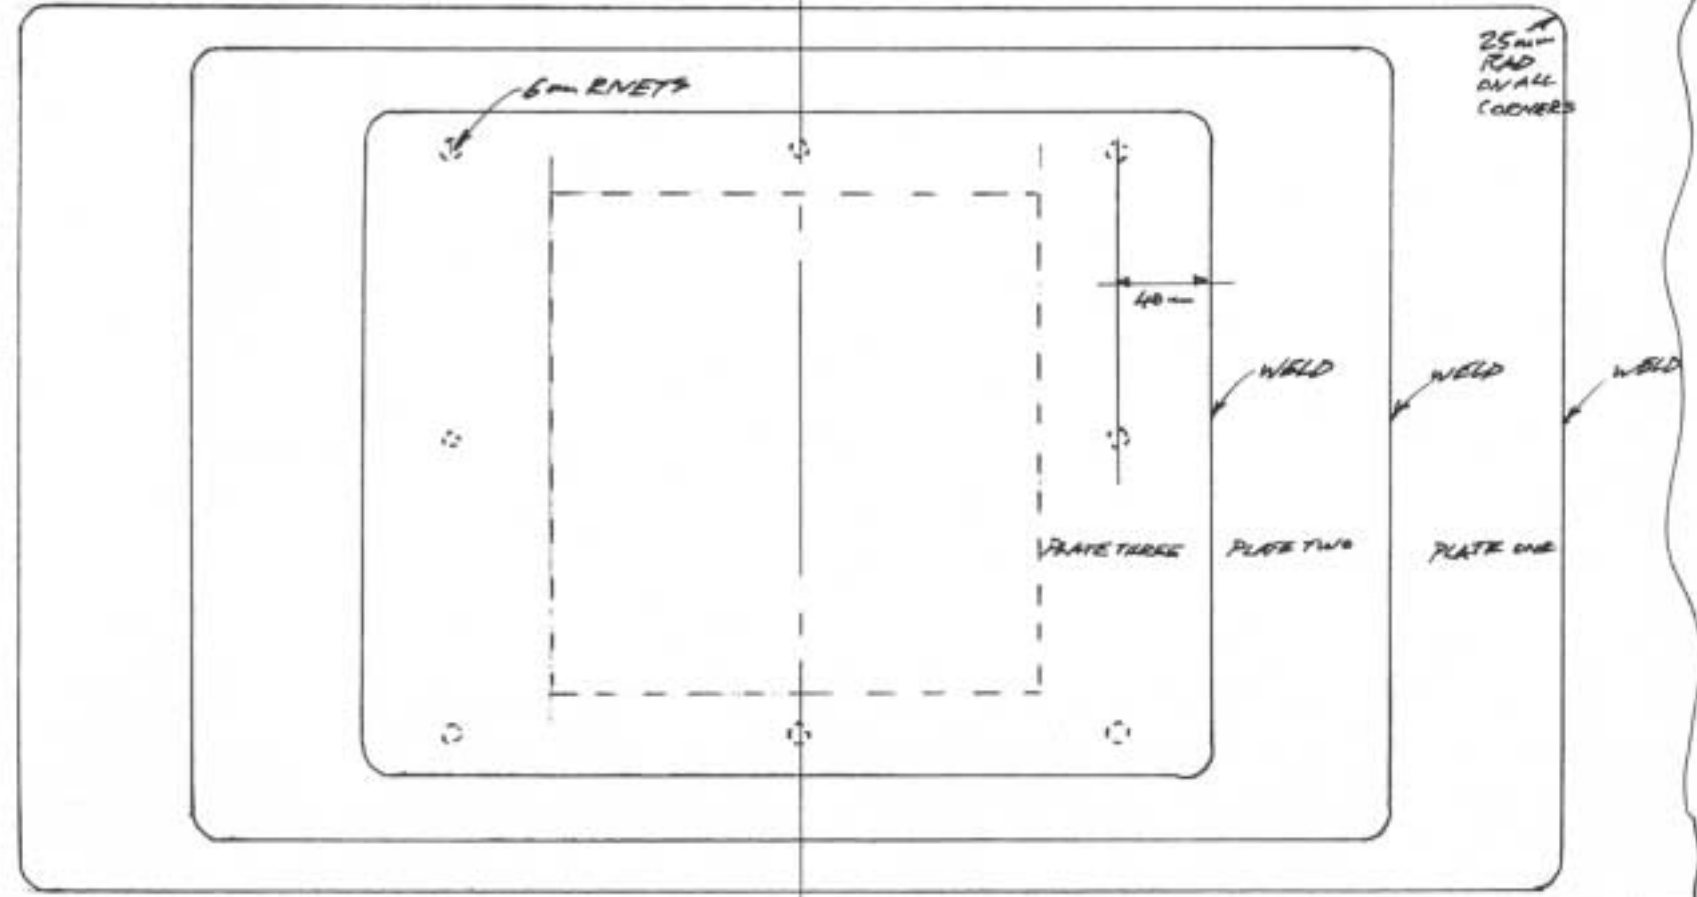
DRAWING 2D - NOT TO SCALE

TRANSVERSE C/L OF DUCT DAMAGE

SCHEMATIC DRAWING SHOWING RELATIVE POSITIONS OF 6mm MS RIVETS

ALL REINFORCEMENT PLATES TO HAVE 25mm RADII AT CORNERS
