Report on the investigation of failure of

lifeboat winch brake on

***Marine Explorer***

**Report No 2/2002**  
**January 2002**

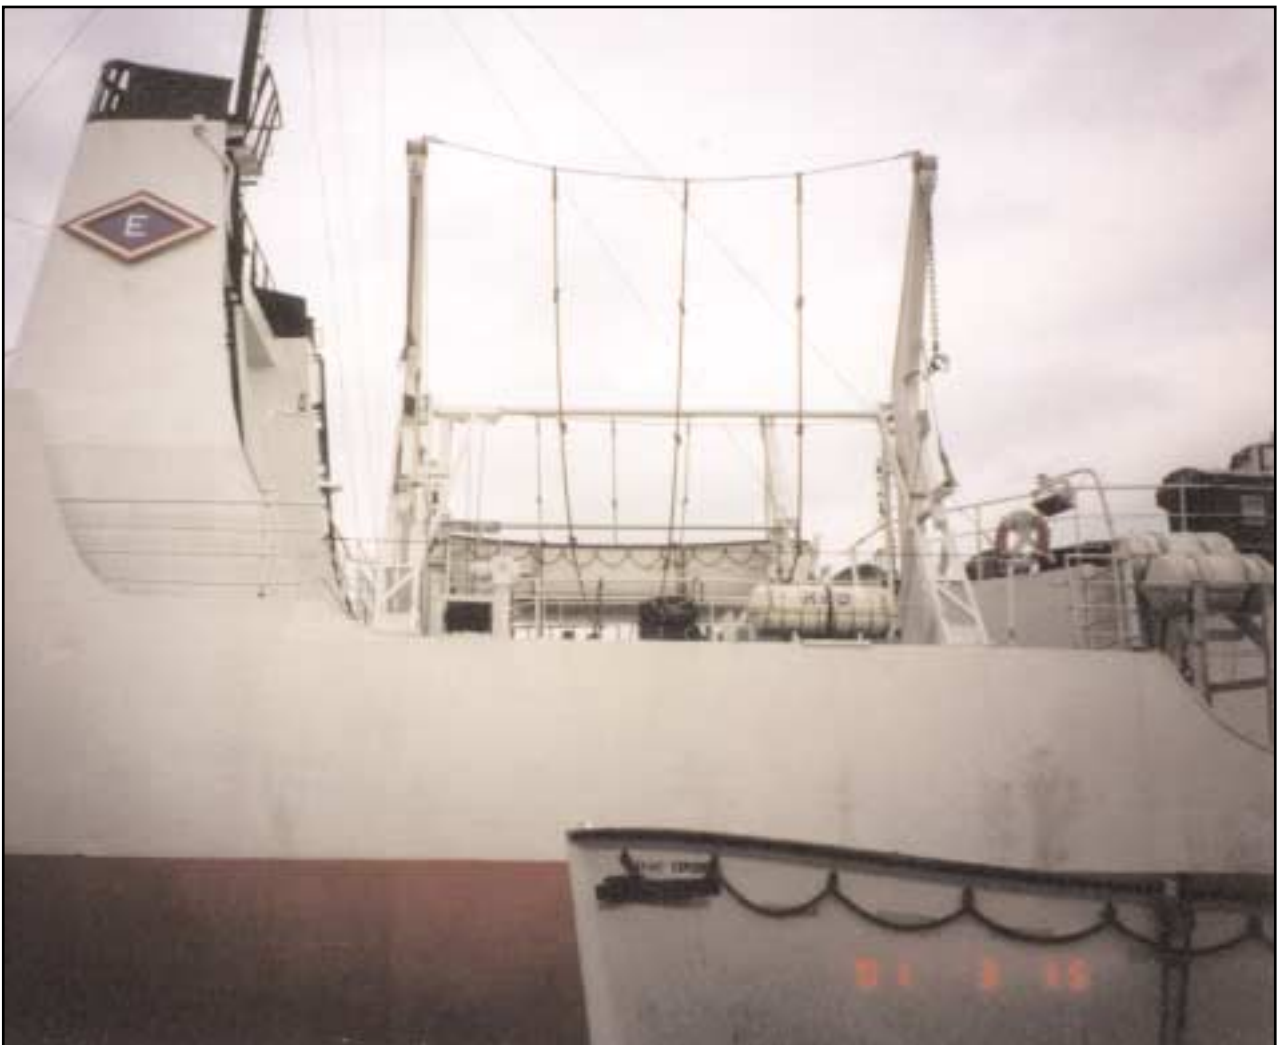
Figure 1

The inboard face of the arms on the port davit had suffered some wear in way of the mechanical stops. Welded repairs had been made to these areas shortly before this accident. Although the owners were making preparations for a load test to MCA's requirements, this test had not been performed at the time of this accident.

The port lifeboat davits

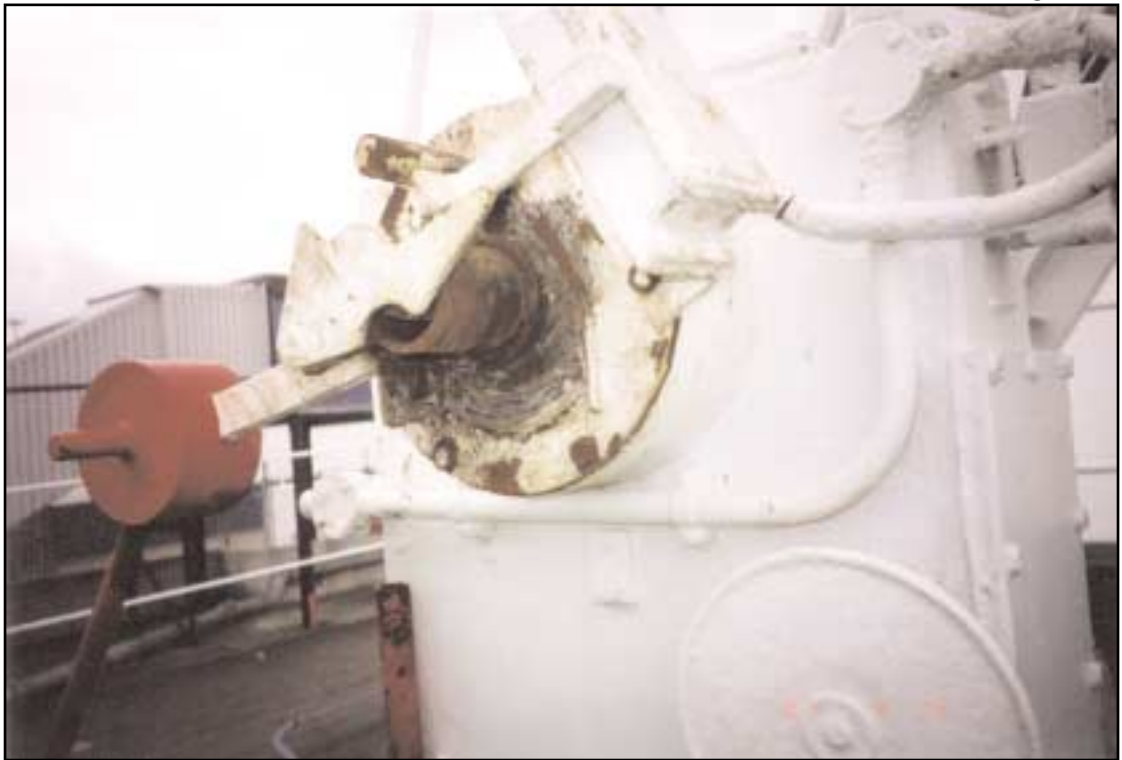
Figure 2

Before dismantling began, it was noted that the brake operating lever was resting on the external stop (**Figure 2**). The lever's securing screw was first removed which allowed the lever to be slid from its splines on the eccentric. Once the lever was clear of the splines, it was clear, from the relative position of the securing screw's slot in the eccentric, that the lever had been at the limits of its adjustment. This position corresponded to worn friction linings (**Figure 3**).

Brake housing of winch

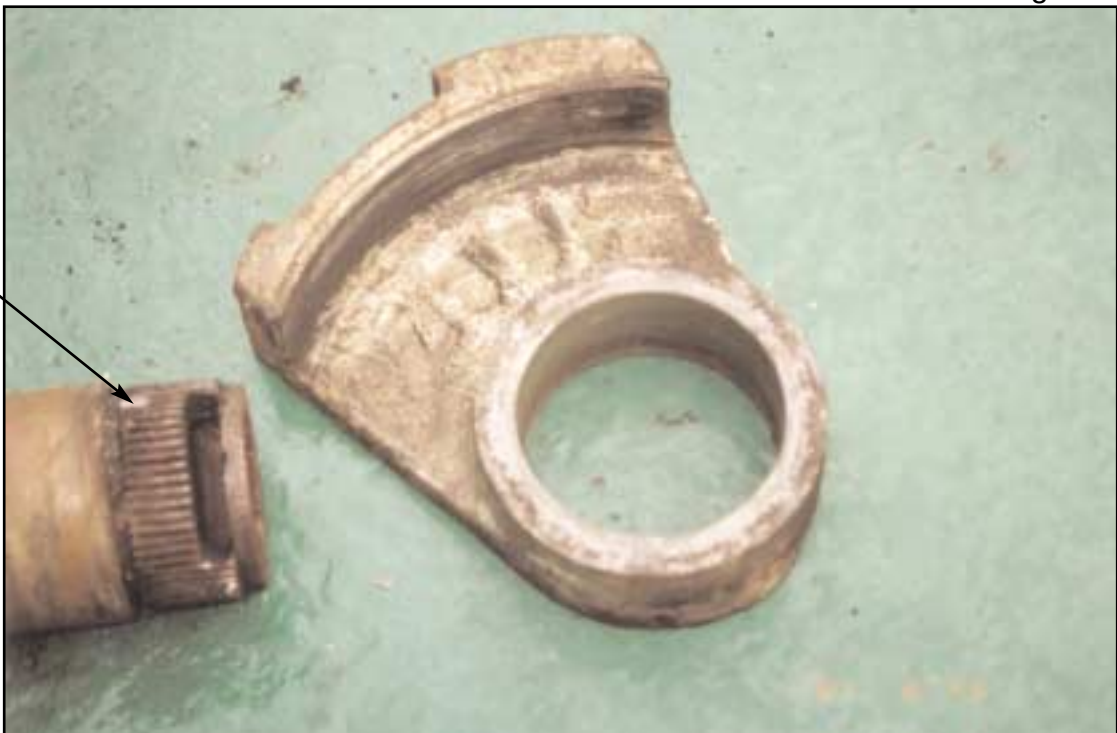
Figure 3

The eccentric was not a smooth running fit in the cover bearing and required several blows to remove. The bearing surfaces were dry and partially covered in unidentified deposits. The brake shoe was a smooth running fit on the eccentric, and the friction material was not seriously worn or contaminated (**Figure 3**).

White mark  
shows  
position of  
lever's  
adjusting  
screw

Splines of eccentric (left)  
Brake shoe, or sector (right)

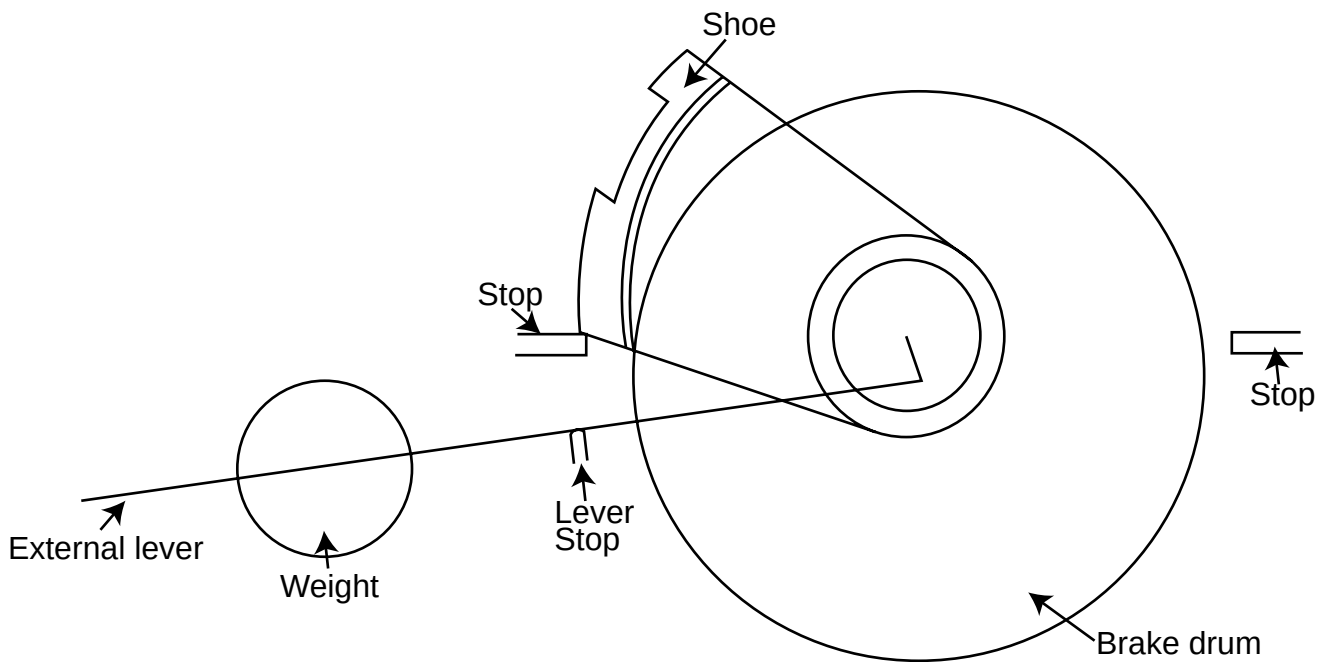
The setscrews securing the cover were removed, and the cover levered off. As this cover was being removed, the position of the brake shoe was seen as in **Figure 4**. The assembly of cover, eccentric and shoe were lifted clear and then dismantled.

Position of brake sector as found after incident

As shown by the post-accident examination, the brake shoe was not properly located by its stop pin (**Figure 4**). In the position found, there was no contact between the friction surfaces of the shoe and drum. Further, because the operating lever was in contact with its stop, the brake could offer no resistance to the drum and winch rotating, no matter how great the effort applied to the lever. This is why efforts to apply the gravity brake during the unintended descent of the lifeboat were unsuccessful.

However, when the winch's motor began to hoist the lifeboat, there was contact between the drum and the brake shoe. The friction force between them allowed the drum, now moving in the hoist direction, to accelerate the shoe away from its stop pin. This acceleration was sufficient to cause the shoe to swing over to the stop pin on the opposite side of the casing. In this position there was no contact between the shoe and the drum, and thus no means of returning the shoe to a position where it would provide effective braking (**Figure 4**).

The owners are recommended to place winch maintenance, adjustment and repair data on board the vessel, so as to be available to ship's staff and others who may undertake work on the lifeboat winches.

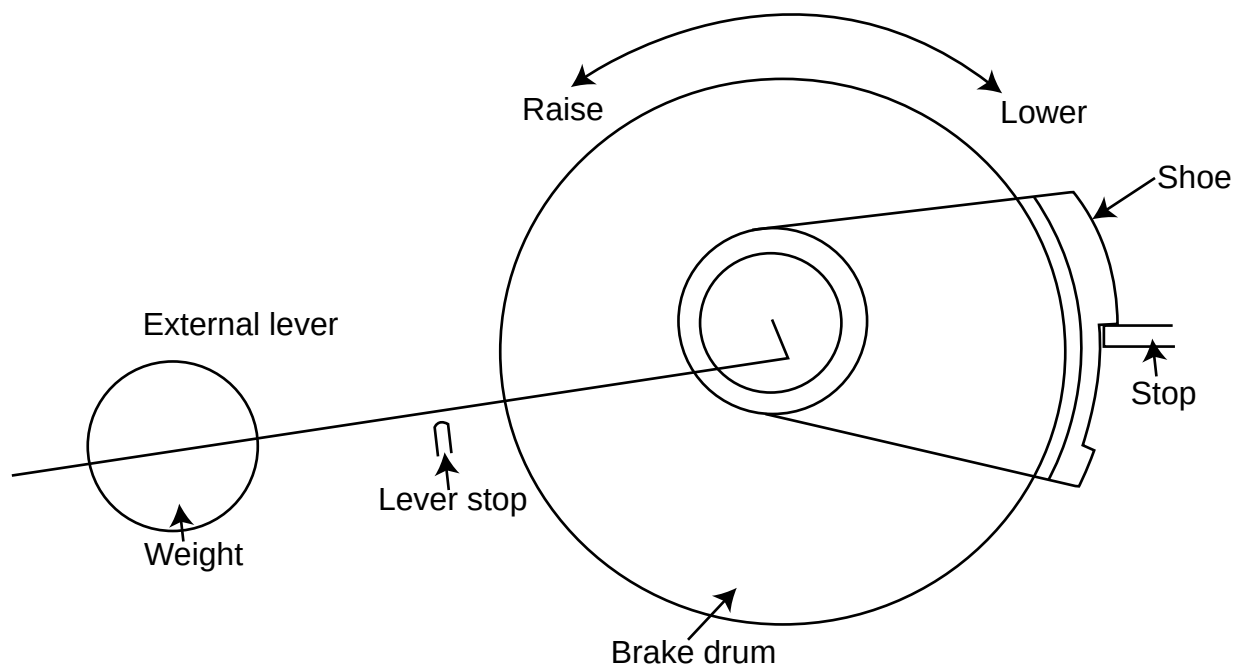
Figure 5

Gravity on hand brake system with brake applied

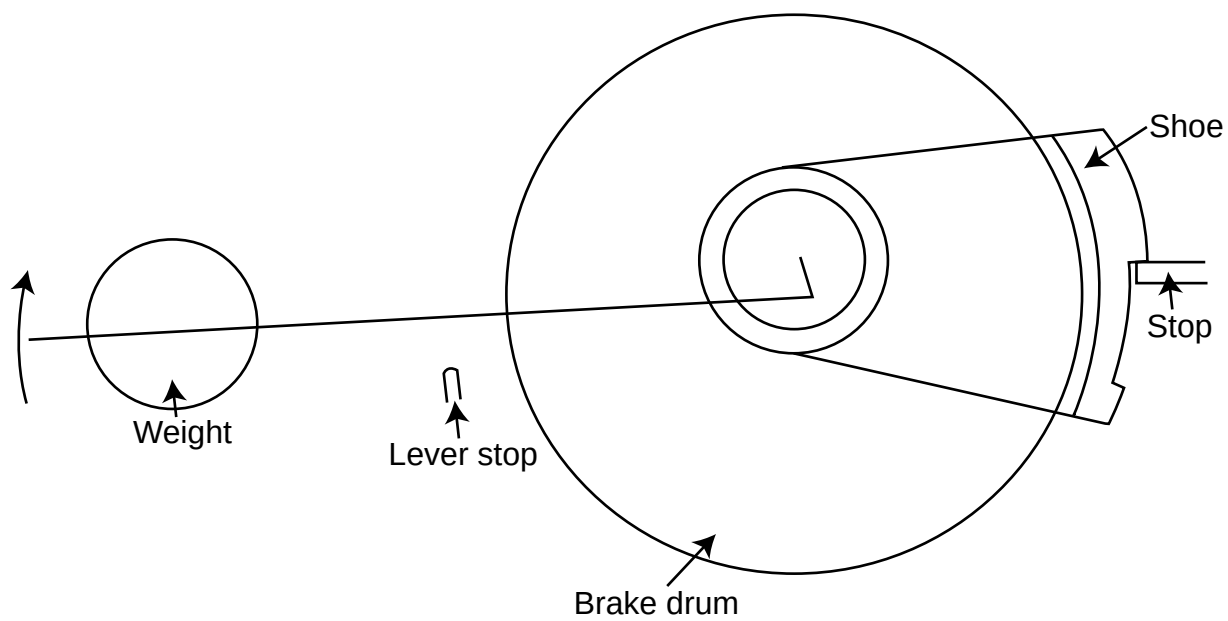
Figure 6

Brake released by raising lever

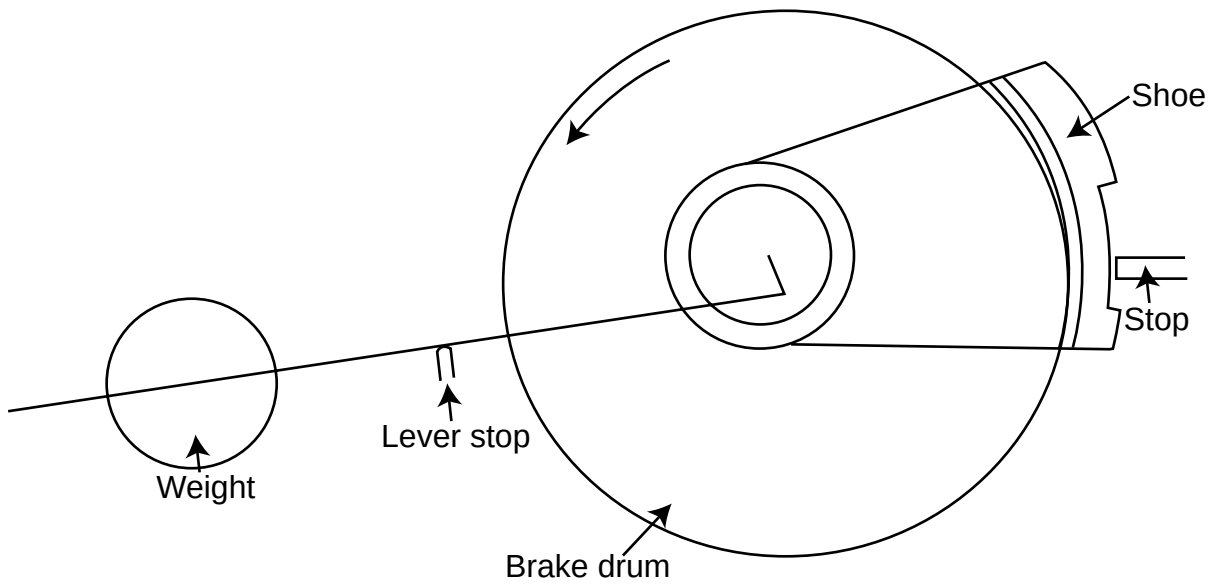
Figure 7

Automatic release of brake when hoisting

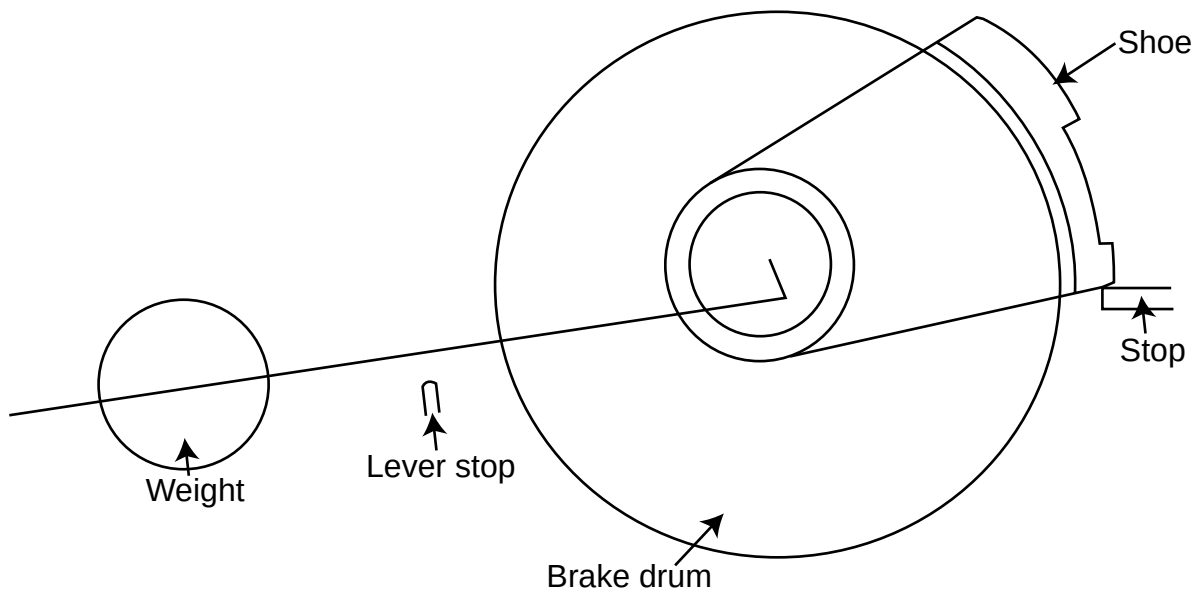
Figure 8

Brake, as assembled

Clearly, when the weight of the lifeboat was transferred from the mobile crane to the davit, the winch and its brake were able to support the lifeboat's weight. This was possible because the brake shoe was sitting on its stop pin with the lever at its extreme limit of adjustment. Any tendency of the brake drum to move in the lowering direction was resisted by the shoe and stop pin (**Figure 8**).
