Report on the investigation of the
grounding of the UK ro-ro vessel

Finnreel

off Rauma, Finland

Report No 17/2002
May 2002

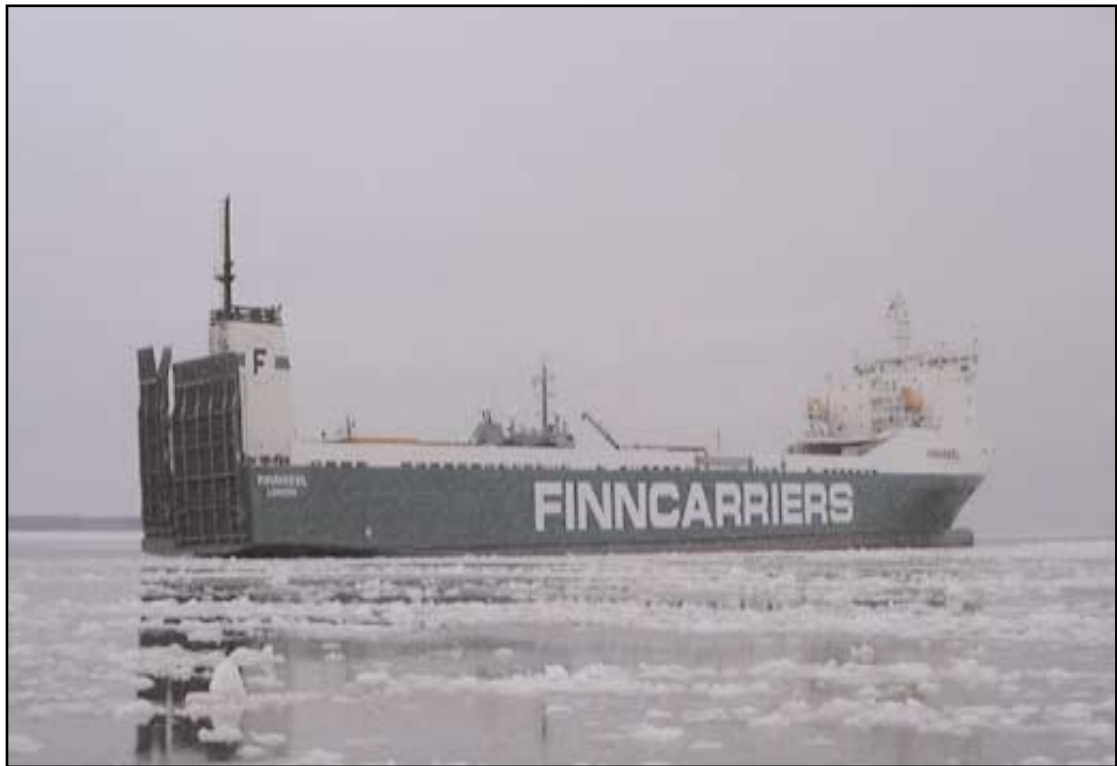
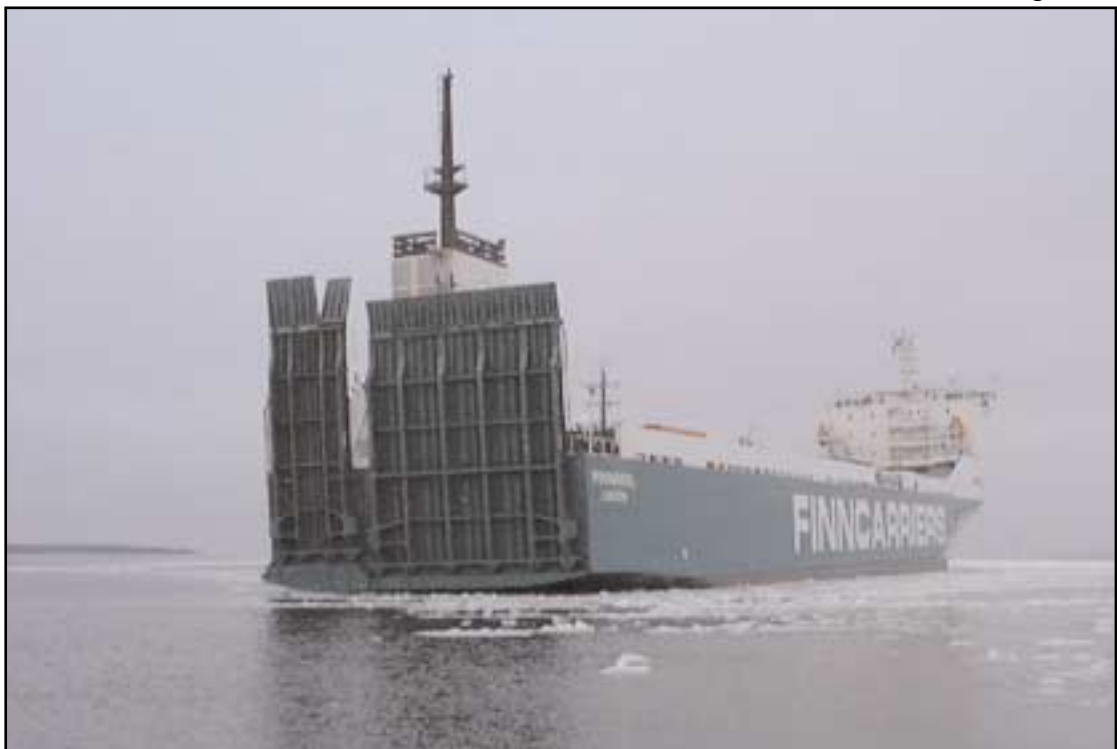
Figure 5

by the master that he could not start the thruster unit. The master placed the propeller pitch control to full astern, and although the pitch moved to the full astern position, the vessel was sufficiently far out of the channel to run aground on the north side close east of the Hylkikarta buoy. The time from the start of the swing to starboard, to the vessel grounding was about 90 seconds. *Finnreel* grounded at 1908, in position 61°06.27'N 21°21.31'E (see Figures 5 and 6).

- 1.4.6 The speed at impact was about 8.5 knots with the ship's heading 276°. The grounding was accompanied by a loud bang, vibration, a sensation of "sliding upwards" and then rolling, before the vessel came to a halt. The pilot used VHF radio channel 67 to tell the VTS of the grounding and then called the pilot boat on channel 13. Coastguard/VTS subsequently used channel 14 while the pilot boat used channel 8 for contact and discussion. The third officer wrote down the ship's position from the GPS and then continued to log the times of the various actions undertaken by the ship's crew.

Finnreel aground

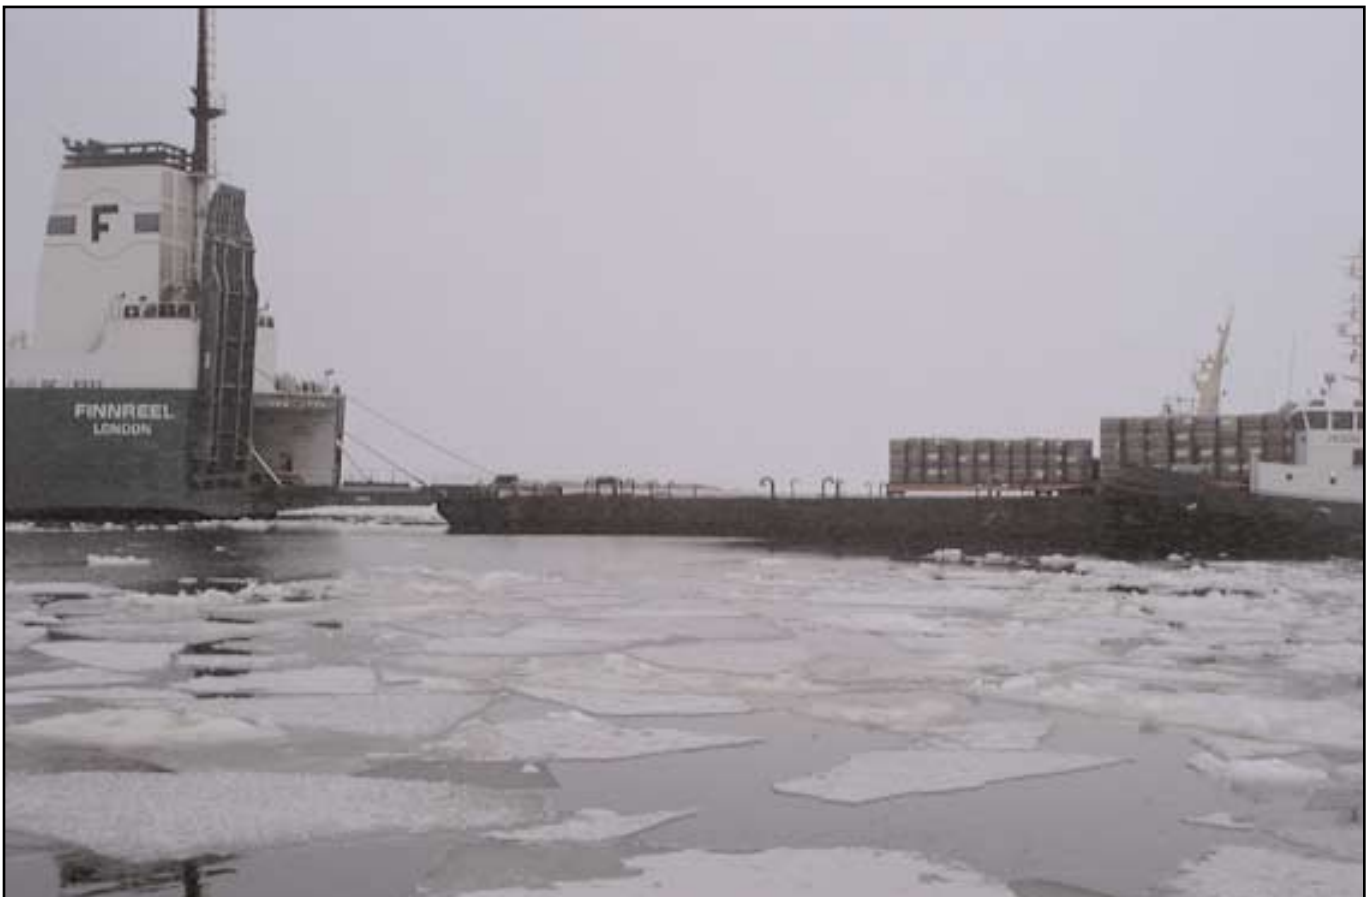
Figure 7

Throughout the morning of 15 March 2001, various officials boarded the vessel, and ballast operations and cargo damage inspections were carried out. By 1445, the vessel was considered ready for the cargo lightening operation, with barges and discharge equipment in position. During the next 10 hours, cargo discharge to a barge moored astern continued, until two barges had been loaded (**see Figure 7**).

Cargo being discharged while aground

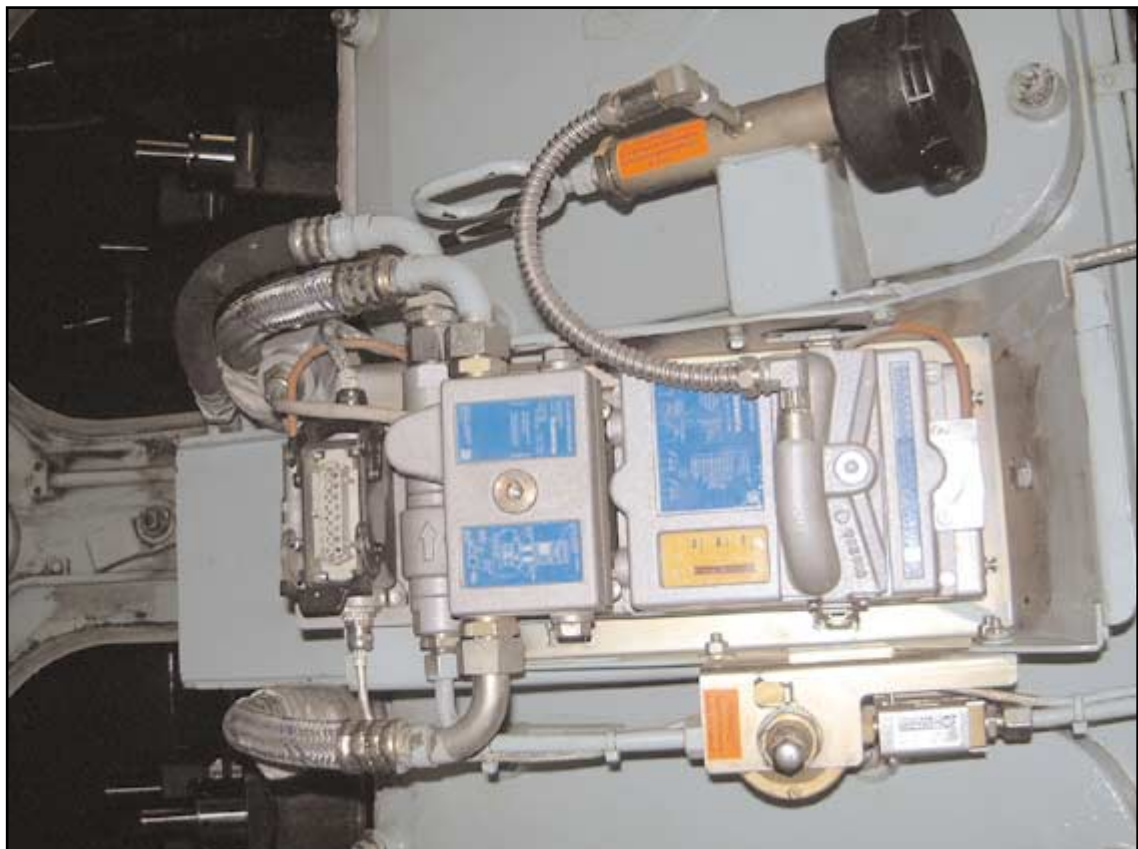
Figure 9

Oil mist detector

2.2.1 The automatic shutdown device on the main engine was activated as a result of the oil mist detector unit sensing a potentially explosive condition within the crankcase.

In his report, the service engineer mentions that he found "a little oil" and cleaned the unit. Whether this oil was sufficient to cause an alarm and shutdown is not known but, so far, it is the only evidence seen that offers a reason for the auto shutdown.

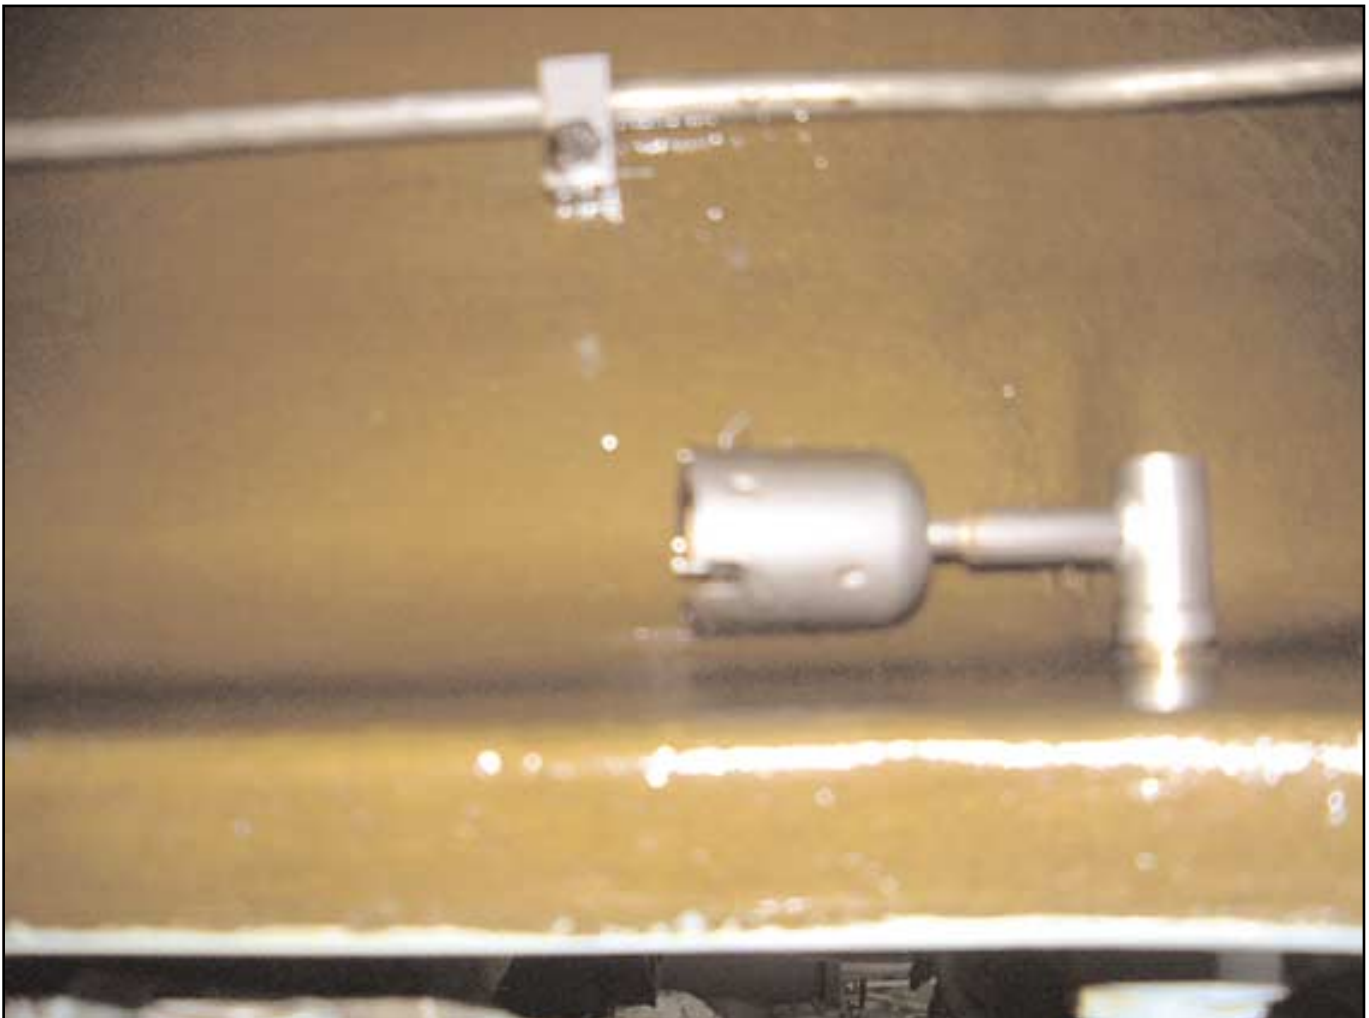
The crankcase sampling pipe system (**see Figure 10**) is installed with a rise of between 2° and 4° to the horizontal leading up to the unit intake. This is to prevent the build-up of oil droplets within the sampling lines causing misleading alarms because of a false impression of opacity.

Crankcase sampling head

2.2.4 The possibility of an oil carry-over relies on the existence of an oil pocket somewhere in the air sampling system. As mentioned earlier, the crankcase sampling pipe system needs to be installed with a rise of between 2° and 4° to the horizontal leading up to the unit intake. This prevents any accumulation of oil in the line. If, during the outfitting, or as a result of internal maintenance work, the sample pipes are disturbed or kinked, then it is possible for oil to accumulate at that point. Once oil starts to accumulate, there is a very real possibility that under the right conditions, a slug of oil will be carried forward into the measuring chamber. Once that occurs, the opacity reading will rise and an alarm condition will register and could lead to an auto shutdown.

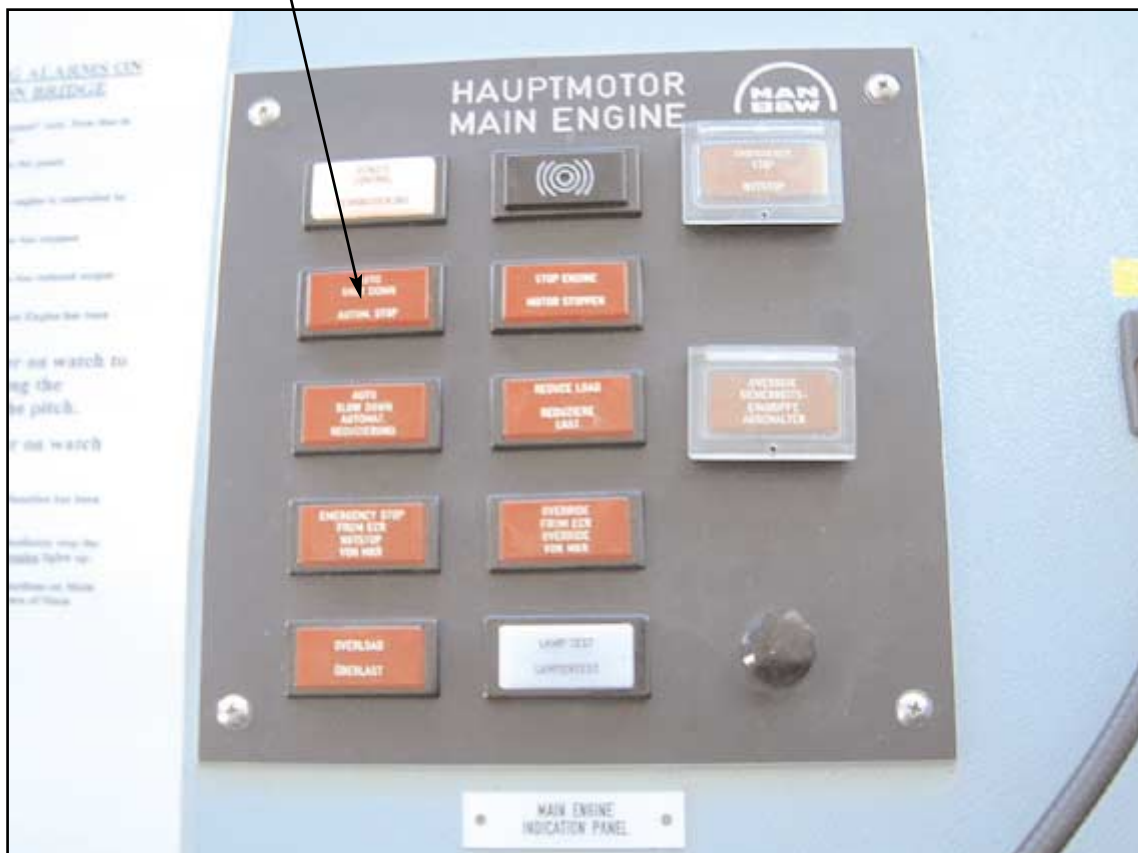
Figure 11

The master could hear an alarm sounding on the centre console but assumed it was the thruster alarm, which had a very similar tone to the auto shutdown alarm. He did not see any alarm lit on the main engine alarm panel. Later it was found that the alarm light bulb had failed, a fault not picked up in the pre-sailing tests. However, even if the master had been made aware by the alarm that the engine had shut down, it would have made little difference to the situation and would not have prevented the grounding (**see Figure 11**).

Shutdown light
(bulb not working at the time of the incident)

Bridge console engine alarms
