# MAIB report - Philomena

Report No 34/2001

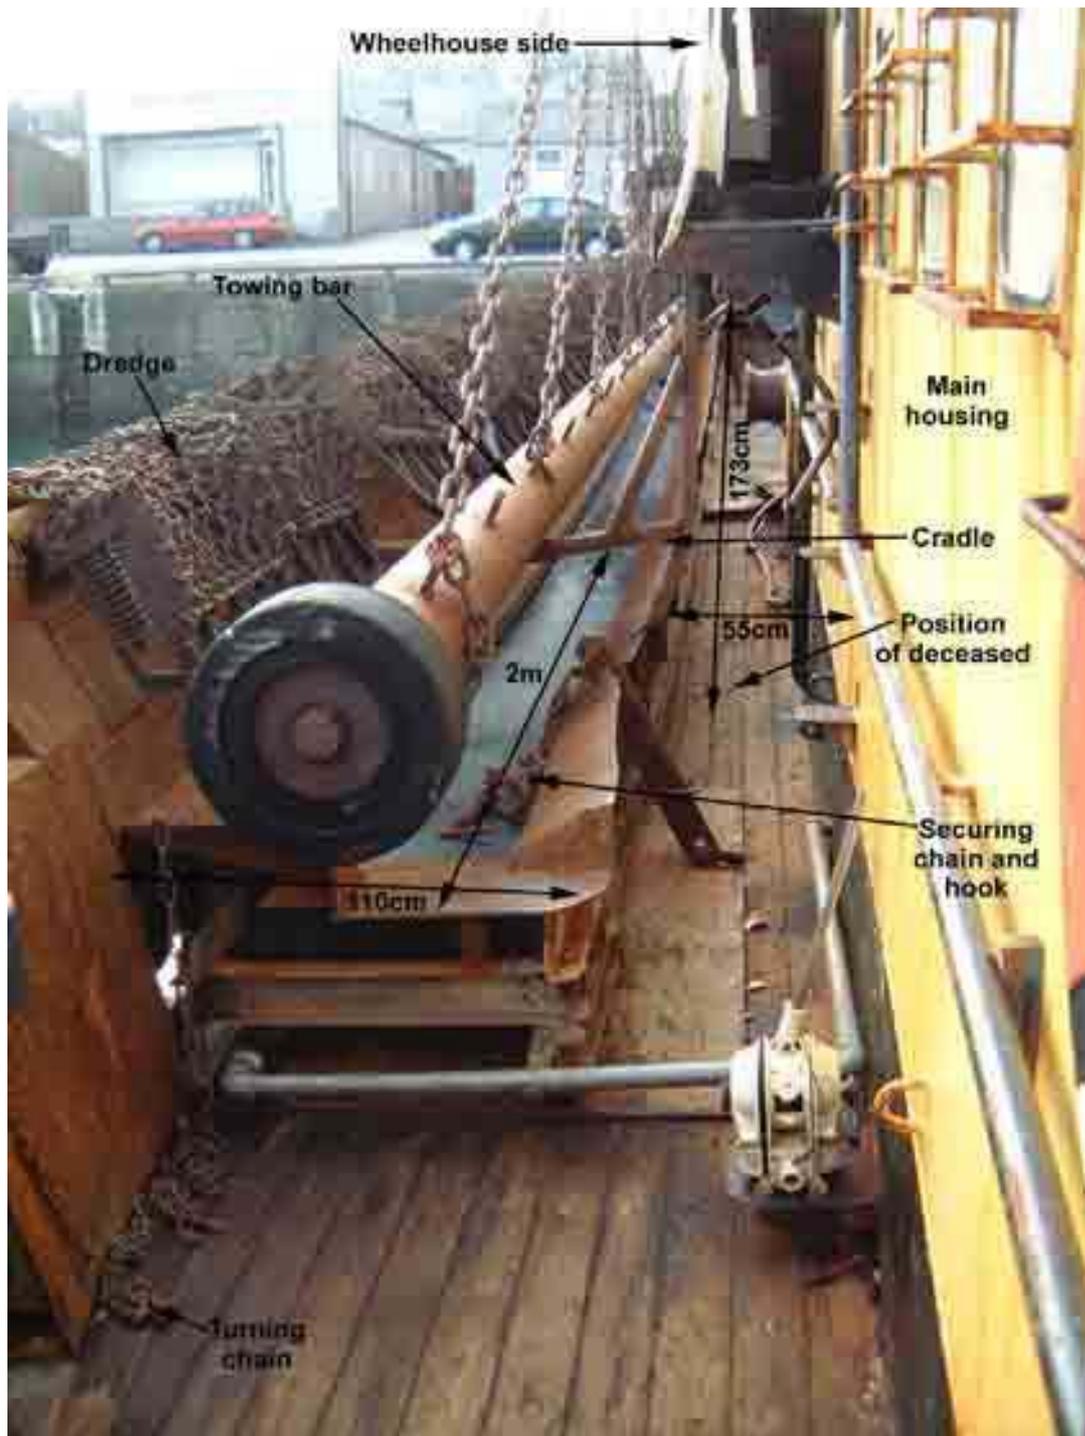
During the times the towing bar was free to swing inboard, the inner side of the cradle prevented the bar from swinging into the main housing up to a height of about 170cm, the height of the deck overhang above. The distance from the inner side of the cradle, which is coincident with the inner edge of the conveyor, to the main housing bulkhead is approximately 55cm. The cradle was 2m forward of the aft end of the towing bar and about 50cm above the conveyor. The conveyor was 110cm wide. The casualty was found between the conveyor and the main housing bulkhead just forward of the cradle. **Figure 1** shows the layout of this area of the vessel and indicates key features. There were several major trip hazards in this area.

Regardless of Mr Davies reasons for moving from a safe area, passage forward could have been achieved safely had the deck area between the main house and the conveyor been used. As can be seen in **Figure 1**, this area is protected by the inboard side of the bar cradle and wheelhouse overhang, even with the towing bar raised from its cradle and free to swing unchecked. Although the deceased was found lying in this area, he could not have been standing in it when struck.

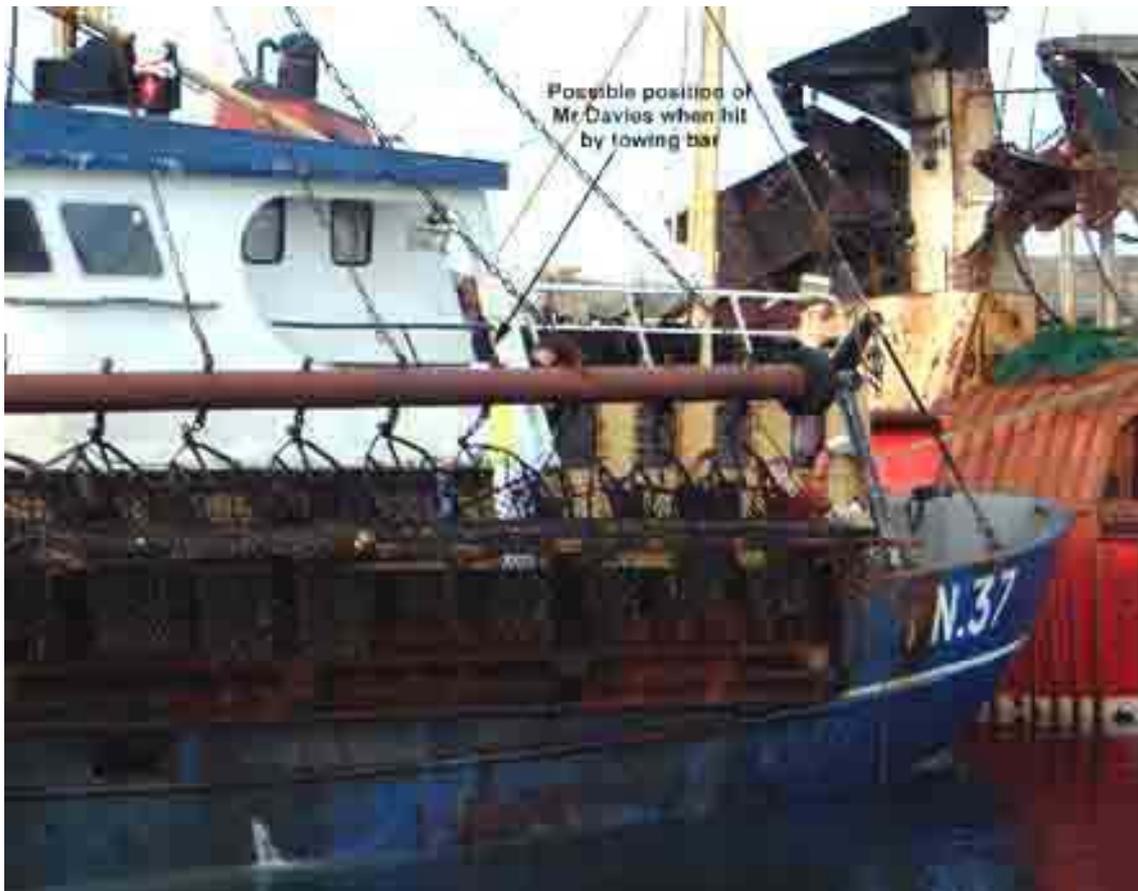
**Estimated height of the towing bar and position of Mr Davies at the time of the accident  
Figure2**

It is estimated that when the towing bar first struck the wheelhouse, its height above the conveyor belt was about 168cm (198cm above the deck). When it struck the second time, it is estimated it had been raised about a further 40cm.

Practical demonstrations of the hauling and shooting procedure were conducted alongside at Buckie on 8 March 2001. With the towing bar positioned at the height above the deck observed at the time of the second strike, it was found that the bar could only strike the head of a person of similar height to Mr Davies, if they were standing on a platform higher than the conveyor (see **Figure 2**). This would have been possible if the deceased was standing on either the raised edges of the conveyor, the cradle, or on top of the catch.

In view of the position in which the deceased was found, it is likely that he was in the vicinity of the cradle when hit. Mr Davies could have easily reached this position during the 5 to 10 second interval between the successive strikes of the towing bar. Furthermore, given the estimated height of the towing bar at the time of the second strike, he must have been standing either on the cradle itself, on the raised sides of the conveyor, or on the catch for his head to be forced against the wheelhouse side (see **Figure 2**).
