MAIB report - Philomena

SYNOPSIS

On 6 March 2001, the coastguard informed the MAIB that a fatal accident had occurred on board Philomena. An investigation began the following day.

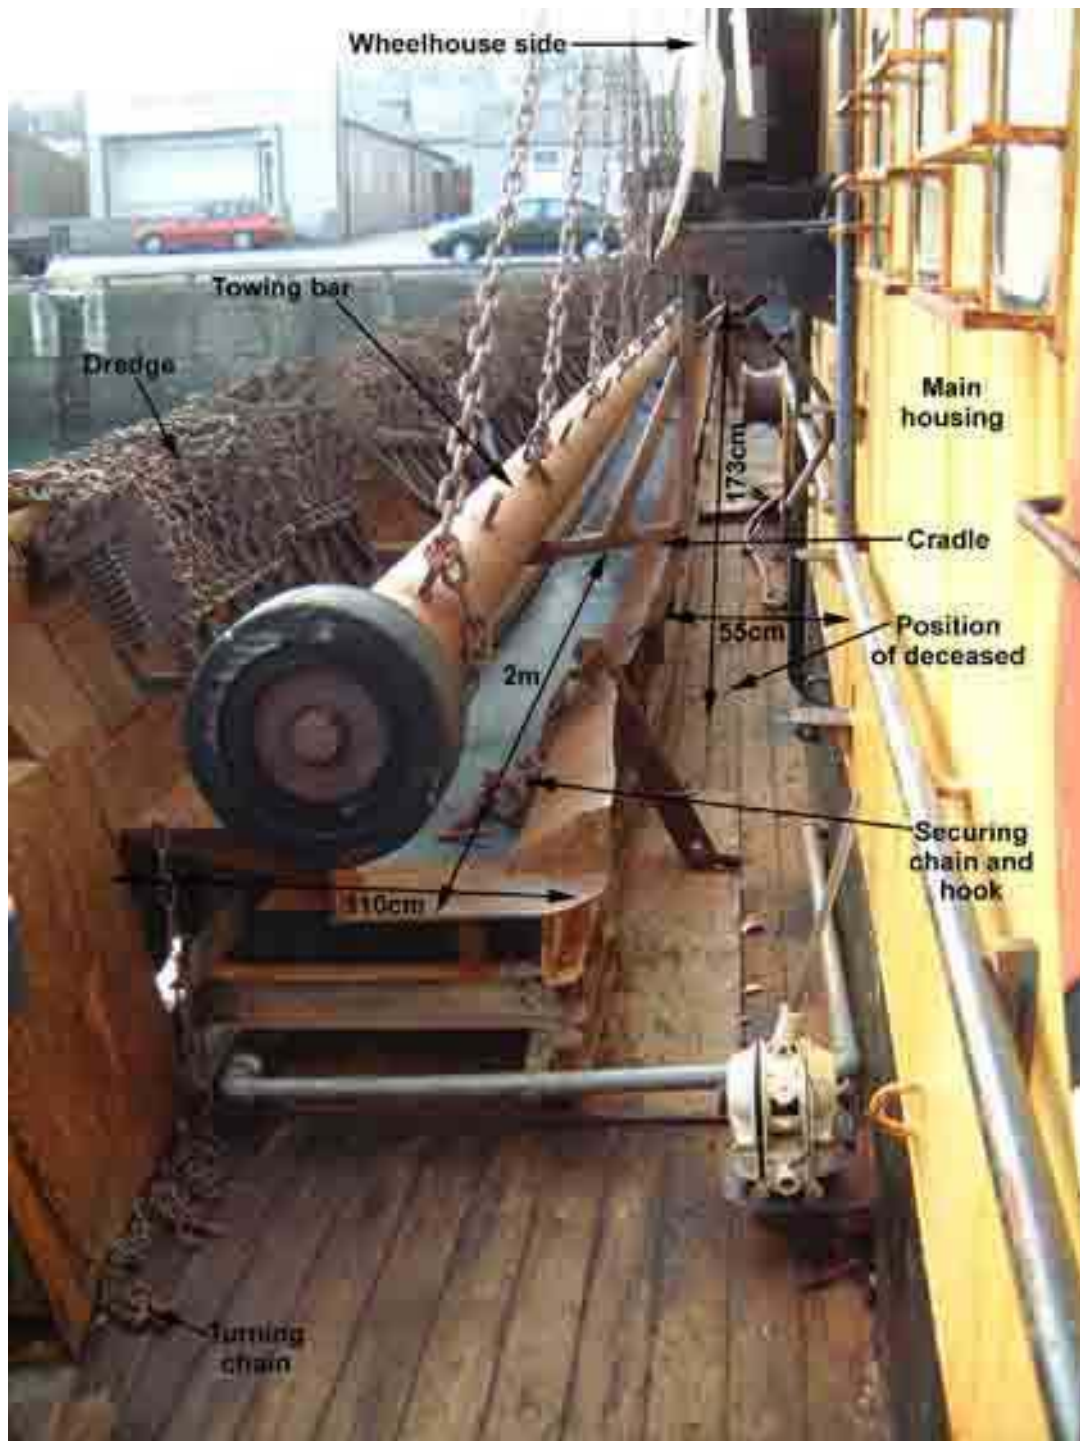
Figure 1

In conducting his tasks, the only occasions Mr Davies had to stand between the towing bar and the main housing, when the bar was neither over the side nor in its cradle, were when hooking the securing chain on to the towing bar, and when checking the dredges during hauling. On these occasions, the dredges prevented the towing bar from swinging inboard. His other tasks, including the resecuring of the turning chain, could be achieved from a position aft of the towing bar.

During the times the towing bar was free to swing inboard, the inner side of the cradle prevented the bar from swinging into the main housing up to a height of about 170cm, the height of the deck overhang above. The distance from the inner side of the cradle, which is coincident with the inner edge of the conveyor, to the main housing bulkhead is approximately 55cm. The cradle was 2m forward of the aft end of the towing bar and about 50cm above the conveyor. The conveyor was 110cm wide. The casualty was found between the conveyor and the main housing bulkhead just forward of the cradle. **Figure 1** shows the layout of this area of the vessel and indicates key features. There were several major trip hazards in this area.

Regardless of Mr Davies reasons for moving from a safe area, passage forward could have been achieved safely had the deck area between the main house and the conveyor been used. As can be seen in **Figure 1**, this area is protected by the inboard side of the bar cradle and wheelhouse overhang, even with the towing bar raised from its cradle and free to swing unchecked. Although the deceased was found lying in this area, he could not have been standing in it when struck.

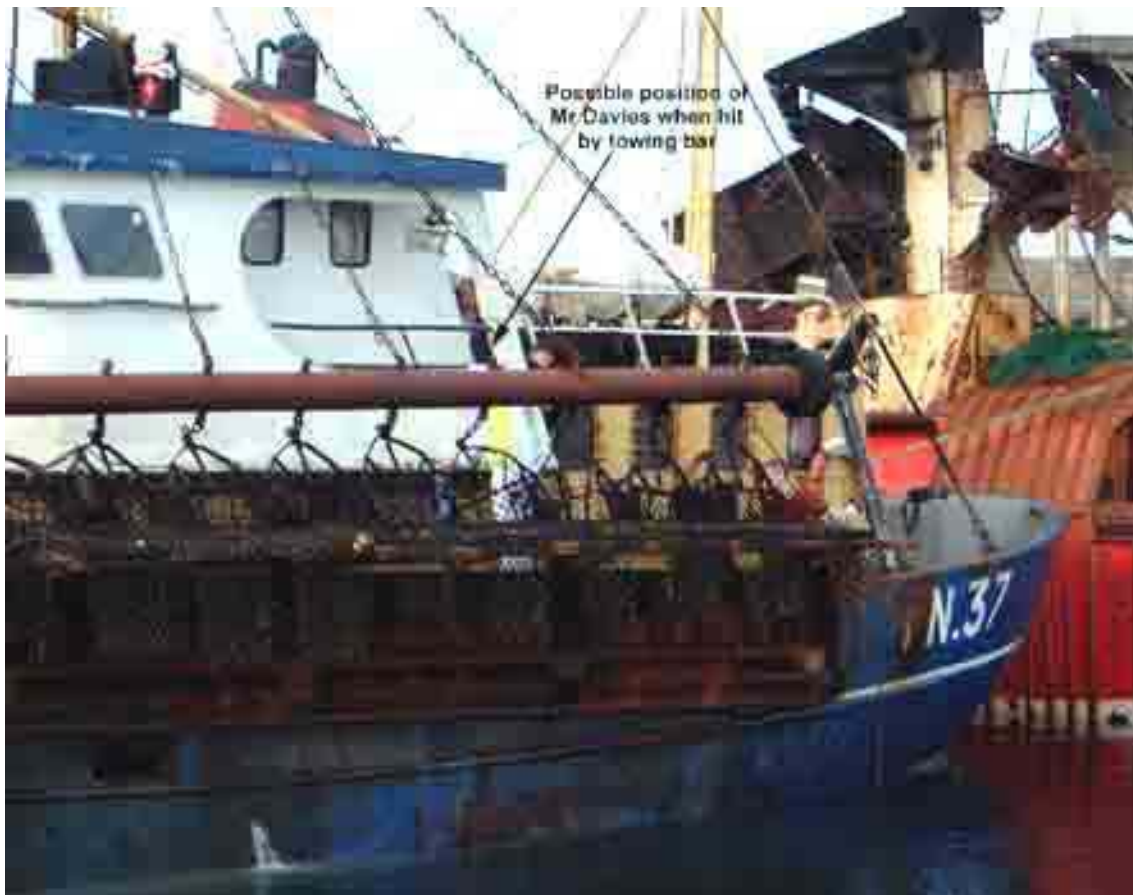
It is estimated that when the towing bar first struck the wheelhouse, its height above the conveyor belt was about 168cm (198cm above the deck). When it struck the second time, it is estimated it had been raised about a further 40cm.

Practical demonstrations of the hauling and shooting procedure were conducted alongside at Buckie on 8 March 2001. With the towing bar positioned at the height above the deck observed at the time of the second strike, it was found that the bar could only strike the head of a person of similar height to Mr Davies, if they were standing on a platform higher than the conveyor (see **Figure 2**). This would have been possible if the deceased was standing on either the raised edges of the conveyor, the cradle, or on top of the catch.

**Estimated height of the towing bar and position of Mr Davies at the time of the accident
Figure2**

In view of the position in which the deceased was found, it is likely that he was in the vicinity of the cradle when hit. Mr Davies could have easily reached this position during the 5 to 10 second interval between the successive strikes of the towing bar. Furthermore, given the estimated height of the towing bar at the time of the second strike, he must have been standing either on the cradle itself, on the raised sides of the conveyor, or on the catch for his head to be forced against the wheelhouse side (see **Figure 2**).
