Report on the investigation of  
the grounding of  
the Liberian-registered container ship  
***P&O Nedlloyd Magellan***  
in the Western Approach Channel to Southampton Water  
on 20 February 2001

Marine Accident Investigation Branch  
First Floor  
Carlton House  
Carlton Place  
Southampton  
United Kingdom  
SO15 2DZ

**Report No 18/2002  
May 2002**

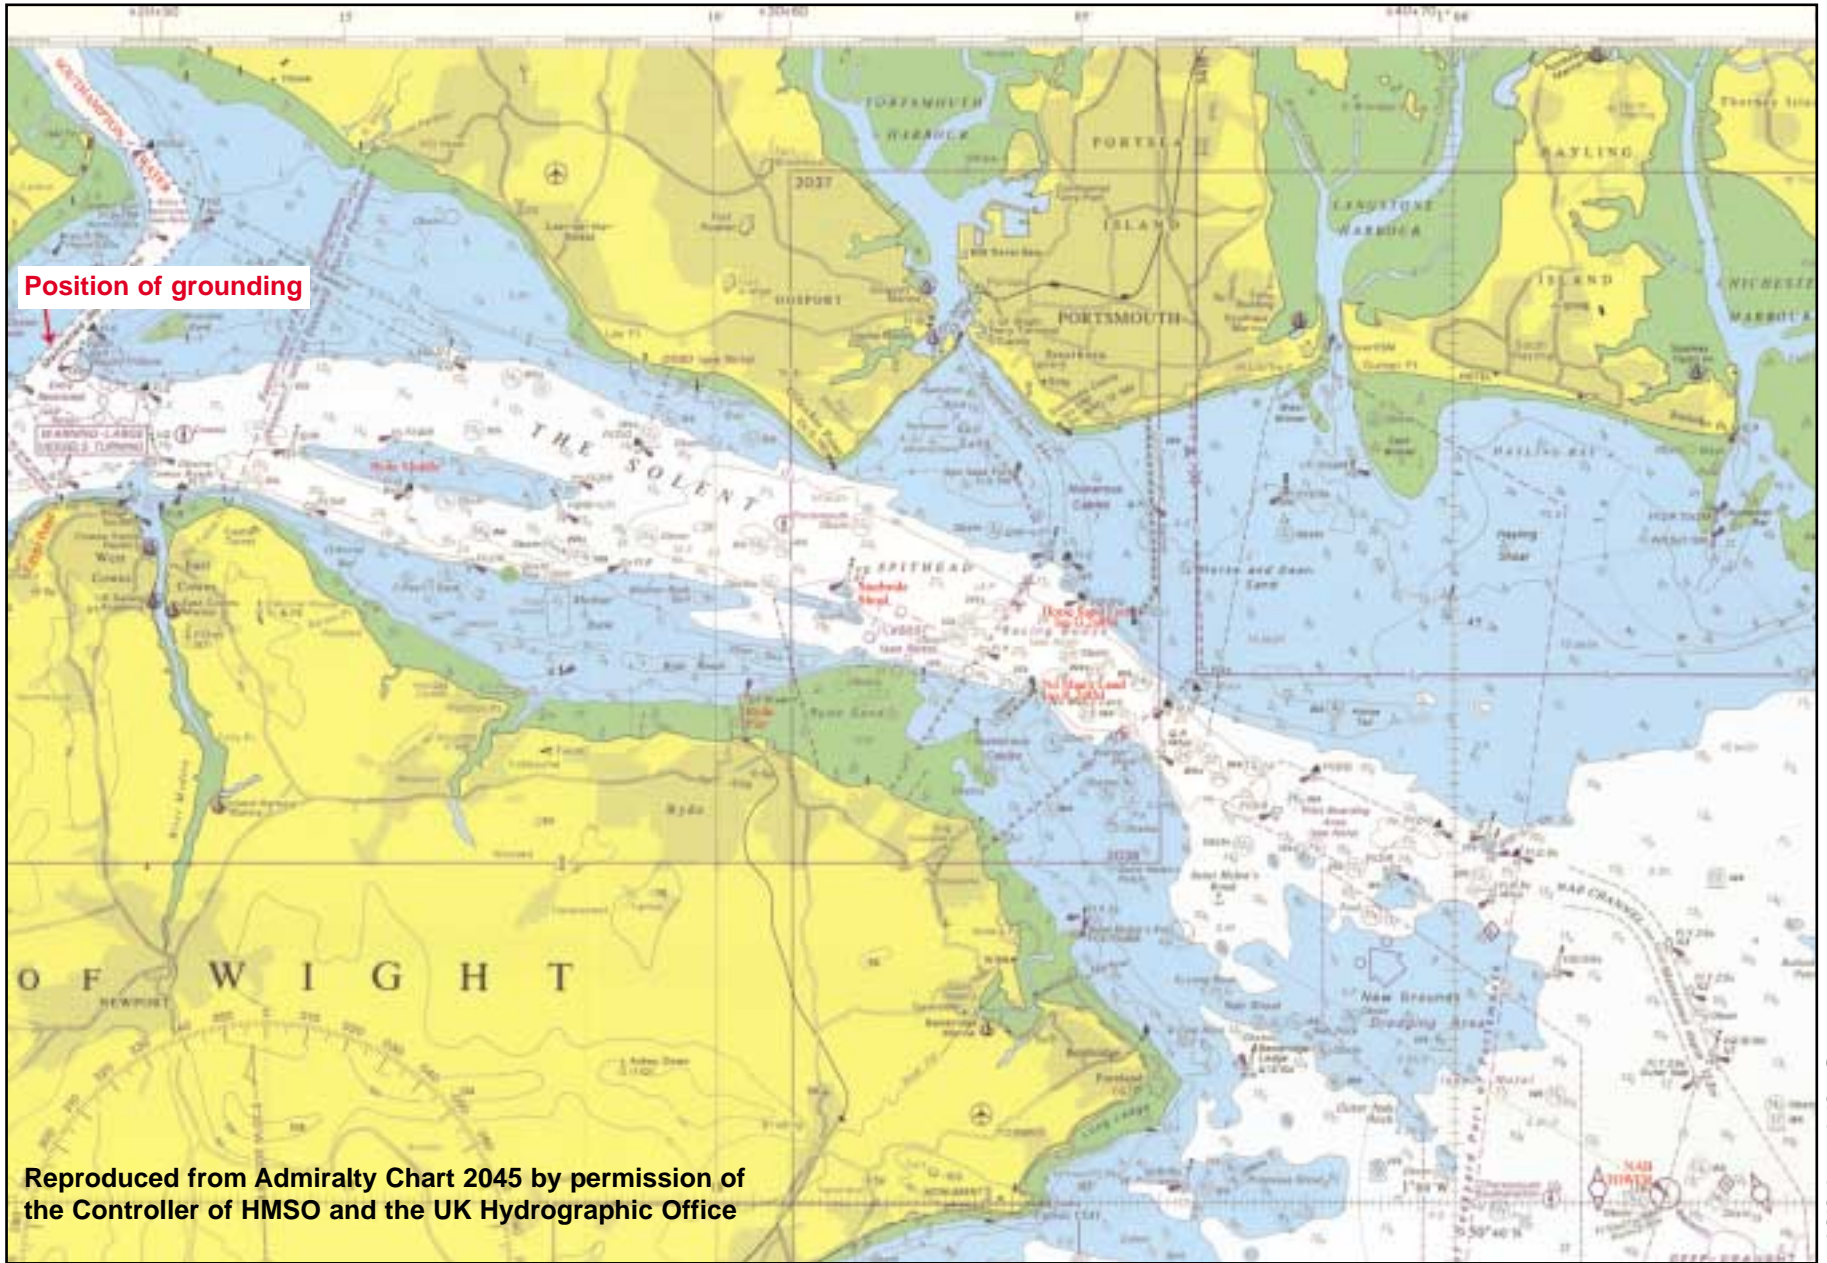
Chart Extract 1

Position of grounding

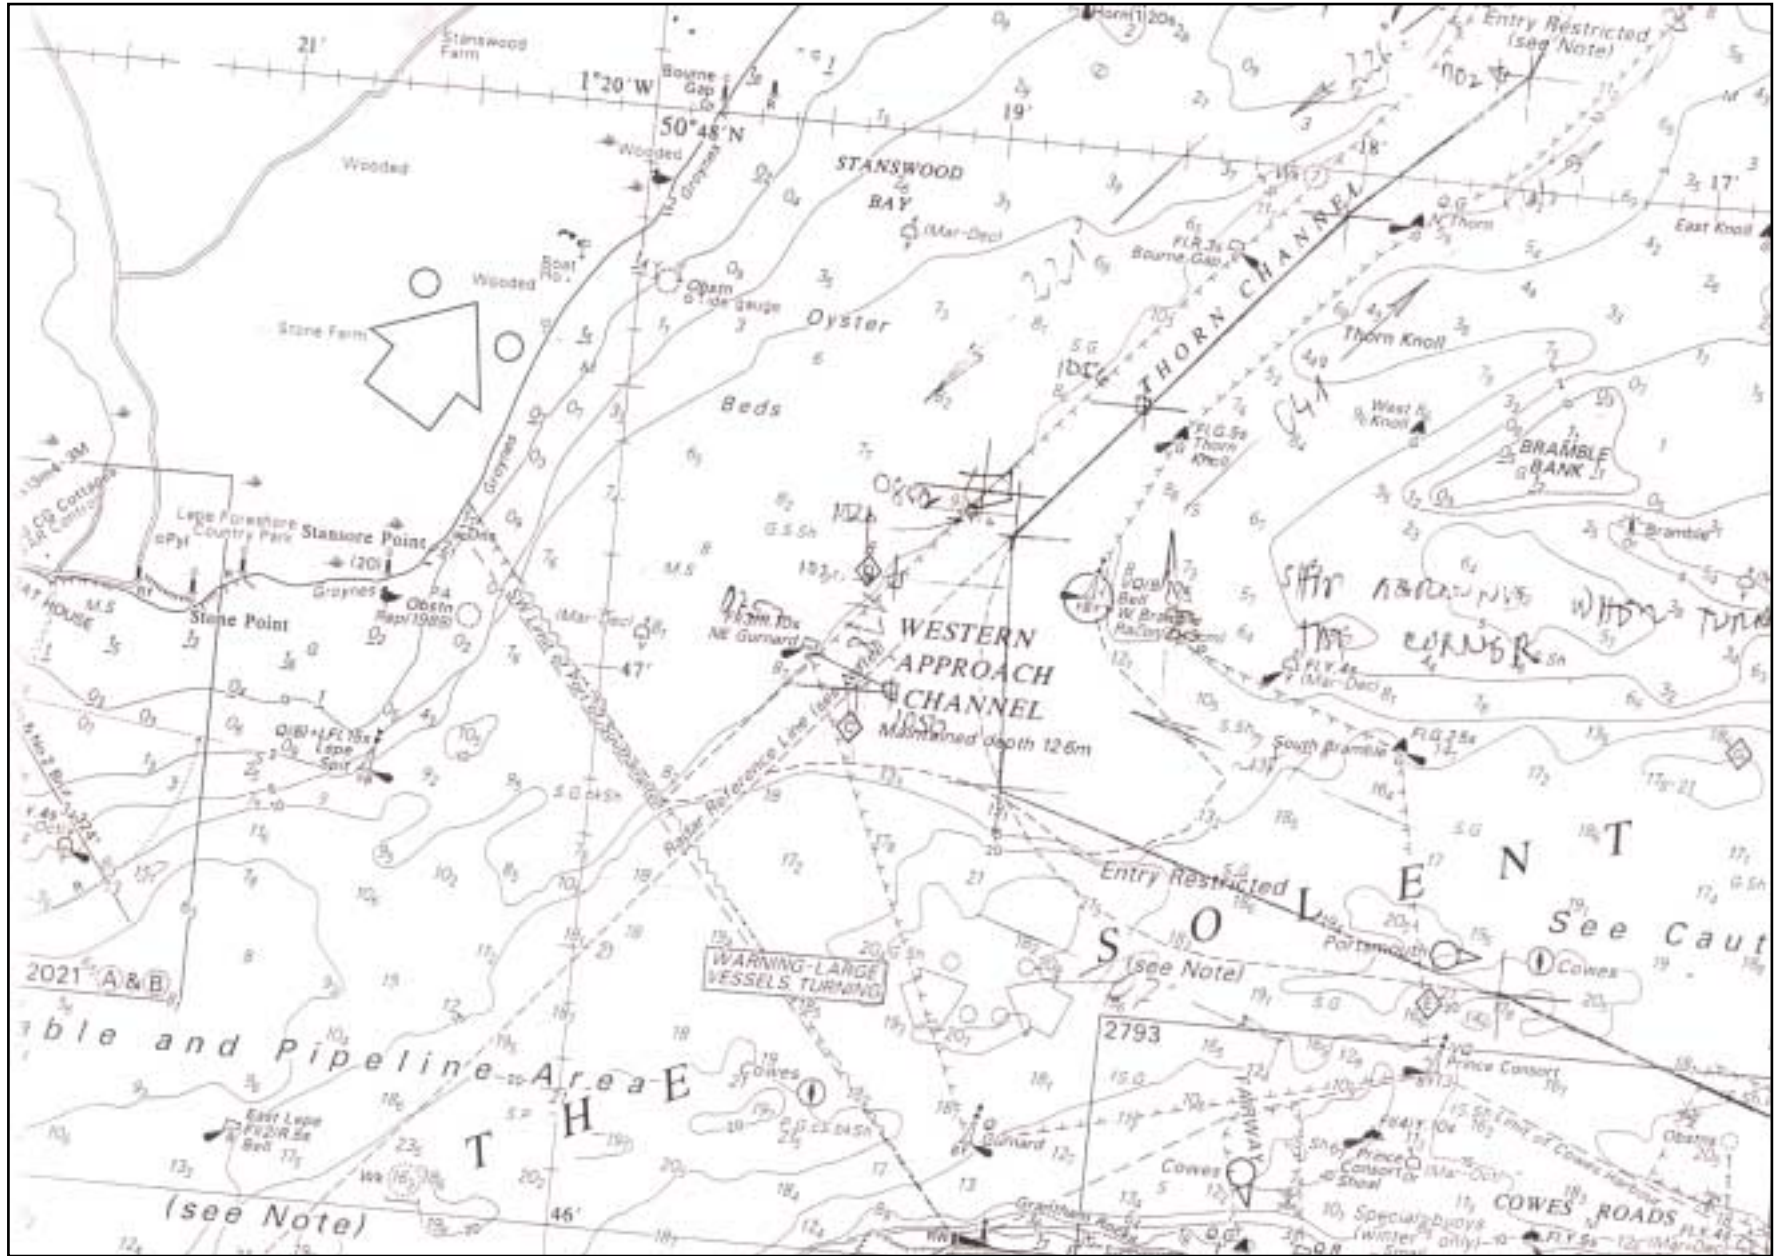
Extract of working chart

As part of the passage plan, waypoints were plotted from berth to berth, both on the paper charts and on the electronic ARCS charts (**extract of charts 3 and 4 and Section 2.3**).

4. Monitor, more closely, the standard of passage plans and navigational procedures on board its managed ships.
5. Produce, for its large container ships, turning data for various loaded conditions, speeds and degrees of helm.

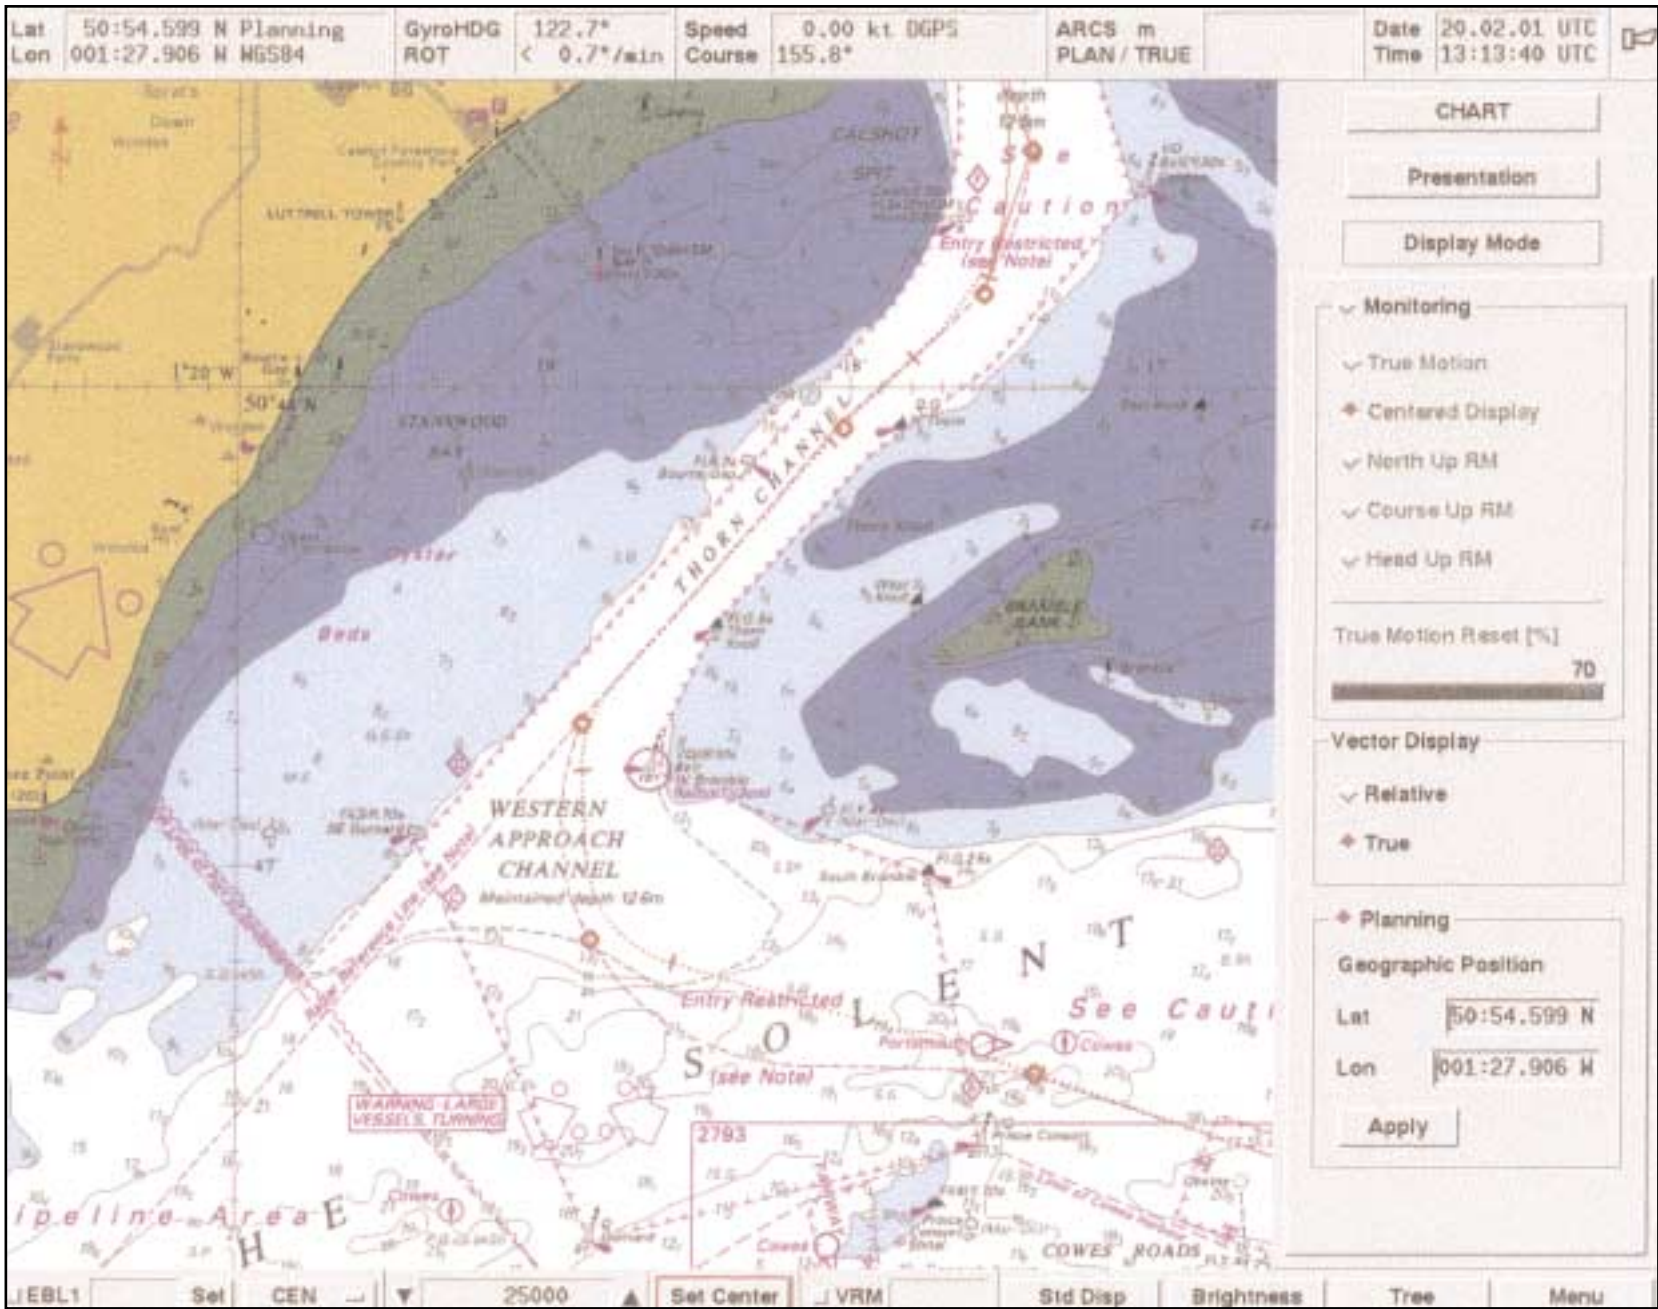
Chart Extract 4

Extract of electronic chart

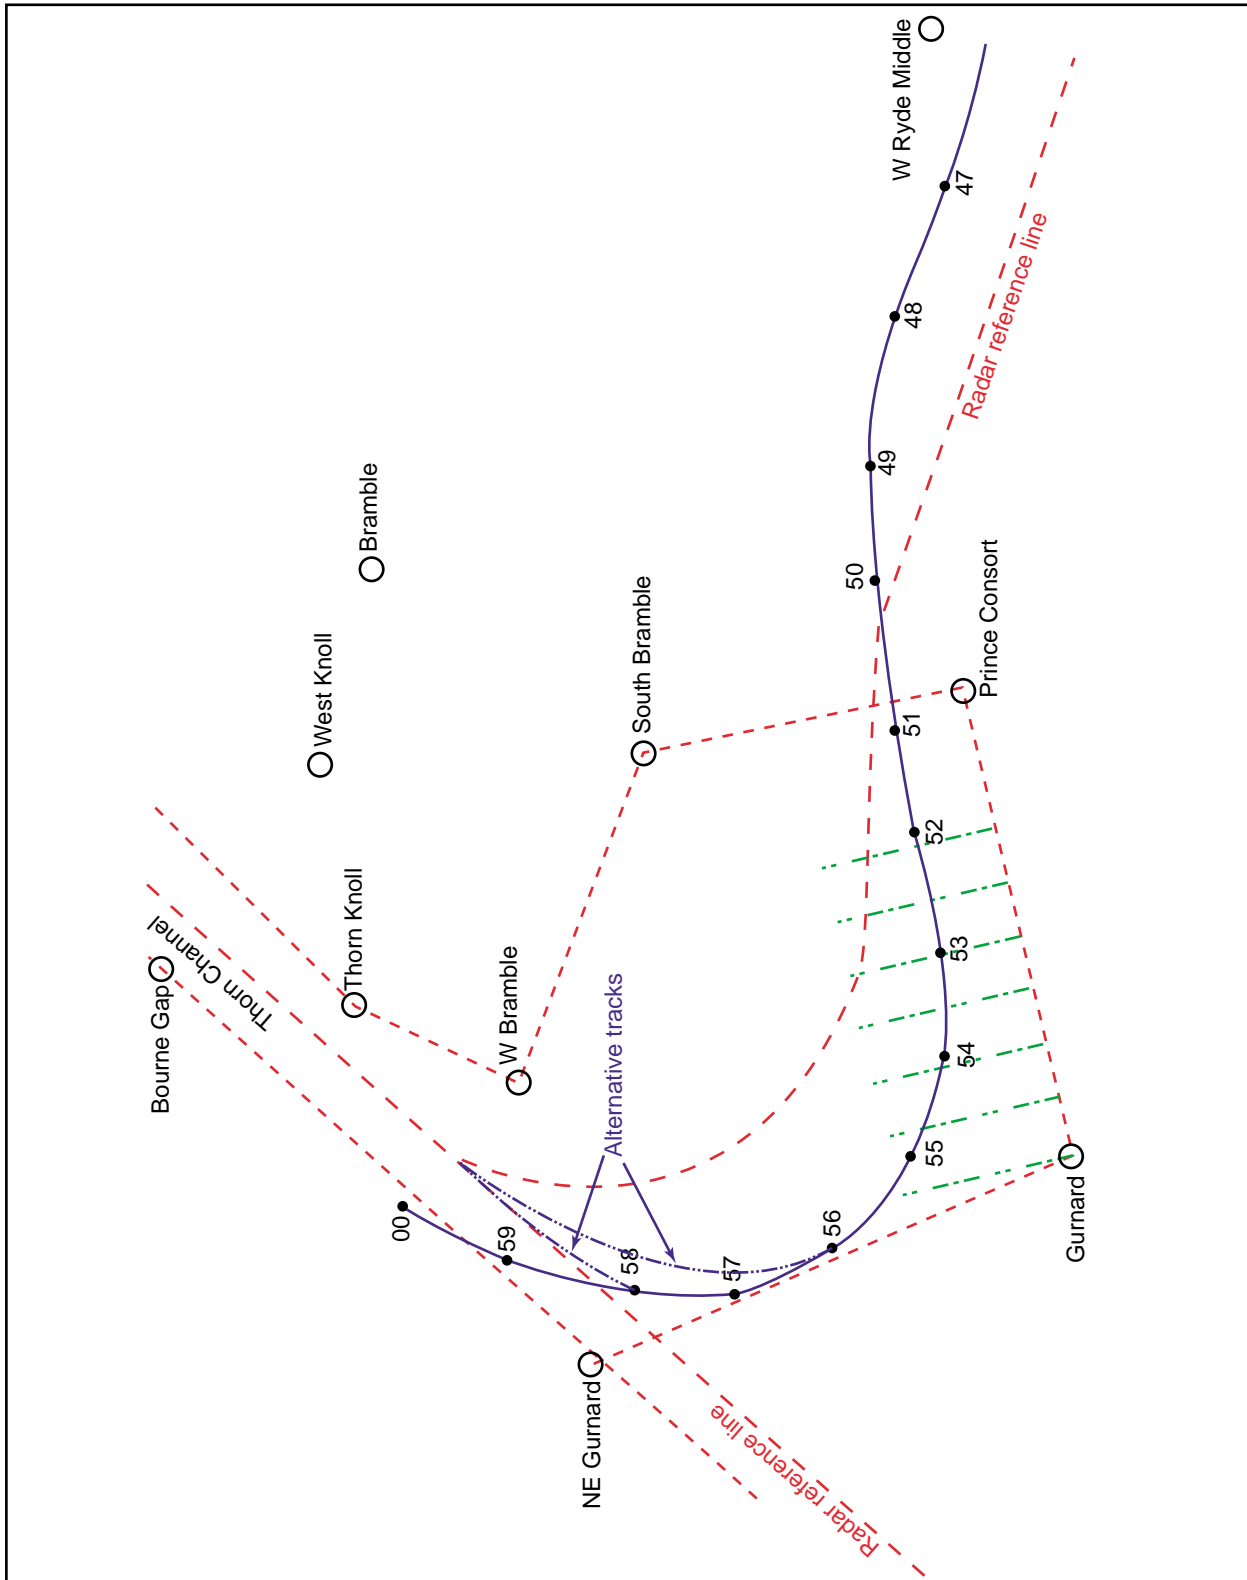
Figure 1

From his experience, the vessel ideally should have been passing through a heading of 320°/325° when NE Gurnard buoy was ahead at a distance of 7 cables. If the distance was greater, the helm should have been eased as the vessel would have been turning too quickly. If the distance was less than 7 cables, the helm should have been either maintained or increased. The VTS

A reconstruction of the grounding

playback indicates that, at about 0656, the bridge of *P&O Nedlloyd Magellan* was 5 cables from the buoy when she was on a heading of between  $320^{\circ}/325^{\circ}$ . The distance to the NE Gurnard buoy at this time was less than ideal because, at least in part, of the pilot reducing the helm from  $15^{\circ}$  to  $5^{\circ}$  at 0645. He had done this when he had seen the rate of turn indicator reading the desired  $30^{\circ}/\text{minute}$ . In accordance with his normal procedure, he subsequently increased the helm from  $10^{\circ}$  to  $15^{\circ}$  to quicken the turn.

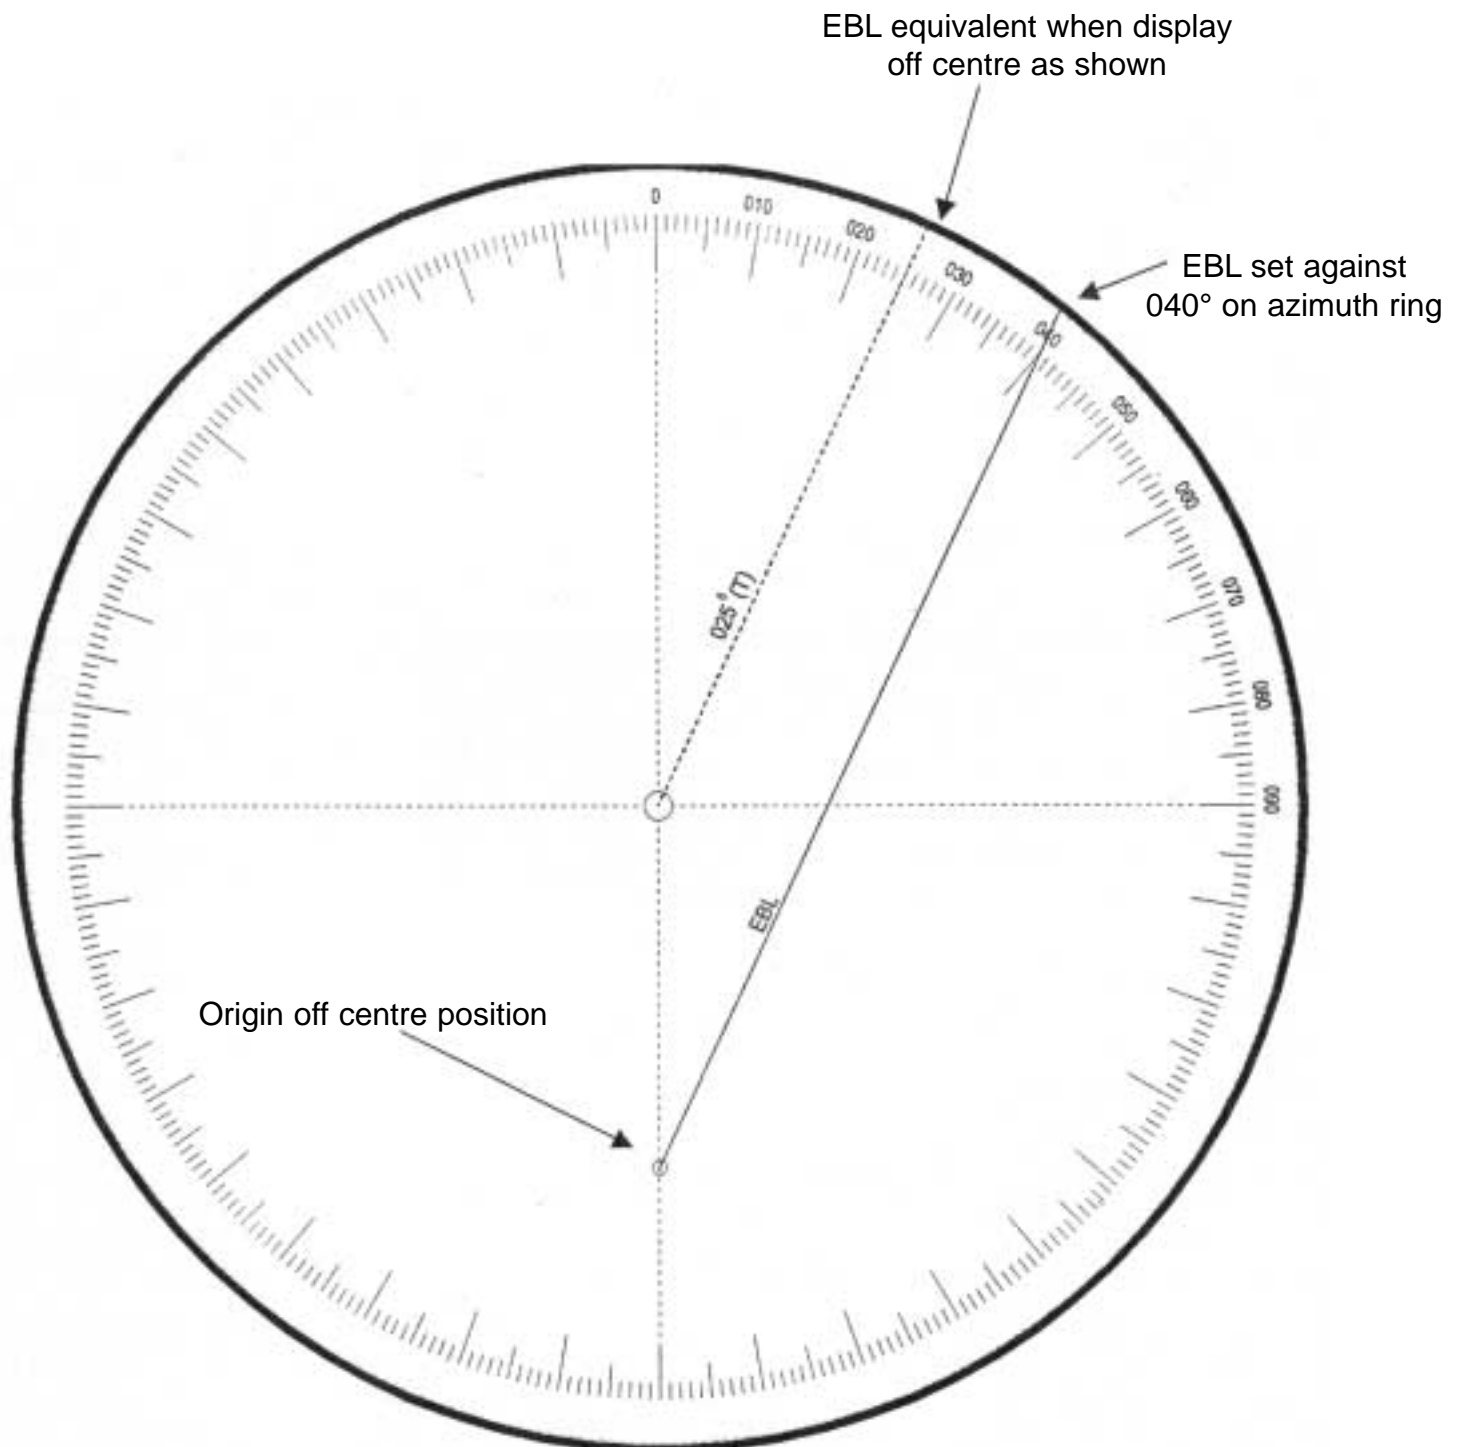
Figure 2

Reconstruction of radar display on *P&O Nedlloyd Magellan*
