Report on the investigation  
of broaching of fast rescue boat  
while being launched from  
***Commodore Clipper***  
on 18 February 2001

Marine Accident Investigation Branch  
First Floor Carlton House  
Carlton Place  
Southampton  
SO15 2DZ

**Report No 19/2002**  
**June 2002**

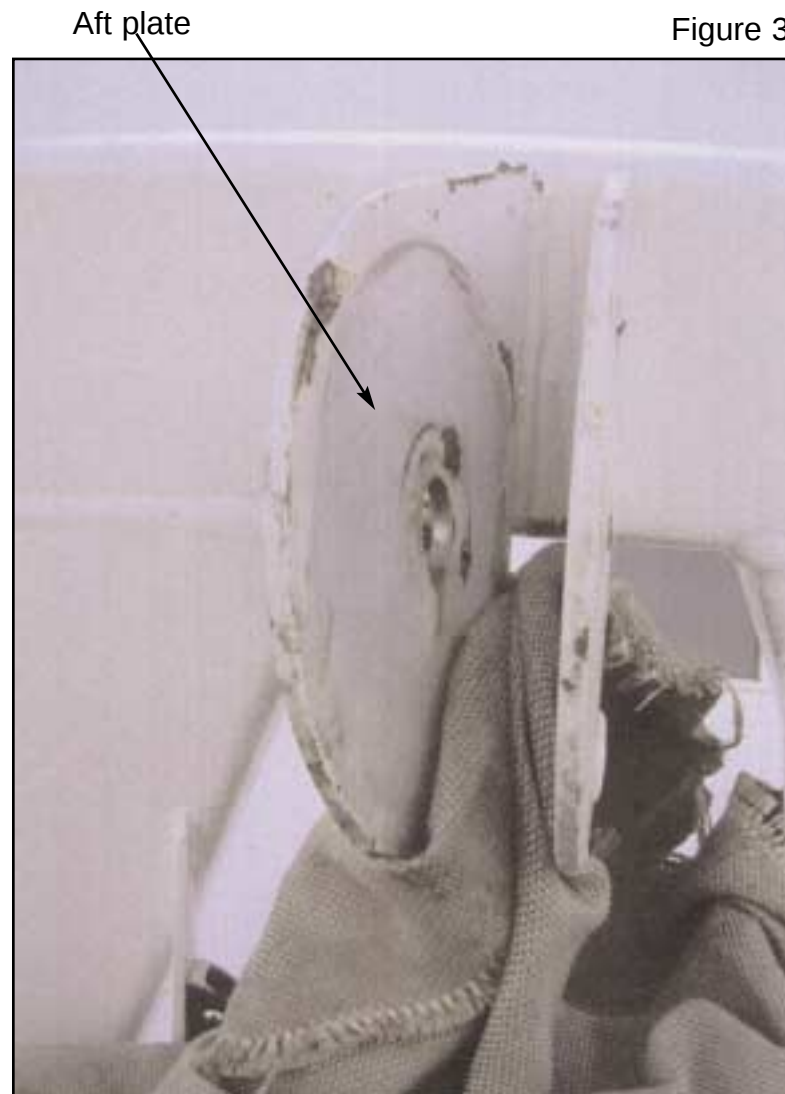
Damaged cheek plates at davit head

The davit was also rendered unserviceable owing to the davit head having opened out in way of the sheave (**Figure 3**).

Following the accident, the cheek plates of the top sheave of the davit were found to have spread; the aft plate had suffered much more than the forward.

This damage is consistent with the fall wire being pulled aft, from the plumb condition, by the broaching FRB.

At the time of the broach, the davit's compensating system, which maintains a limited tension in the fall wire, was engaged. This load, even if applied at an angle from the vertical, is unlikely to have been sufficient to cause the cheek plate damage. However, the broaching load on the FRB would have been enough to cause the fall wire to run out until it was well off the vertical.

This suggests the possibility that the fall wire then became trapped, or partly trapped, between the sheave and the cheek plate. This would have introduced a much larger cheek spreading force. It is suggested that this is the reason for the damage. This mechanism is also consistent with the marks made on the inner face of the cheek plate, most probably by the trapped fall wire.

10. The dangers of cold water immersion in the prevailing conditions were not fully recognised. [2.7]
11. The davit head was damaged by the excessive fore and aft load generated by the FRB broaching. [2.8]

The cause and direction of this load is so exceptional that the failure does not indicate any need to modify the davit or its specification.

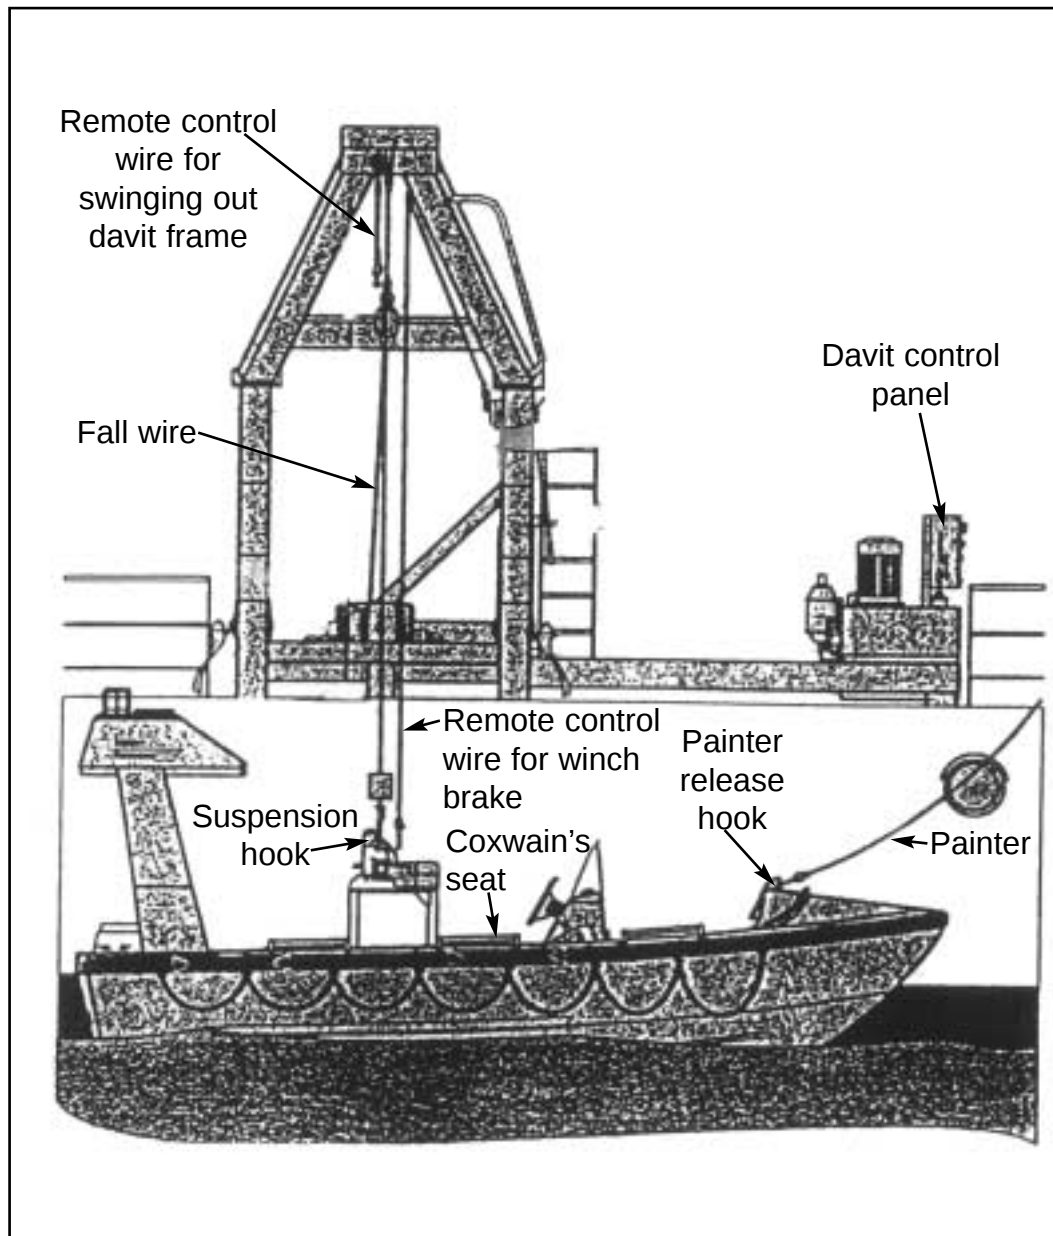
Figure 4

The davit is an electro-hydraulically powered swinging frame design with a single block and fall wire leading from its head (**Figure 4**). A stored energy system allows the frame to swing out in the event of a loss of electrical power. Power for the remainder of the launching operation is supplied by gravity.

The painter release hook can be released while under load by movement of a directly mounted operating lever (**Figure 4**). Although within sight of the coxswain, when at his controls, the release is beyond his reach and is normally controlled by a third crewman forward of him.

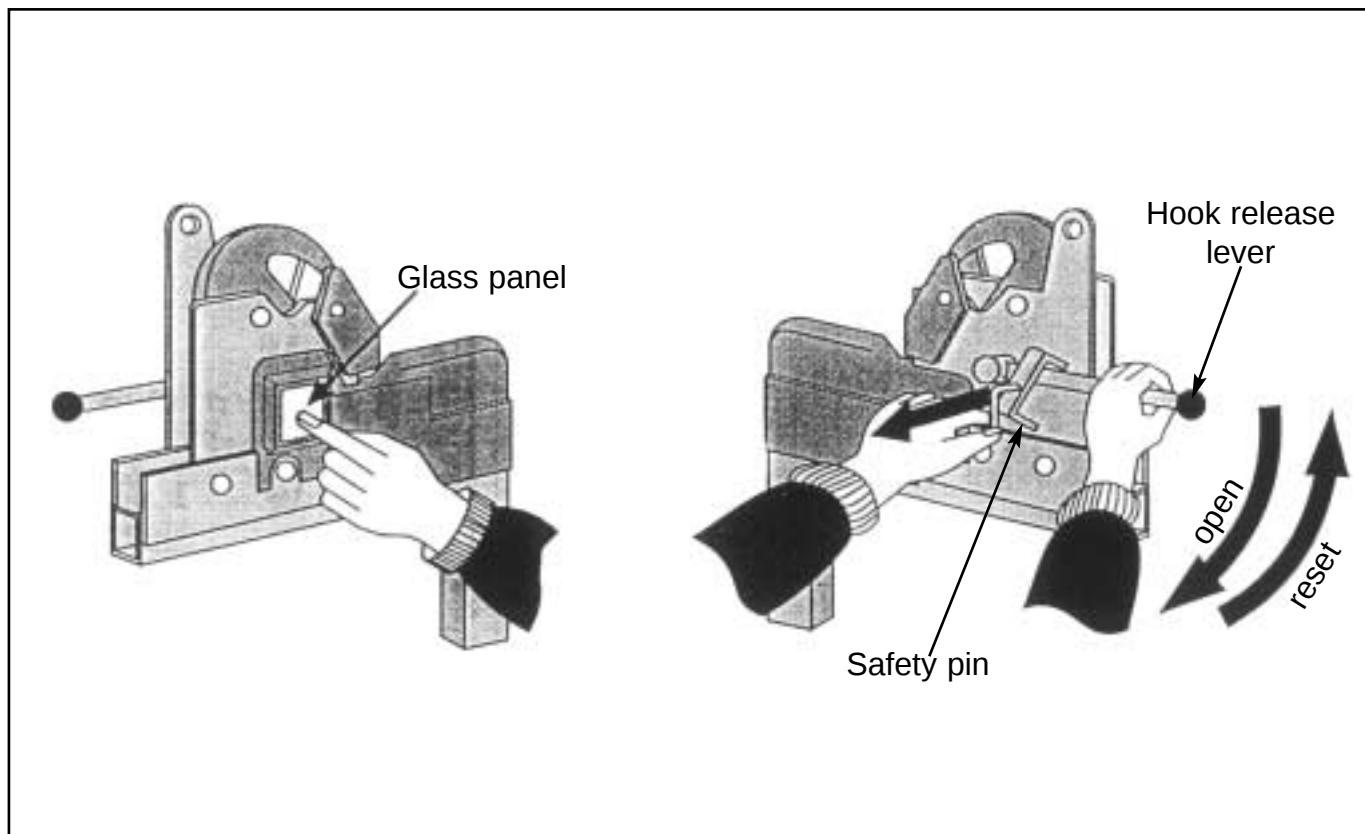
FRB suspension hook

The FRB's suspension hook is of the on/off load release type (**Figure 5**). Because it is positioned aft of the coxswain's seat, the hook is released under the control of a second crewman, rather than the coxswain.

To prevent inadvertent release of the suspension hook before the FRB has taken to the water, a hydrostatic interlock is fitted which prevents operation of the release lever. This interlock may be overridden by breaking a small glass panel covering the mechanism, and moving the interlock lever clear by hand before operating the release lever. A separate safety pin is also fitted, which prevents operation of the release lever until removed.

The FRB's suspension hook is designed to be capable of being released when under load. Had it been released as soon as it was realised the boat was broaching, the launch might have been completed without major incident. At that stage the boat was afloat, so the hydrostatic interlock would have automatically disengaged, allowing the suspension hook's release lever to be operated. However, the AB attending the release lever was unable to release the hook when he realised that the painter had been released and the FRB was beginning to broach. This was largely because the release lever's safety pin was still in place, which is in accordance with manufacturer's operating instructions.

Safety devices which prevent premature release of suspension hooks are important, particularly when FRBs, or other LSA, are lowered from high-sided vessels. This FRB is fitted with a hydrostatic interlock, designed to prevent the suspension hook being released until the boat becomes waterborne. However robust this interlock system might be, and there is no suggestion this system was in any way defective, a safety pin has the advantage of simplicity, both in design and operation and is likely to offer a high level of confidence to the operator while his boat is being lowered to the water.
