Report on the investigation of the
near miss between
Pride of Cherbourg and Briarthorn
in the Eastern Solent
on
7 February 2001

Marine Accident Investigation Branch
First Floor
Carlton House
Carlton Place
Southampton
United Kingdom
SO15 2DZ

**Report No 4/2002
February 2002**

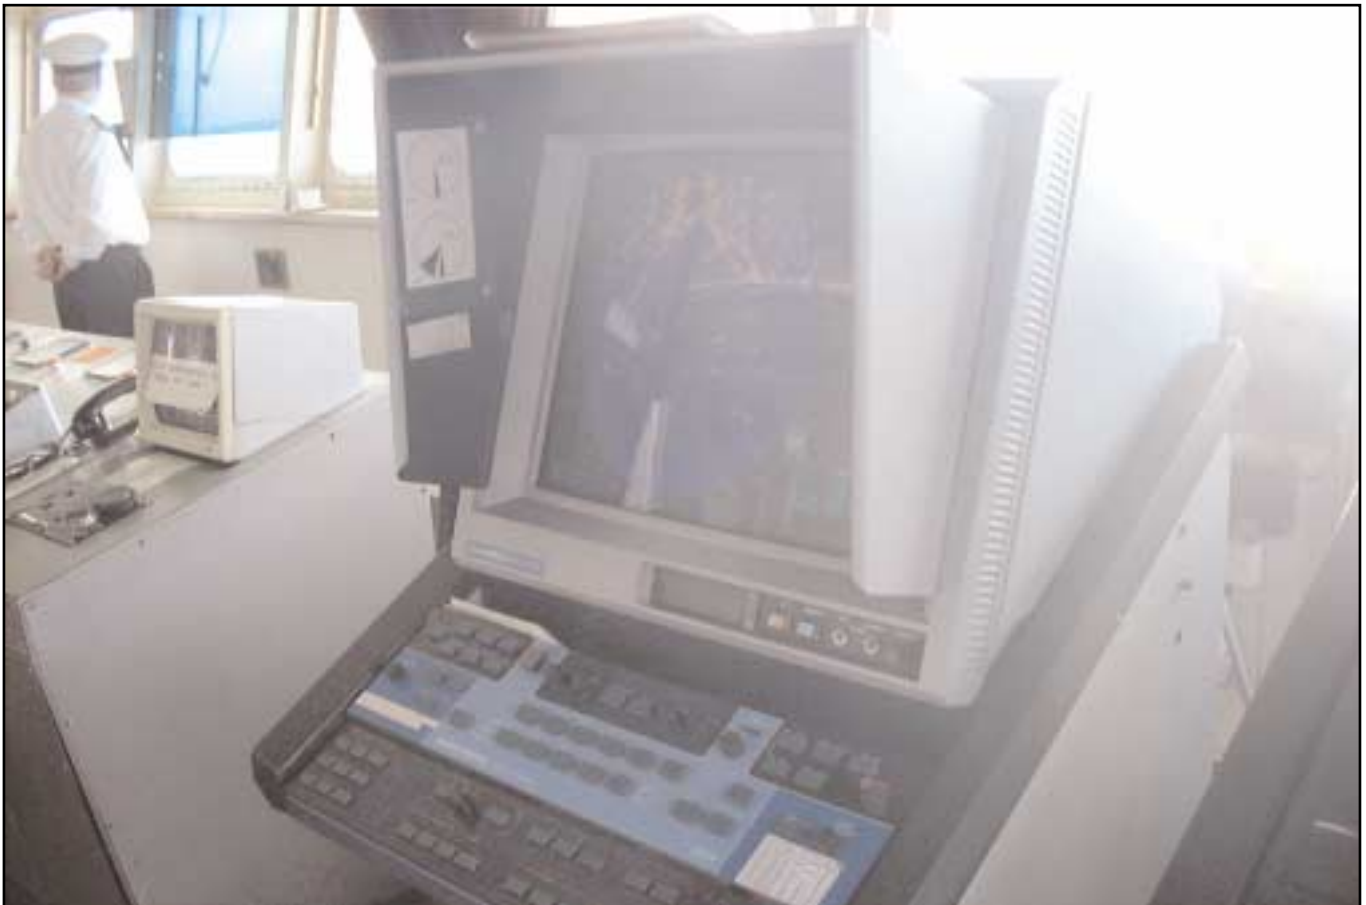
Figure 3

ARPA on *Pride of Cherbourg*

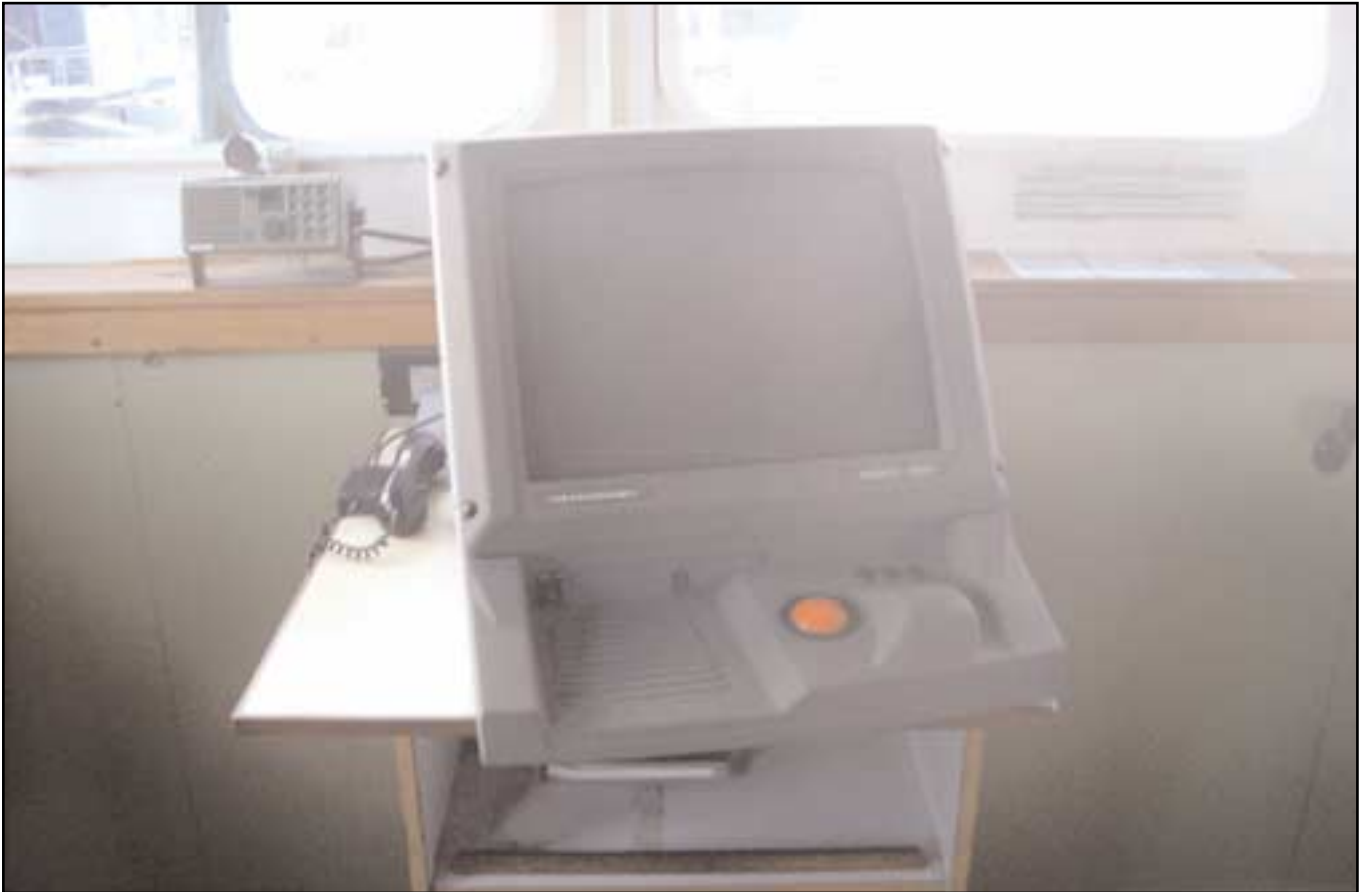
Briarthorn did not have a gyro compass fitted, which required the radar to be kept in an unstabilised mode with ship's head up.

Radar on *Briarthorn*

The only radar on board was not a full ARPA but had to be used in “ship’s head up” mode of presentation because the vessel was not fitted with a gyro compass. This did not make taking bearings of crossing vessels easy, or accurate, due to yawing and small alterations of course. The radar had a plotting facility and cursor, but the master chose not to use it. It was possible to use the pelorus, fitted at the front of the bridge, for relative bearings, but the master considered this not practical and too cumbersome.

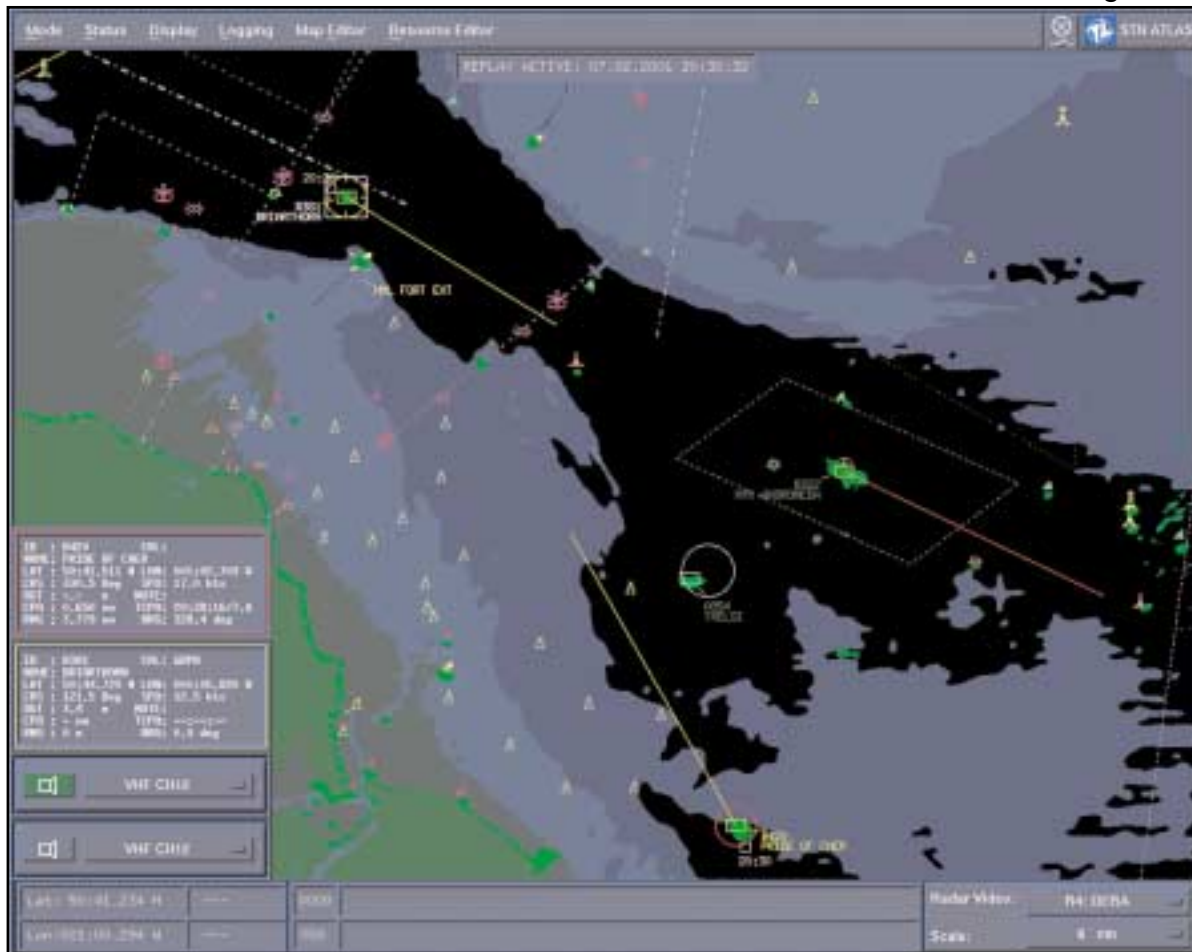
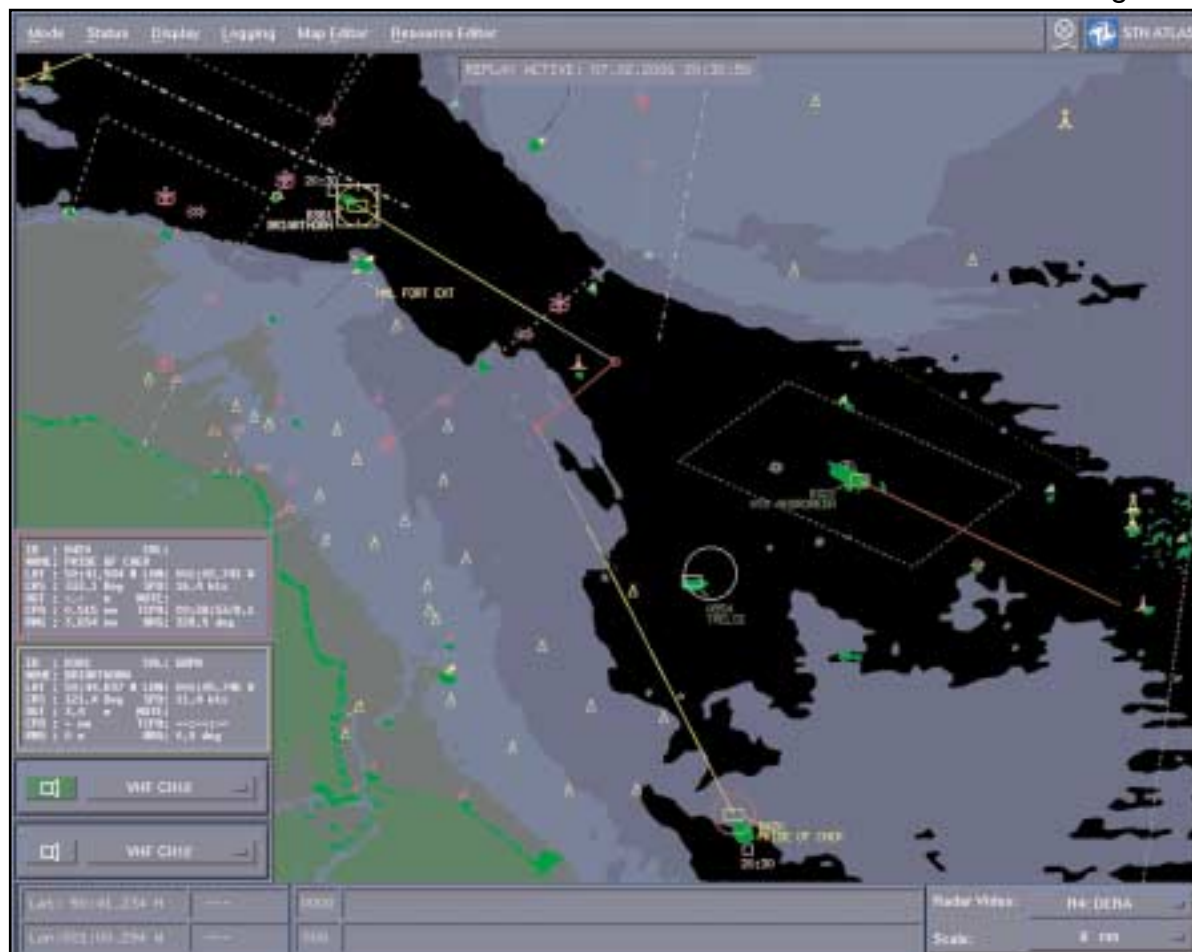
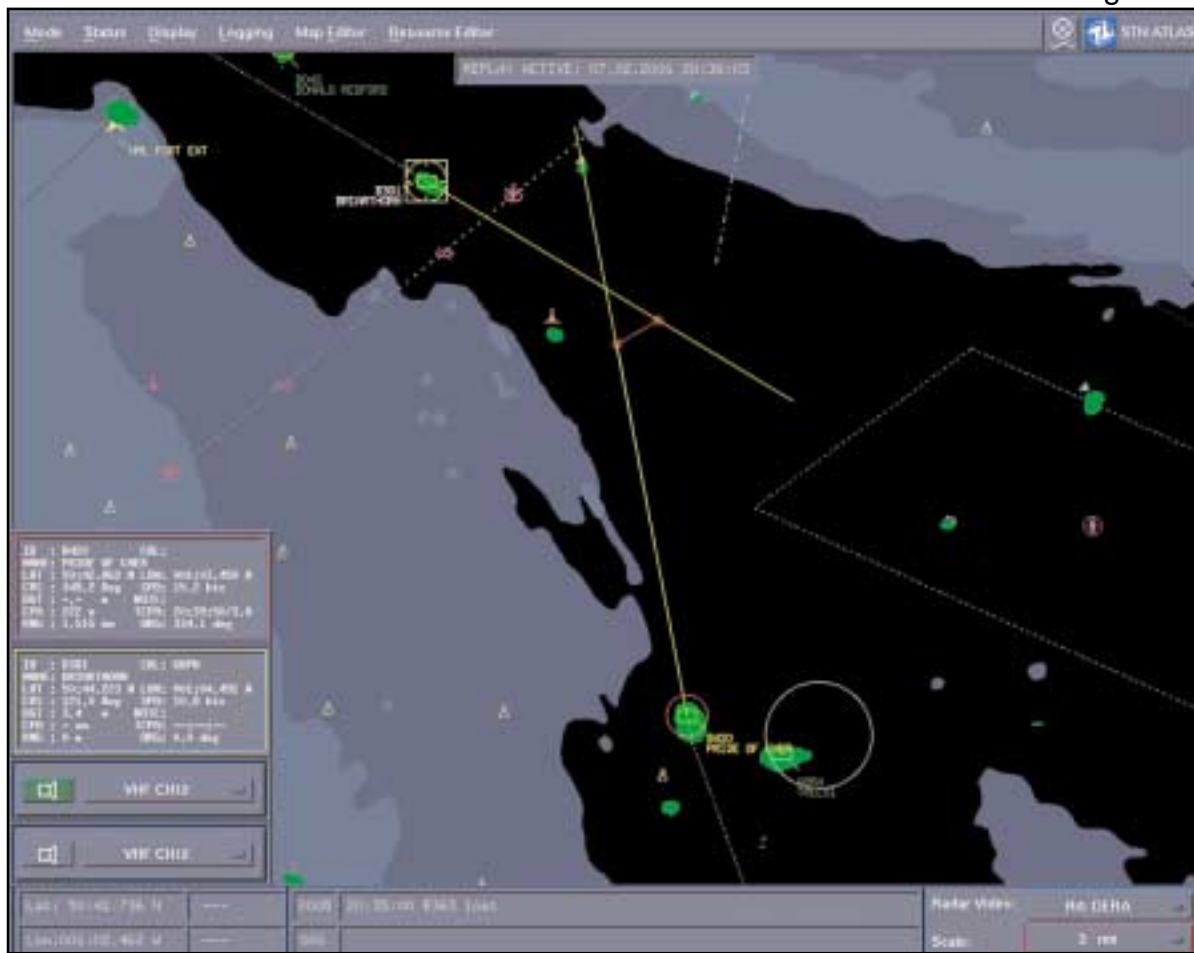
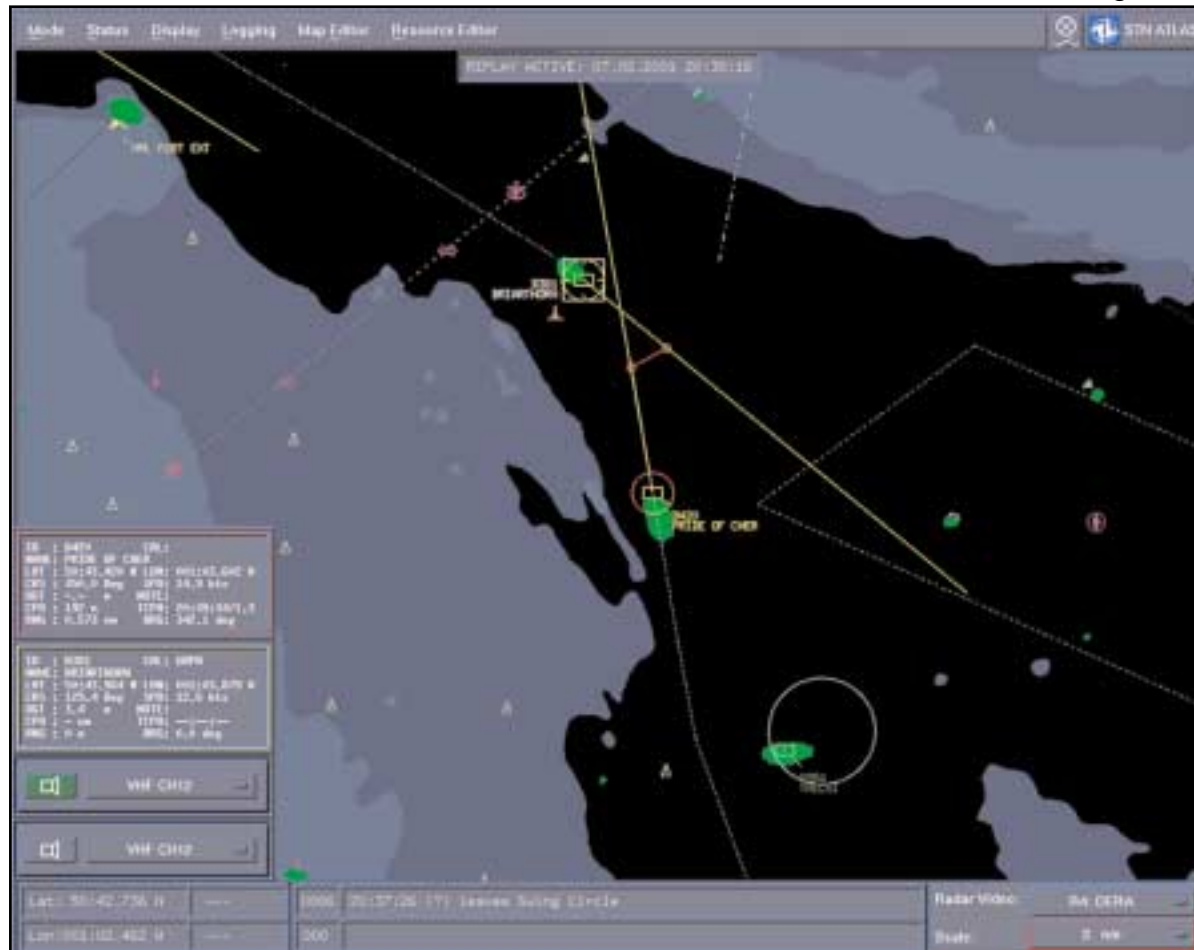
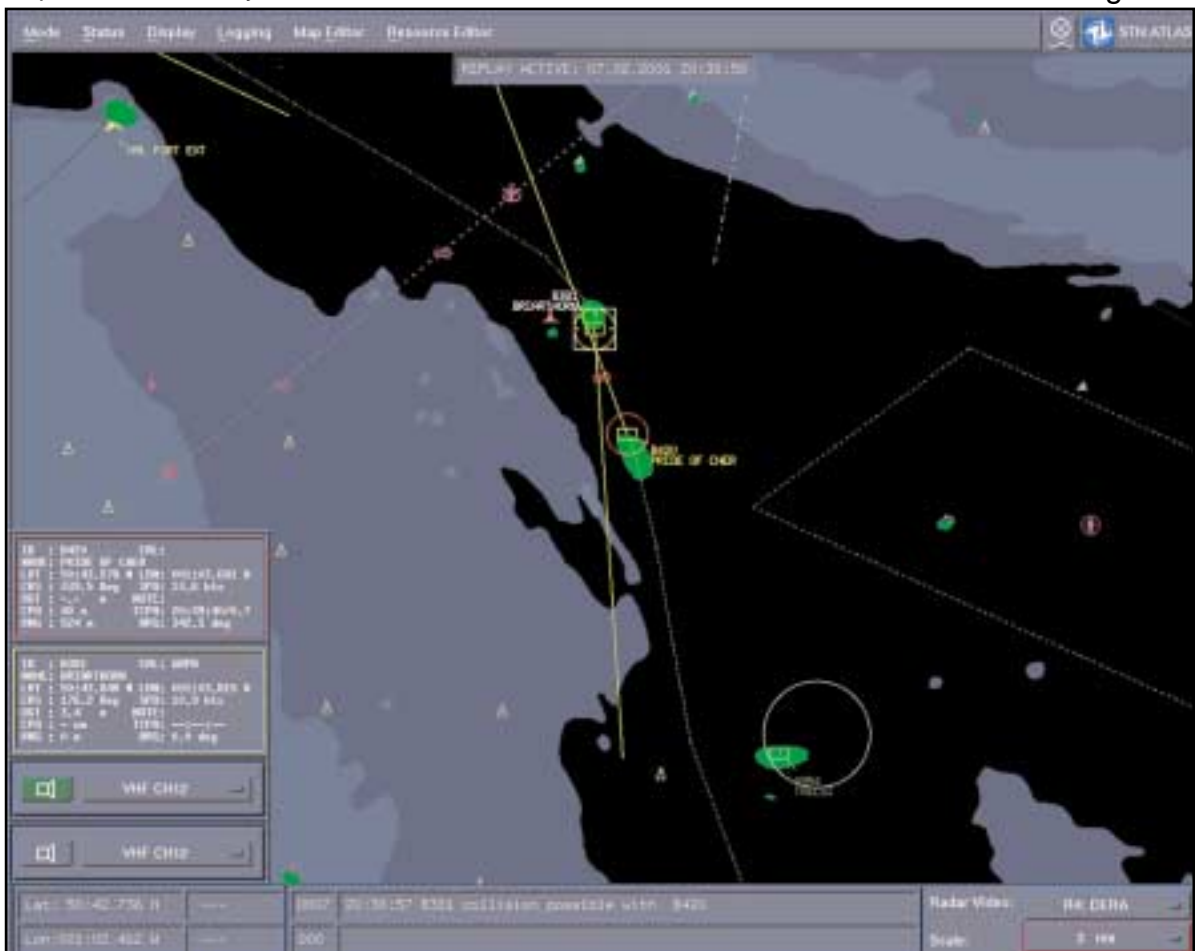
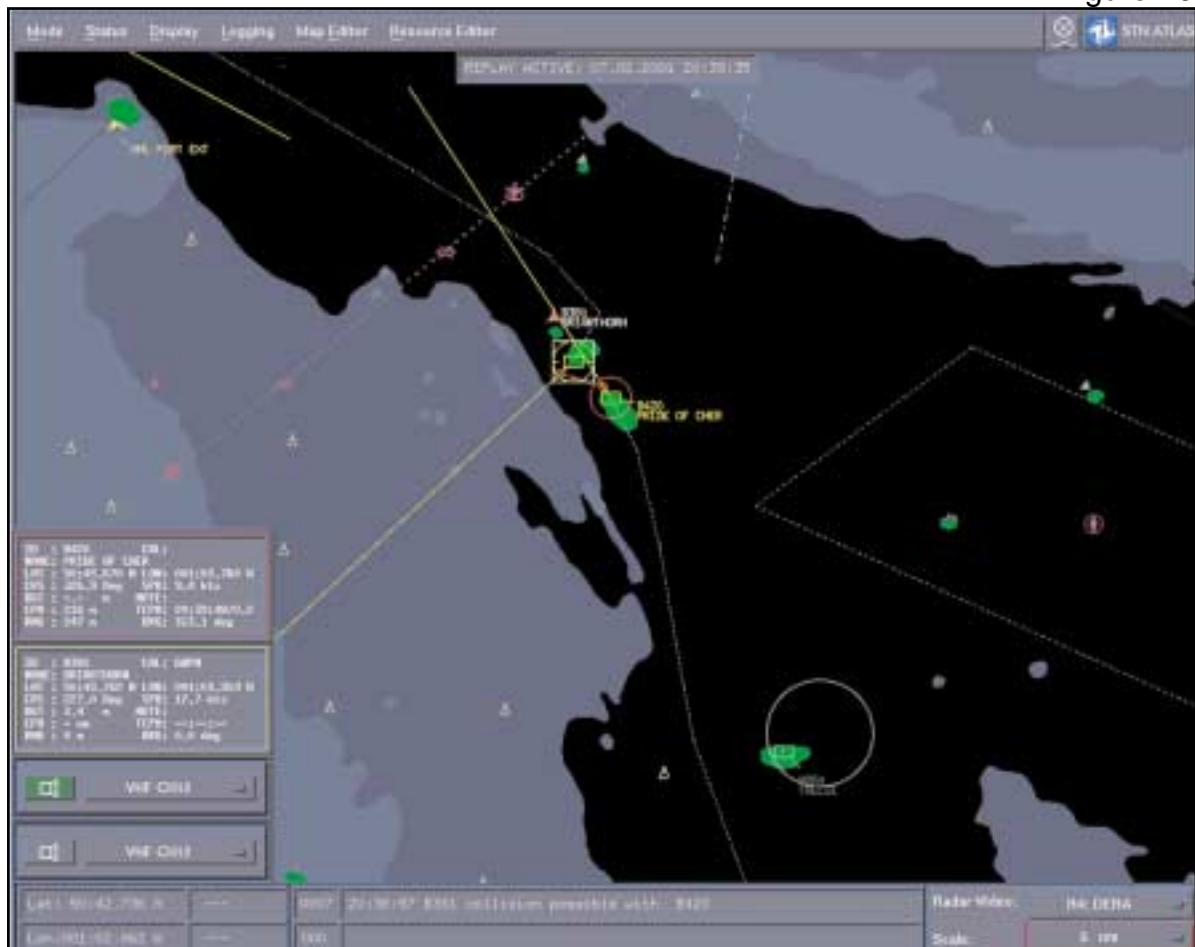
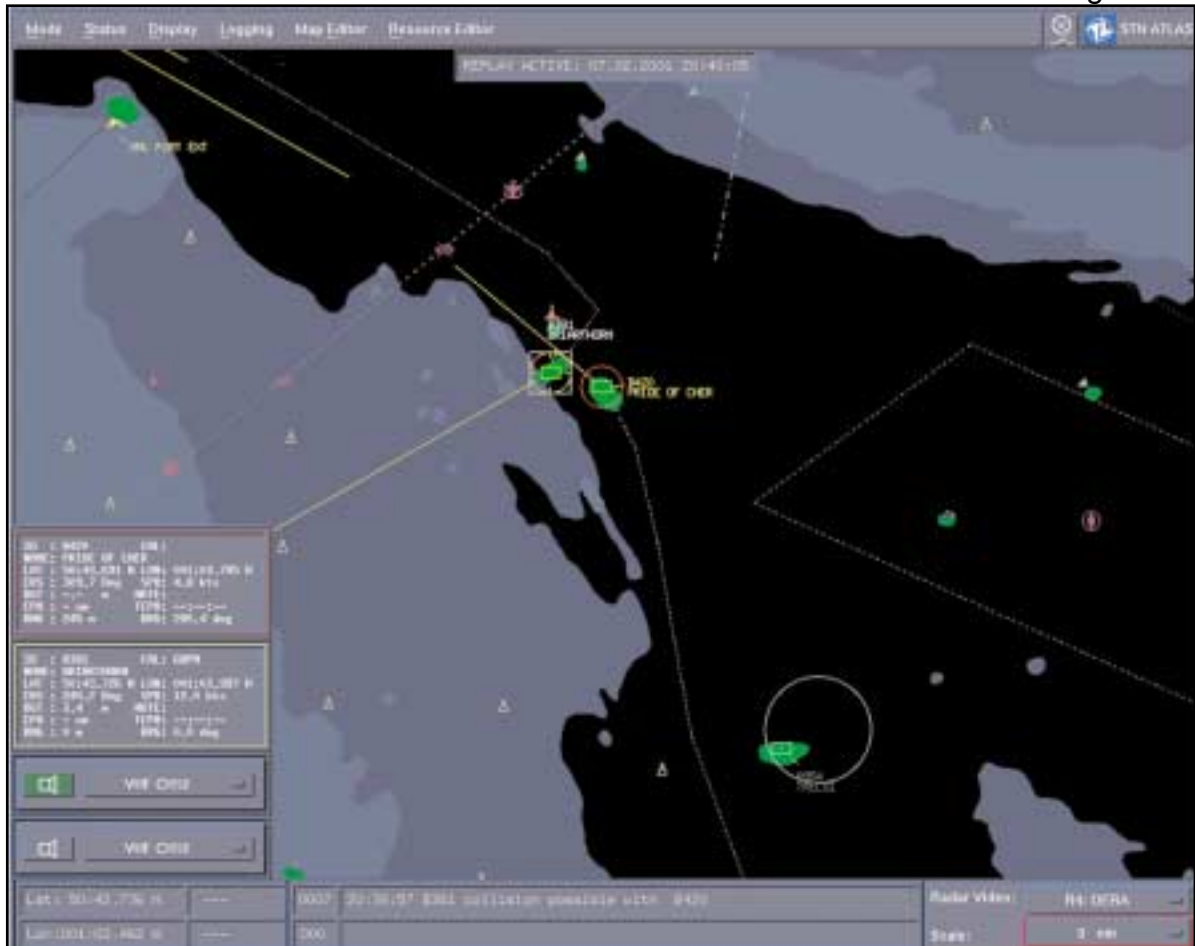
Pride of Cherbourg arrived at Portsmouth about 30 minutes after the incident and *Briarthorn* continued on passage to the Netherlands, reporting to VTS as she passed the Nab Tower. The two vessels did not communicate directly with each other during the course of the incident. (see **Figures 5 - 11** for Southampton VTS radar pictures).

Southampton VTS Radar Pictures
