Report on the investigation of
the death of Michael John Beedie
a fisherman from the fishing vessel

Alma C (N54)

on Turbot Bank about 55 miles west-by-south of
Thyborøn in Denmark
on 25 January 2001

**Report No 33/2001
August 2001**

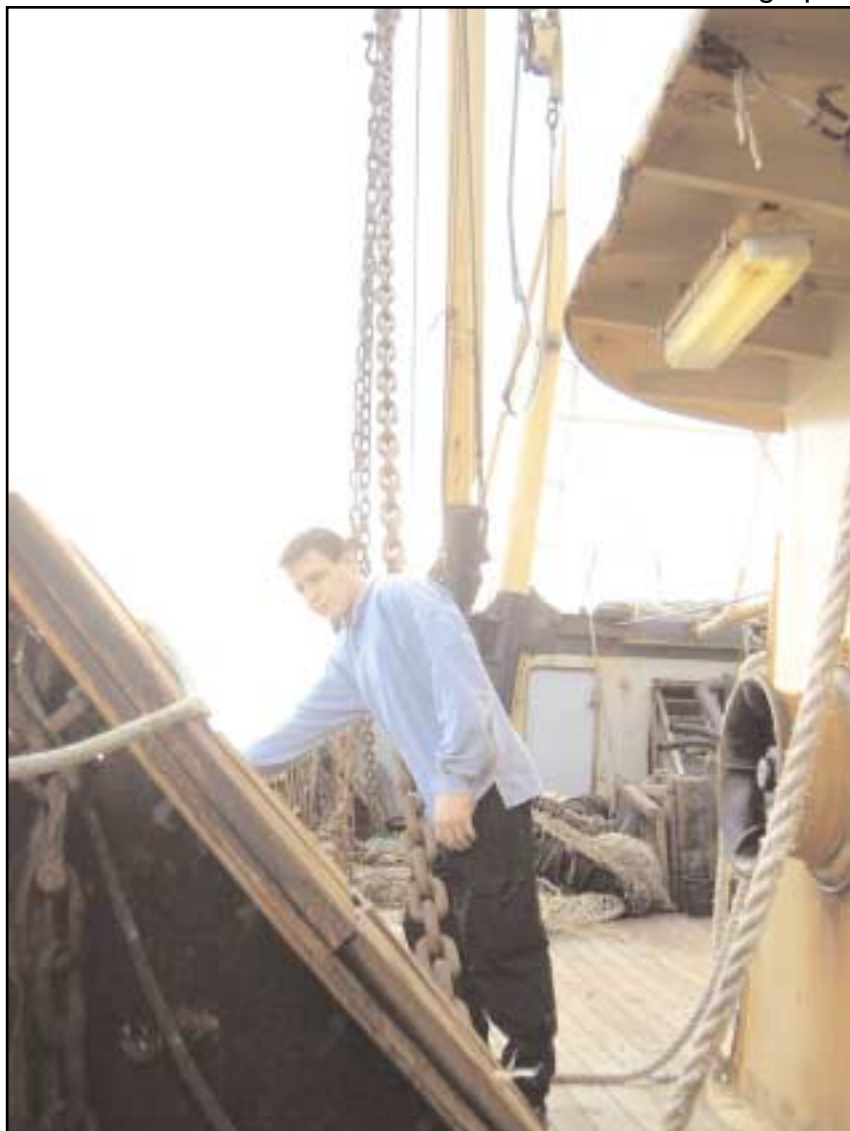
Photograph 1

The vessel was rolling in the seaway, causing the after beam shoe to move away from the bulwark and towards Michael Beedie. Then, as the vessel rolled again, the aft towing chain tightened (**see photograph 1**). The deckhand forward saw Michael Beedie being thrown by the chain and he shouted out. The other deckhand, standing forward of the wheelhouse, turned round and saw Michael Beedie going over the side of the vessel and shouted, "man overboard". The skipper heard the shout, went to the port side, and saw Michael Beedie in the sea, who in turn shouted to his colleagues that he could not swim.

A re-enactment of the accident by a colleague of Micheal Beedie

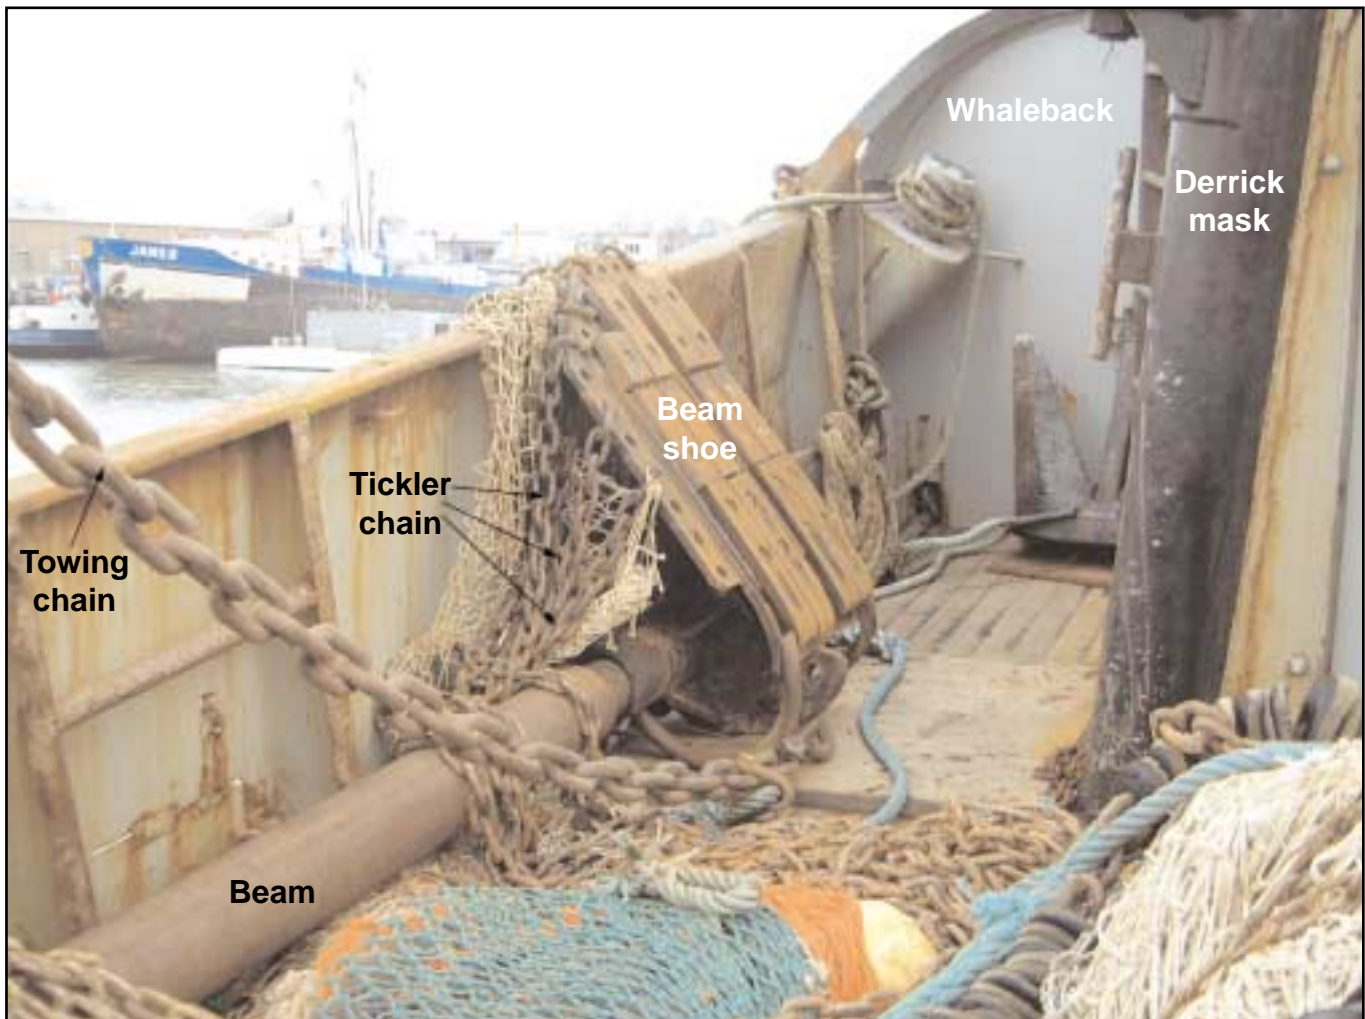
Photograph 2

Photographs 2 and 3 were taken during the MAIB investigation, and they show both beam shoes resting up against the bulwarks, both facing in the same direction and resting on deck on their heaviest parts. At the time of the accident, the tickler chains needed to be brought inboard. This was being carried out by crew members on each side of the vessel, while Michael Beedie was waiting near the aft end of the port beam.

The forward end of the beam

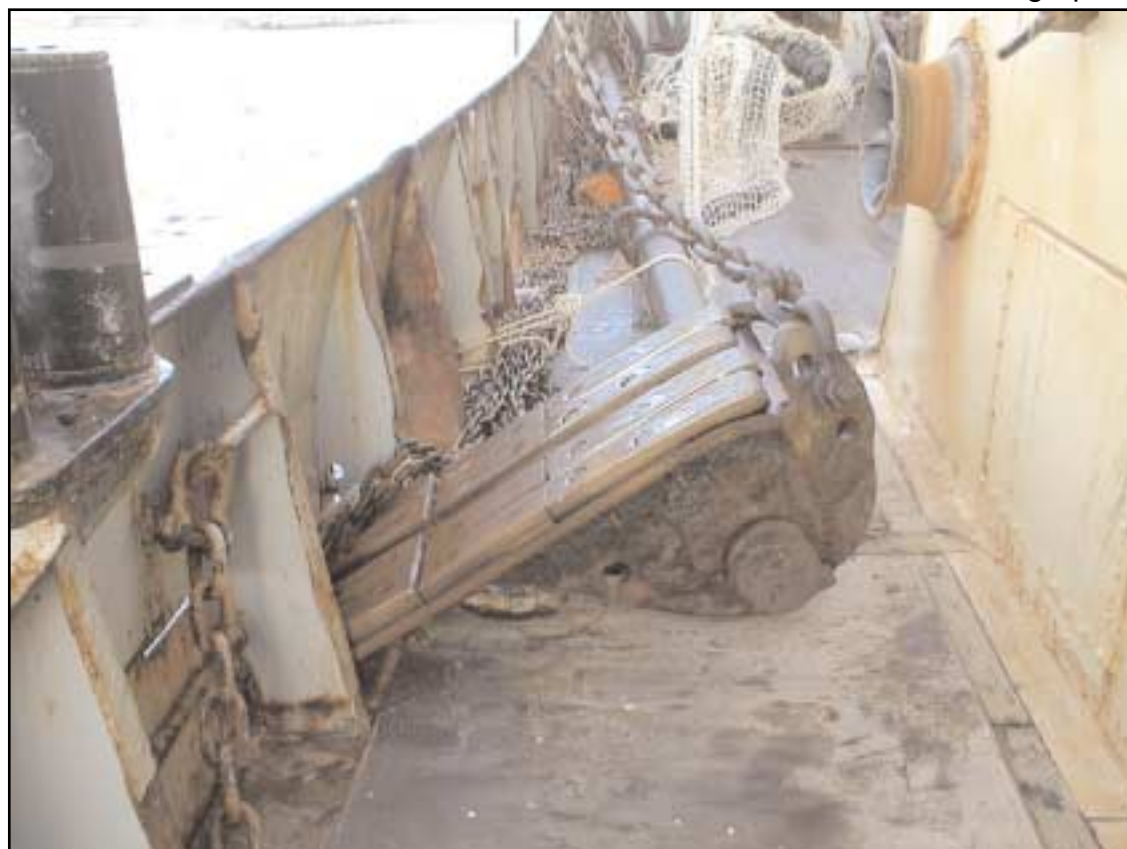
Photograph 4

Photographs 4 and 5, taken by the Danish Maritime Authority the day after the accident when the vessel berthed at Thyborøn, show that the aft port side beam shoe was in the opposite position* to the forward beam shoe, which was in the same position as photograph 2. For some reason, while the beam was brought inboard, the aft beam shoe had landed upside down and had come to rest on its trailing edge with its heaviest part propped up against the bulwark, making it top heavy and unstable. This is shown in diagram 1. When the vessel rolled, the after beam shoe fell away from the bulwark and inboard towards Michael Beedie. He probably jumped up to avoid the beam, and leant over the after towing chain, as shown in photograph 1. However, the vessel rolled back causing the derrick and the upper blocks to move and, in turn, caused the towing chain to suddenly become tight under Michael Beedie's midriff. This sudden movement of the towing chain was of such force that he was thrown overboard.

View from aft of the beam shoe having fallen down onto the deck

- 1 Formalise the following safety measures into the vessel's risk assessment:
 - Procedures for beam shoes to be landed with the heaviest part on deck
 - Procedures for crew members not to stand in places of danger when not directly involved in operations; and
 - The wearing of buoyancy aids while working on deck.

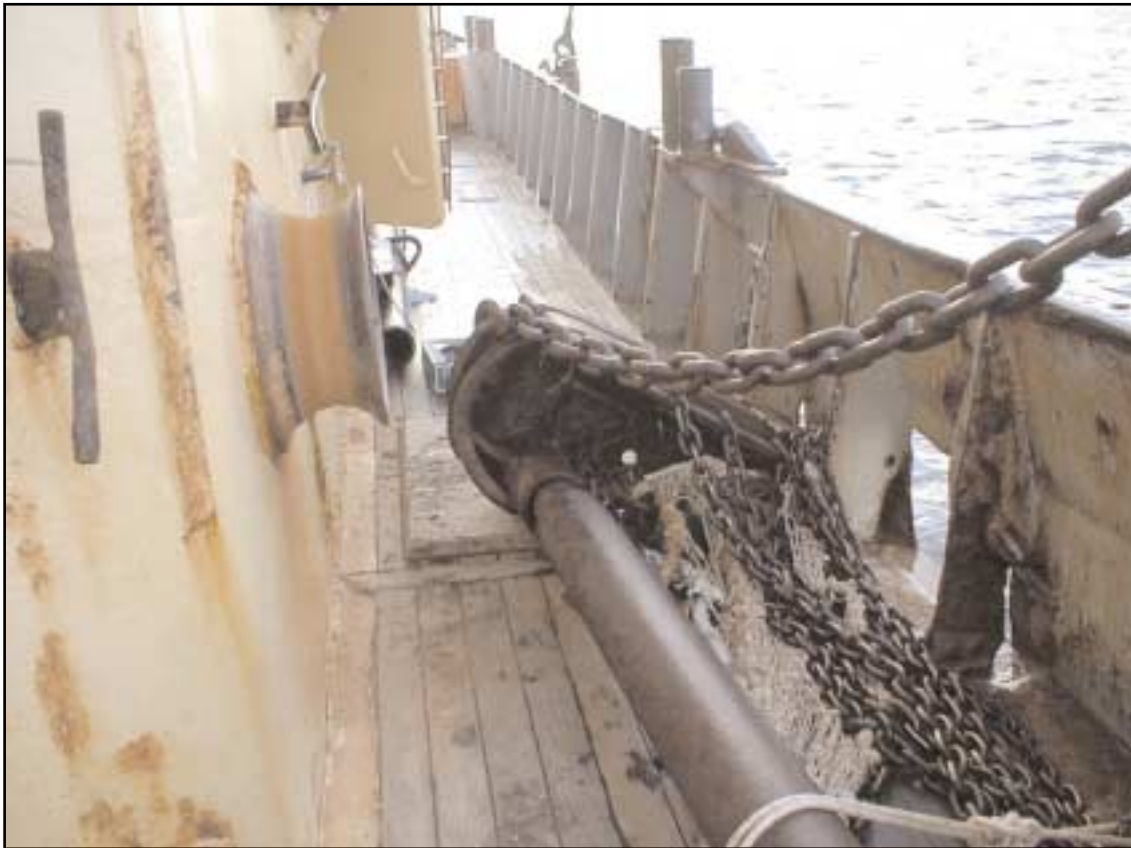
View from forward of the beam shoe having fallen onto the deck

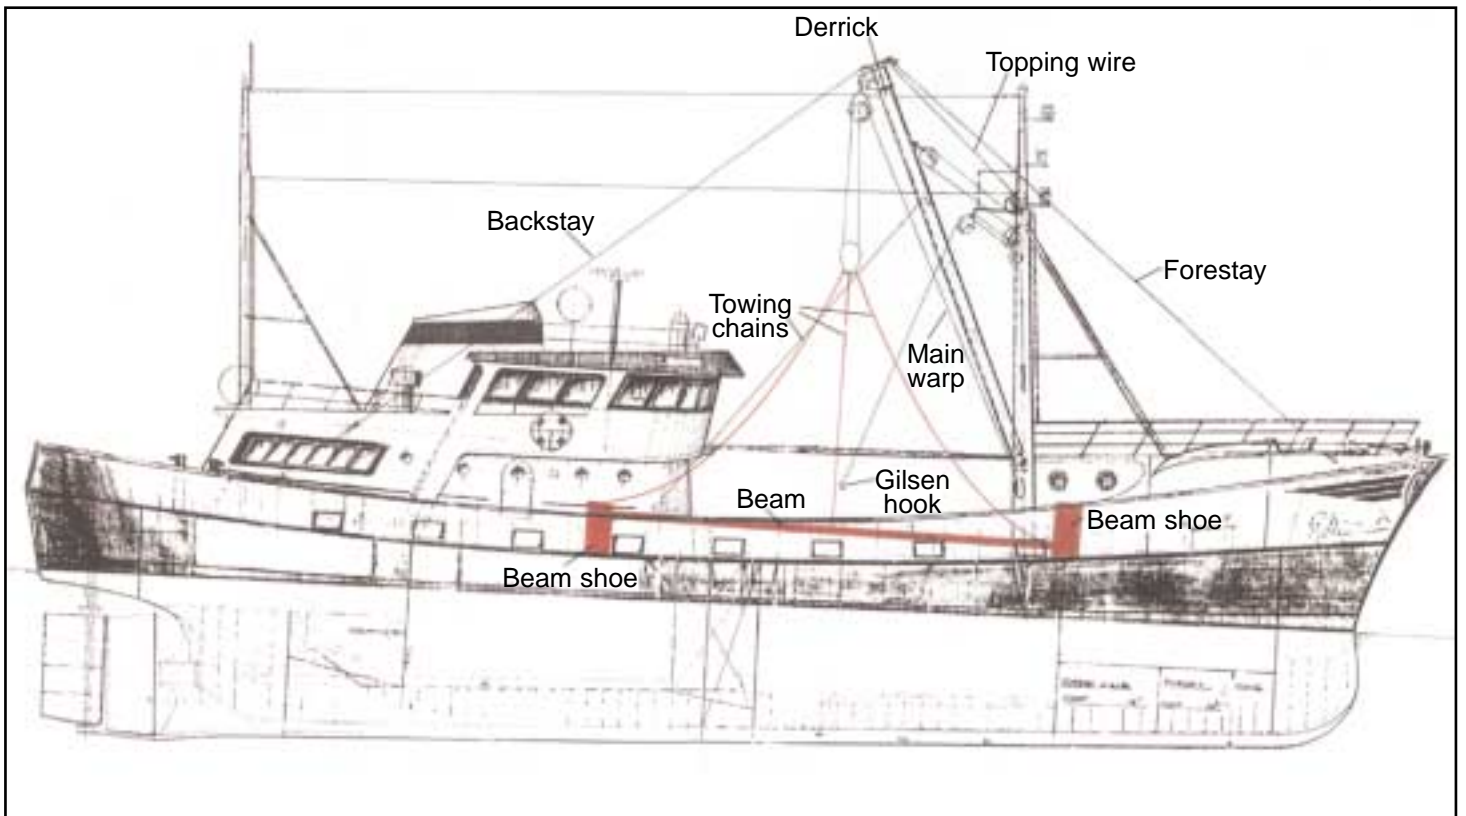
Diagram 1

While waiting for his next task, Michael Beedie must not have realised that the after part of the beam was unstable and was about to fall over towards him. He had been standing close to the beam and the superstructure he was caught between the two. He had been standing in a place of danger, and the consequences of this are described above (see section 1.4).

A diagram showing the beam just after it had been brought in board
