Report on the investigation of
the grounding of
Happy Lady
off Shoebury Ness,
Thames Estuary
21 January 2001

Marine Accident Investigation Branch
First Floor
Carlton House
Carlton Place
Southampton
United Kingdom
SO15 2DZ

Report No 21/2001

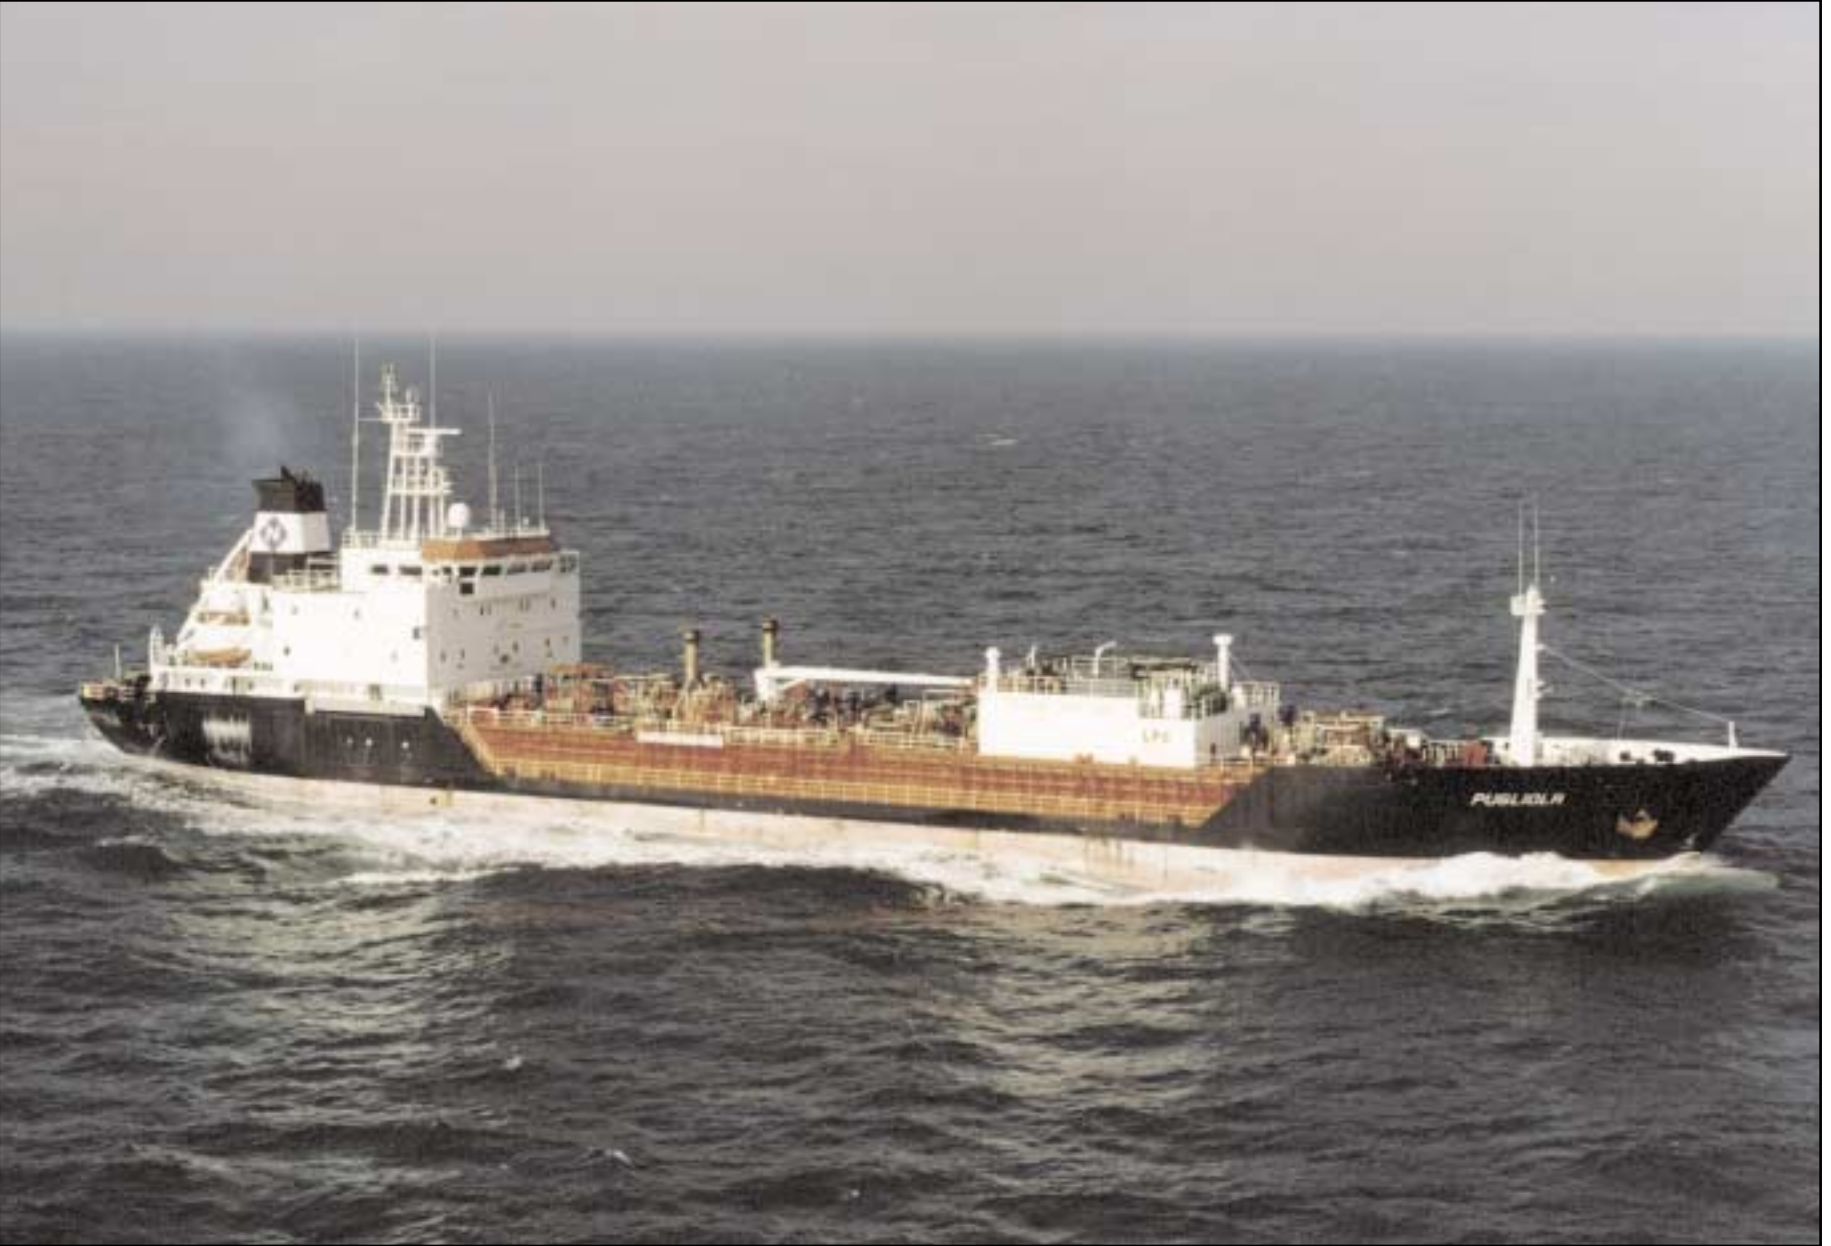
Figure 1

Happy Lady
(previously named *Pugliola*)

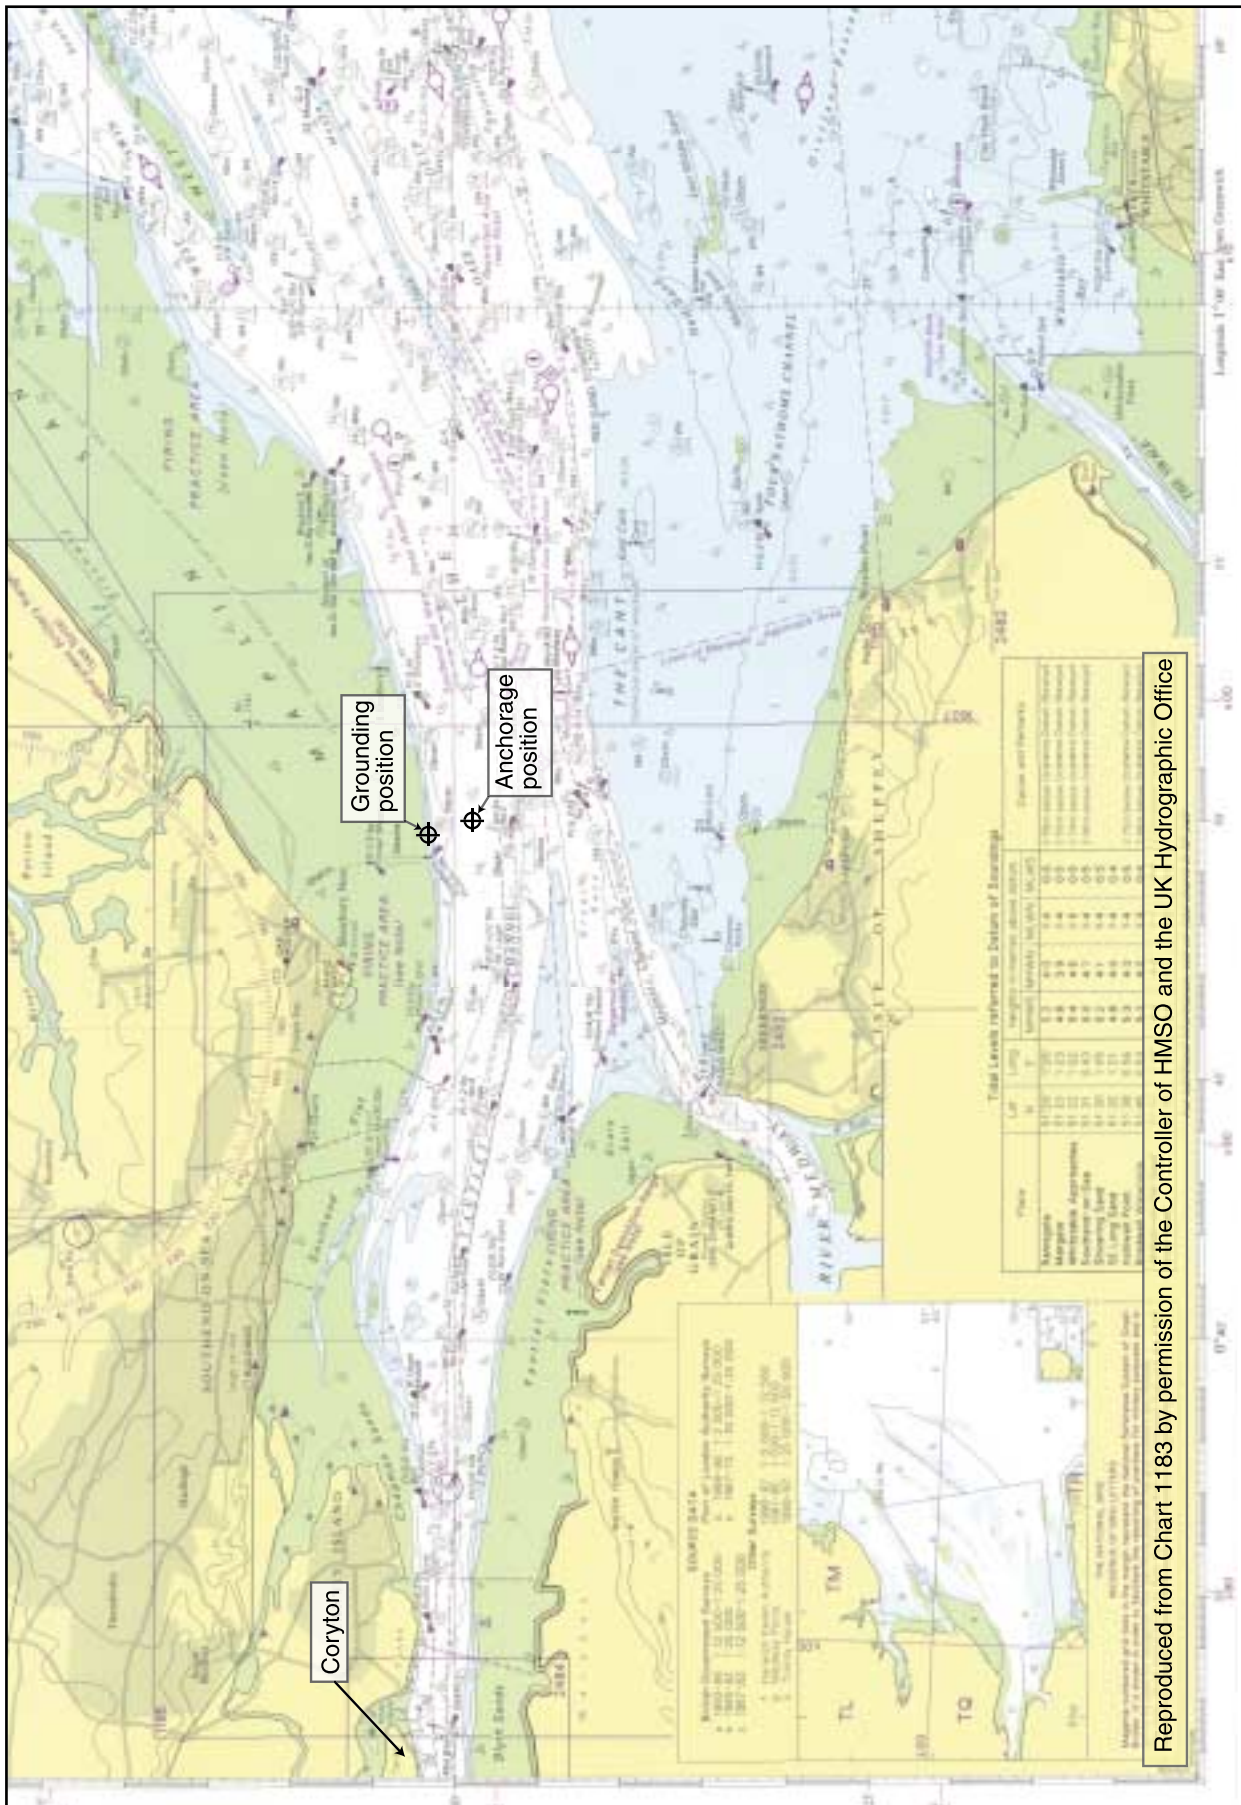
Figure 2

Happy Lady arrived at the Sunk pilot station in the Thames estuary on the evening of 20 January after an uneventful 22 hour passage from Grangemouth. She had been due to berth at Coryton on arrival, but was instructed to anchor at Z4 anchorage off Shoebury Ness as there was thick fog at the berth (**Figure 2 Chart Extract**).

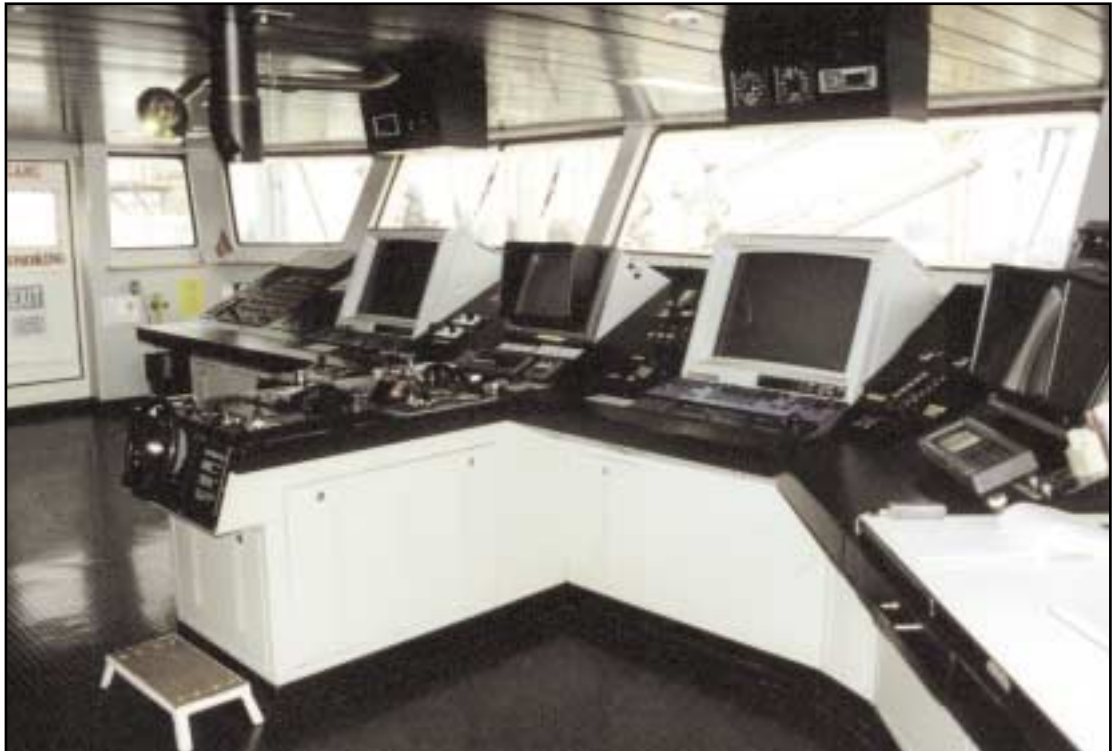
Figure 4

Wheelhouse console

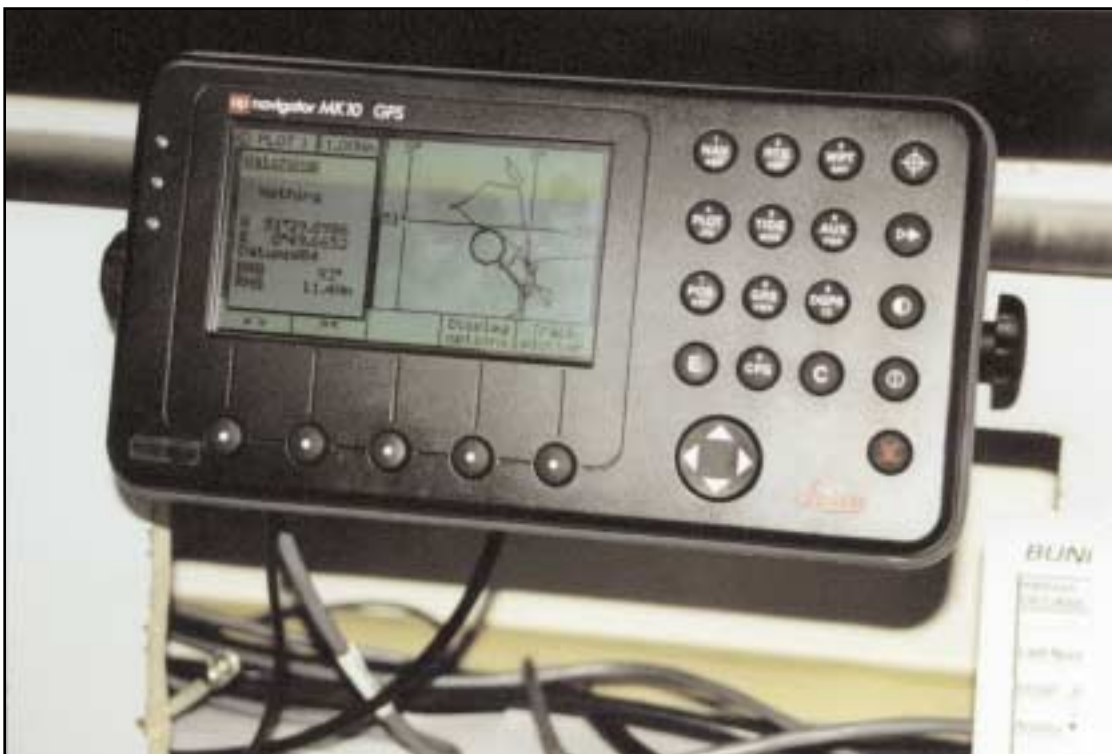
Figure 5

GPS showing track to grounding position and subsequent track back to anchorage

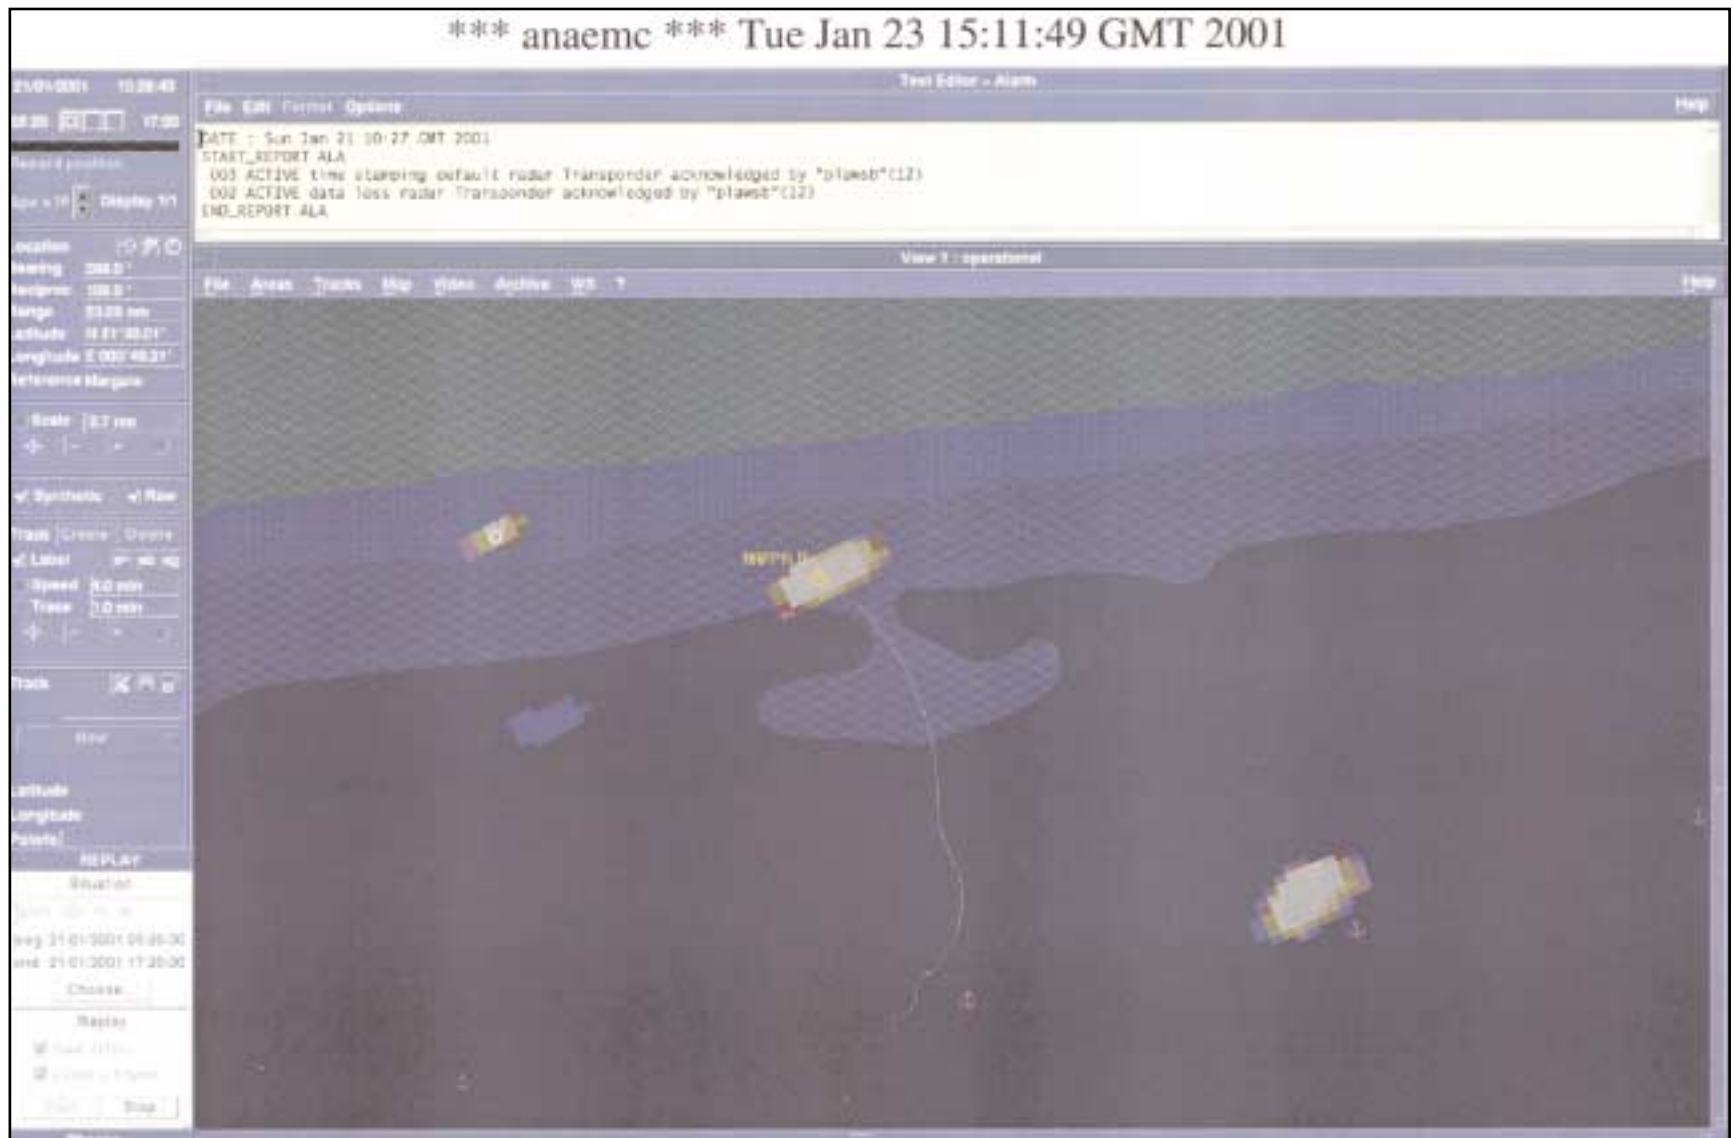
Figure 6

The drift of the vessel towards the sandbank was recorded both on the vessel's GPS recorders and the PLA VTS's radar system (**Figure 6 PLA plot**). It is clear that *Happy Lady* dragged her anchor steadily at about 1.25 knots in a north-northeasterly direction between 1015 and the time of grounding at about 1040 (**Figure 7 Chart Extract**). During this time the master was trying to clear the anchor cable which was leading over the bulbous bow and around the raked stem. The bell book reveals that the master used various ahead and astern engine movements in addition to the bow thruster and the rudder. He was unable to clear the anchor cable from the bulbous bow. The bow thruster was having little or no effect, and the master had stopped using it by the time the vessel's head had reached about 300°.

PLA plot

In the event, enough cable had been raised to allow the vessel to start dragging her anchor before the chief officer arrived on the forecastle. The PLA's radar recording indicates she started to do so at about 1005 when the charted water depth was about 14m. Once momentum had built up she dragged steadily towards the shore at a rate of about 1.25 knots. The master had been preoccupied with trying to manoeuvre the vessel to clear the anchor cable and, thinking he had time to clear the cable and then manoeuvre clear of the shoal water, he concentrated on this, rather than ensuring the vessel remained in safe water. He could, and perhaps should, have dropped the port anchor before he got to the point of no return. In the event, when the anchor became visible near the surface and the ship's heading was about 275°, she was probably aground, and being held firmly against the bank by the wind. The tide was falling.
