Report on the investigation of
the grounding of
Happy Lady
off Shoebury Ness,
Thames Estuary
21 January 2001

Report No 21/2001

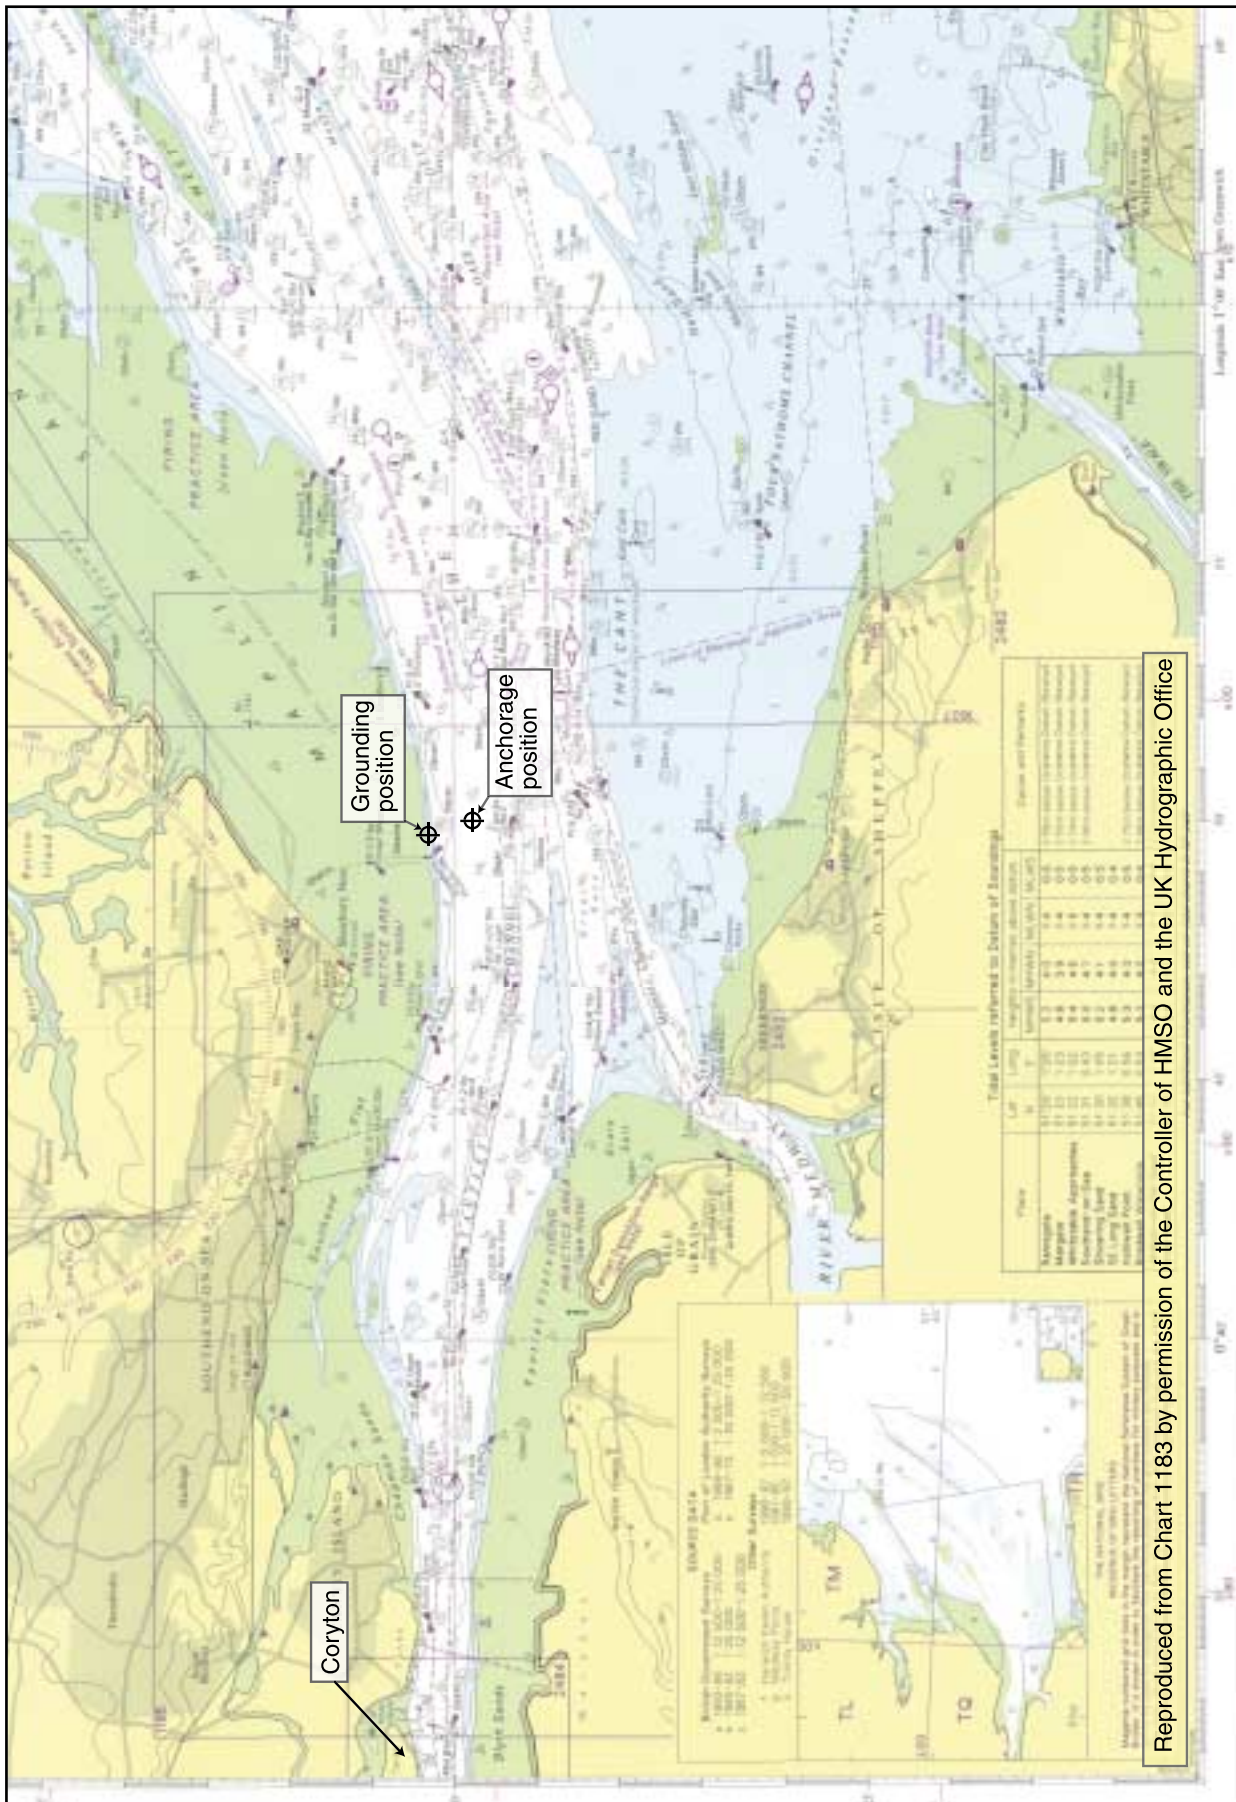
Figure 2

Happy Lady arrived at the Sunk pilot station in the Thames estuary on the evening of 20 January after an uneventful 22 hour passage from Grangemouth. She had been due to berth at Coryton on arrival, but was instructed to anchor at Z4 anchorage off Shoebury Ness as there was thick fog at the berth (**Figure 2 Chart Extract**).

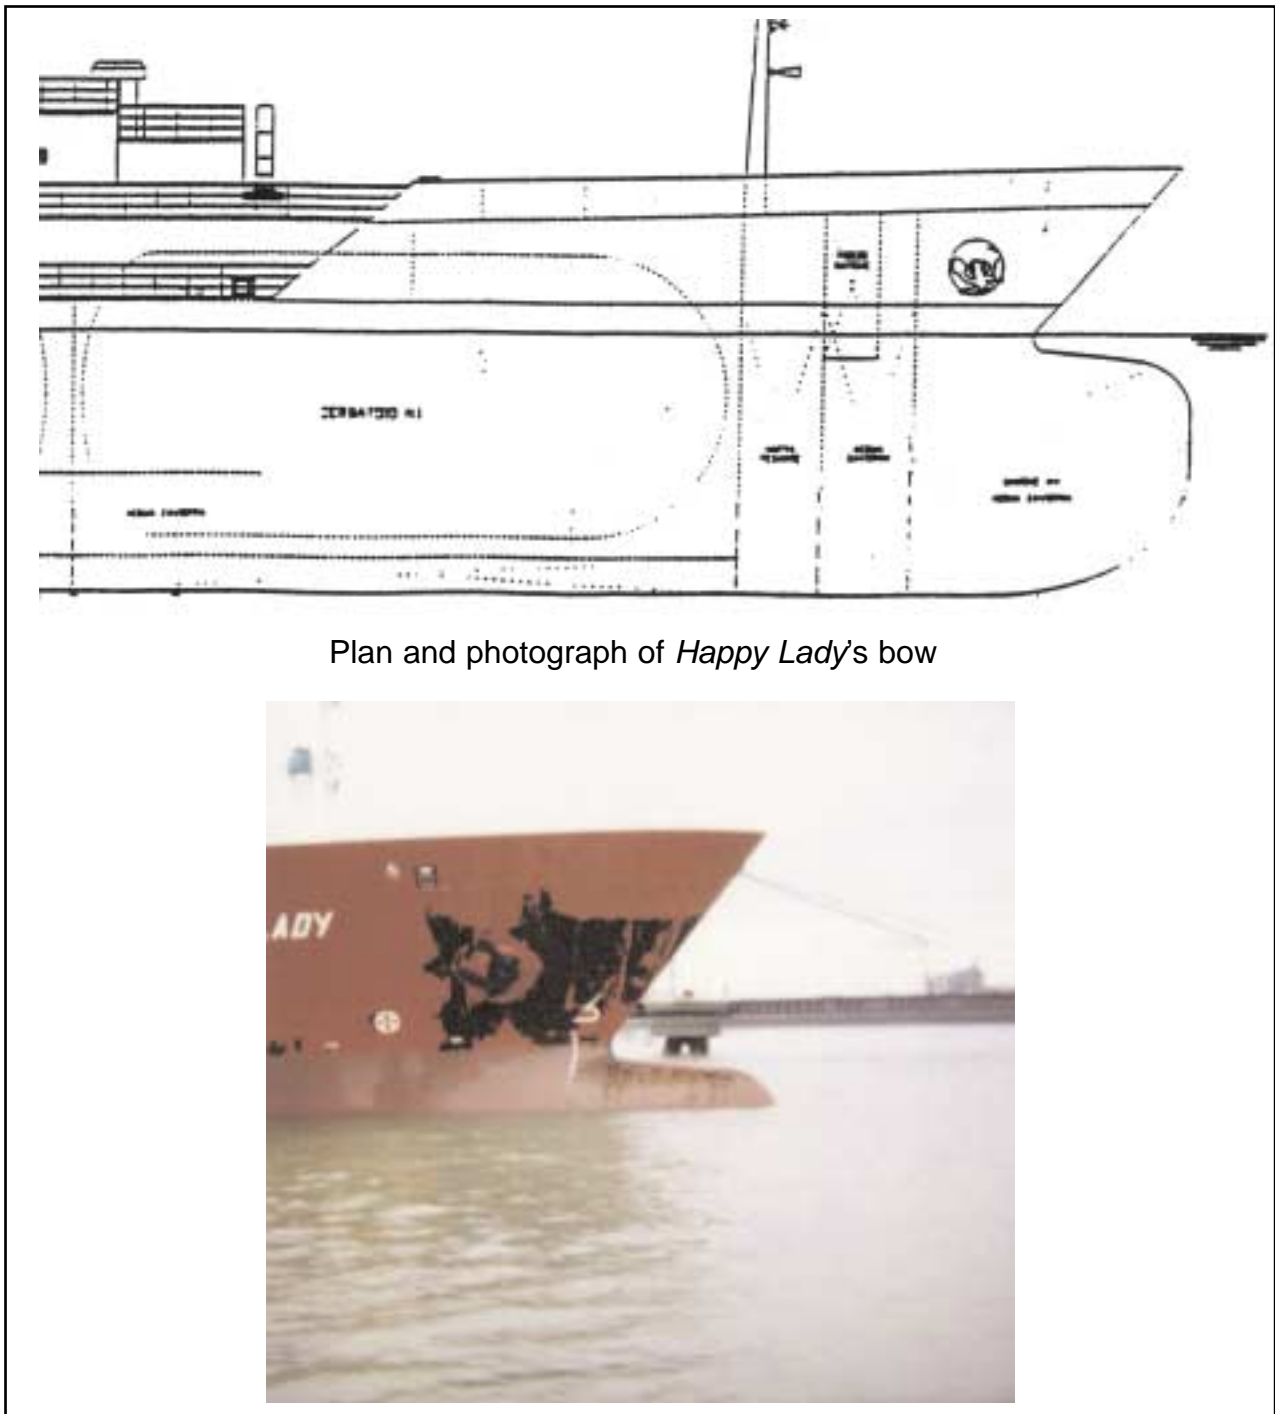
Figure 3

Happy Lady was an LPG carrier of 112m length overall and 6,107gt. She was launched in 1993 under the name of *Jade Star* but was brought into service as *Pugliola* in 1994. Her name, ownership and management changed in October 2000. At the time of the accident she was fully certificated under international regulations. She was designed with her superstructure aft, a heavily raked stem and large bulbous bow (**Figure 3 Plan and Photograph**).

Plan and photograph of *Happy Lady*'s bow

- 3.1.4 The crew on the forecastle had trouble heaving the anchor cable as it frequently became jammed in the angle between the rake of the stem and the bulbous bow. [1.3, 1.6]

The design of the fore part of the vessel allowed the anchor cable to jam between the rake of the stem and the bulbous bow in certain circumstances. [1.3,2.3]

1. Ensure that:
 - Its onboard procedures are such that, when anchoring or raising the anchor in strong wind or tidal conditions close to shoal water, an officer is placed in charge on the forecastle of *Happy Lady*;
 - Every attempt is made to establish the correct lead of the cable before starting to heave up; and
 - More effective procedures are put in place to avoid the cable becoming trapped between the bulbous bow and the rake of the stem.

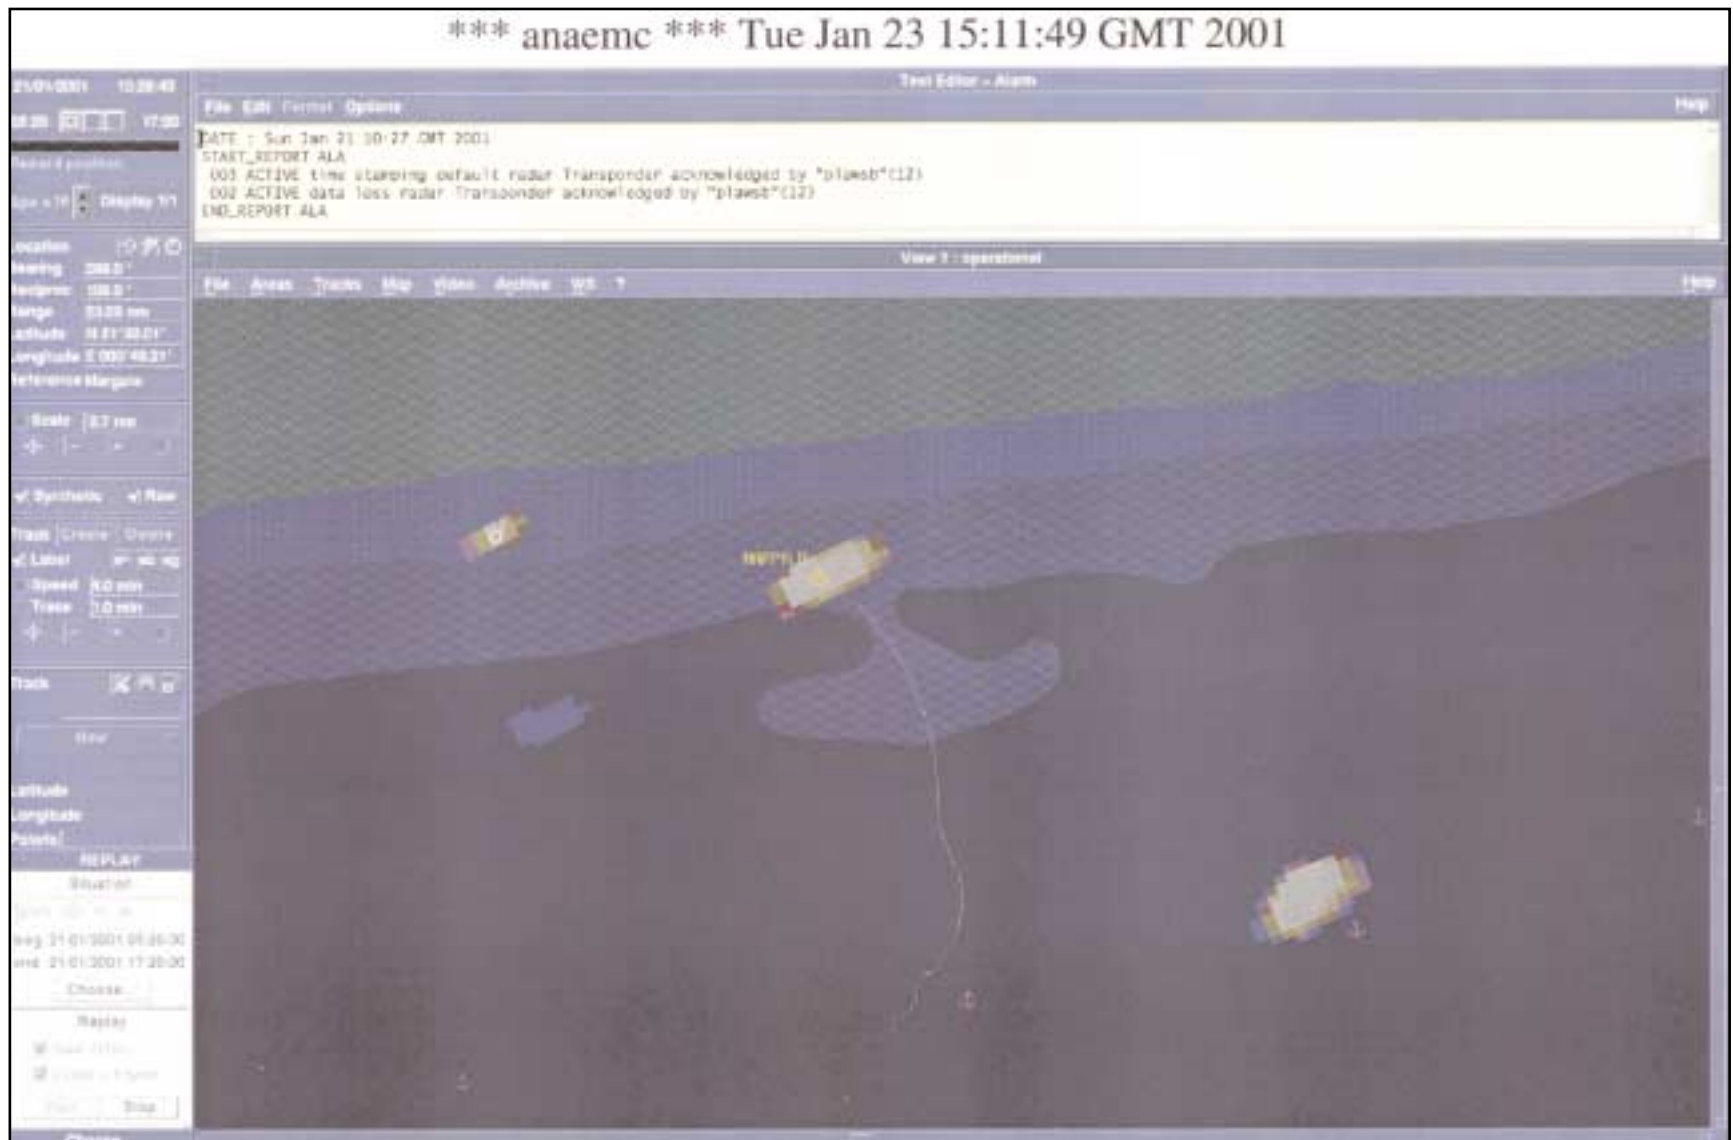
Figure 6

The drift of the vessel towards the sandbank was recorded both on the vessel's GPS recorders and the PLA VTS's radar system (**Figure 6 PLA plot**). It is clear that *Happy Lady* dragged her anchor steadily at about 1.25 knots in a north-northeasterly direction between 1015 and the time of grounding at about 1040 (**Figure 7 Chart Extract**). During this time the master was trying to clear the anchor cable which was leading over the bulbous bow and around the raked stem. The bell book reveals that the master used various ahead and astern engine movements in addition to the bow thruster and the rudder. He was unable to clear the anchor cable from the bulbous bow. The bow thruster was having little or no effect, and the master had stopped using it by the time the vessel's head had reached about 300°.

PLA plot

In the event, enough cable had been raised to allow the vessel to start dragging her anchor before the chief officer arrived on the forecastle. The PLA's radar recording indicates she started to do so at about 1005 when the charted water depth was about 14m. Once momentum had built up she dragged steadily towards the shore at a rate of about 1.25 knots. The master had been preoccupied with trying to manoeuvre the vessel to clear the anchor cable and, thinking he had time to clear the cable and then manoeuvre clear of the shoal water, he concentrated on this, rather than ensuring the vessel remained in safe water. He could, and perhaps should, have dropped the port anchor before he got to the point of no return. In the event, when the anchor became visible near the surface and the ship's heading was about 275°, she was probably aground, and being held firmly against the bank by the wind. The tide was falling.
