Report on the investigation of  
a collision between  
***Nordsee and Poole Scene***  
in the River Clyde on  
27 December 2000

**Report No 40/2001  
December 2001**

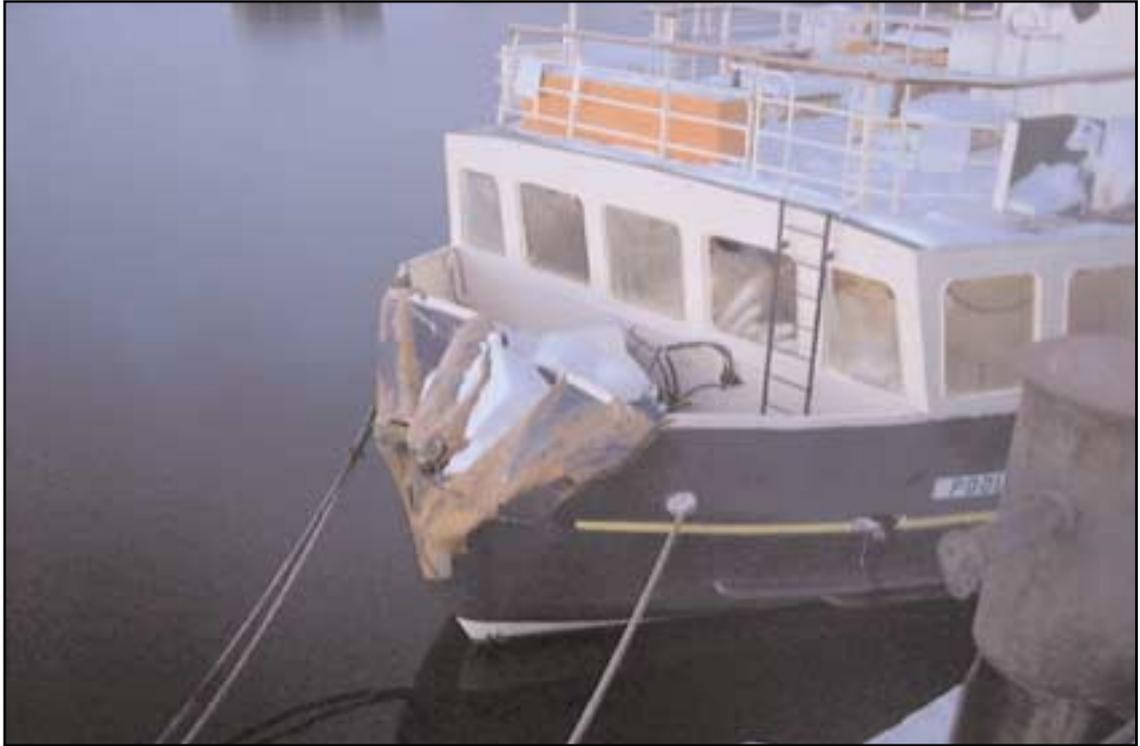
*Poole Scene* sustained substantial bow damage, while *Nordsee* sustained slight shell plate damage.

*Nordsee* sustained only slight damage to her hull plating on the starboard side. *Poole Scene* however, sustained substantial damage to her bow (**see Figure 5 and 6**).

Damage to *Poole Scene*
