Report on the investigation
of the collision between

Bruce Stone

Loverval

**Report No 31/2001
August 2001**

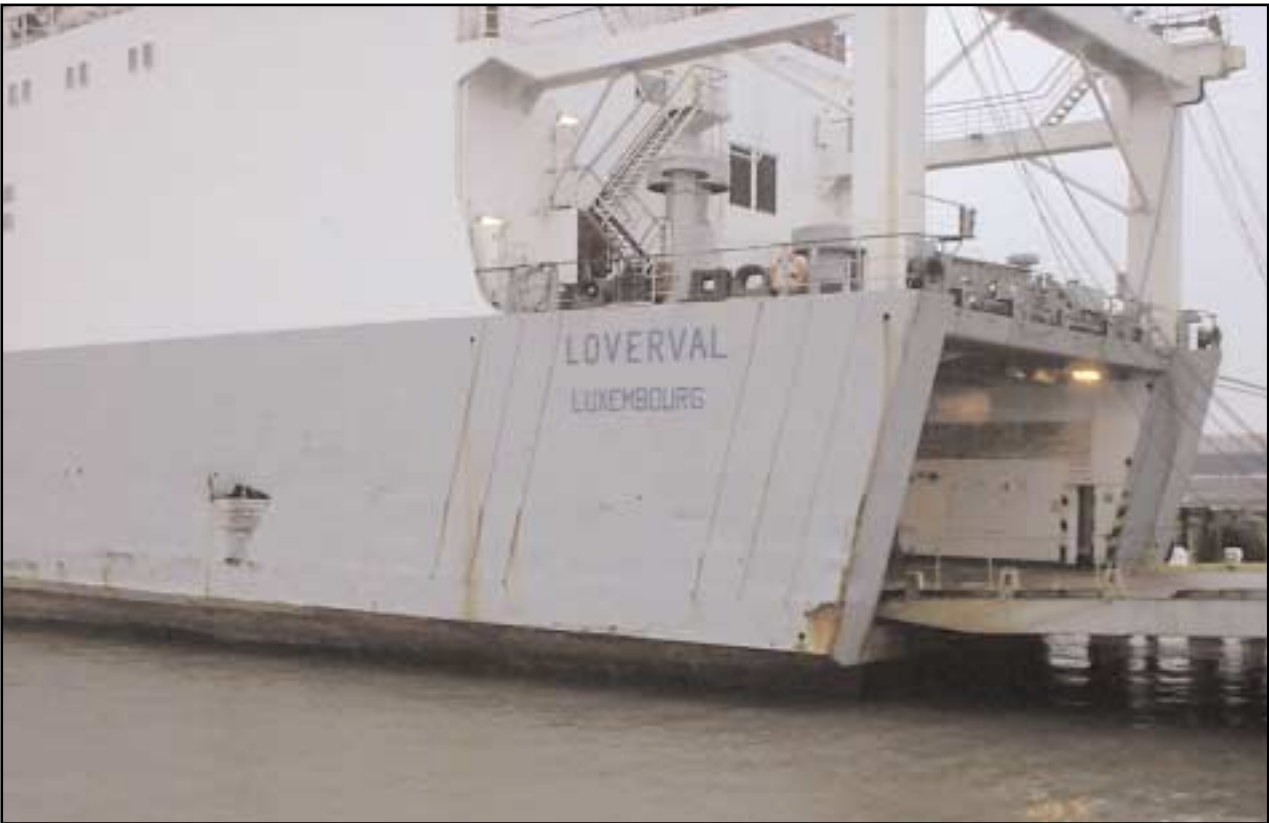
Figure 3

Damage : Holed above waterline - port side

External damage to *Loverval*

It then contacted *Loverval* to enquire the same and was informed, some minutes later, that there were no injuries but that the vessel had suffered hull damage above the waterline on the port side.

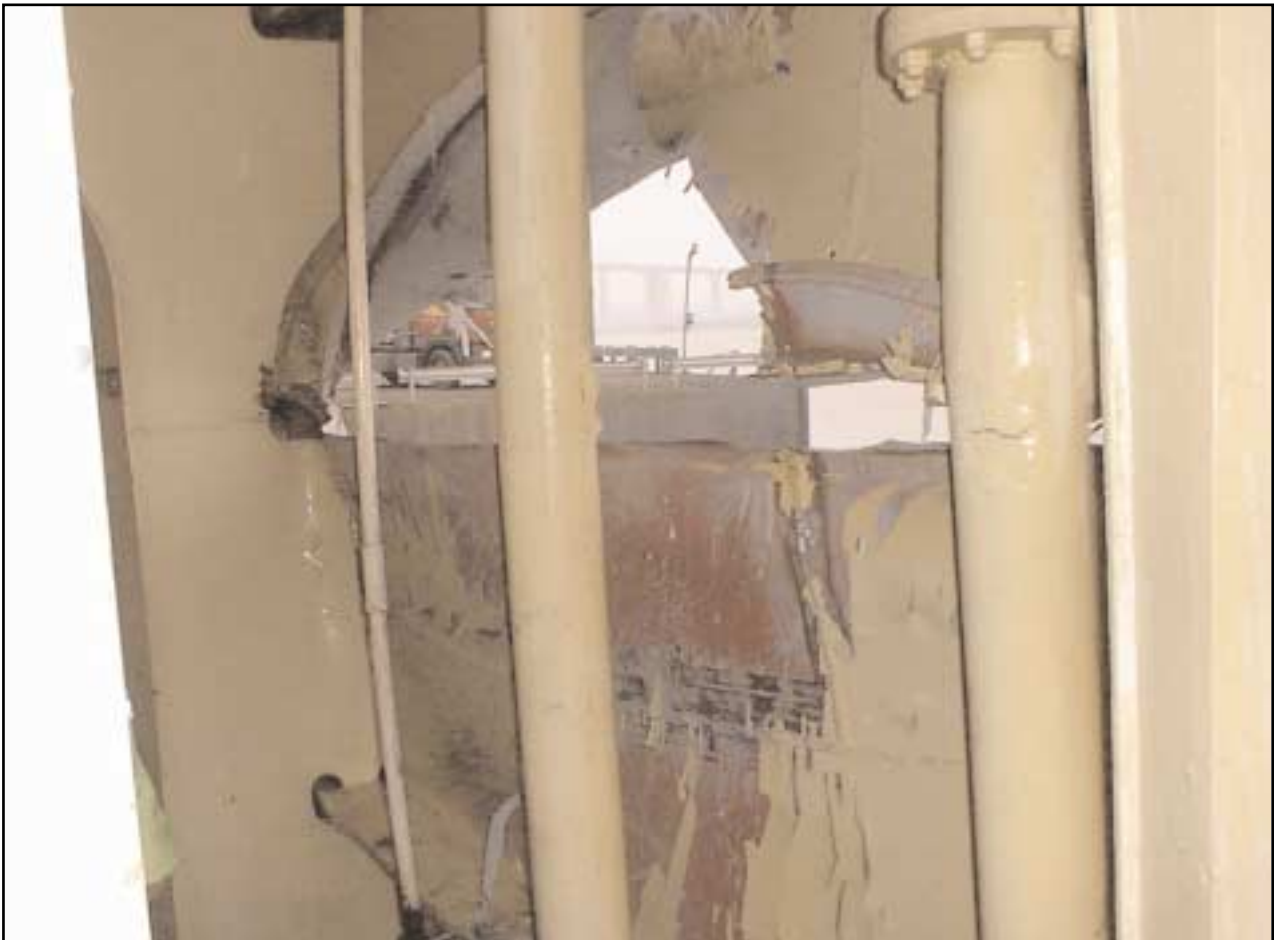
Figure 4

Internal view of damage to *Loverval*
