Report on the investigation  
of the parting of the mooring line  
between the Tetney buoy and the North Sea shuttle tanker

***Randgrid***

resulting in the discharge of 12 tonnes  
of crude oil into the Humber Estuary  
on 20 December 2000

**Report No 6/2002  
February 2002**

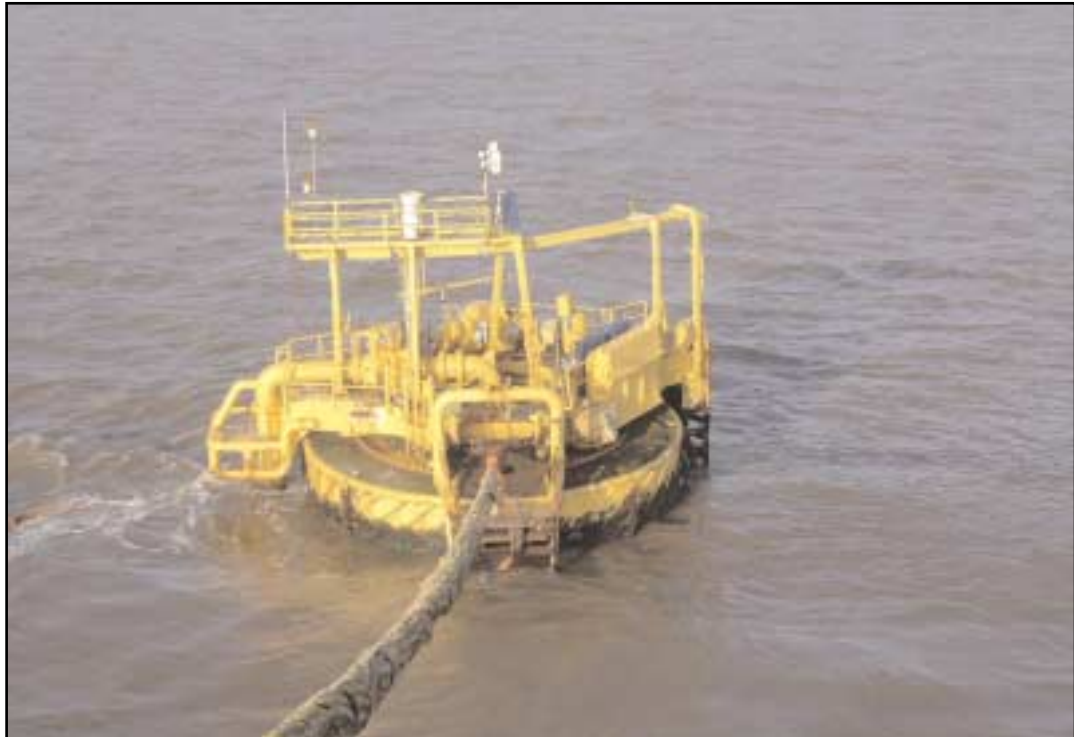
Figure 1

The Tetney monobuoy

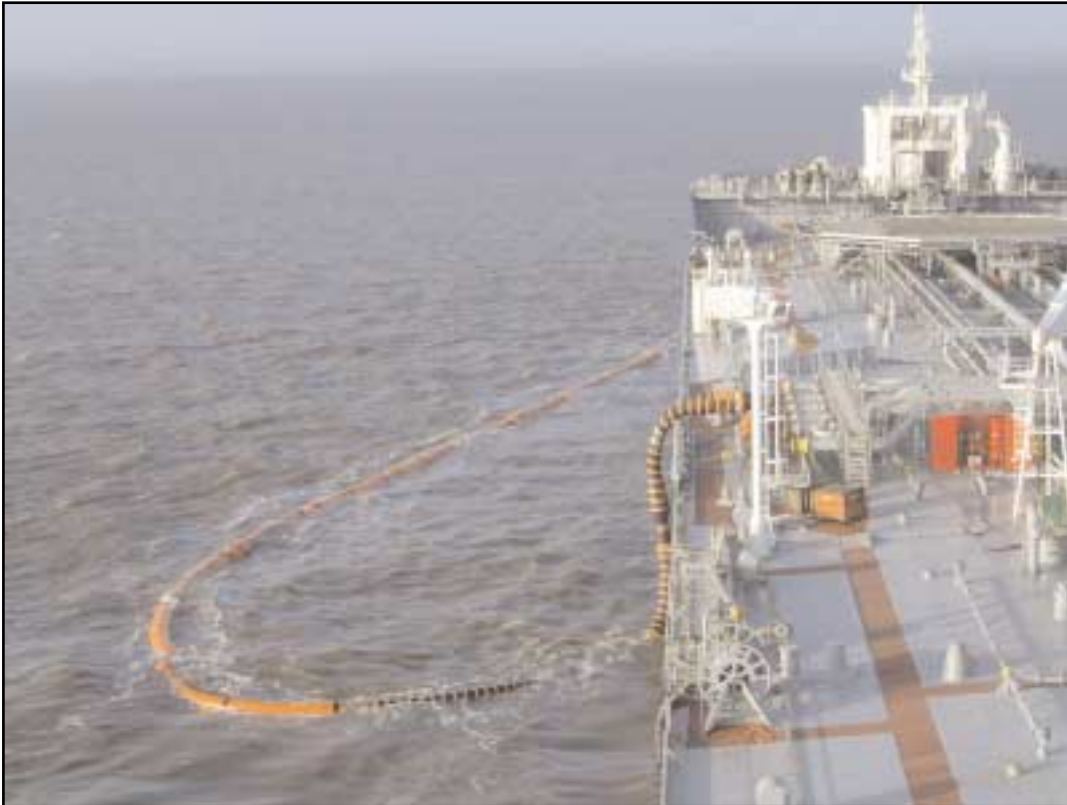
A single floating flexible discharge hose connected between the monobuoy and vessel's discharge manifold

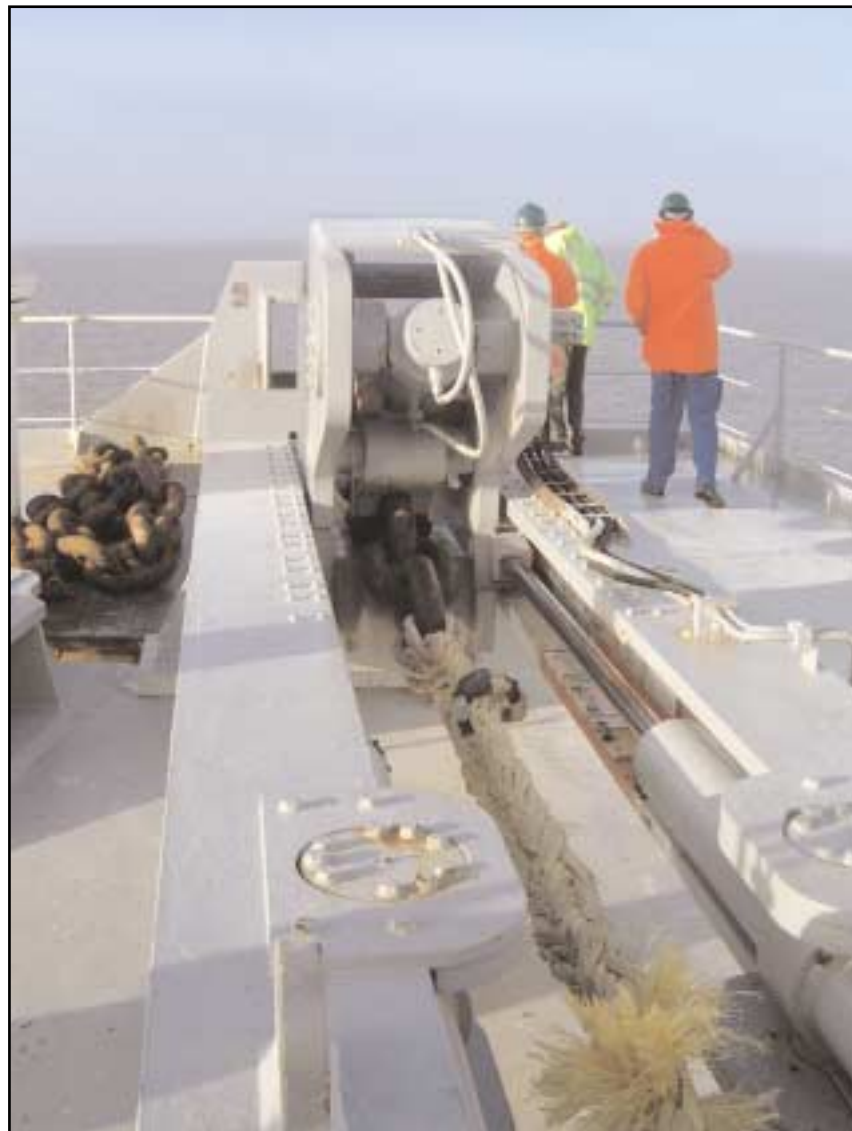
Figure 4

Inboard view of chain stopper showing messenger rope

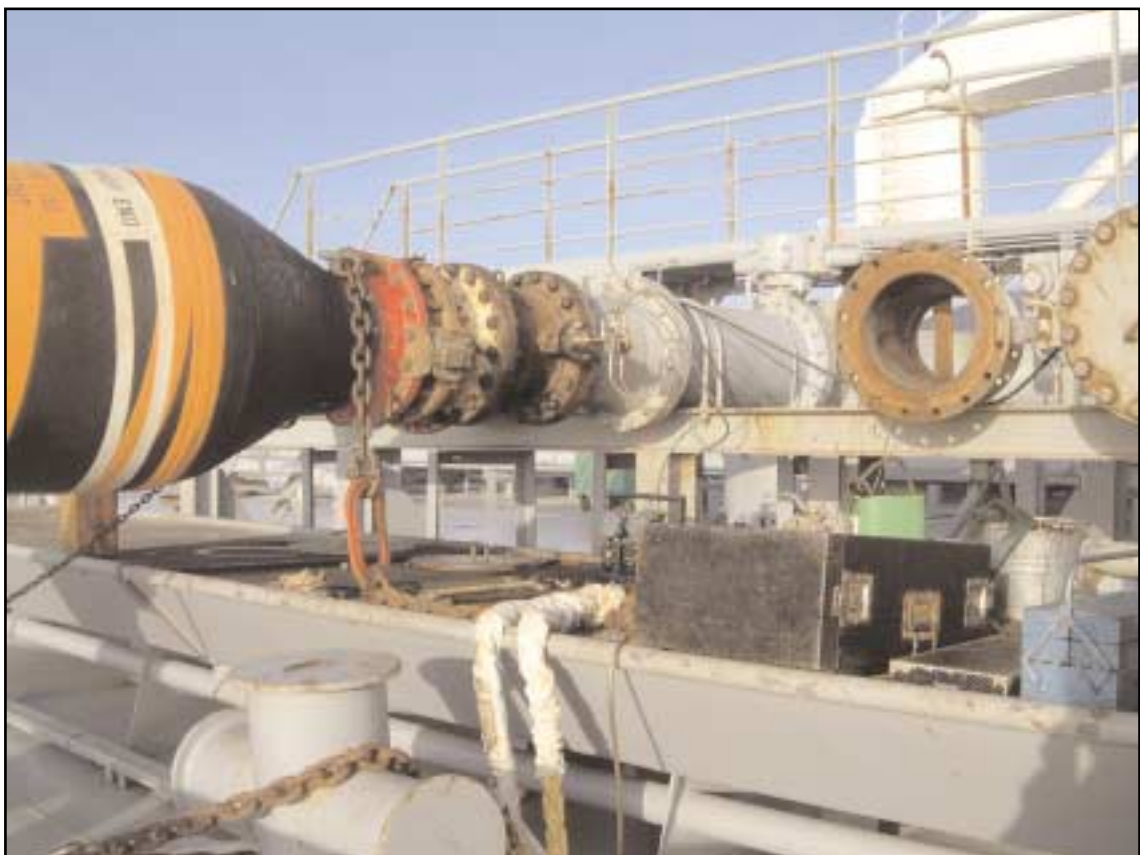
Figure 5

At 0748, the duty AB checked the pump room before returning on deck to inspect the discharge pressure at the manifolds. Just as he approached the area he heard a bang and saw that the safety chain for the aft discharge hose had snapped (**Figure 5**). Almost immediately, oil started to leak around the manifold flange. Using his UHF radio, the AB then called the second officer in the CCR, telling him that the pumps should be stopped. The second officer immediately used the emergency shutdown procedure on the pumps, and started to close the manifold valves (this took about 20 seconds). Meanwhile, the aft discharge hose bolts broke, and the hose was pulled overboard. A few seconds later, the forward hose coupling broke in a similar manner. At 0753, the second officer, having closed the valves, called the master and the chief officer. The latter said he would come down to the CCR straightaway. Soon after this the AB called again, saying that both discharge hoses had pulled free from the manifold.

Discharge manifold showing couplings and safety chain

- 1.3.9 Once *Randgrid* was clear of the monobuoy, both berthing masters went forward to the manifold area to inspect the damage. They found both hoses had been carried away, together with both ship's reducers and SGS auto sampler spool pieces. All bolts had been sheared off between the ship's reducer and the manifold. Damage to the forward end of the hose rail, and the ship's rail forward of this, indicated that the hoses had been subjected to a pull from ahead, rather than from below or outward.
