Report on the investigation  
of the parting of the mooring line  
between the Tetney buoy and the North Sea shuttle tanker

***Randgrid***

resulting in the discharge of 12 tonnes  
of crude oil into the Humber Estuary  
on 20 December 2000

**Report No 6/2002  
February 2002**

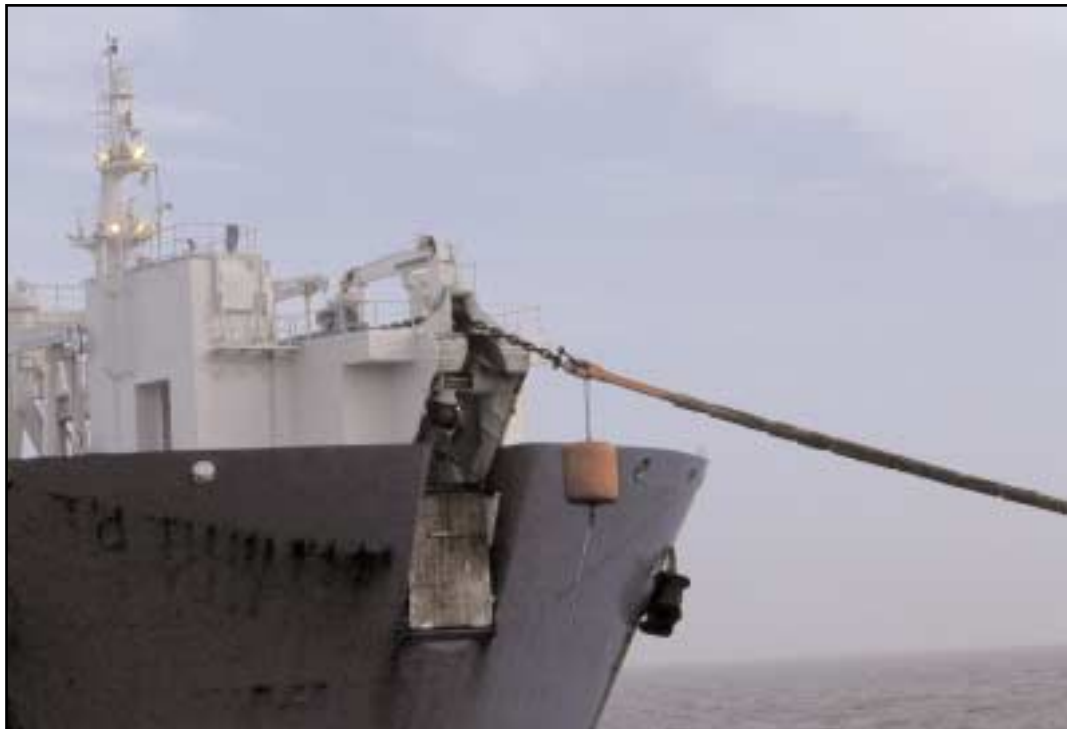
Figure 2

Vessel secured to buoy with hawser and chafing chain, the chain passing over bow roller and locked into the chain stopper

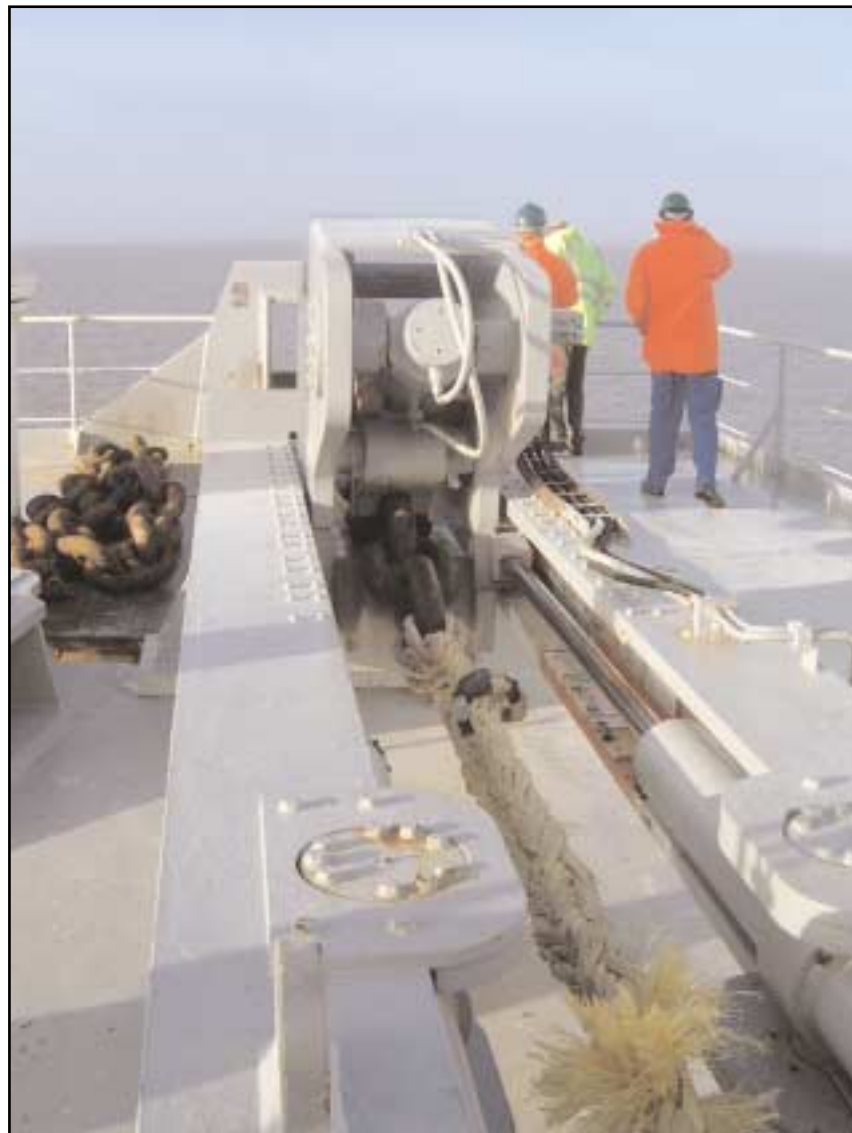
Figure 4

Inboard view of chain stopper showing messenger rope

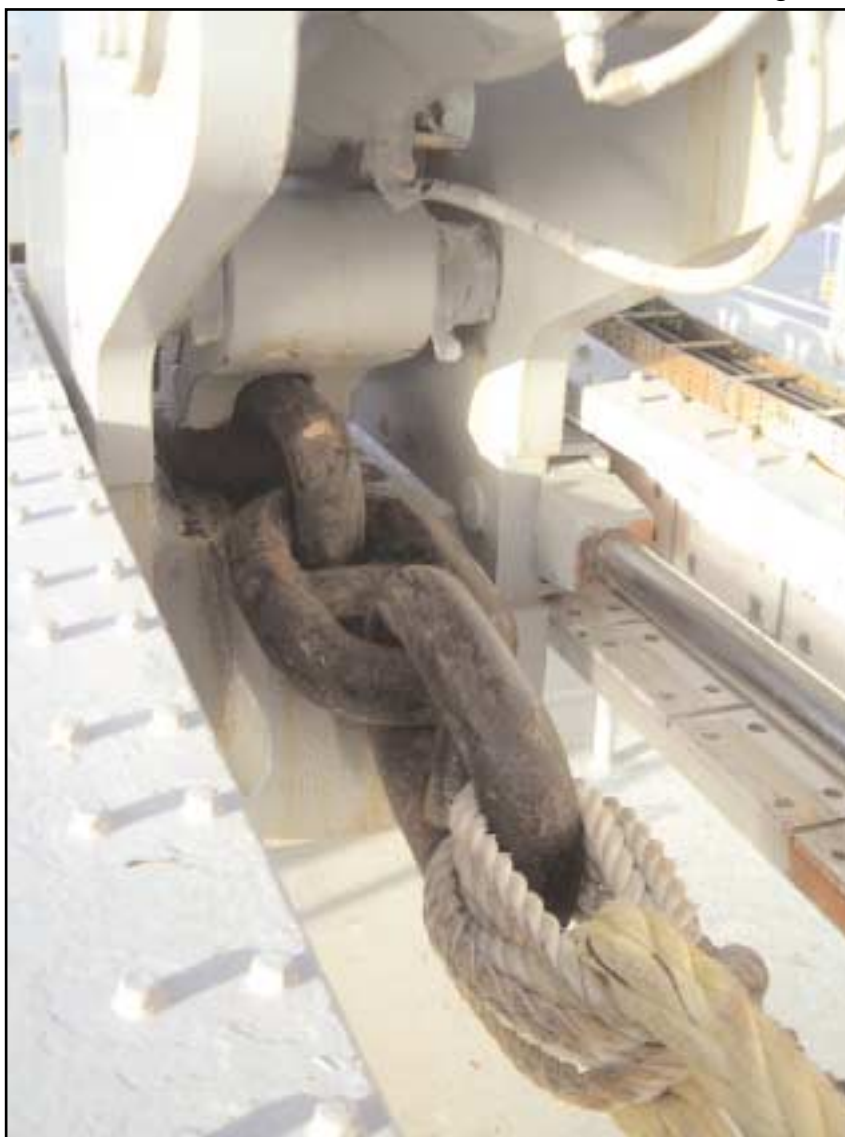
The chain stopper is essentially an hydraulically-operated steel claw and a shaped steel anvil. With one link in the chain positioned horizontally on the anvil, the claw is lowered on to that horizontal link. In that position the claw face sits on the horizontal link, while the aft claw face prevents the next chain link (in the vertical position) passing forward. By virtue of the claw rotating round a pivot point slightly aft of the chain lock point ("over centre"), any forward pull on the chain causes the claw to exert a greater mechanical clamping force. Once closed hydraulically, it can only be released by applying hydraulic pressure, either from accumulator bottles or when the hydraulic system is operational **(Figure 6)**.

Chain stopper with hydraulically-operated claw in the locked shut position

Following this incident, the designers of the BLS chain stopper system were invited on board *Randgrid* to carry out a systems check. On arrival they found that the chain stopper was in the closed position and had been so since the vessel left Tetney, the scene of the incident.

A visual inspection of the chain stopper found no material damage which would prevent the successful operation. The chain stopper was operated through a normal work cycle using a section of 76mm chain, and no defects were found in either the actual operation of the system, or visual display on the bridge monitor screen.

The PLC programme was checked, as were the 24-volt control valve solenoids for emergency release. Again no defects were found. Similarly, the positional sensors for the chain stopper were checked and were found fully operational. An oversize chain bar was placed on the chain stopper anvil and the system operated. The system correctly identified the oversize bar and failed to close, showing the correct message "chain stopper operating" on the bridge screen.
