Report on the investigation of

XUCHANGHAI

ABERDEEN

**Report No 30/2001
August 2001**

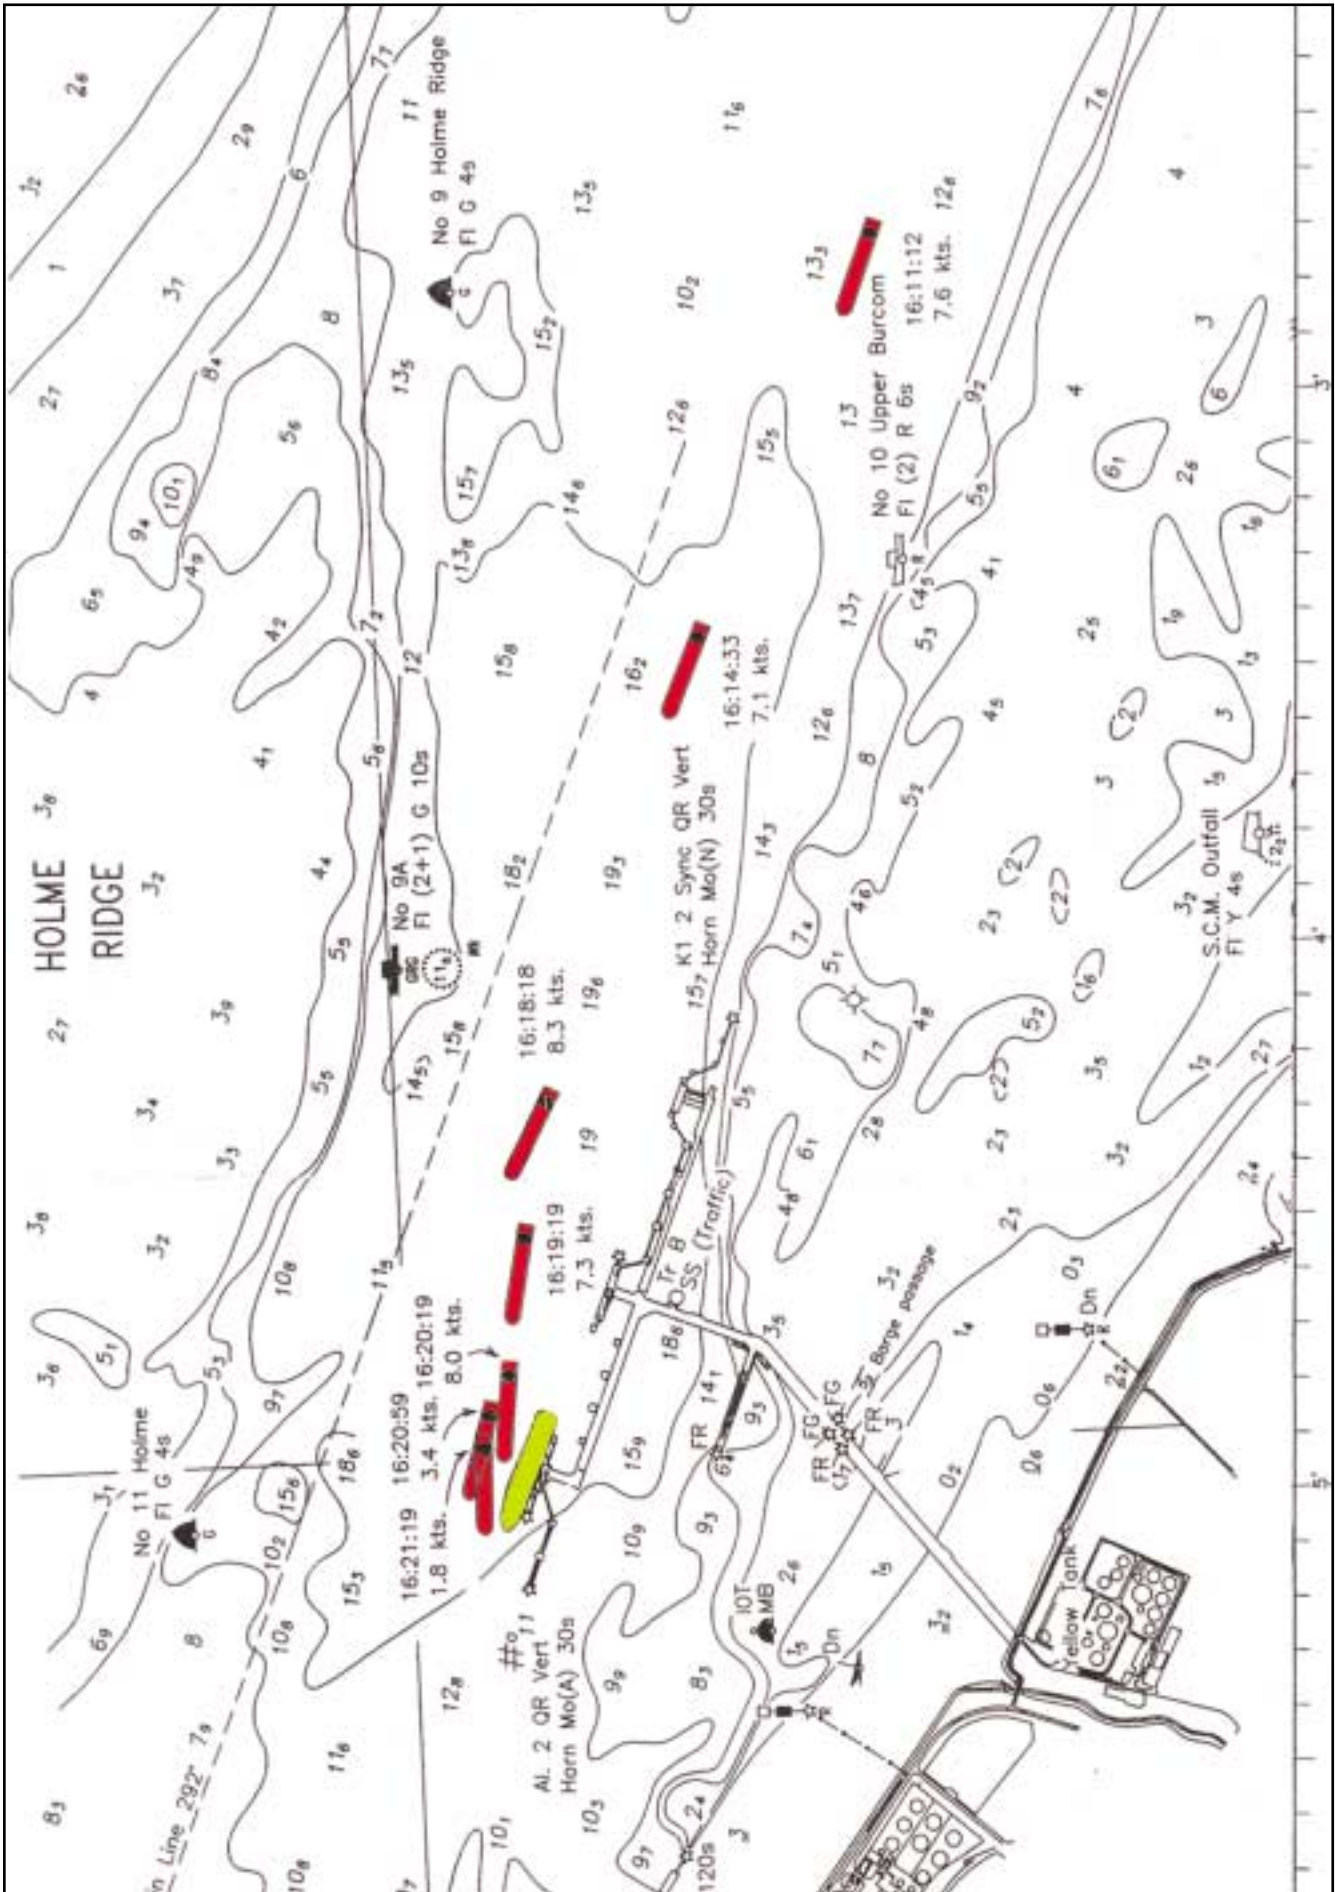
Track of Xuchanghai as recorded by Humber VTS

The navigable channel to the north of the IOT is shown at **Figure 1**.

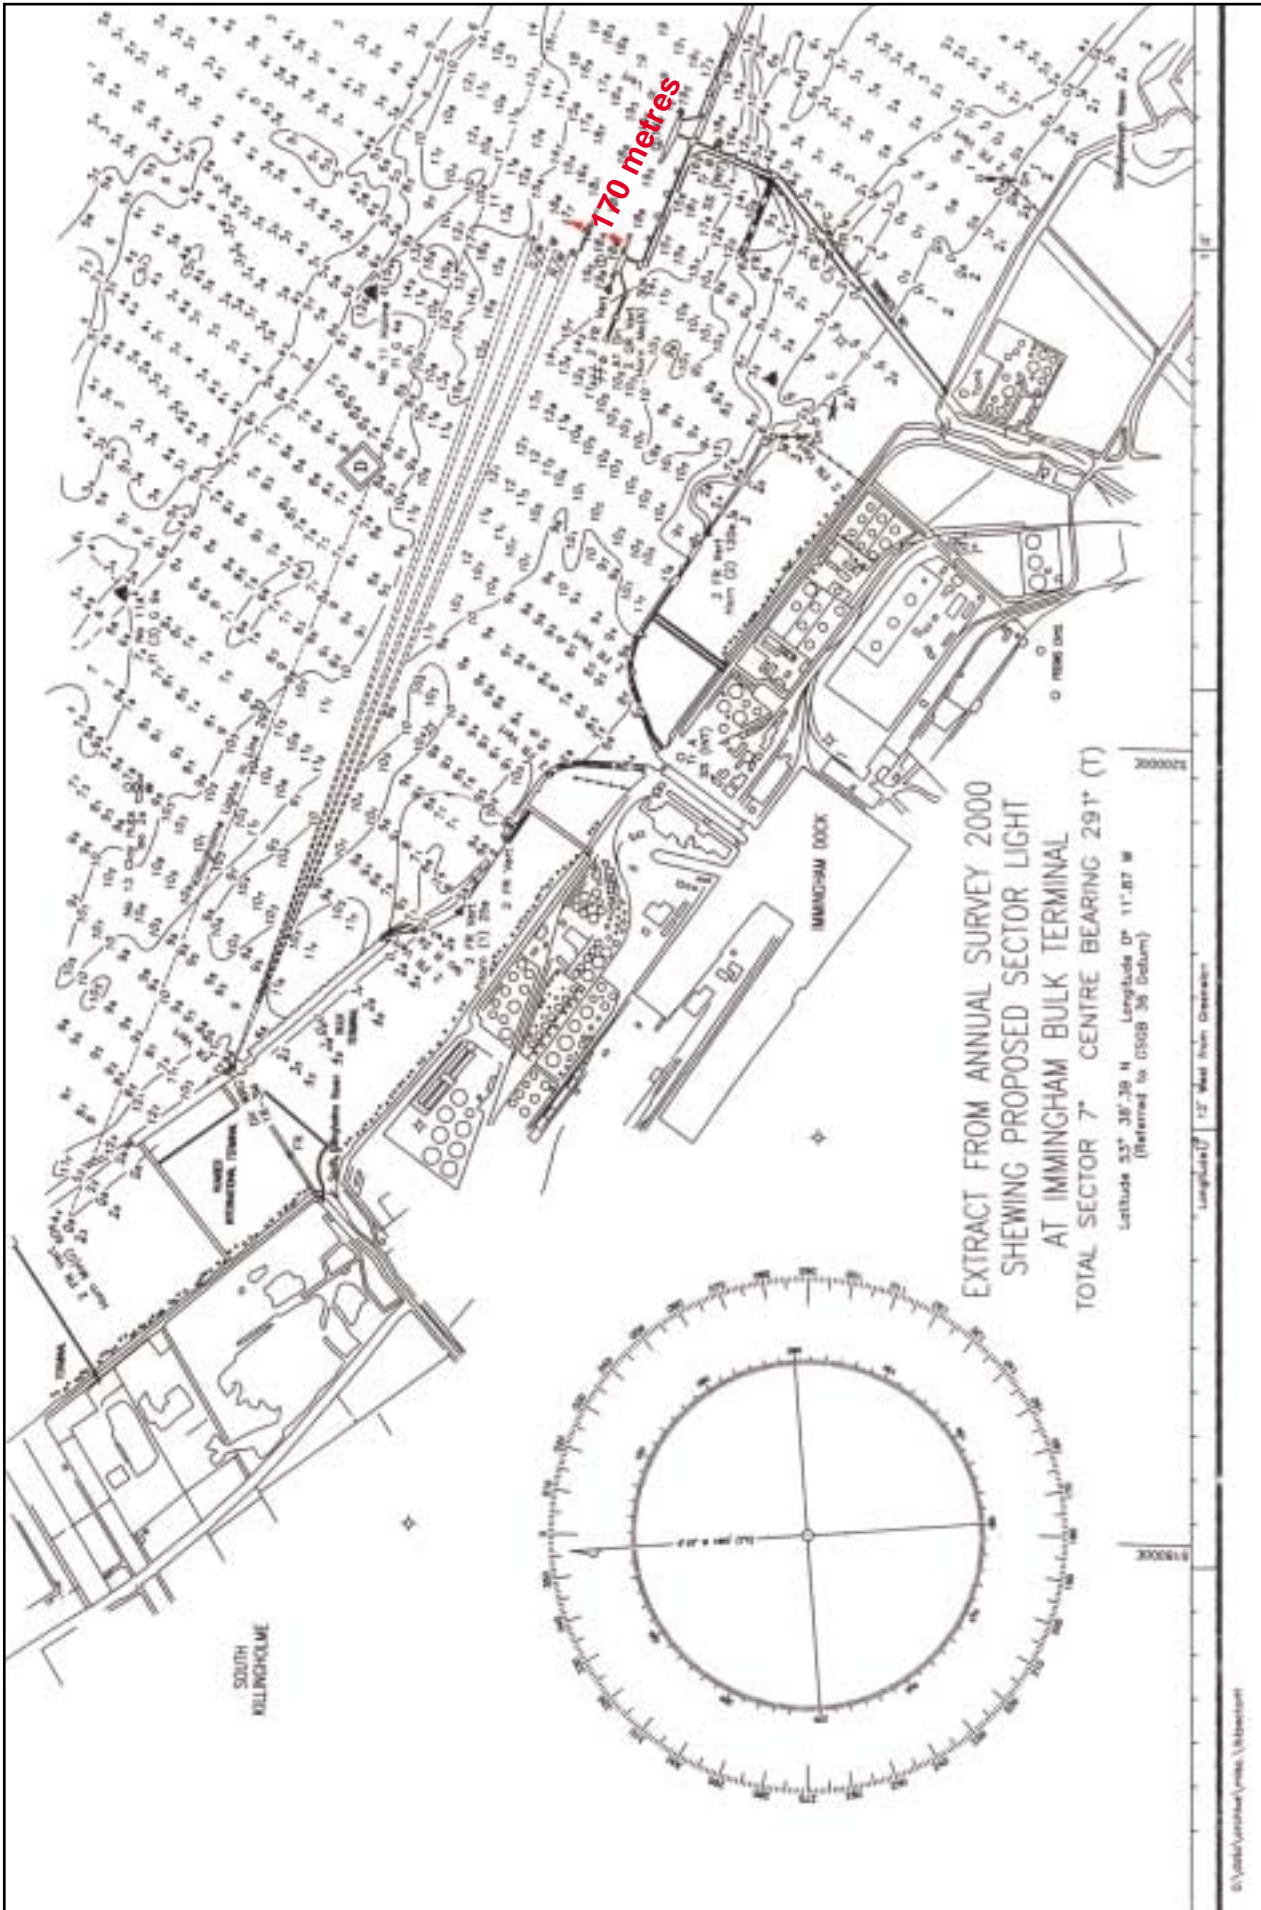
To aid vessels on the approach to the Humber International Terminal (HIT), ABP has installed a sector light on the terminal, in position 53°38'39N 000° 11'87W (OSGB 36 datum). The position of the light and its sectors is shown at **Figure 5**. The central white sector is displaced about 170m from the face of IOT No 1.

Details of the New Sector Light

The provision of the sector light on the HIT, albeit for other reasons, should help pilots and masters visually assess their distance off the IOT accurately, and also allow them to detect the set experienced quickly.
